Arroyo Threat Assessment Surveys of 15 Major Arroyos in the Santa Fe River Watershed

June 21, 2016

Santa Fe Watershed Association

Report to Melissa McDonald, River & Watershed Coordinator, Public Works Dept., City of Santa Fe 2016

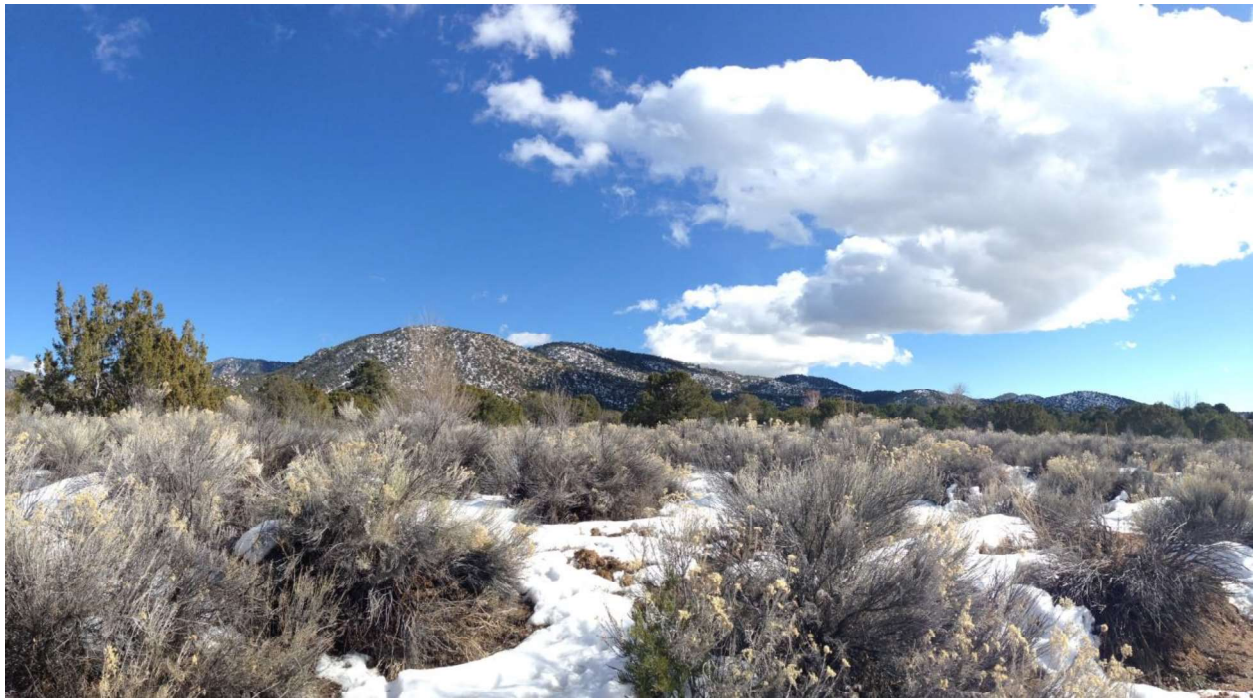
Segment B/ Broad open plain on the Arroyo de los Chamisos, 2016.

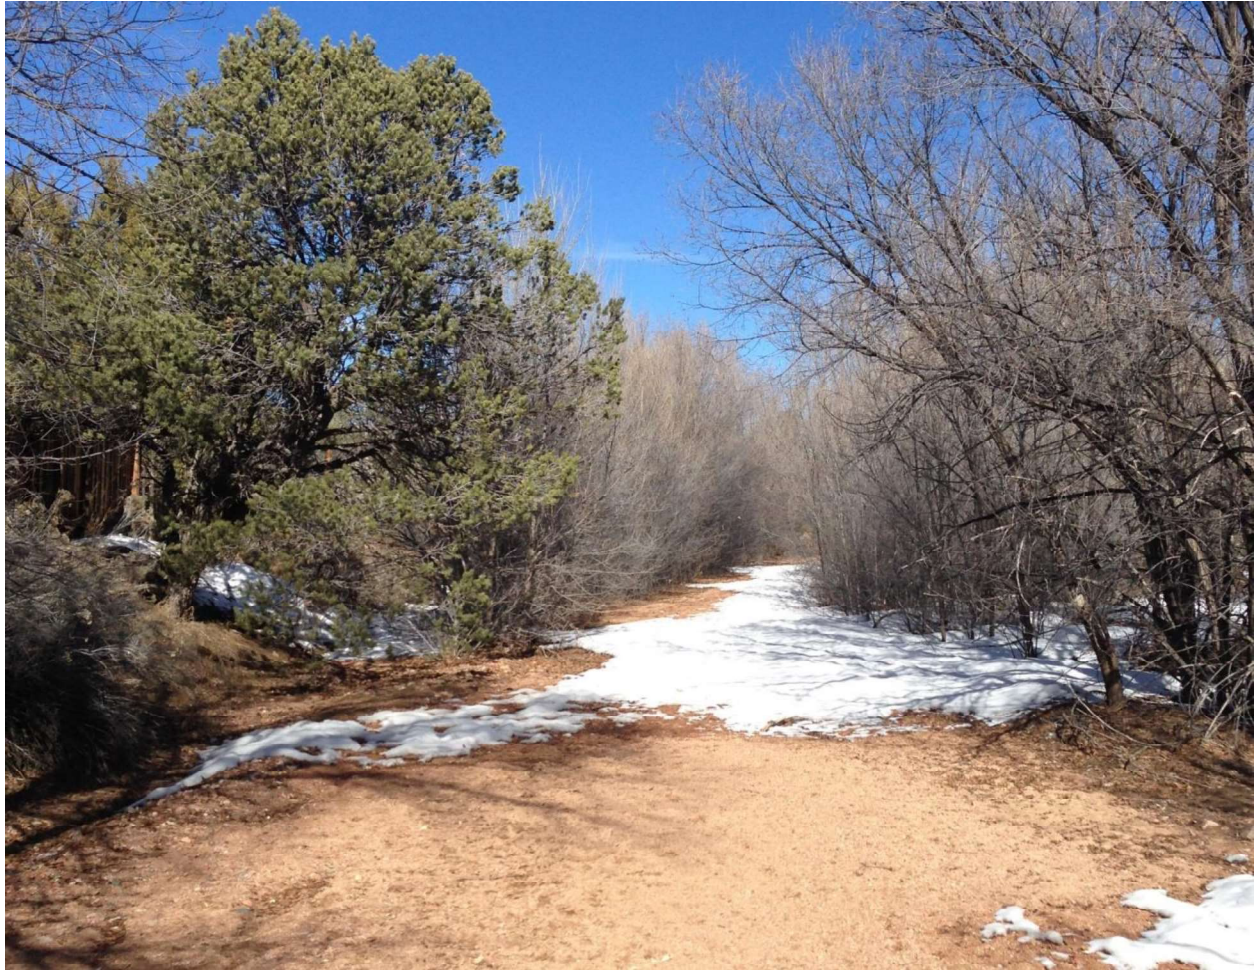
Segment C/ Illustration of the channel characteristic in Arroyo de los Chamisos, 2016.

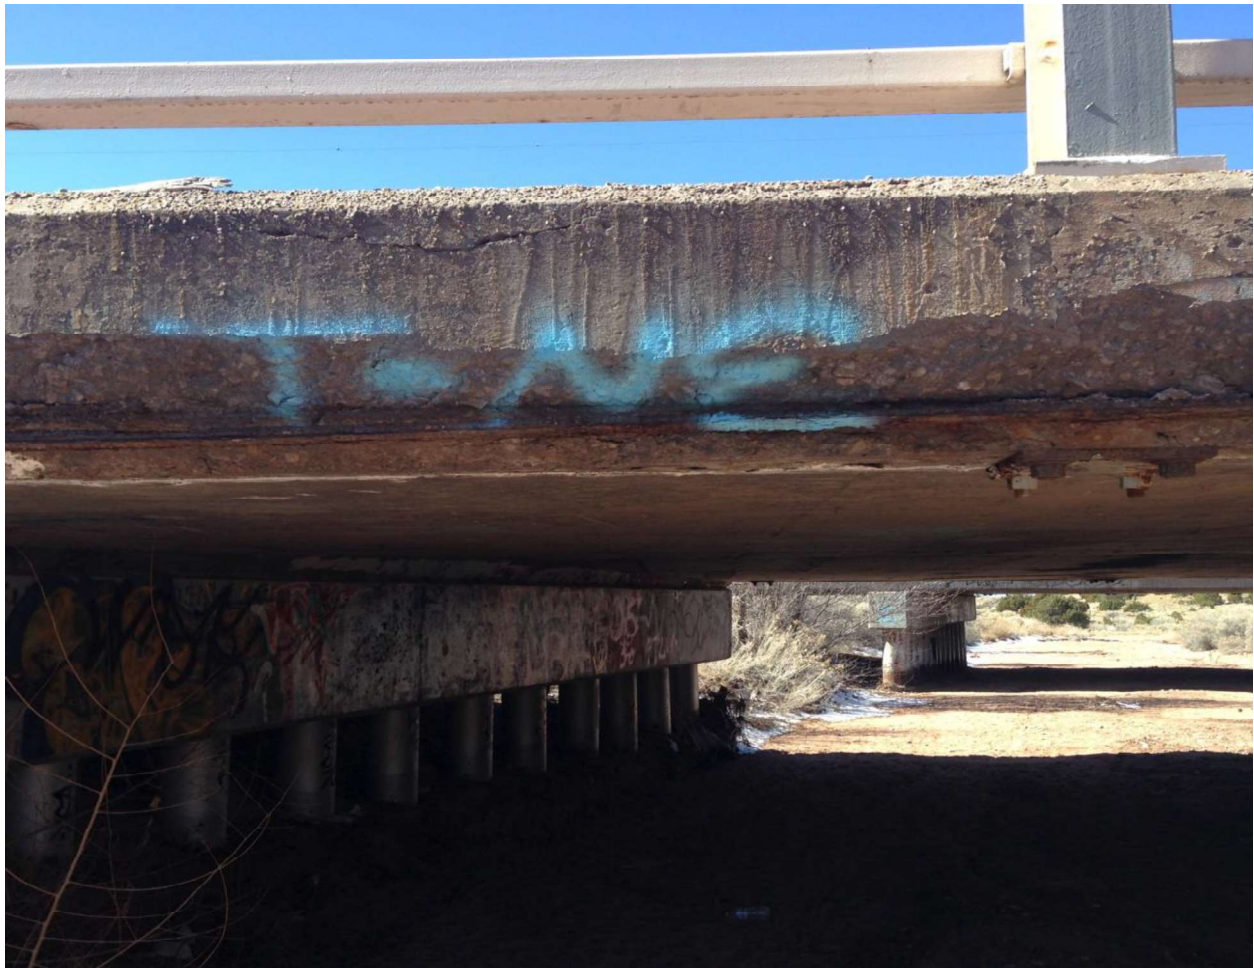
Segment C/ S. St. Francis Bridge with damage in 2016, Arroyo de los Chamisos, and 2016.

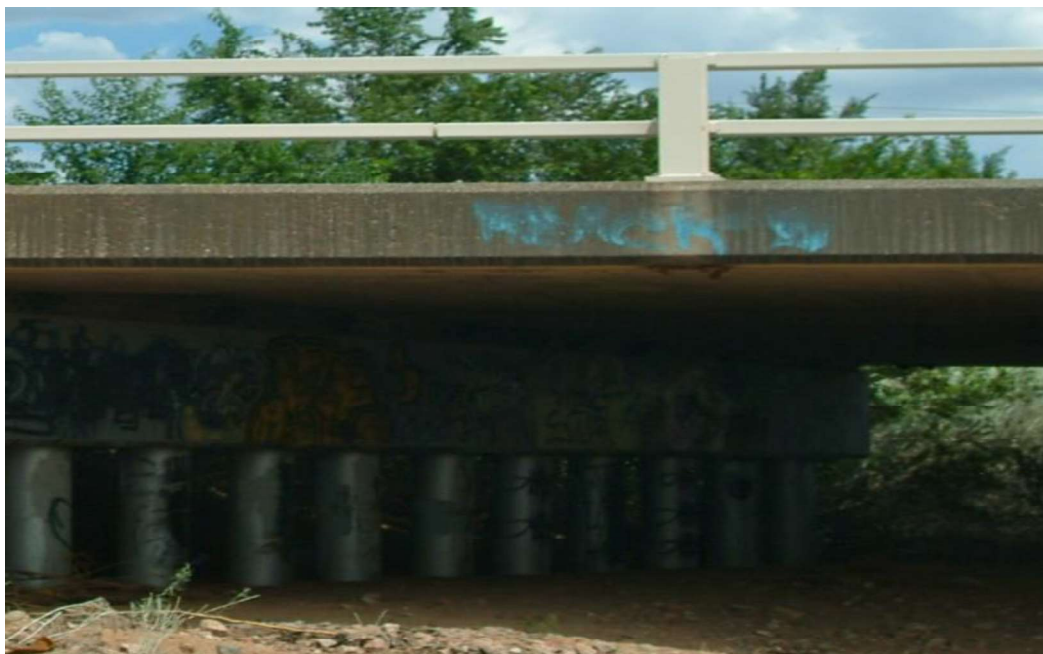
Segment C/ 2012 S. St. Francis Bridge same location as above photo, 2012 Arroyo de los Chamisos.

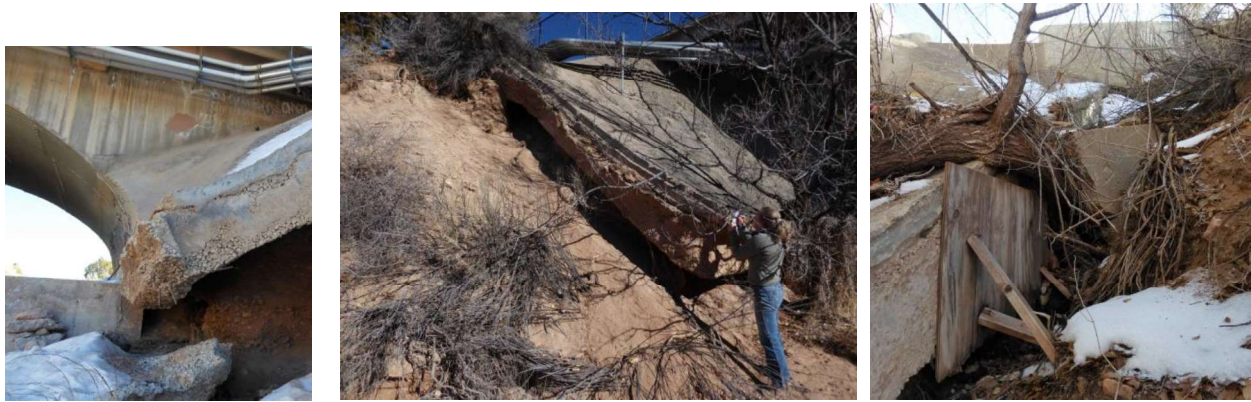
Notes: The arroyo segment has been severely incised due to poor drainage, soil type, natural and artificial constrictions. The height of an intermittent system of vertical walls increases as the arroyo channel drops in elevation. The corridor of these highly eroded vertical walls begins about 145 feet below the Santa Fe Rail Trail. The longest, continual, vertical wall system in the arroyo is approximately 1,300 feet in length. It is found in here. Although it is the longest corridor, the 1,150 foot section of vertical bank between the two Vo-Tech bridges is the most dangerous regarding trail safety and infrastructure stability.

Segment D/ Vo-Tech Bridges with examples of eroding banks and footings, Arroyo Chamisos, 2016.

Improvements since 2012 have helped protect sewage lines and minimized the impact of storm water in some areas. Segment D of Arroyo de los Chamisos is a high -risk area in much need of remediation. Immediate corrective action to the vertical banks along the Arroyo Chamisos trail between the Vo-Tech bridges is recommended.

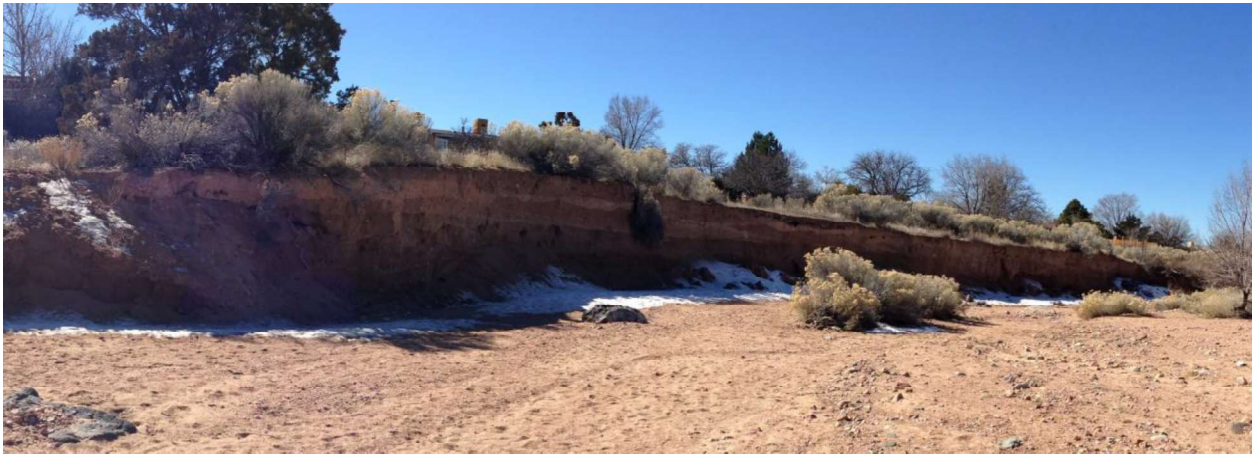
Segment F/ Bank erosion, Arroyo de los Chamisos, 2016.

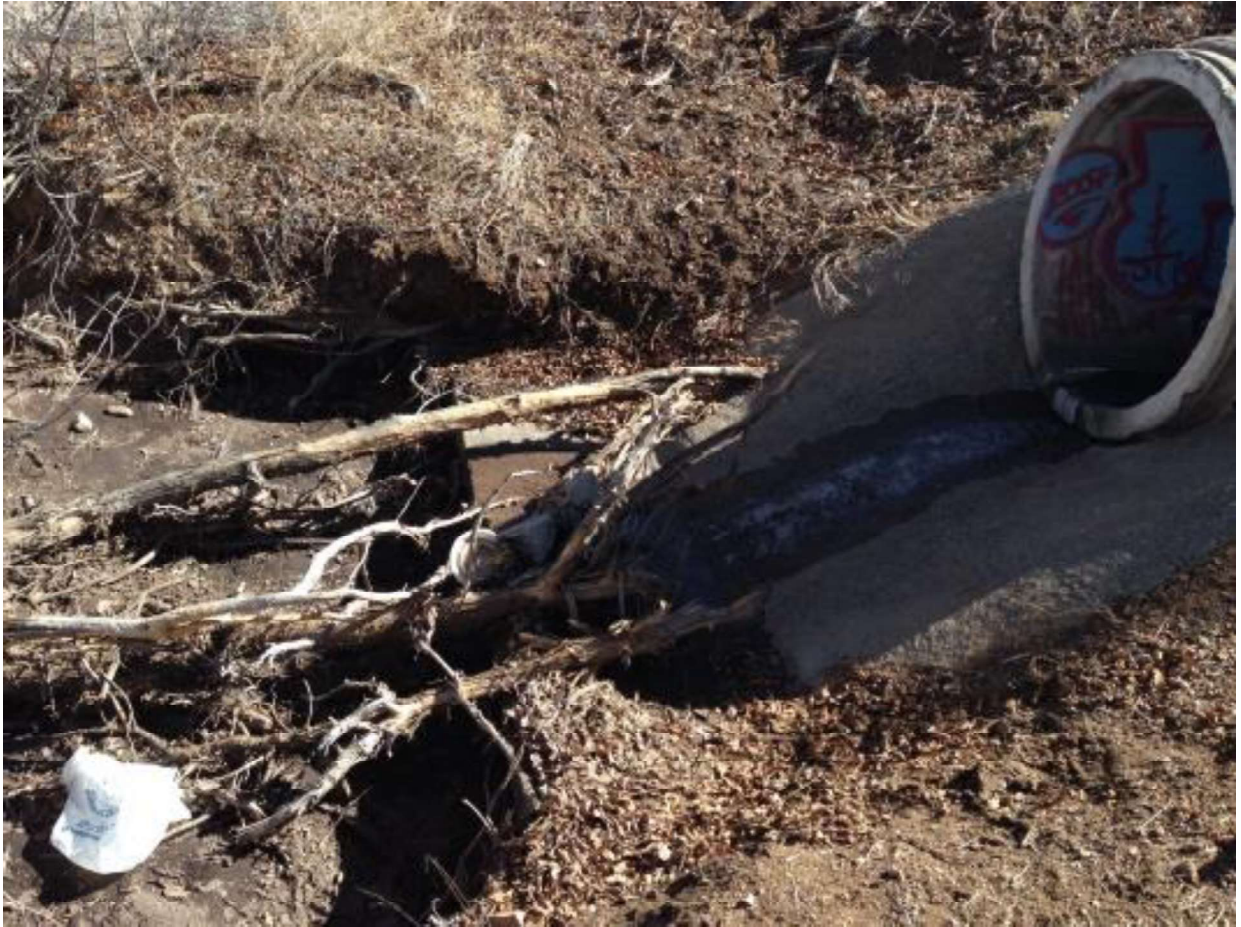
Segment F/Possible location for infiltration basin, Arroyo de los Chamisos, 2016.

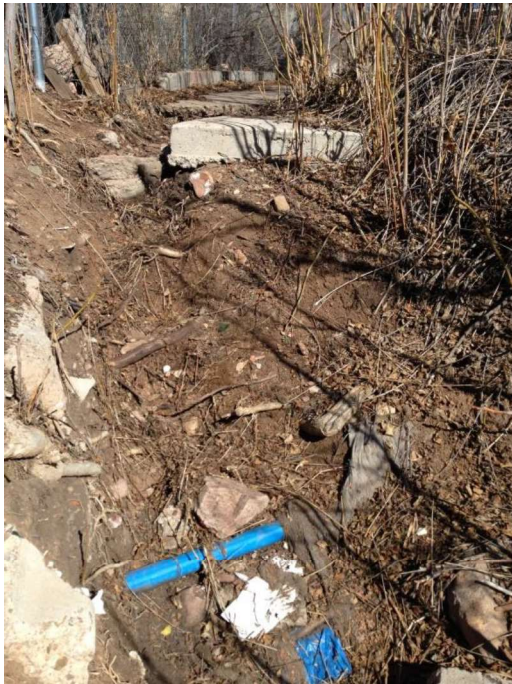
Segment G/ Exposed utility pipe, Arroyo de los Chamisos, 2016.

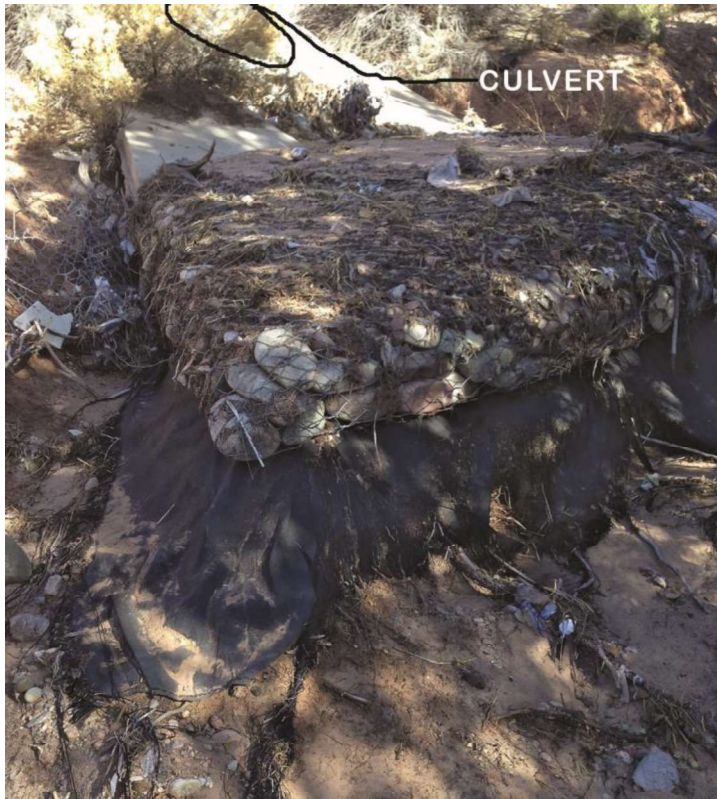
Segment A/ Erosion beneath rip rap mat, Arroyo Rosario, 2016.

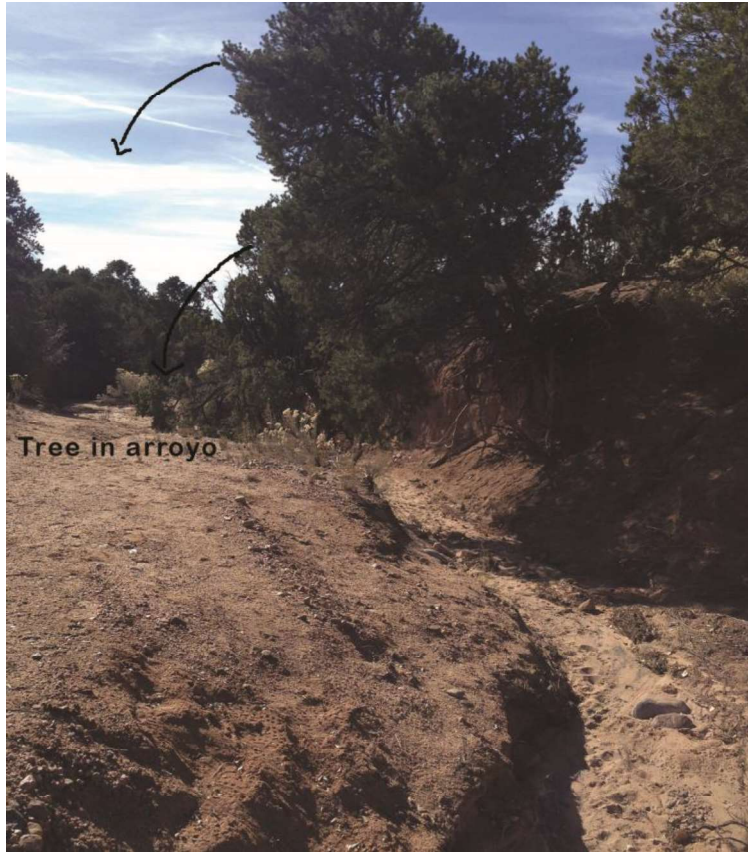
Segment B/Trees become natural barriers, Arroyo Rosario, 2016.

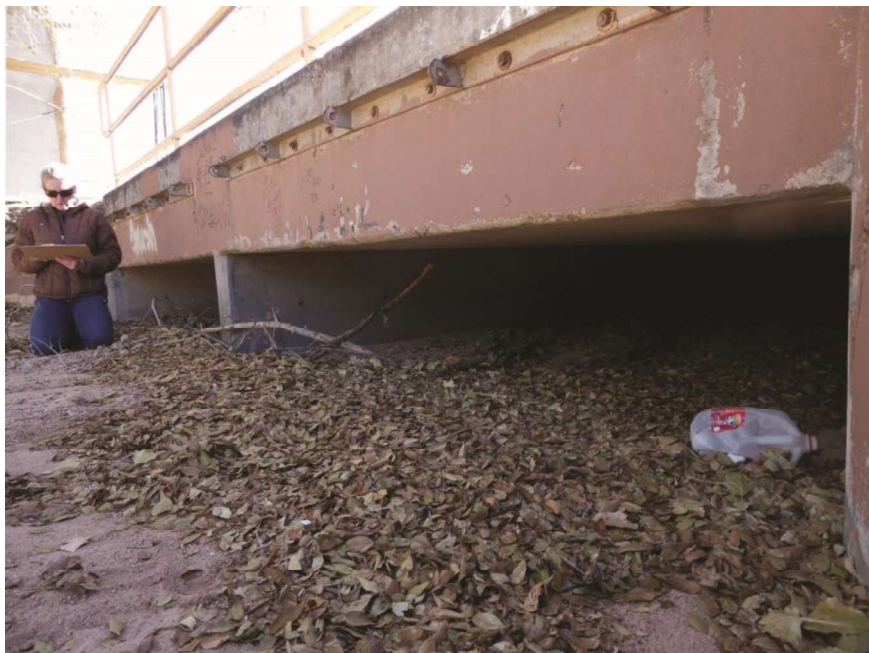
Segment E / Paseo de Peralta box filled with sand, Arroyo Rosario, 2016.

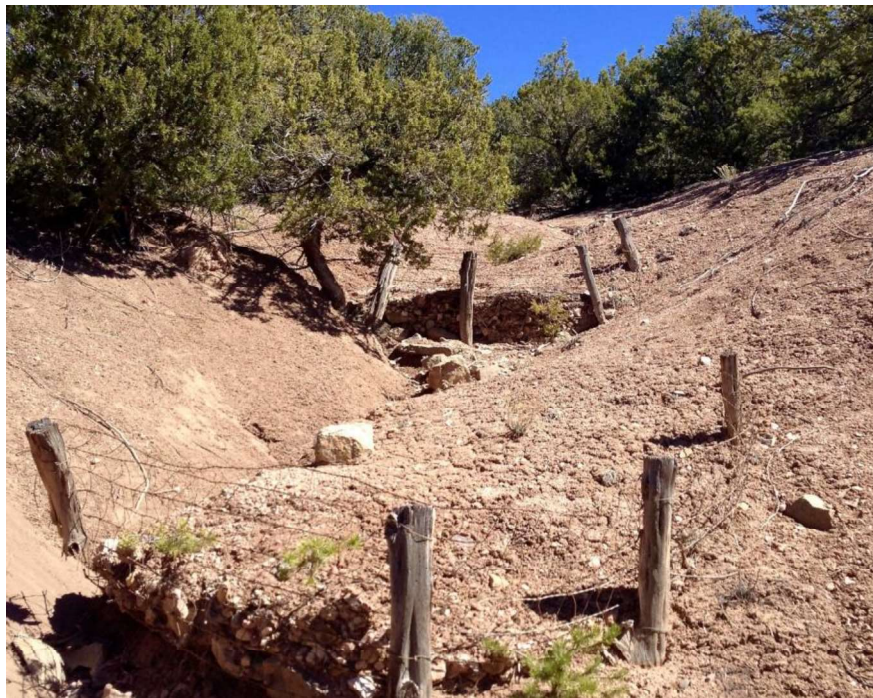
Old silt fencing in the upper Arroyo Saiz, 2016.

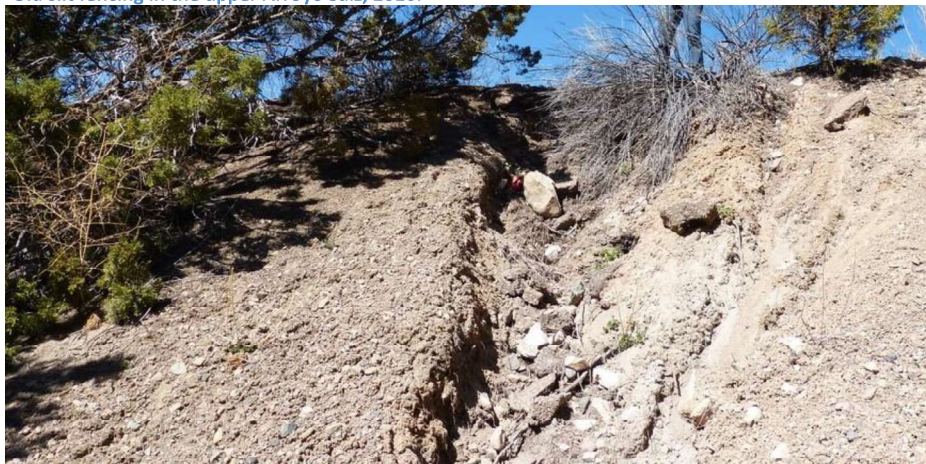
Erosion of f Hyde Park road into the Arroyo Saiz, 2016.

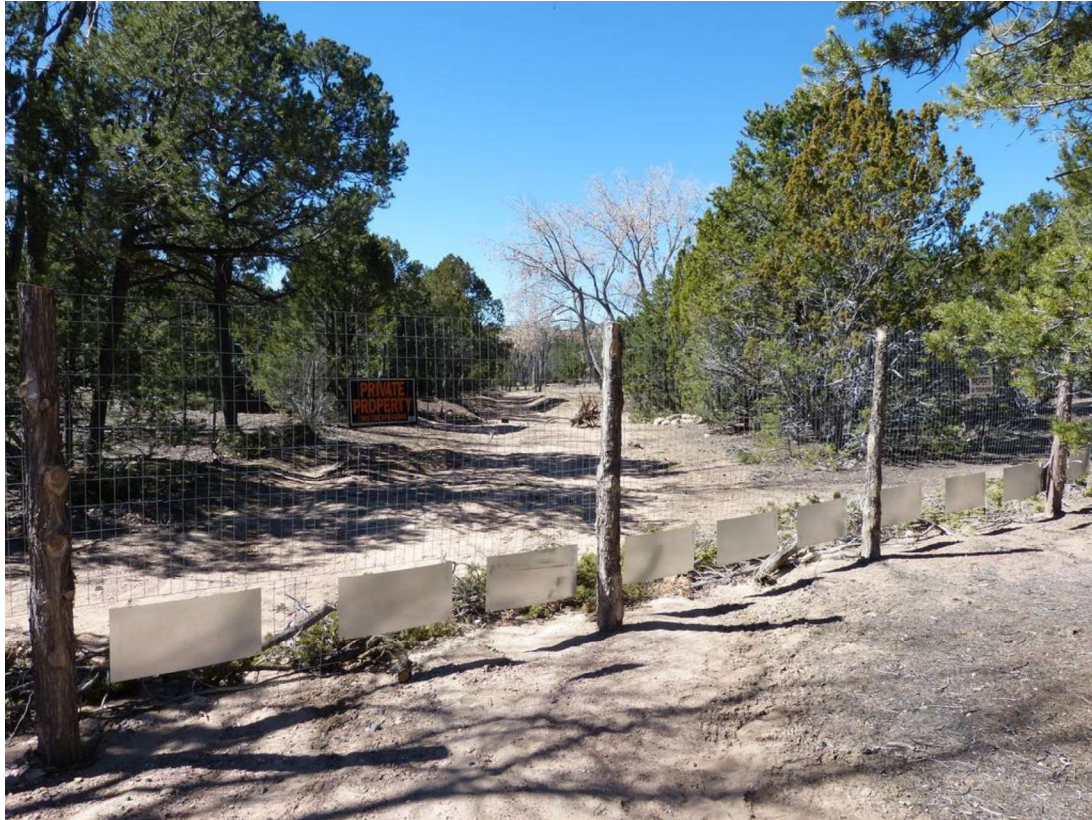
Two separate areas in the arroyo have been fenced off. These fences span the arroyo which may impede storm water flow and are questionable regarding public/private right of ways.

Fencing across the Arroyo Saiz, 2016.

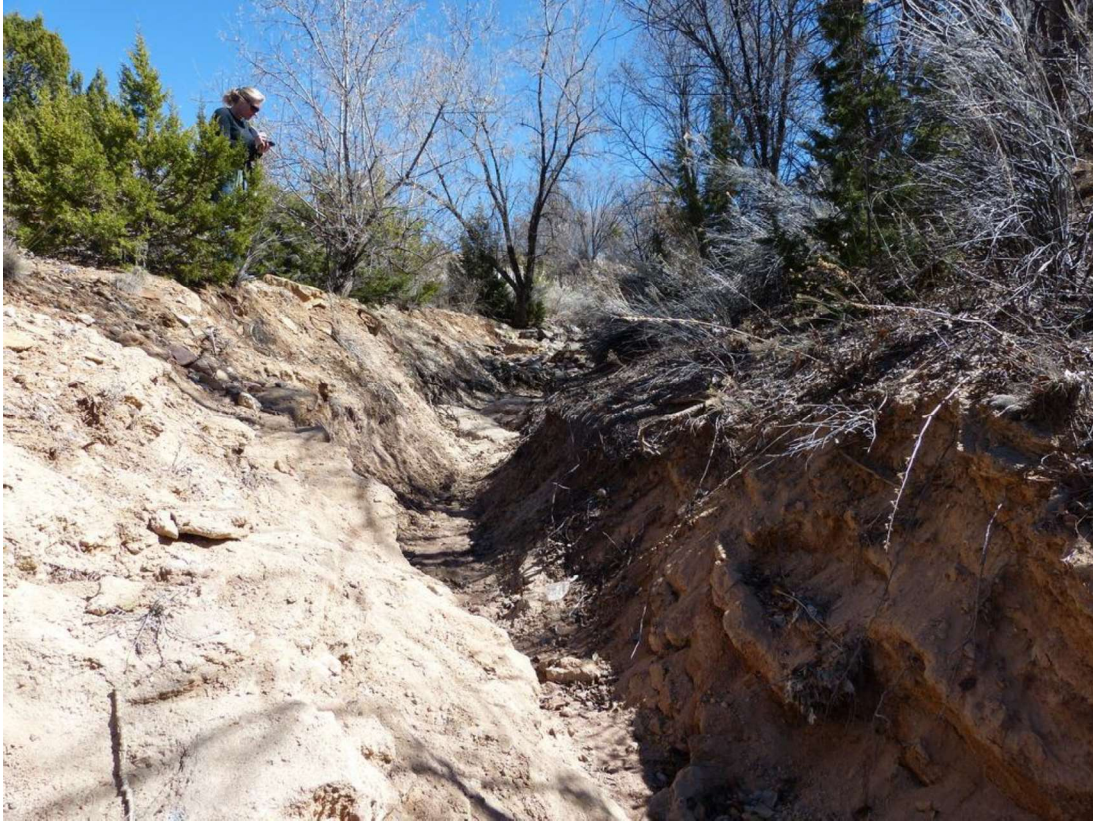
An incised area in the Arroyo Saiz, 2016.

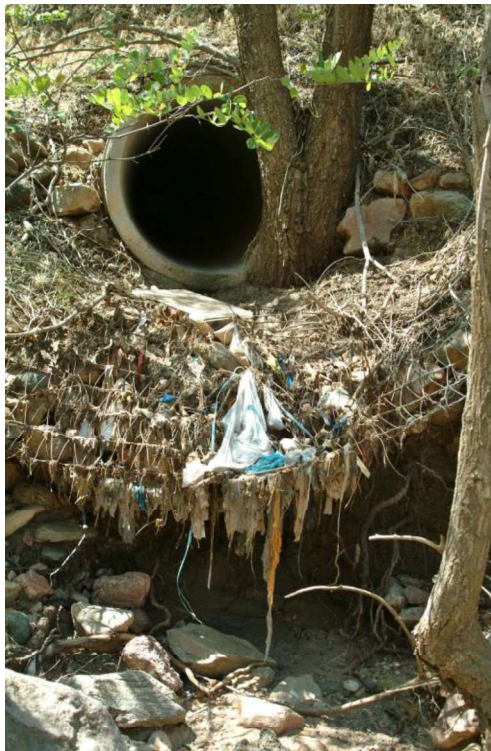
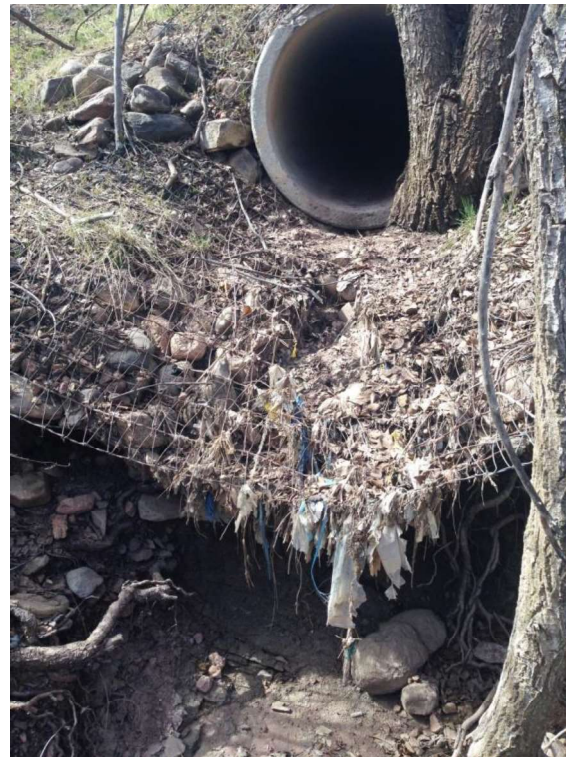
A bank along the Arroyo Cabra continues to rapidly deteriorate in the same location as noted in 2012. Storm water, directed into the arroyo through a culvert, falls onto a rip rap mat that is no longer supported by an earthen bank. The high flow from this water will continue to aid in the rapid deterioration of the bank. The lower arroyo has been officially adopted by Desert Montessori through an Adopt an Arroyo program with the Santa Fe Watershed Association.

Undercut rip rap 2012 and trash below a culvert off Camino Cabra vs 2016, Arroyo Cabra, 2016

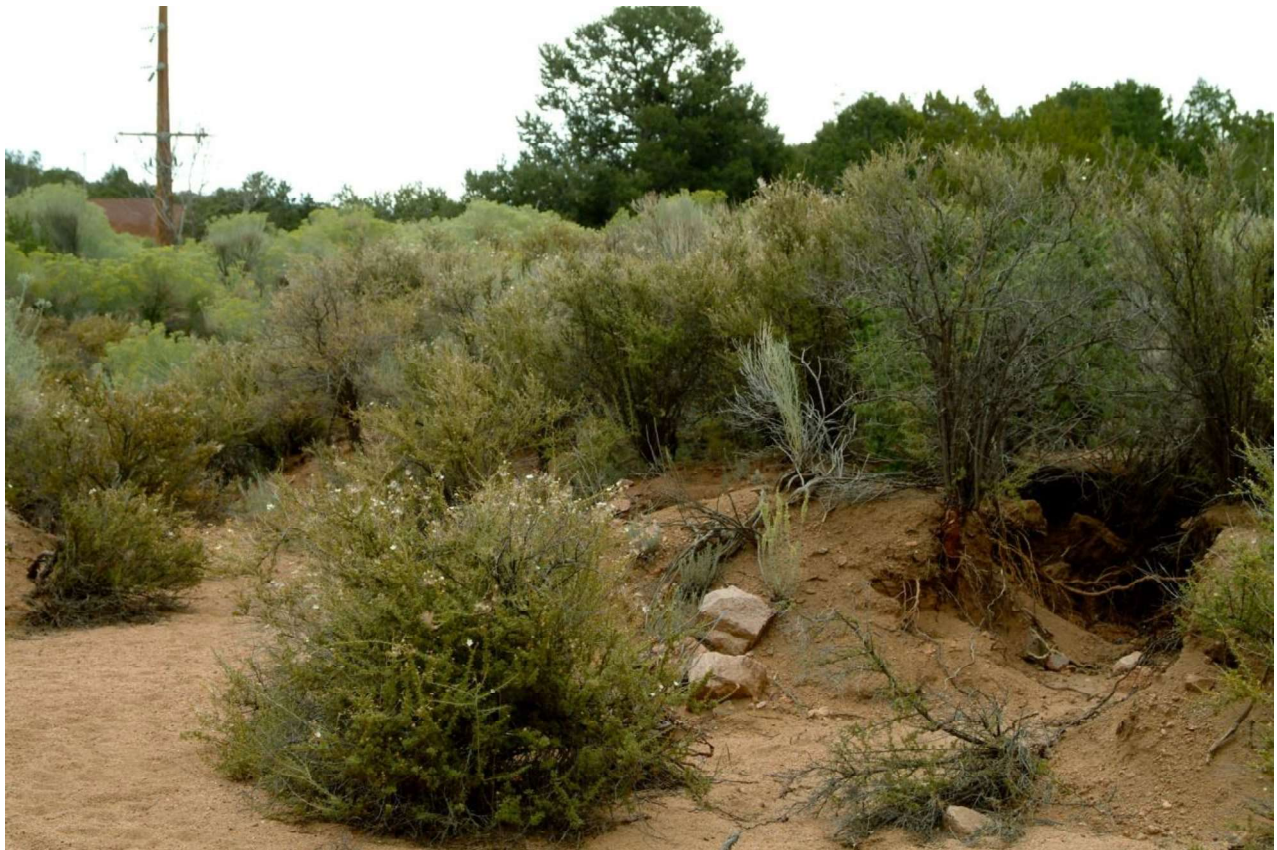
Segment A/ Incising of Upper Arroyo en Medio, 2016.

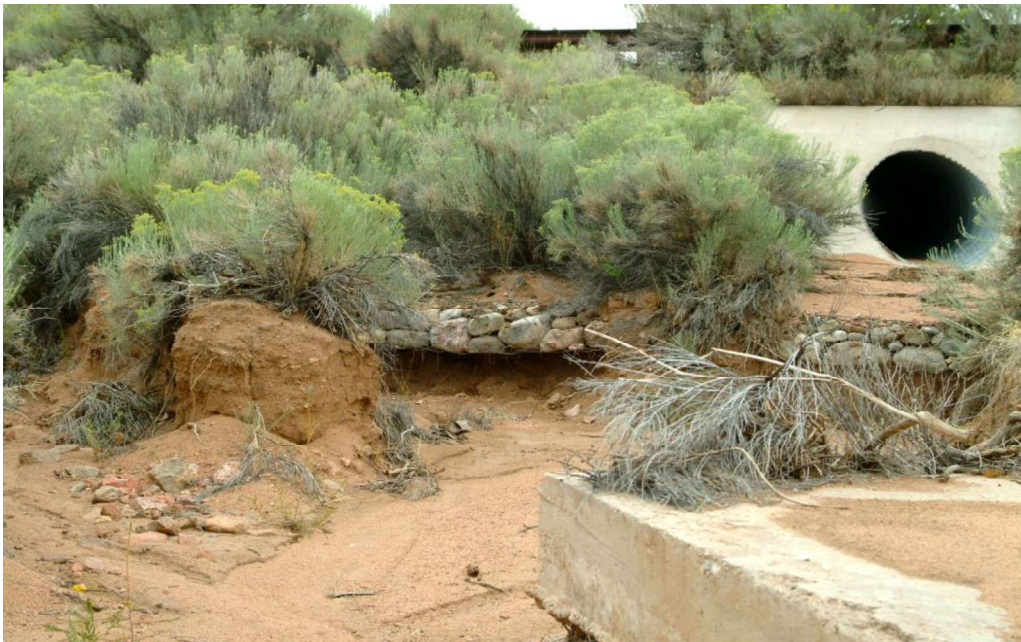
Segment D/ Example of one of many undercut rip rap, banks, in Arroyo en Medio, 2012.

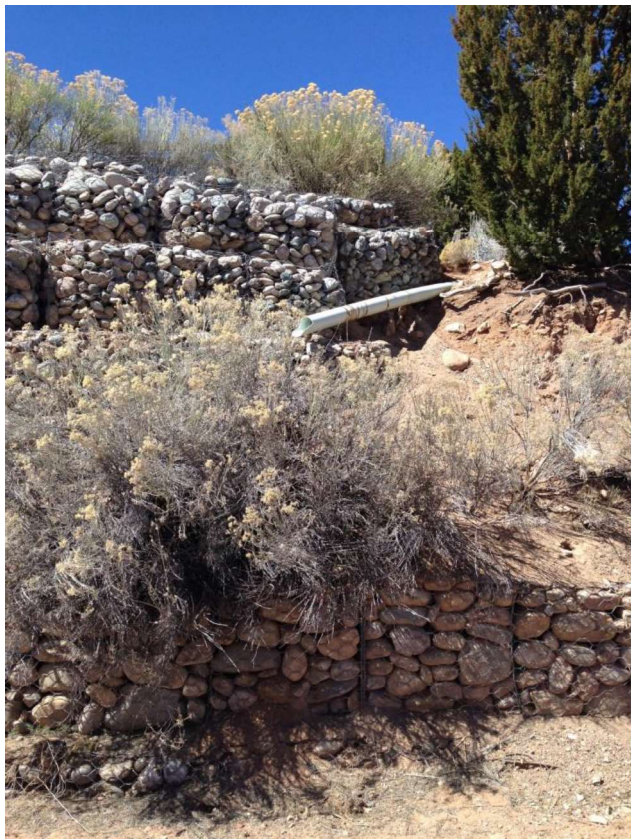
Segment F/Questionable drainage lines into Arroyo en Medio, 2016.

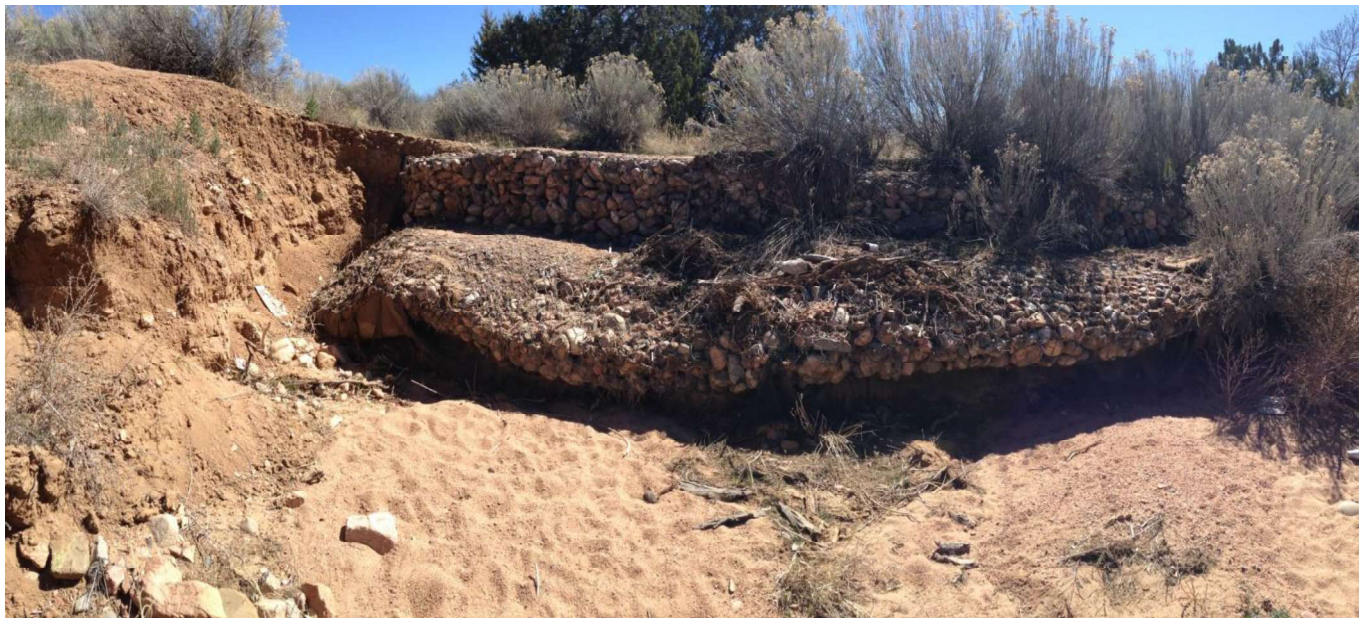
Segment G/Undercut rip rap mat, Arroyo en Medio, 2016

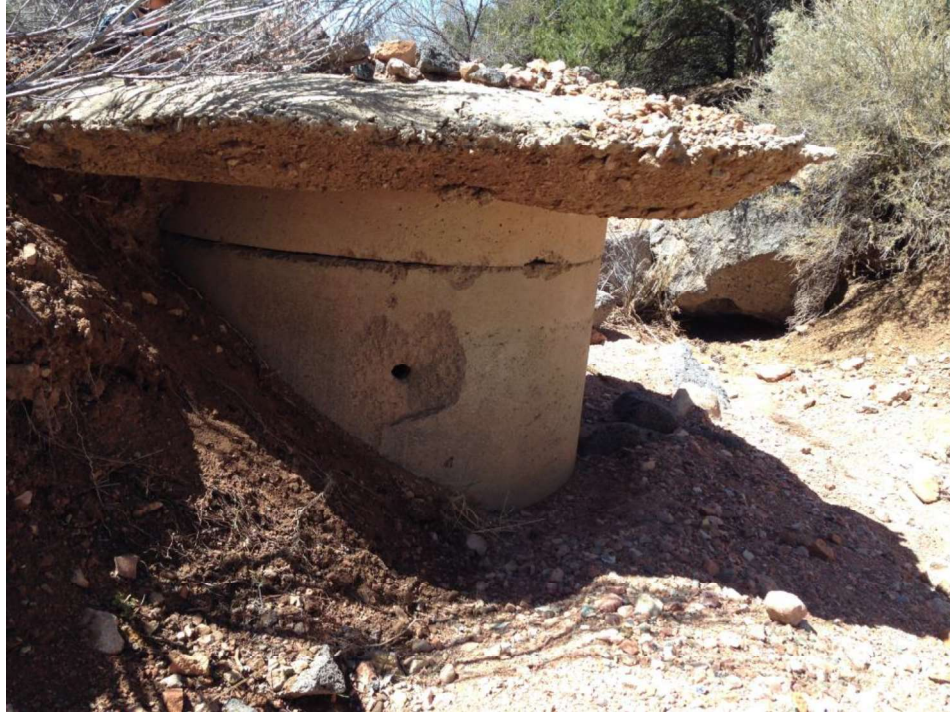
Segment A/One of four sewage outlets emanating noxious odors, Arroyo Ancha, 2016

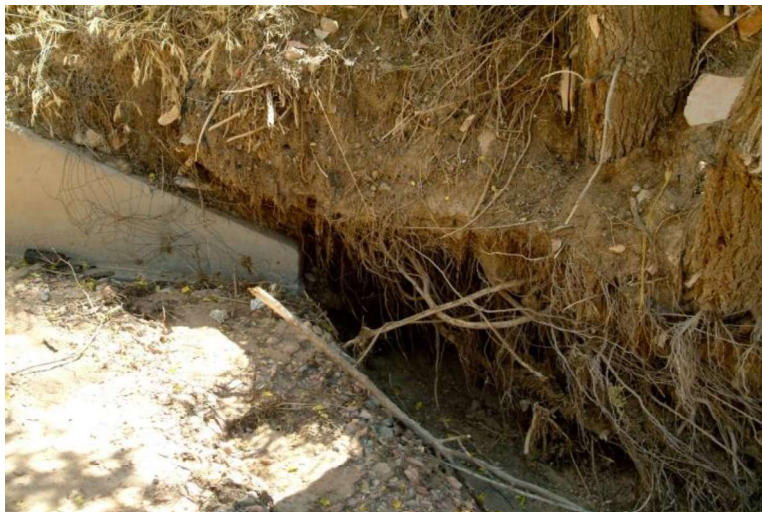
Segment B/ Bank erosion by check dam, Arroyo Ancha, 2016

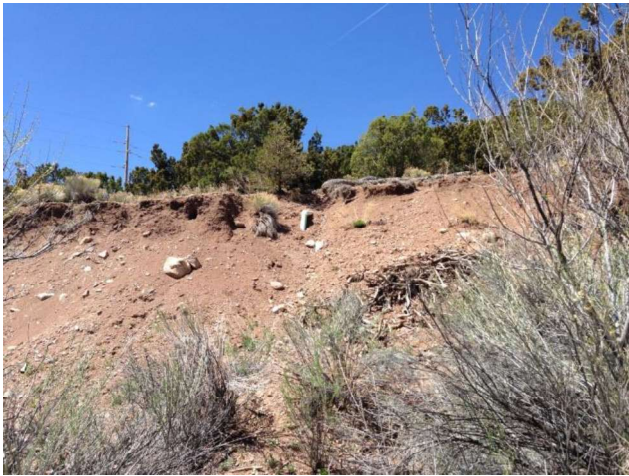
Segment B /Expose pipe at crest of bank, Arroyo Ancha 2016.

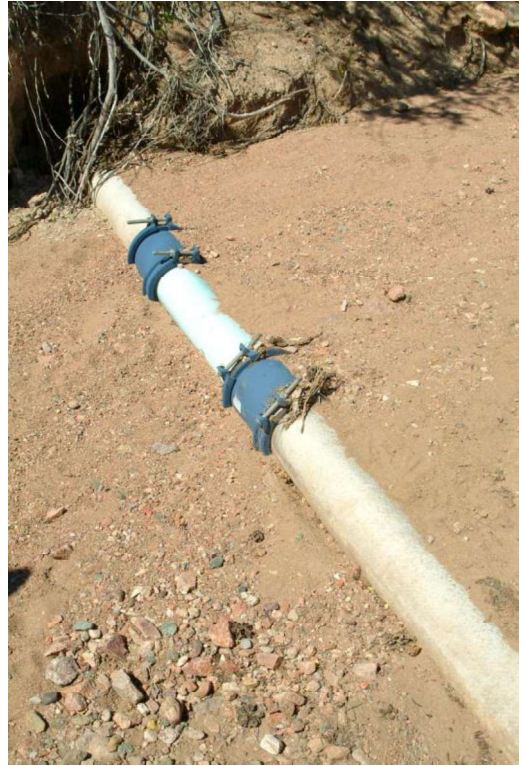
Segment B/ Utility line in bed of the arroyo, appears to be in the same condition, Arroyo Ancha 2012 – 2016 .

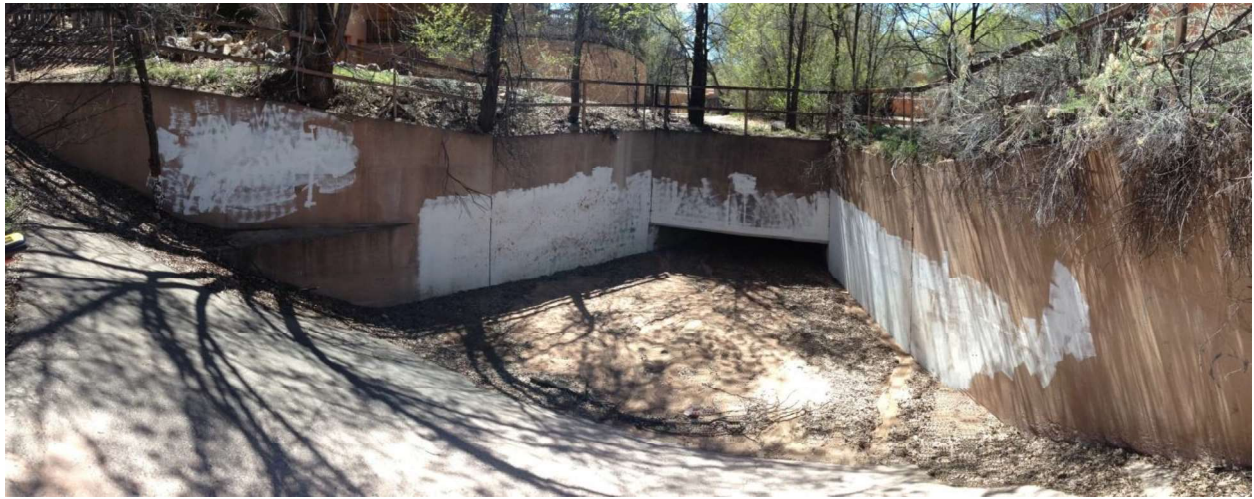
Segment B/ Sediment level rises beneath box culvert E. Alameda St. in Arroyo Ancha, 2016

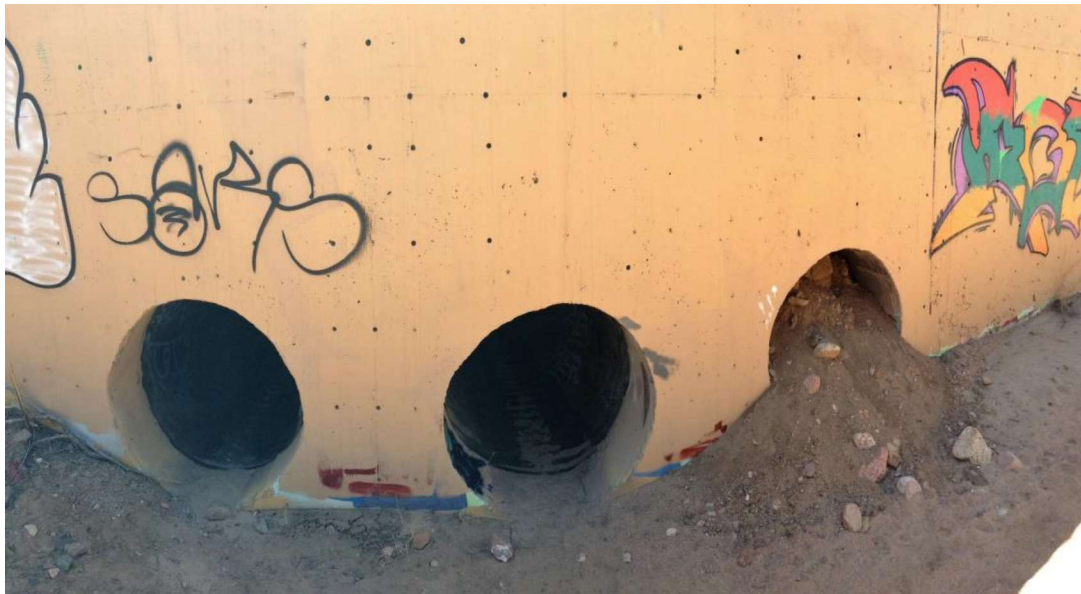
Segment A/ Obstructed culvert, Old Pecos Trail, Upper Arroyo Pinos North, 2016

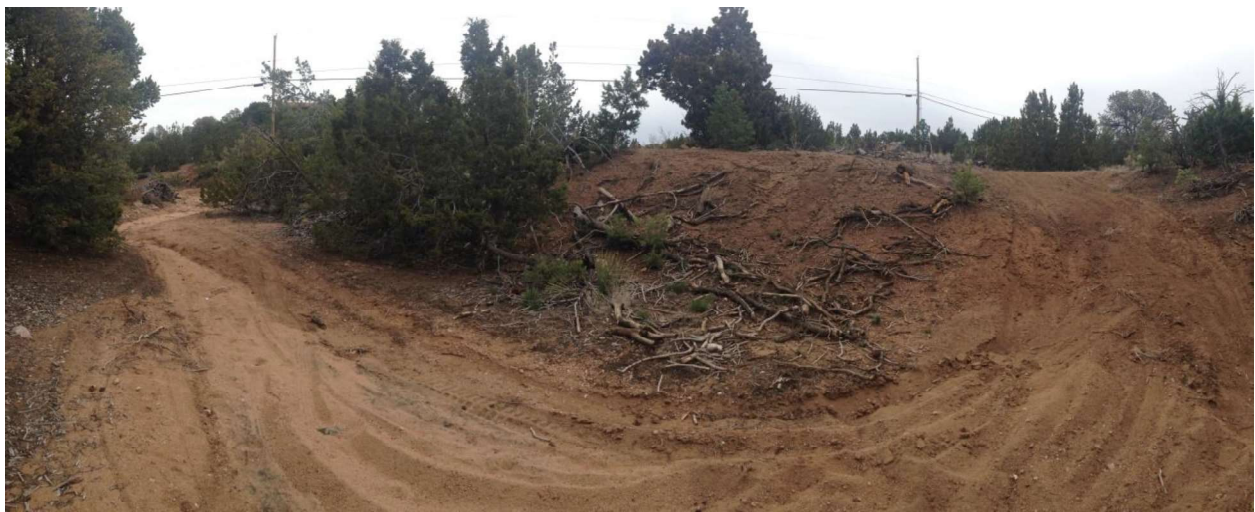
Segment B/New road entering Upper Arroyo Pinos South, 2016.

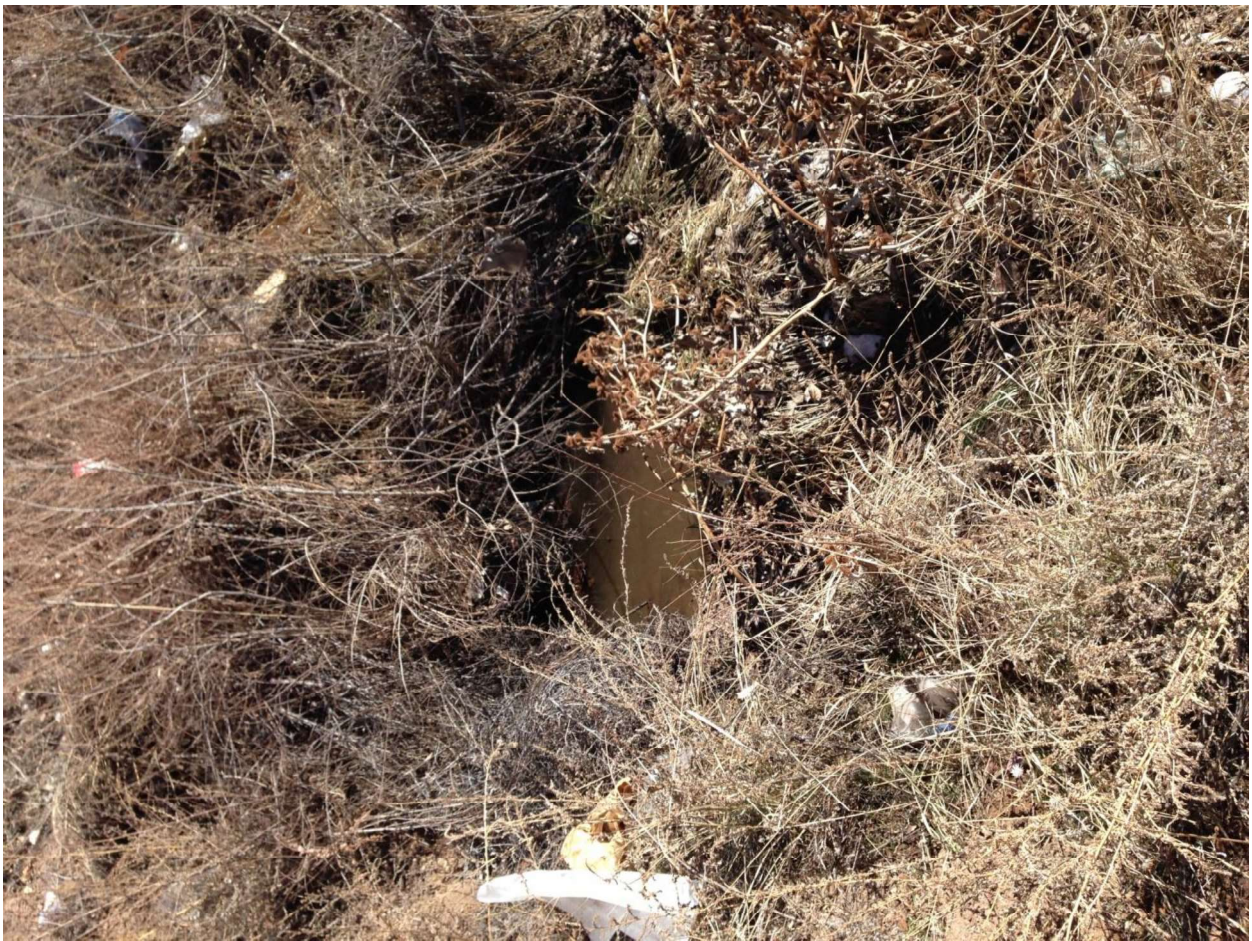
Segment X/ Restricted, sunken culvert, Lower Arroyo Pinos, 2016.

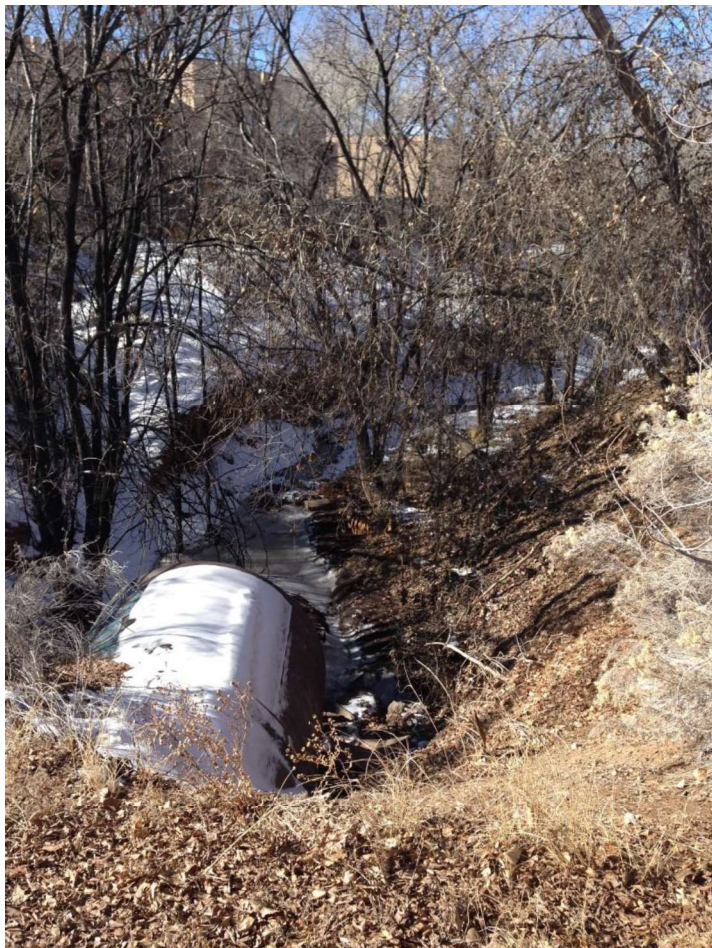
Segment A/Arroyo Pinos culvert located below St. Francis Drive, 2016

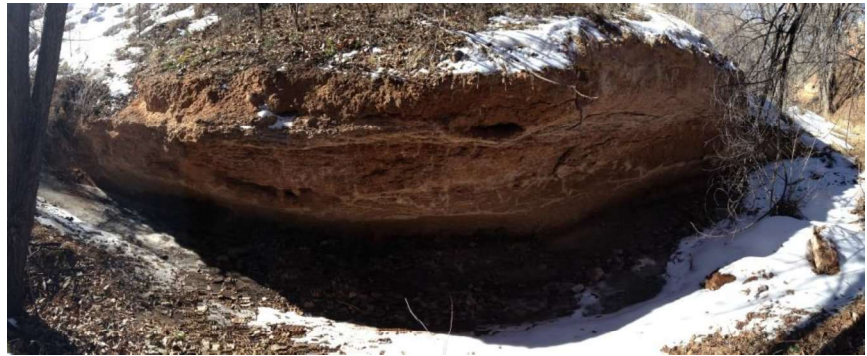
Segment A /Left photo 2012 bank erosion ; photo right 2016 bank erosion same location. Lower Arroyo de los Pinos,2016.

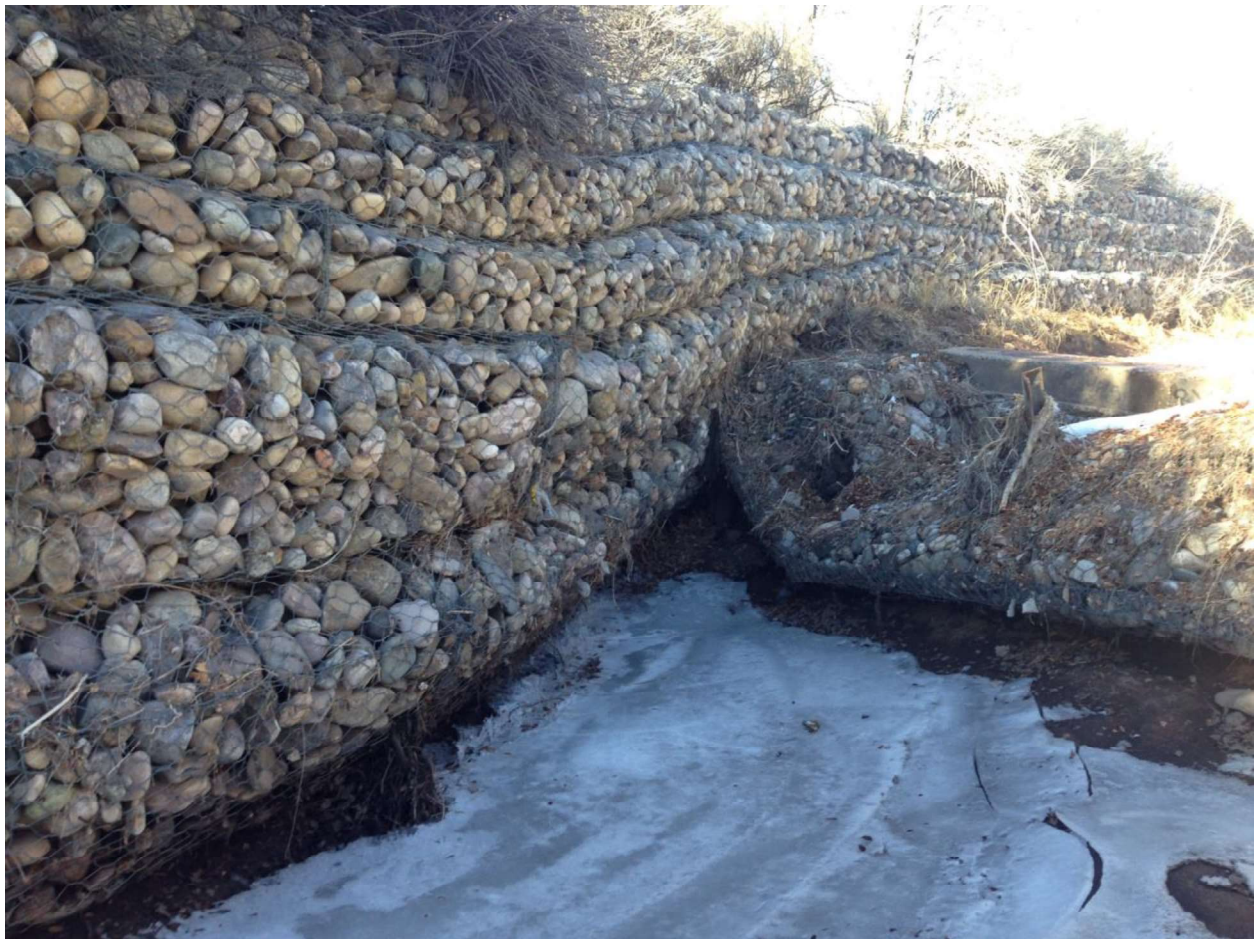
Segment C/, Gabion walls sagging, Lower Arroyo Pinos, 2016.
