Arroyo Threat Assessment Surveys of 15 Major Arroyos in the Santa Fe River Watershed

June 21, 2016

Santa Fe Watershed Association

Report to Melissa McDonald, River & Watershed Coordinator, Public Works Dept., City of Santa Fe 2016

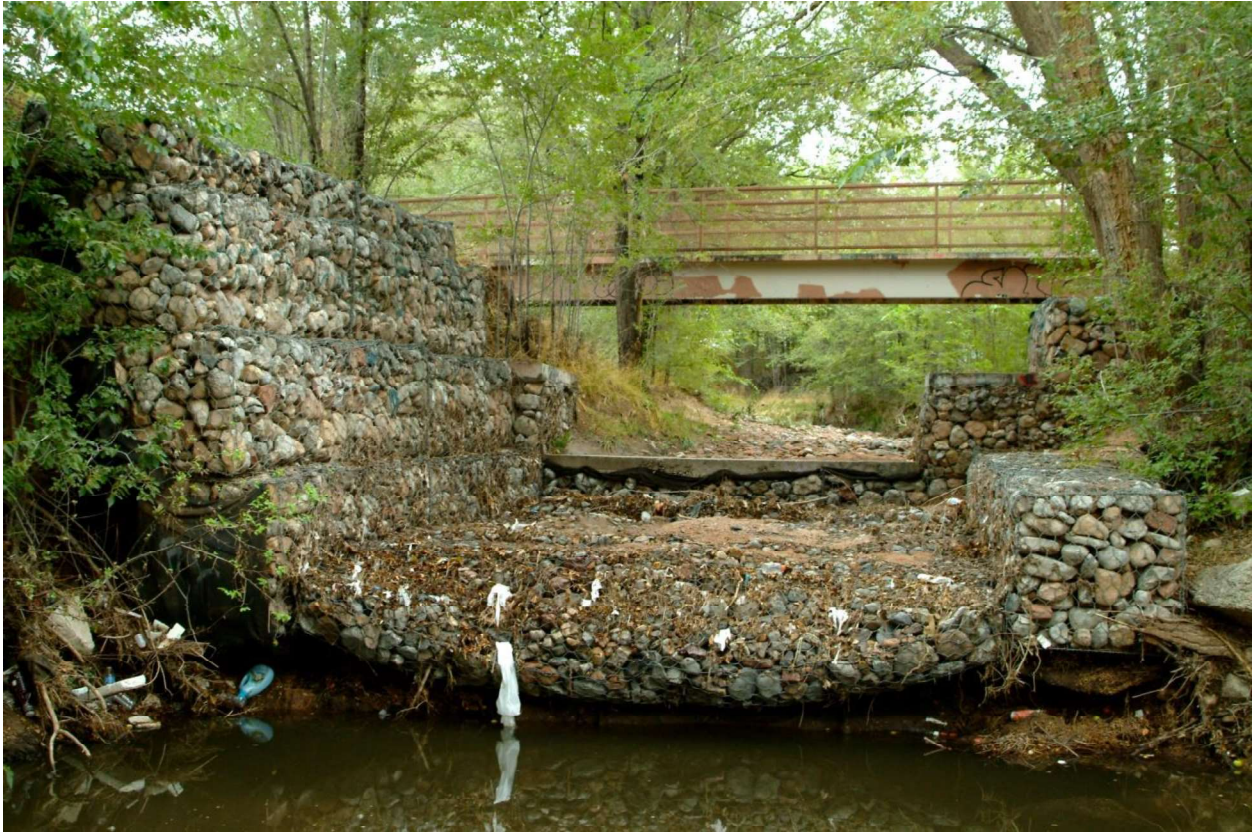
Segment C/ Water standing in deep scour below undercut rip rap mat, Lower Arroyo Pinos, 2016.

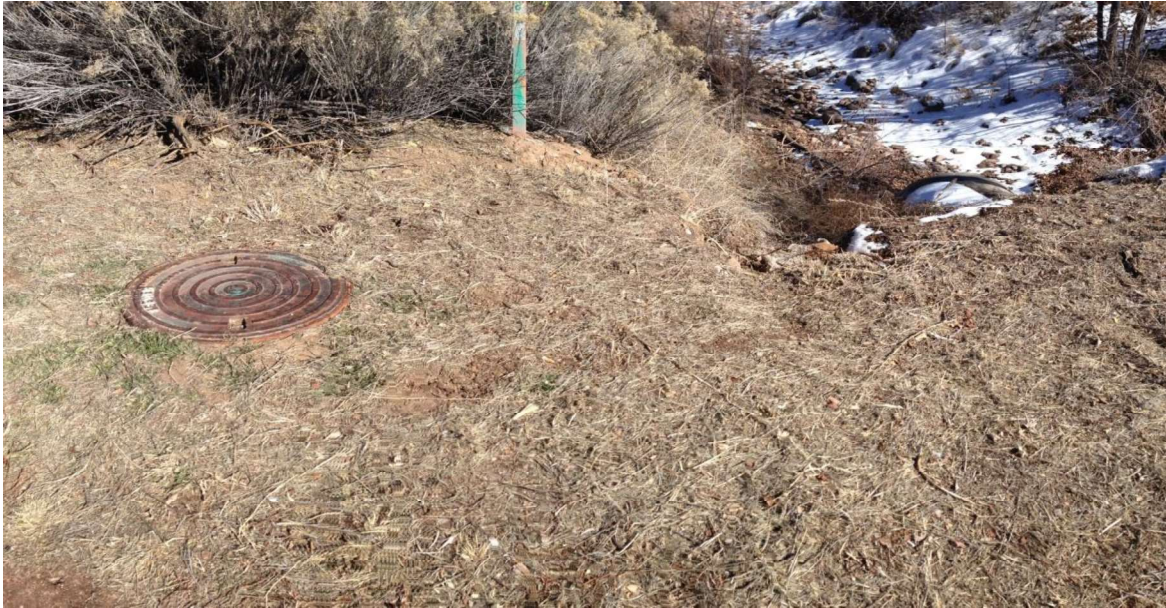
Segment C/ Bank erosion to right of manhole, Lower Arroyo Pinos, 2016.

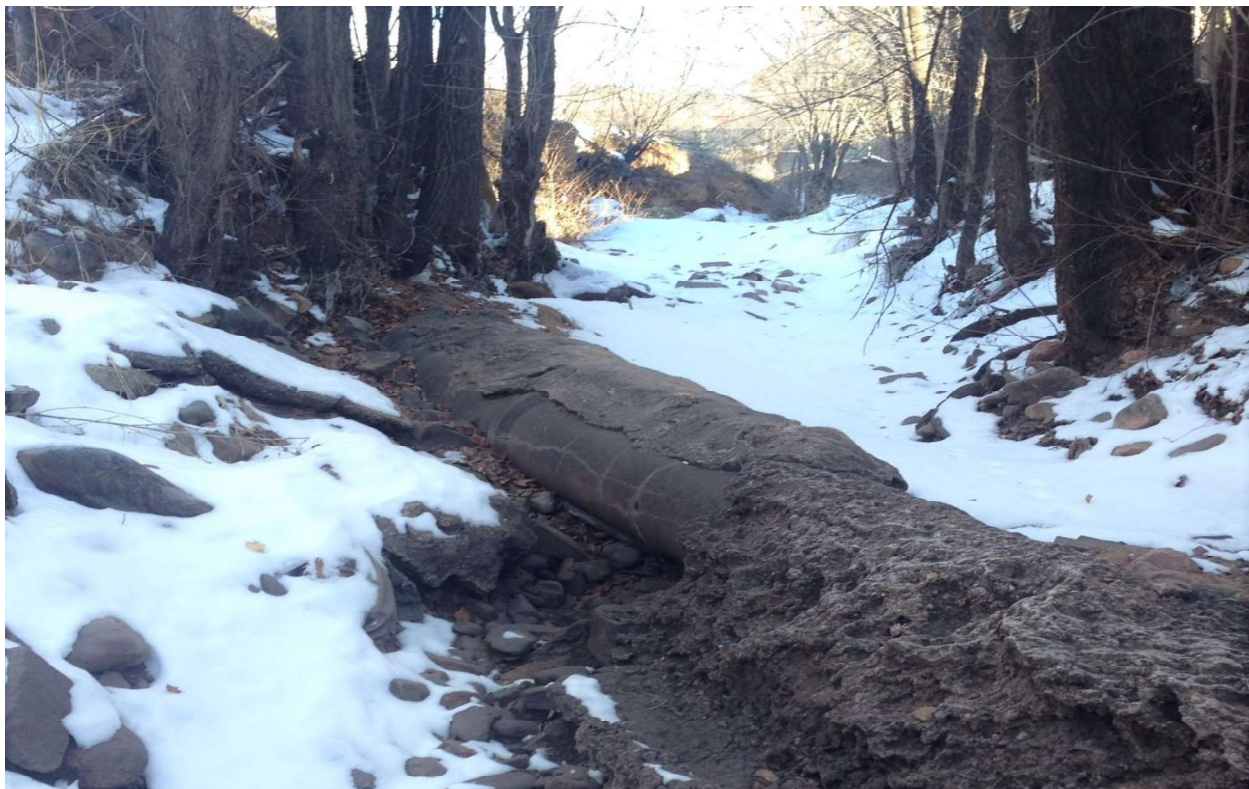
Segment C/Cracked concrete pipeline, Lower Arroyo Pinos, 2016.

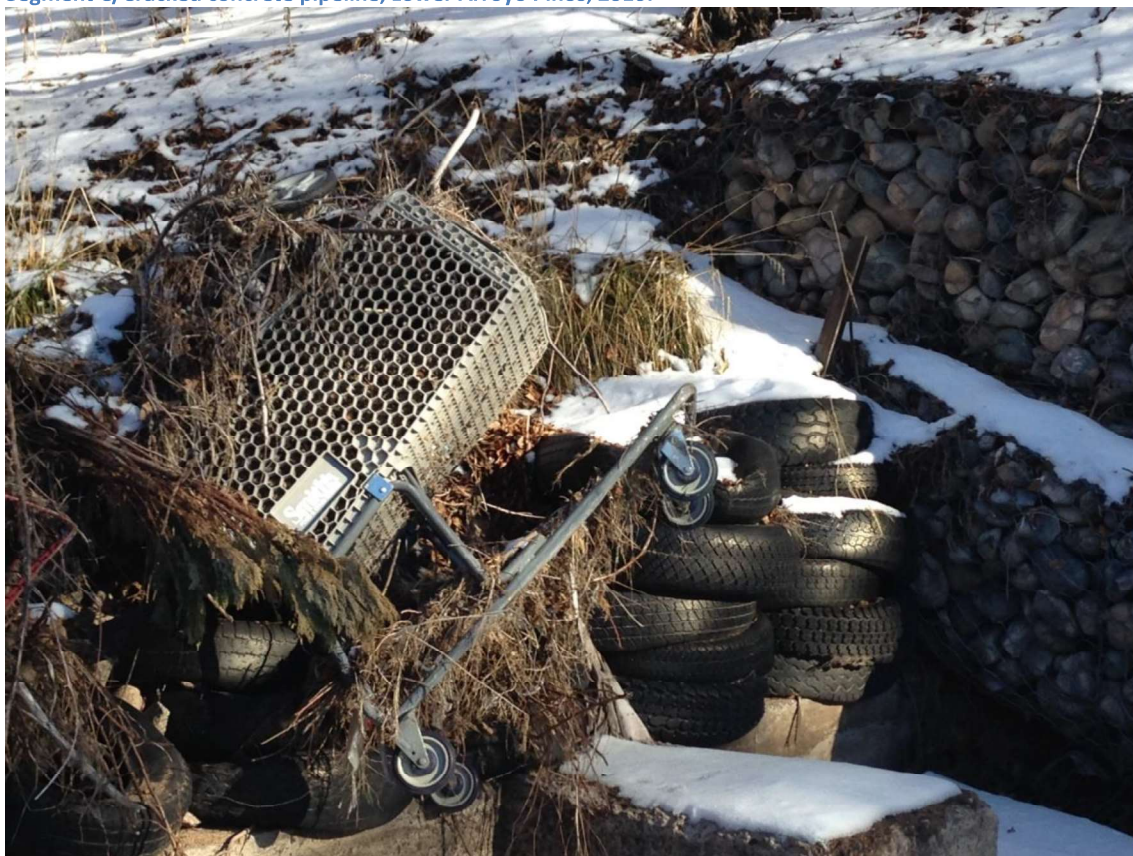
Segment C/ Trash caught in tire check dam, Lower Arroyo Pinos, 2016.

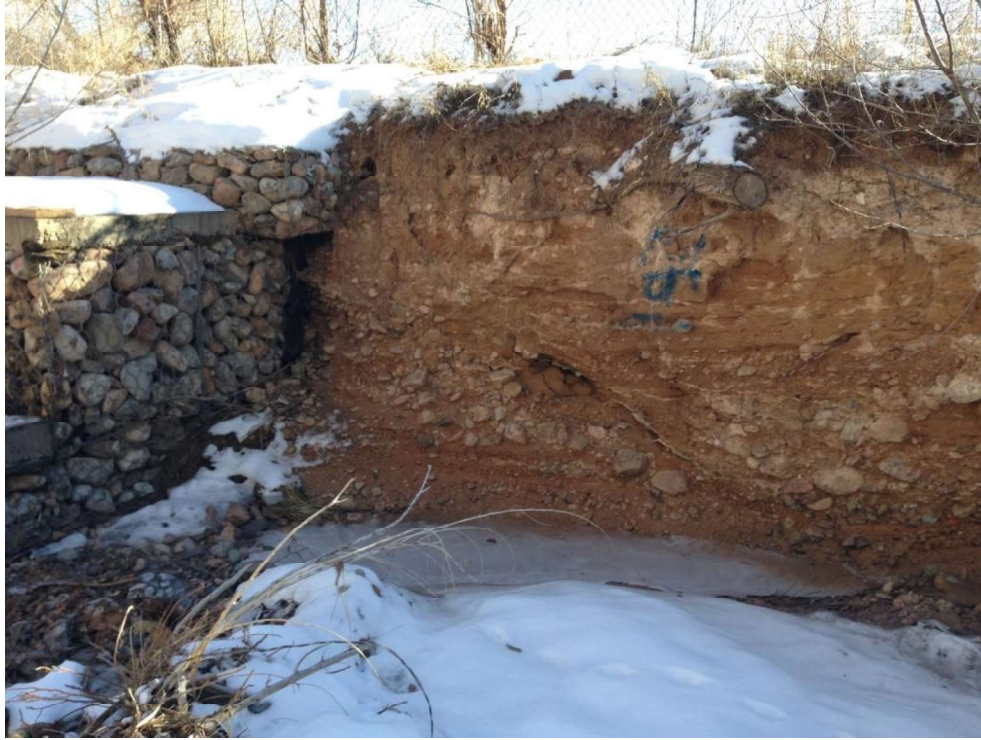
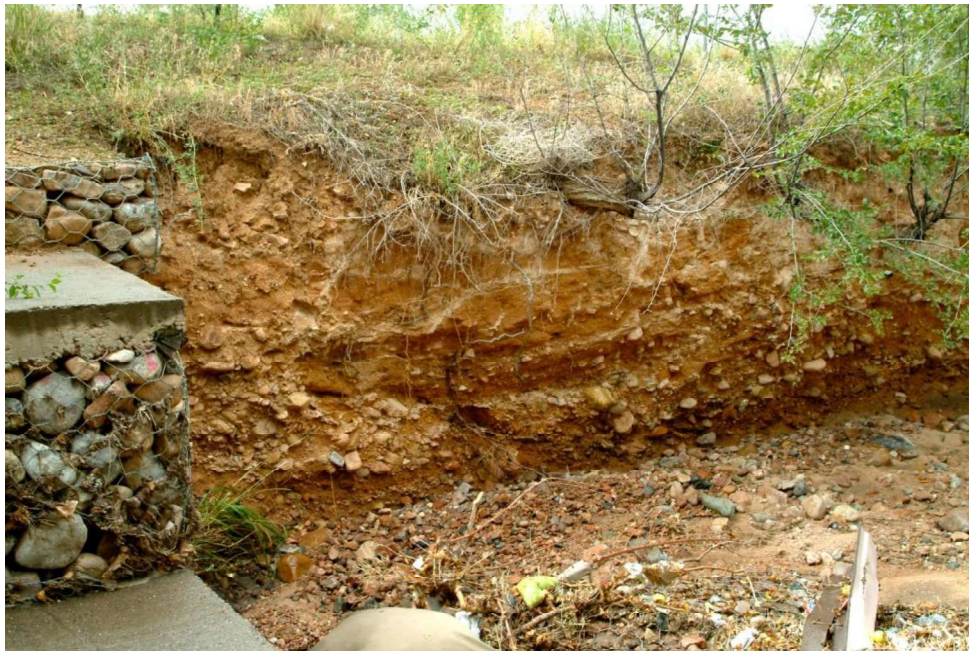
Segment D/ Bank erosion; upper photo 2016, lower photos 2012, Lower Arroyo Pinos.

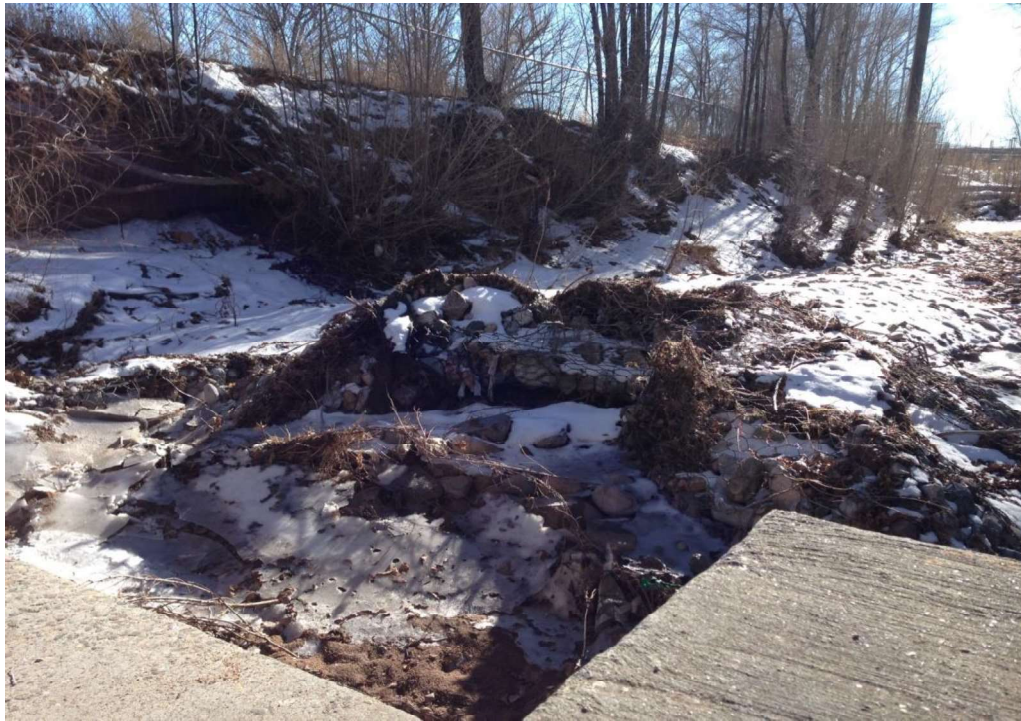
Segment D/ Damaged rip rap mat 2016, Lower Arroyo Pinos.

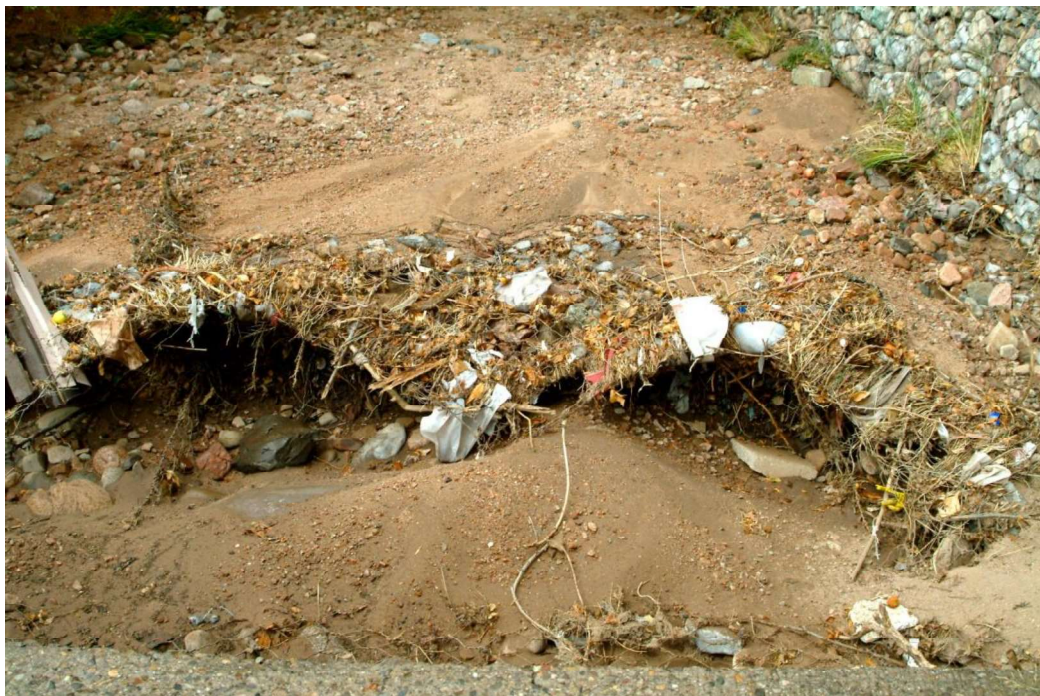
Segment D/ Damaged rip rap mat 2012, Lower Arroyo Pinos.

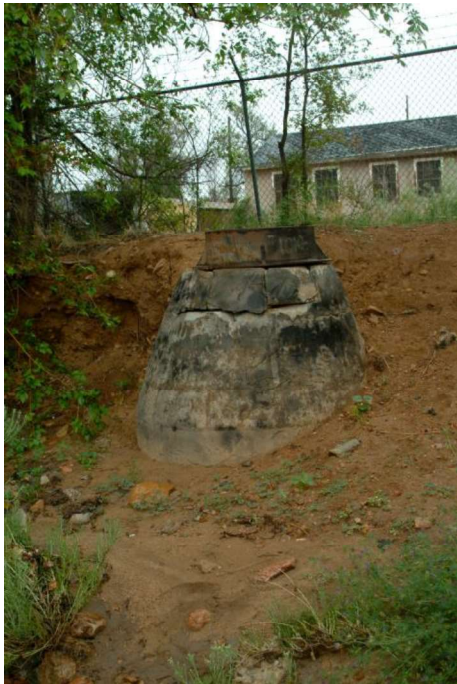
Segment E/ Unprotected Sewer utility, Lower Arroyo Pinos, 2012.

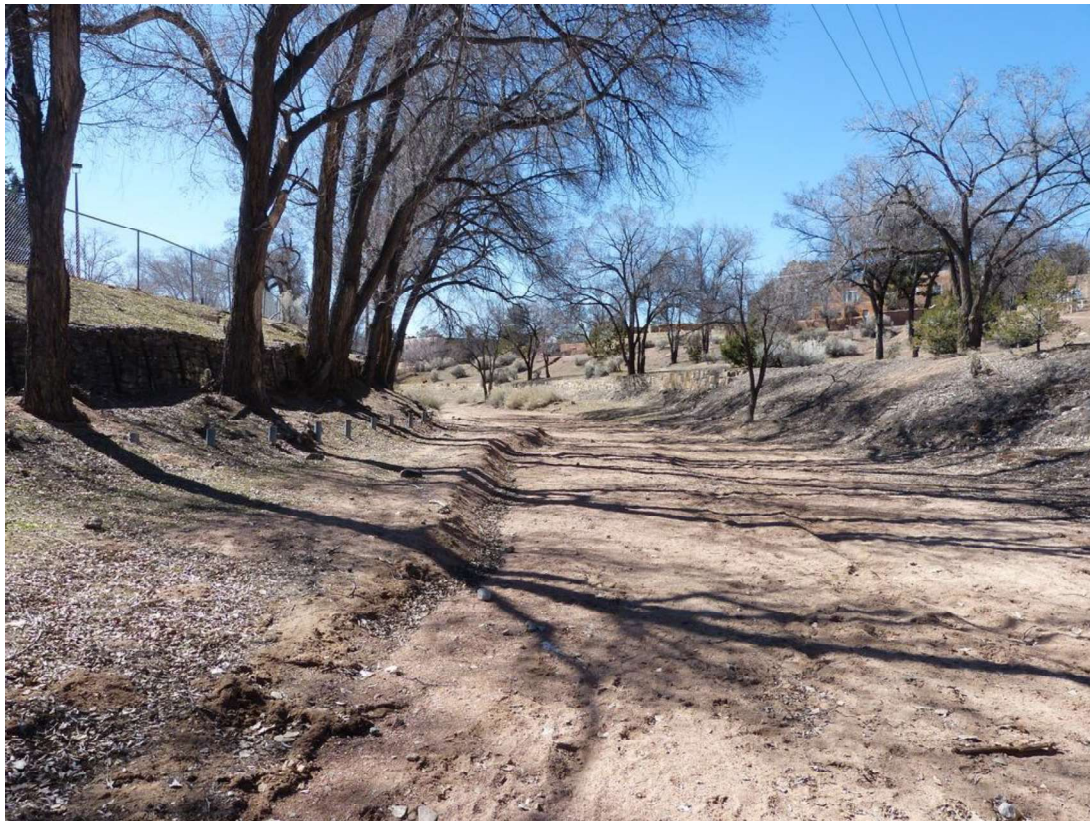
Segment B/Example of Upper Mascaras ,2016.

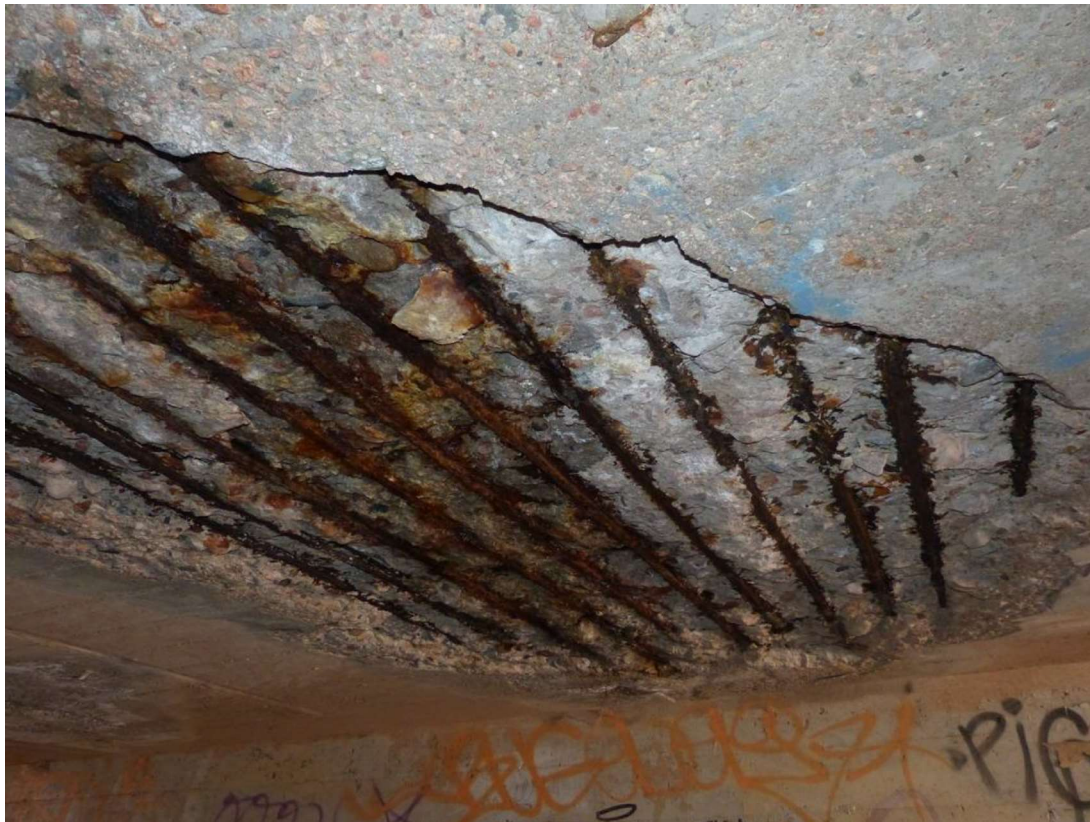
Notes: The arroyo channel in this segment widens and the banks are not steep. The Old Taos Highway Bridge crosses the arroyo. The concrete underside of this bridge is decaying exposing rebar. Also the bridge provides shelter for transient populations. From this segment to the Santa Fe River numerous transient camps can be found. Trash is common in this area as a result of these camps.

Segment B/Underside of concrete damage, Old Taos Bridge Arroyo Mascaras ,2016.

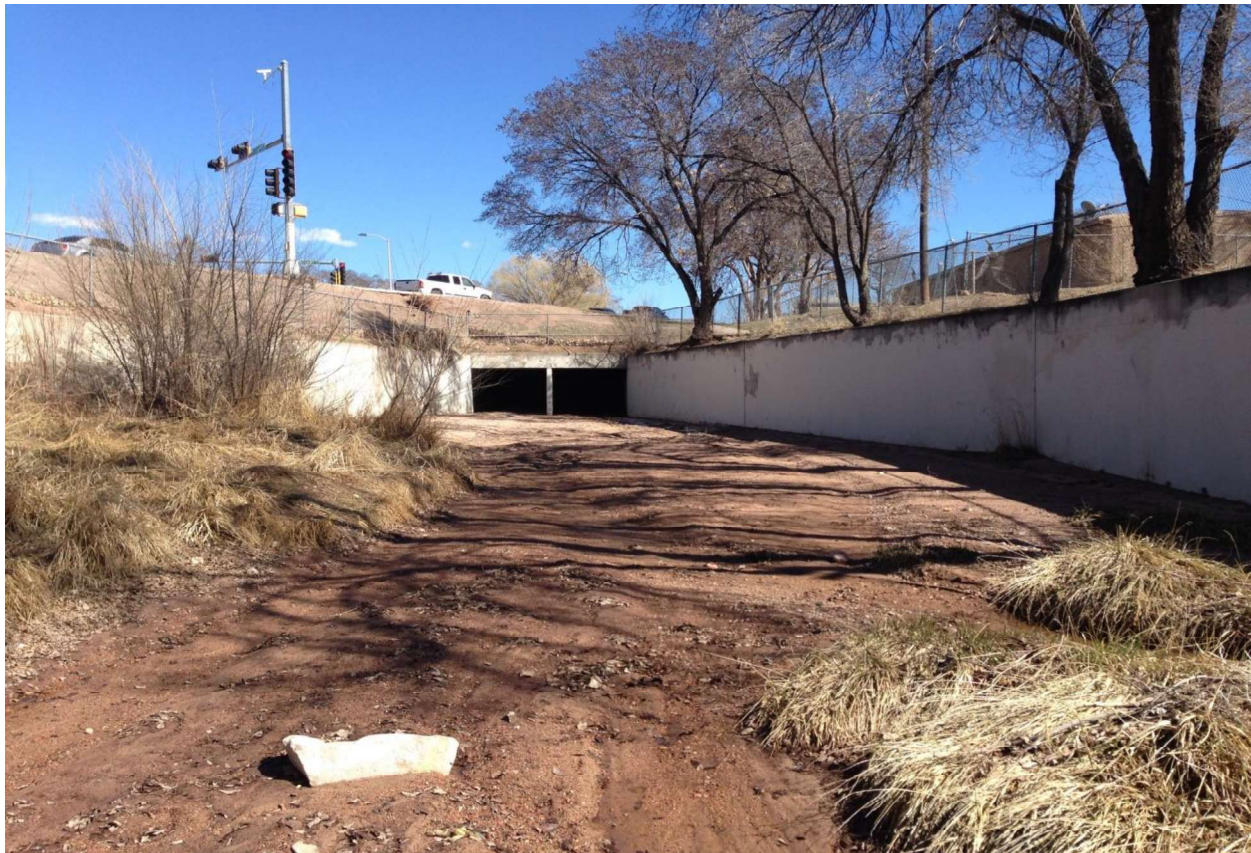
Segment D/Perineal wet area below culvert, Arroyo Mascara , 2016.

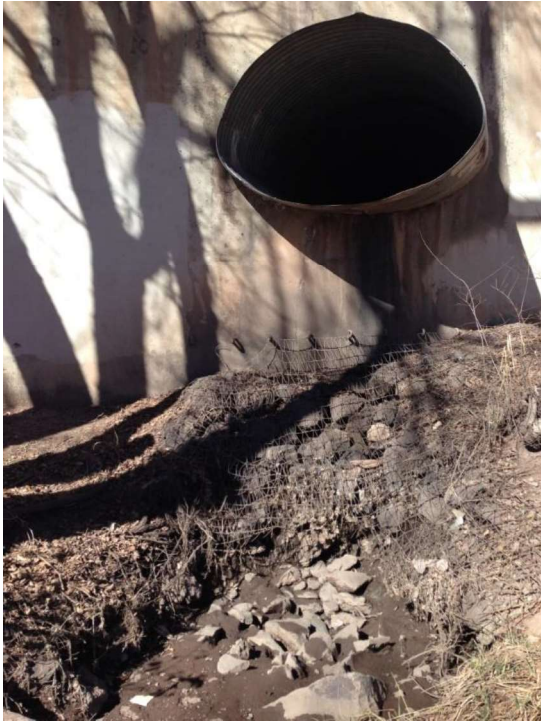
2016

Segment D/Comparison of rip rap damage below culvert, Arroyo Mascaras , 2016.

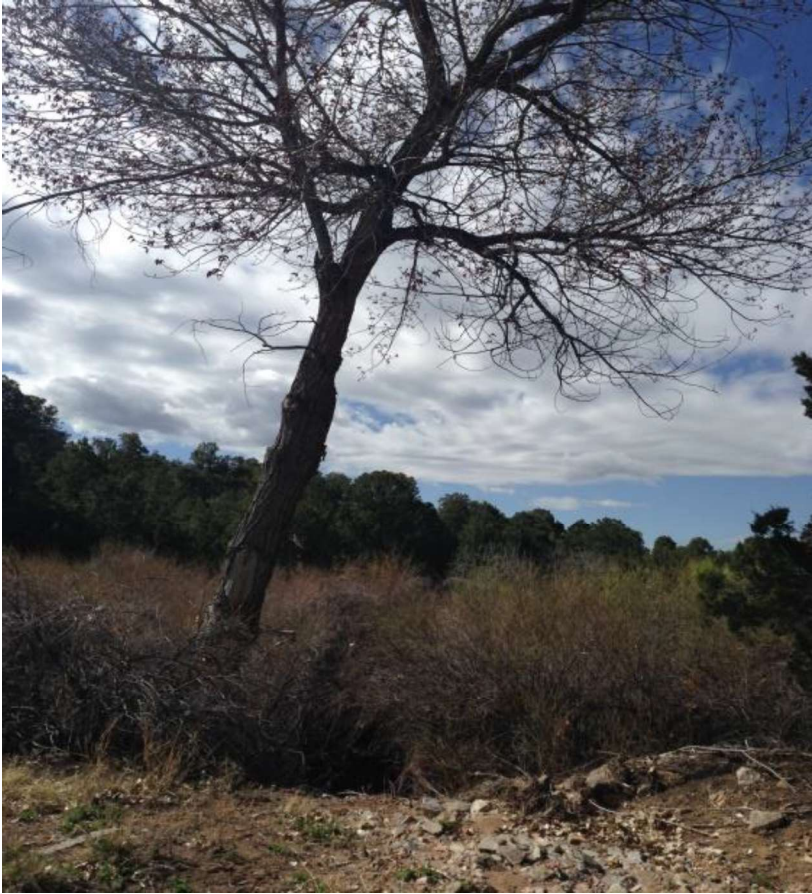
Segment A/ Wetland located in Arroyo Piedra, 2016.

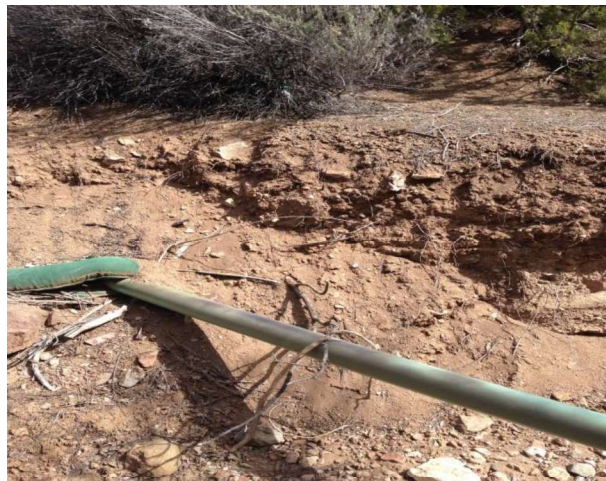
Segment A/ Comparison of exposed green pipe. Photo left 2012 condition and photo right 2016 condition, Arroyo Piedra, 2016.

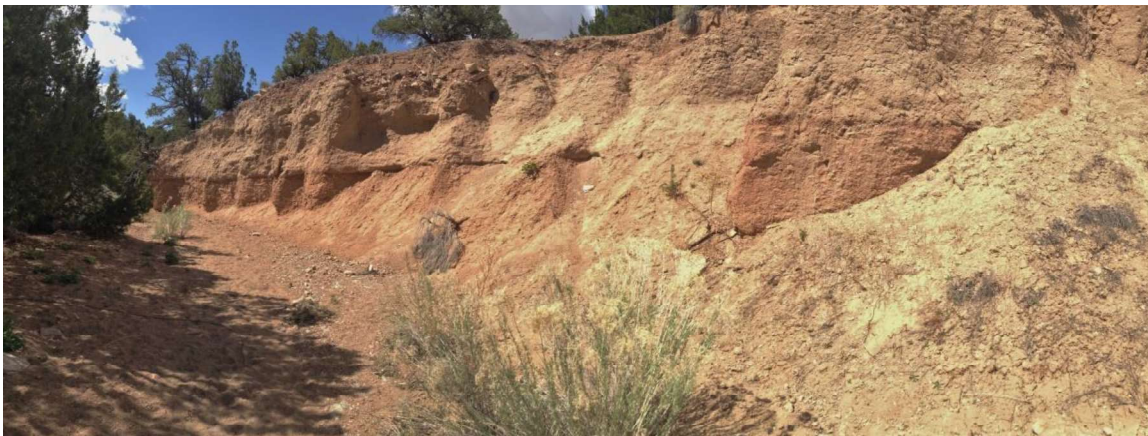
Eroded banks in Arroyo Piedra East, segment A.

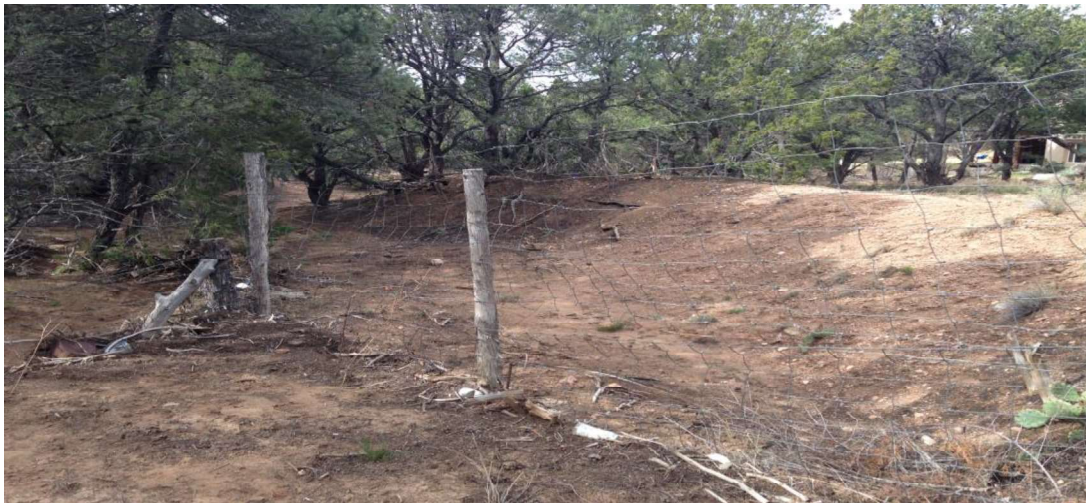
Segment B/Fence across the arroyo bed, Arroyo Piedra, 2016.

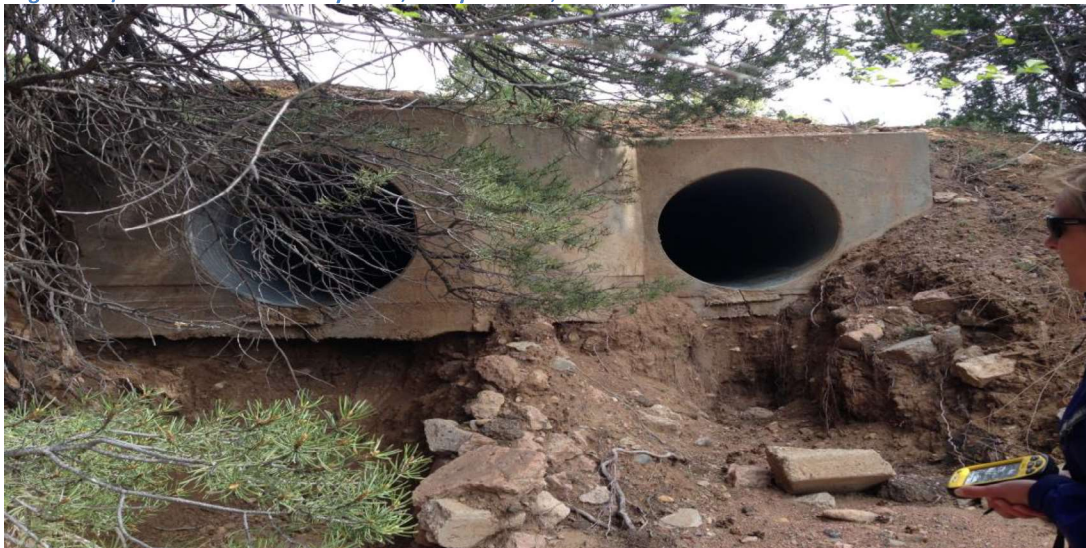
Segment B/Bank deterioration below culverts, Arroyo Piedra, 2016.

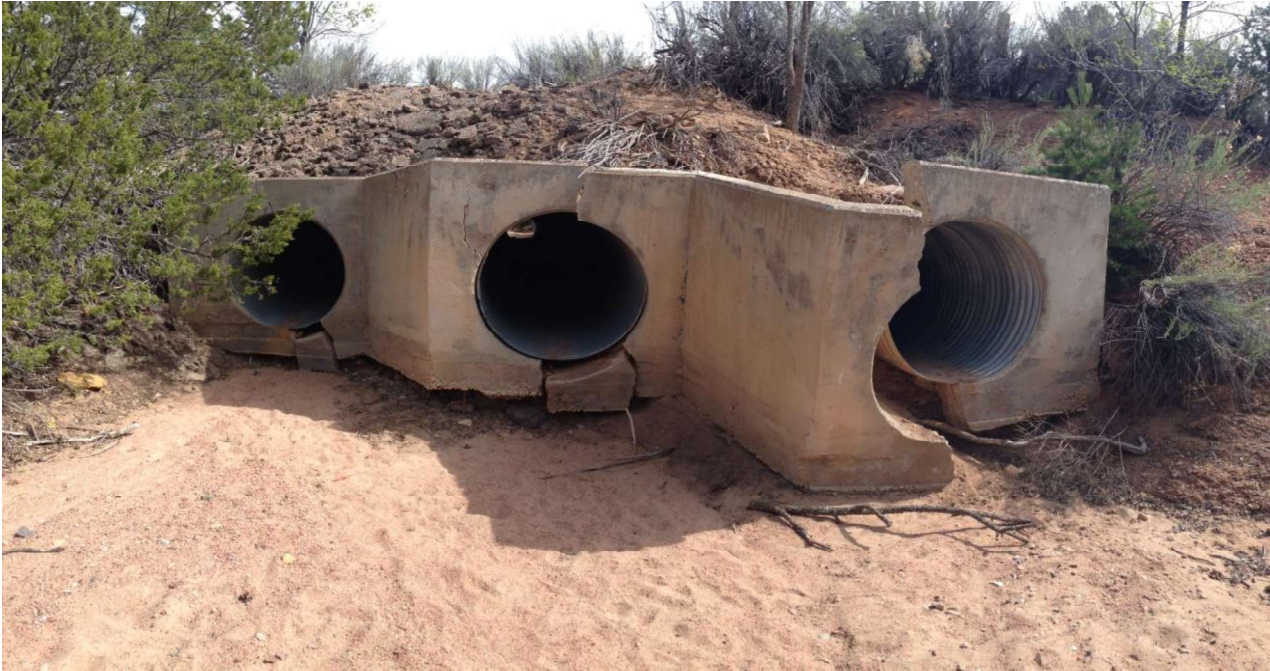
Segment B/ Comparison of culverts, Arroyo Piedra, 2016.

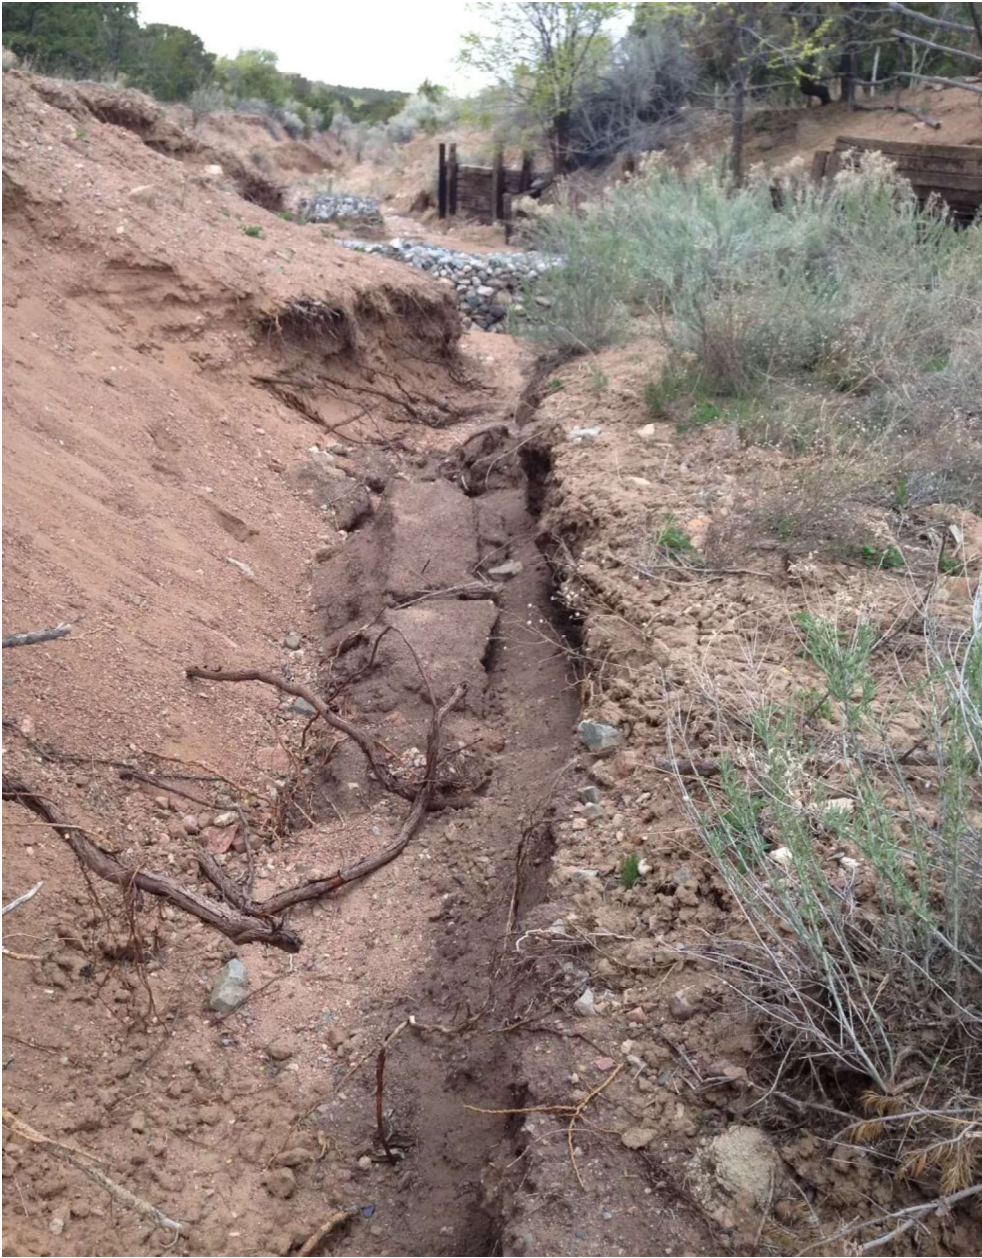
Segment B/ Incising of the arroyo bed and bank deterioration, Arroyo Piedra, 2016.

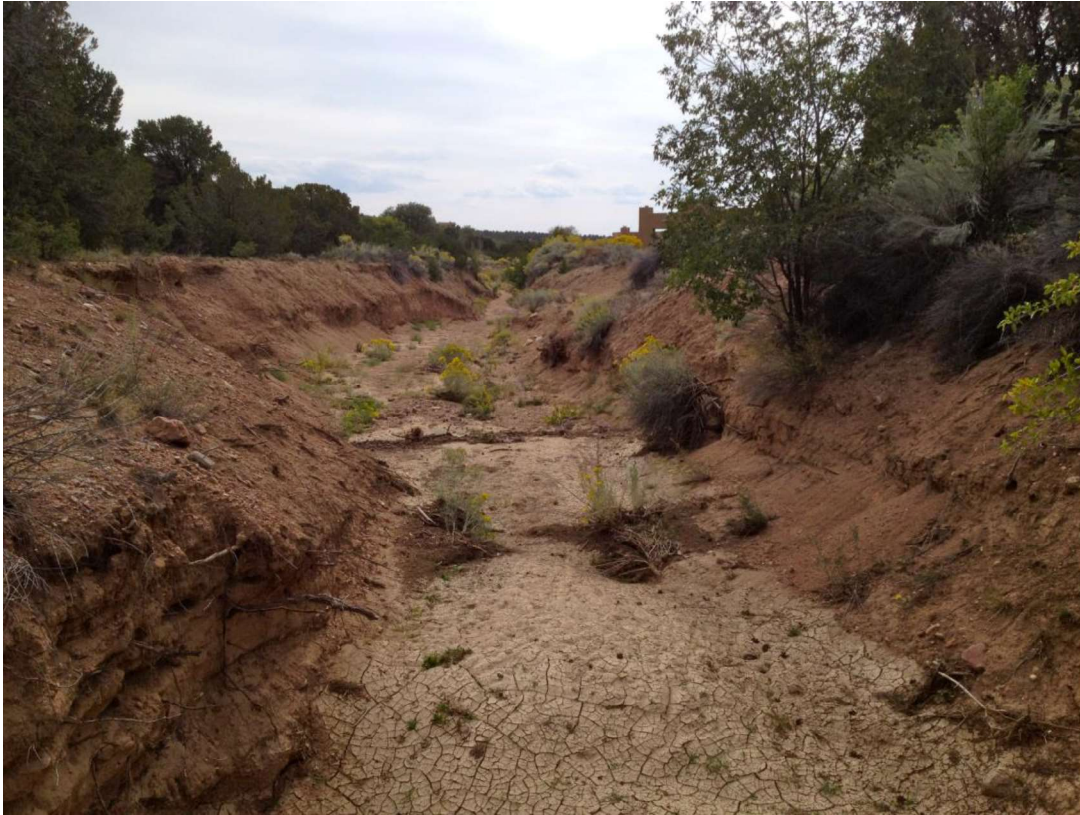
Segment B/ Arroyo channel in 2012, Arroyo Piedra, 2016.

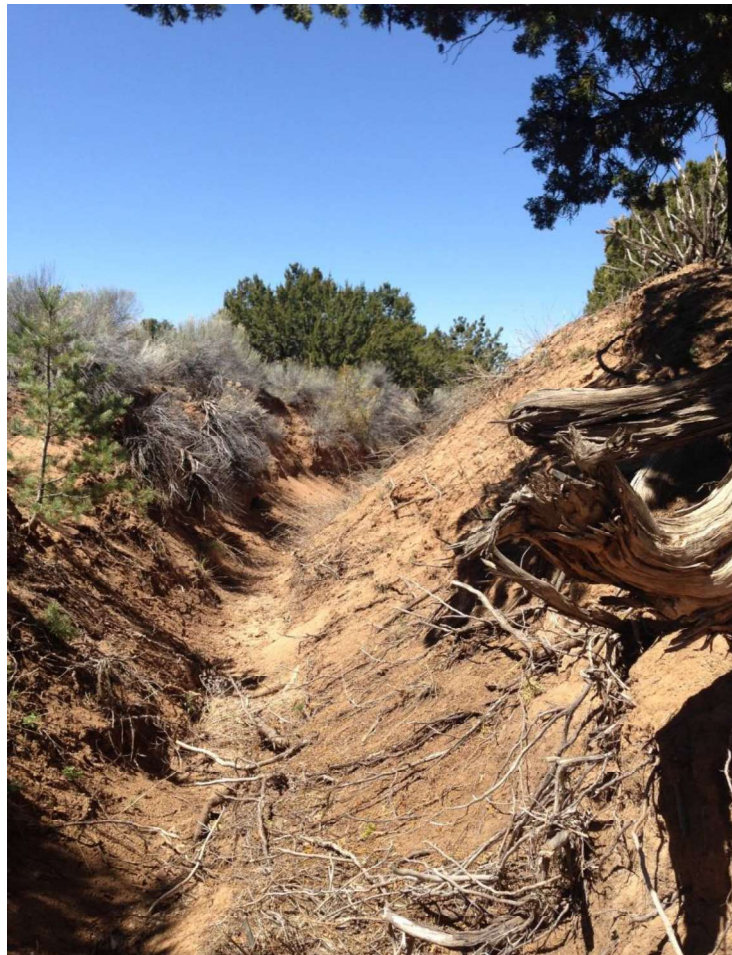
Segment A/ Upper Foothills Arroyo, 2016.

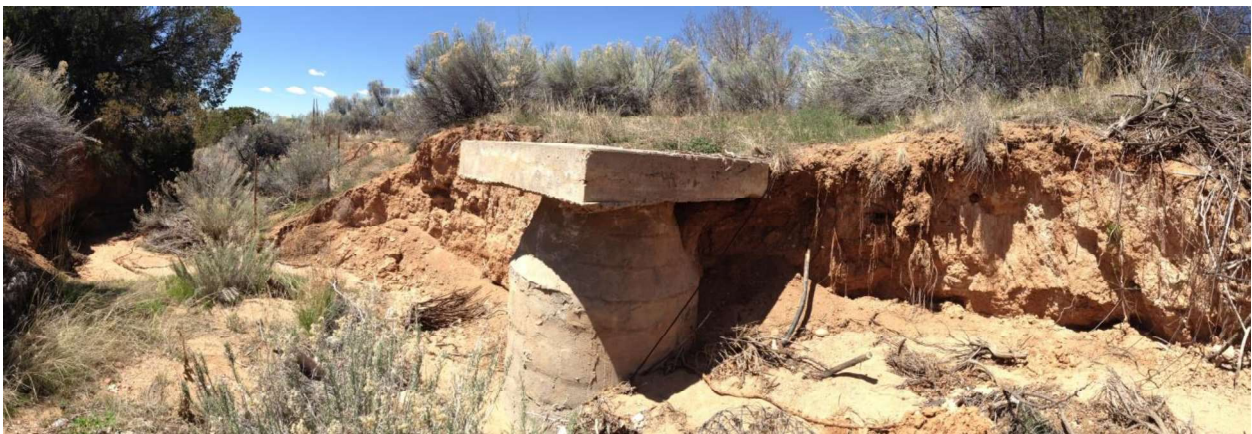
Segment A/ Exposed cables, deteriorating banks and sewer outlet, Foothills Arroyo, 2016.

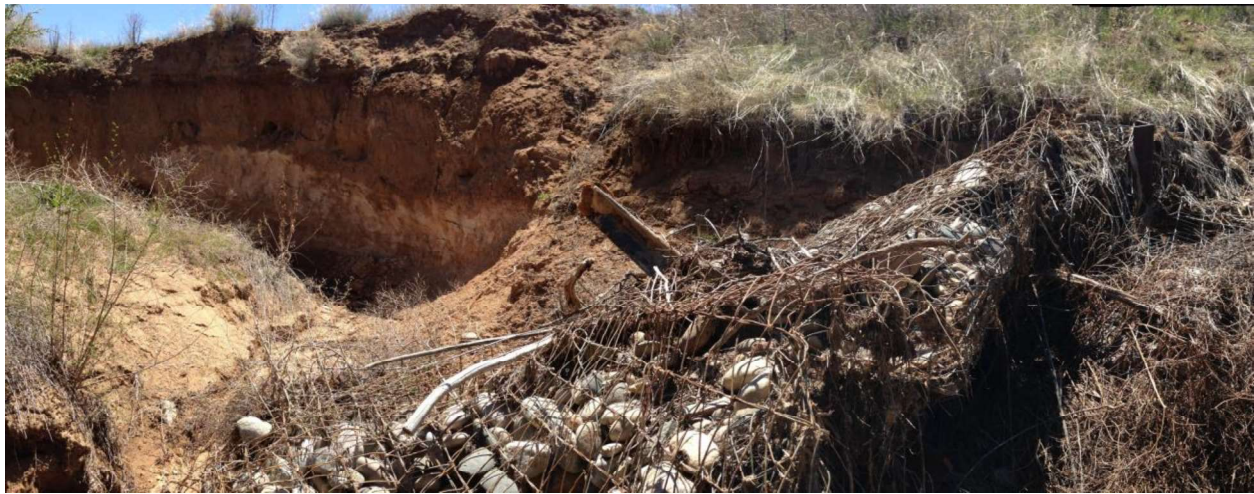
Segment A/ Vertical walls with rip rap mat folded back from flooding, Foothills Arroyo, 2016.

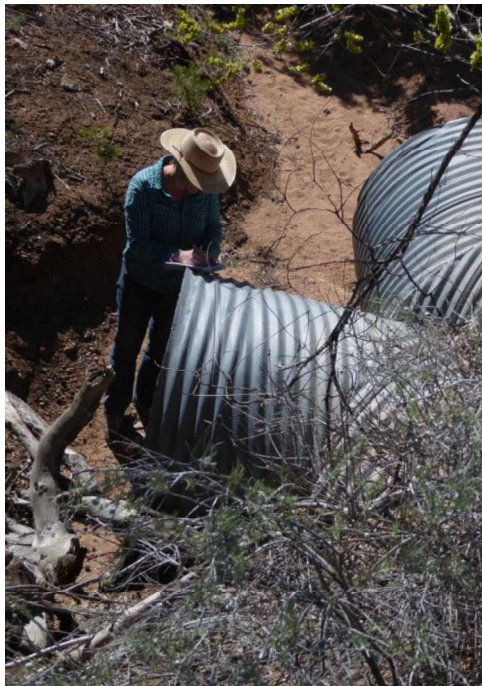
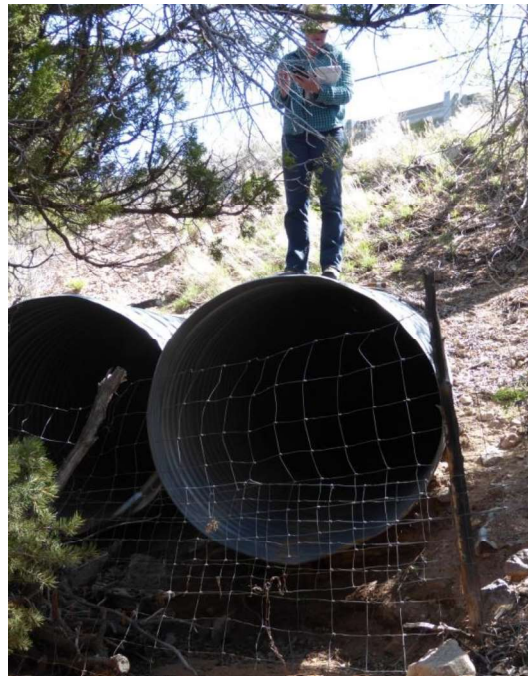
Segment A/Upstream (left) and downstream right) of culvert, Old Santa Fe Trail, Arroyo Cloudstone, 2016.

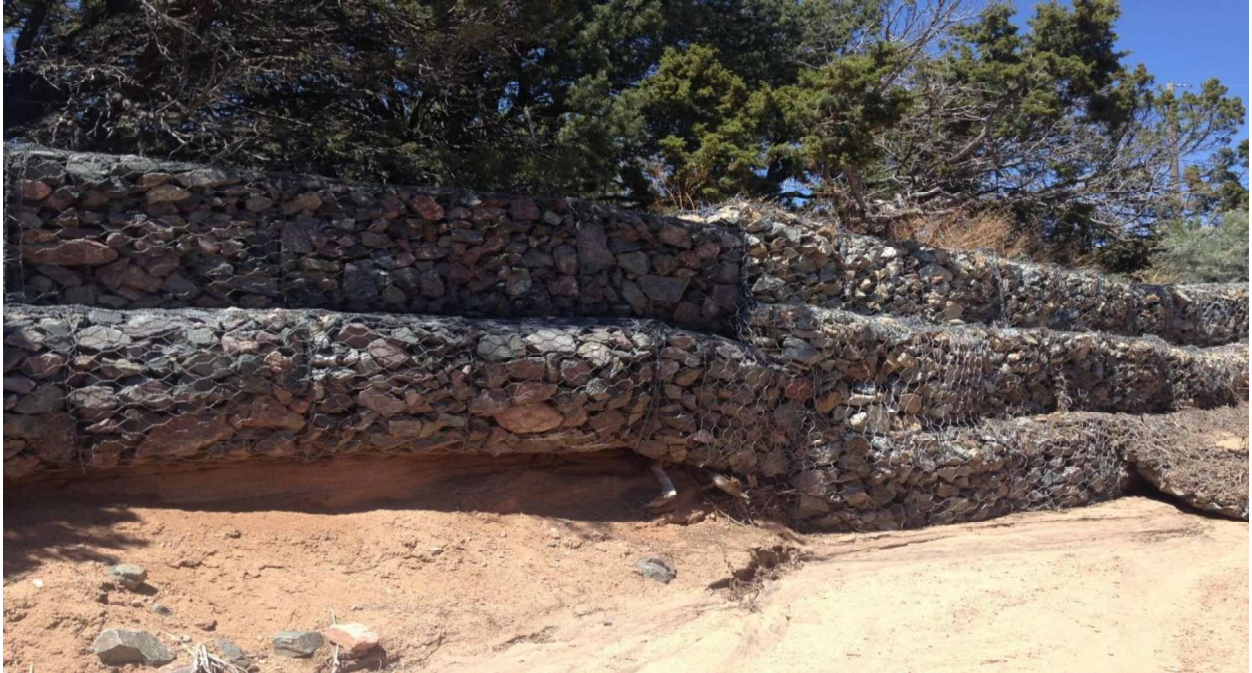
Segment B/Erosion below gabion walls, Arroyo Cloudstone, 2016.

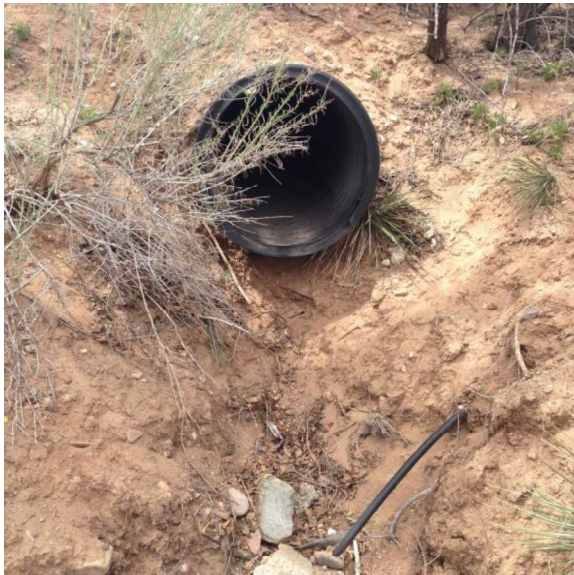
Several culverts drain the west side of Calle Nopal, Arroyo Nopal, 2016.

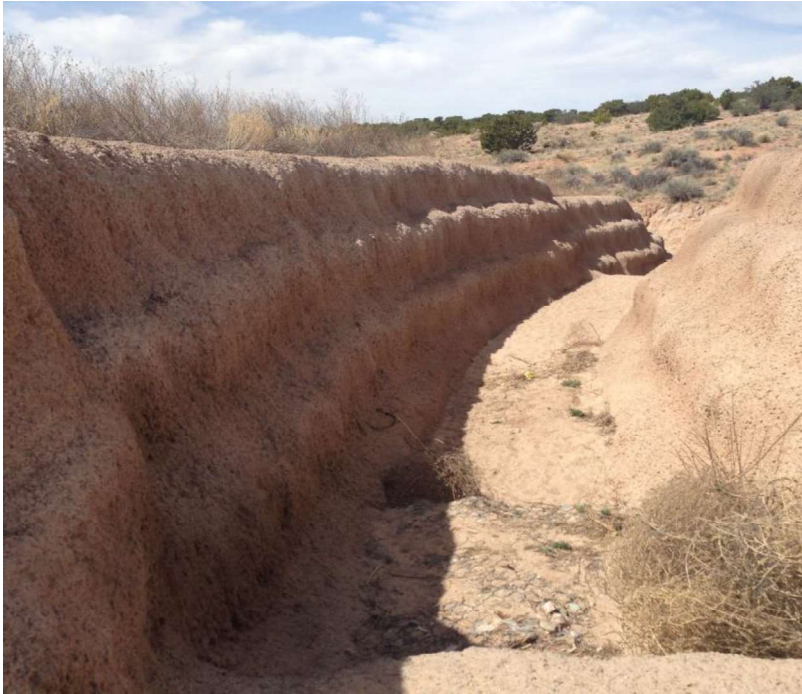
Segment B/Two views of engineered walls made of tire and adobe with undercutting, Arroyo Torreon, 2016.

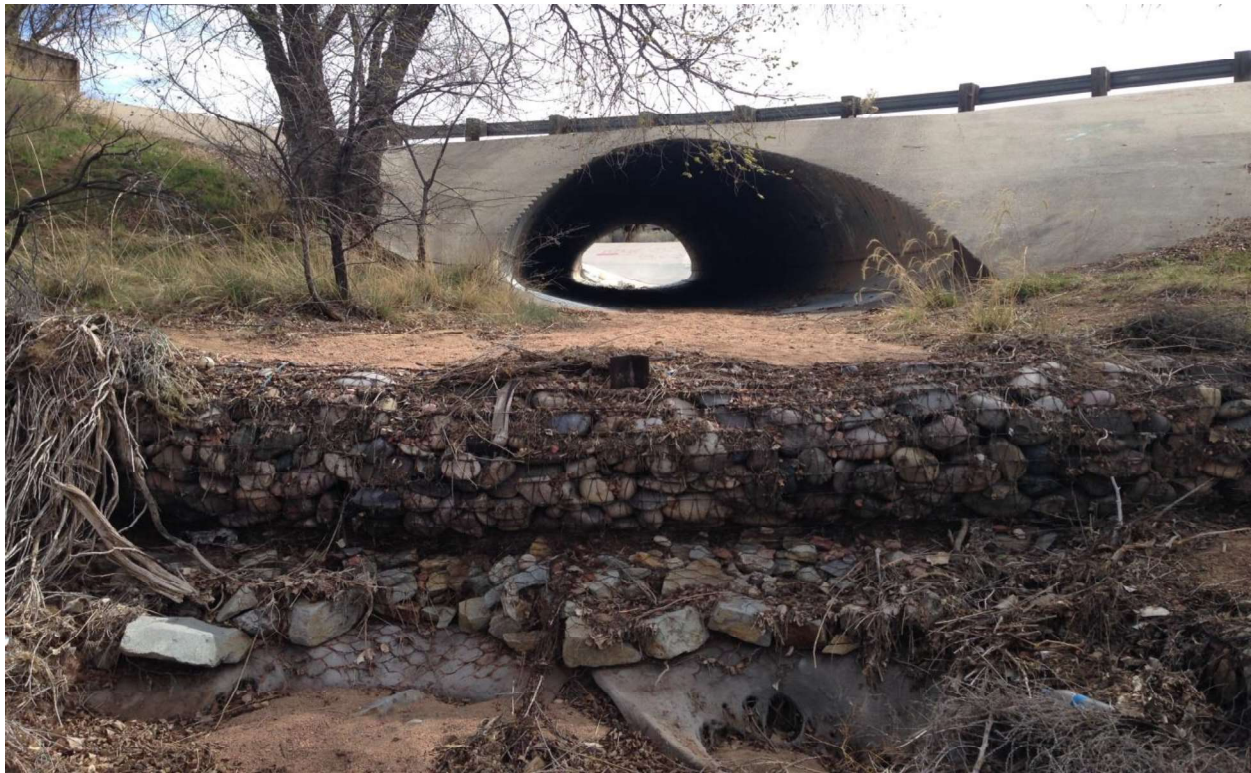
Segment A/Rip rap below culvert, Arroyo Chaparral, 2016.

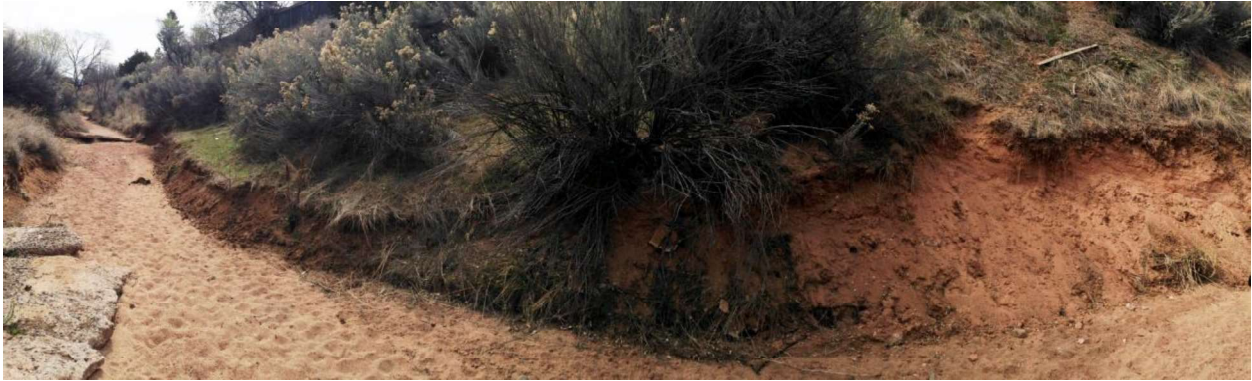
Segment B/ View of upper arroyo with bank deterioration, Arroyo Chaparral ,2016.

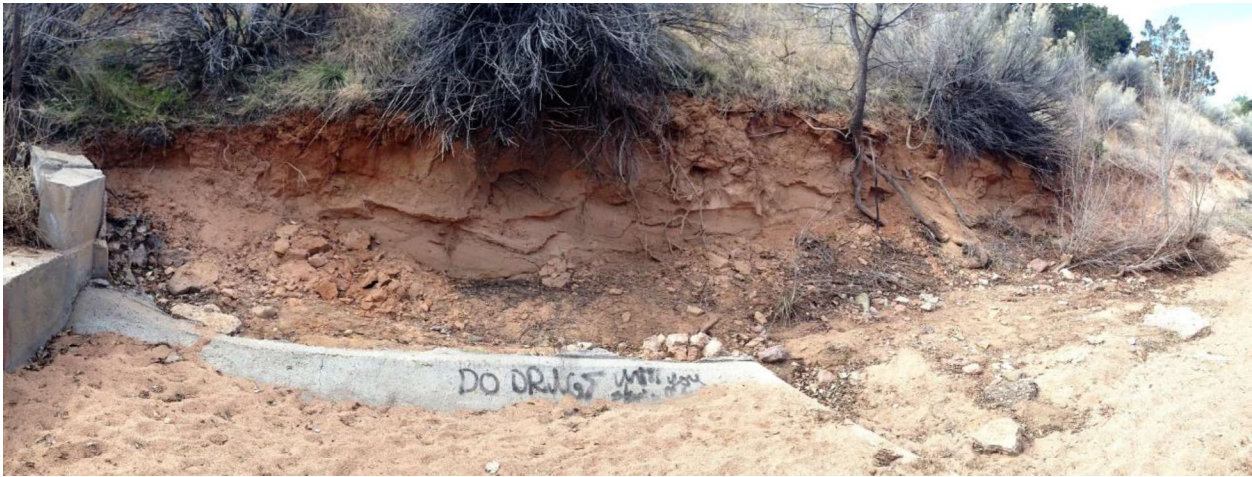
Segment B/ Bank deterioration at check dam, Arroyo Chaparral ,2016.
