Arroyo Threat Assessment Surveys of 15 Major Arroyos in the Santa Fe River Watershed

June 21, 2016

Santa Fe Watershed Association

Report to Melissa McDonald, River & Watershed Coordinator, Public Works Dept., City of Santa Fe 2016

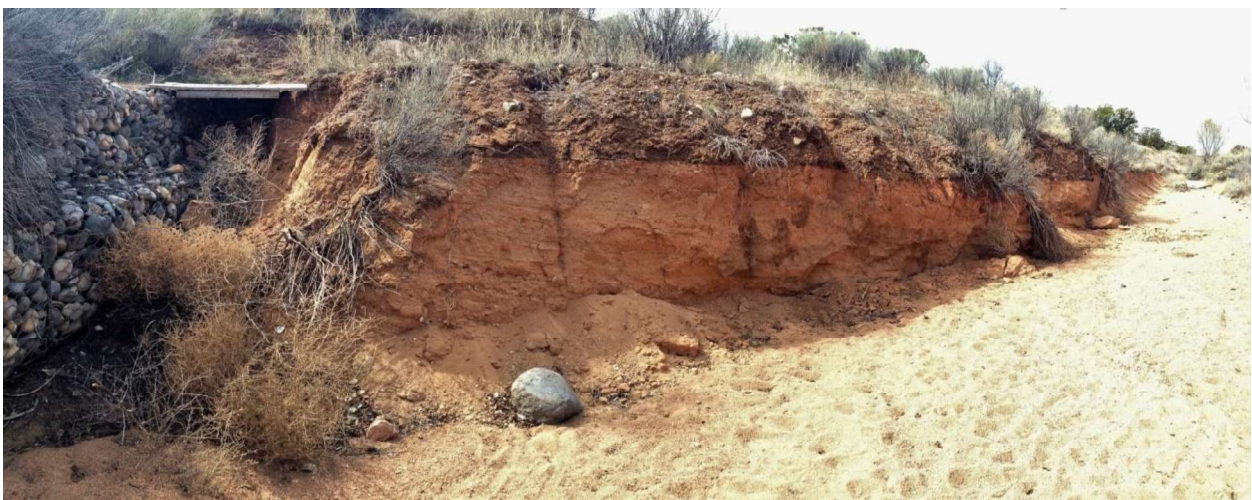
Segment B/ Bank deterioration at gabion wall check dam, Arroyo Chaparral ,2016

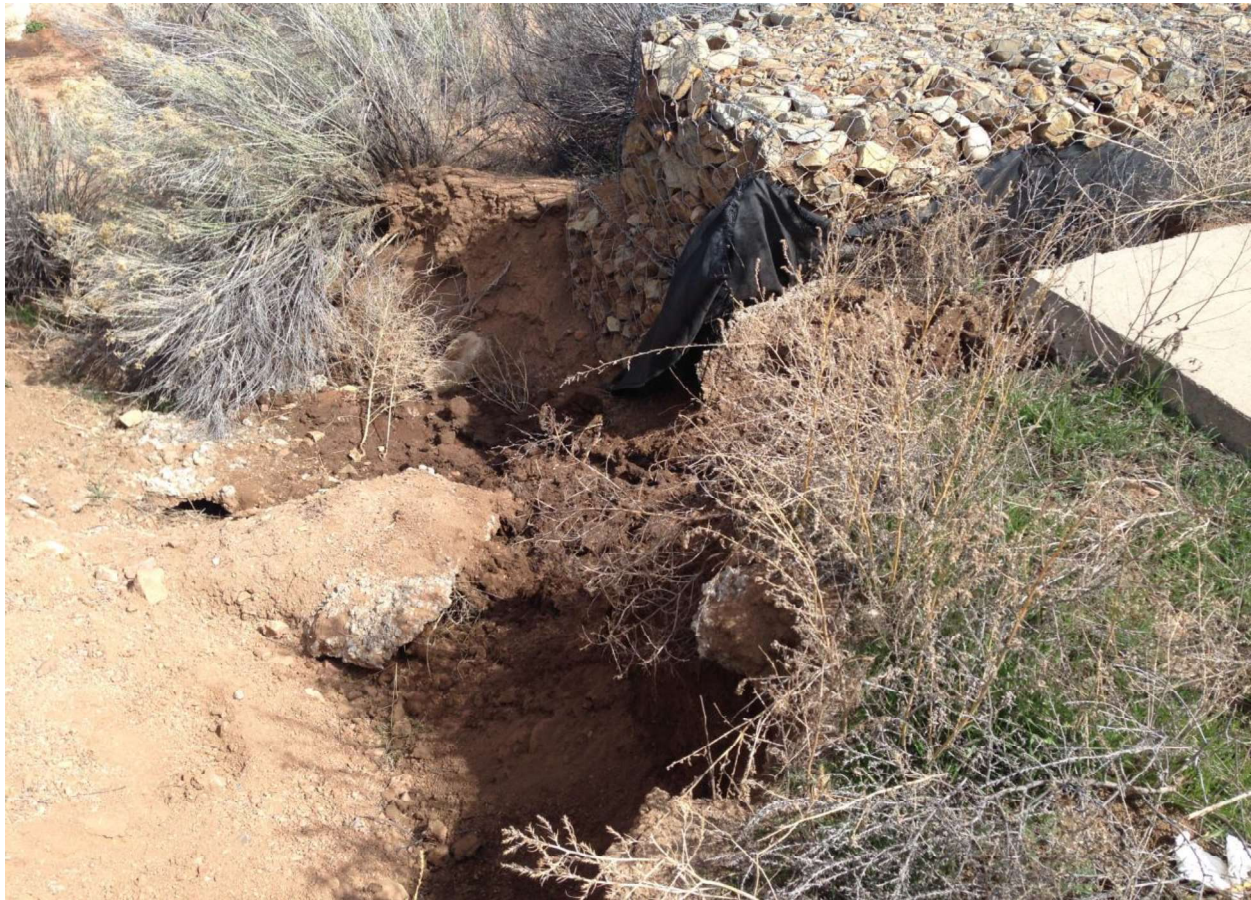
A sudden drop in arroyo bed elevation (head cut) near Chaparral Elementary School has caused storm water to undermine the soil from beneath rip rap and gabion structures placed to protect the arroyo bank and a nearby sewer line should be marked as a high priority area. Raw sewage was found leaking into the bed of the arroyo from this sewer outlet. Past this severely damaged infrastructure the arroyo passes through a highly incised canyon like segment until it flows beneath W. Zia Rd. into the Arroyo de los Chamisos.

Segment B/ Erosion below sewer outlet, Arroyo Chaparral,2016.

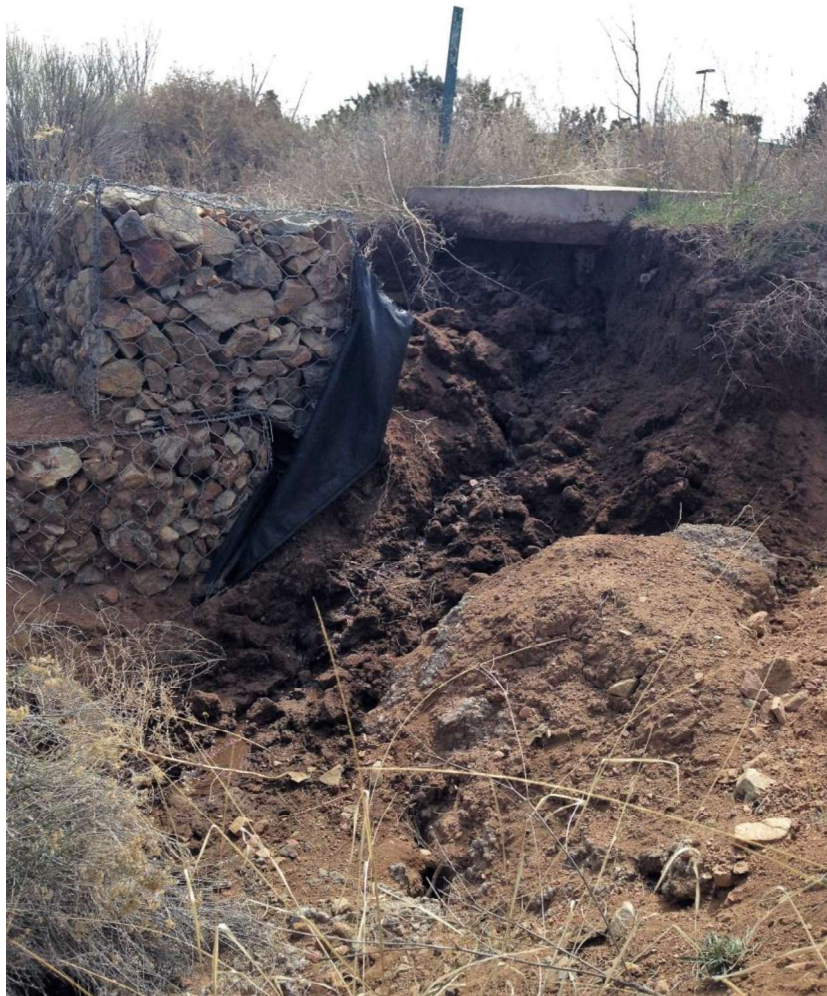
Segment B/ Leaking sewage outlet, Arroyo Chaparral, 2016

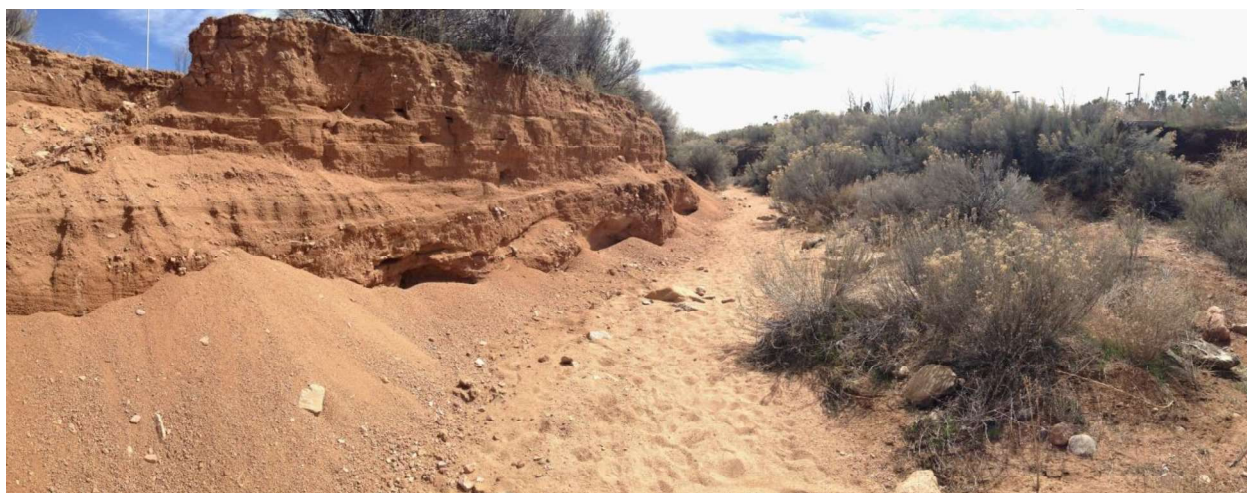
Segment B/ View of banks below leaking sewage outlet, Arroyo Chaparral, 2016
