# **ARROYO ASSESSMENT SURVEYS OF 10 MAJOR ARROYOS IN THE SANTA FE WATERSHED**

November 16<sup>th</sup>, 2012

## **Santa Fe Watershed Association**

**Report to the Public Works Department, City of Santa Fe 2012**

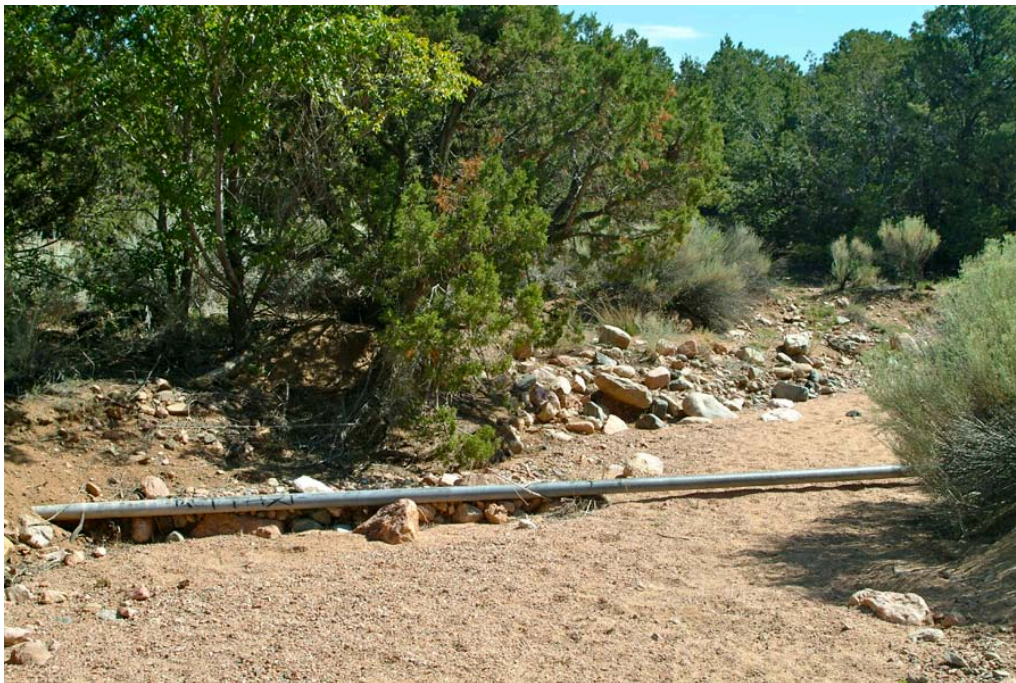
Exposed utility line in bed of Arroyo de los Chamisos, Segment A.

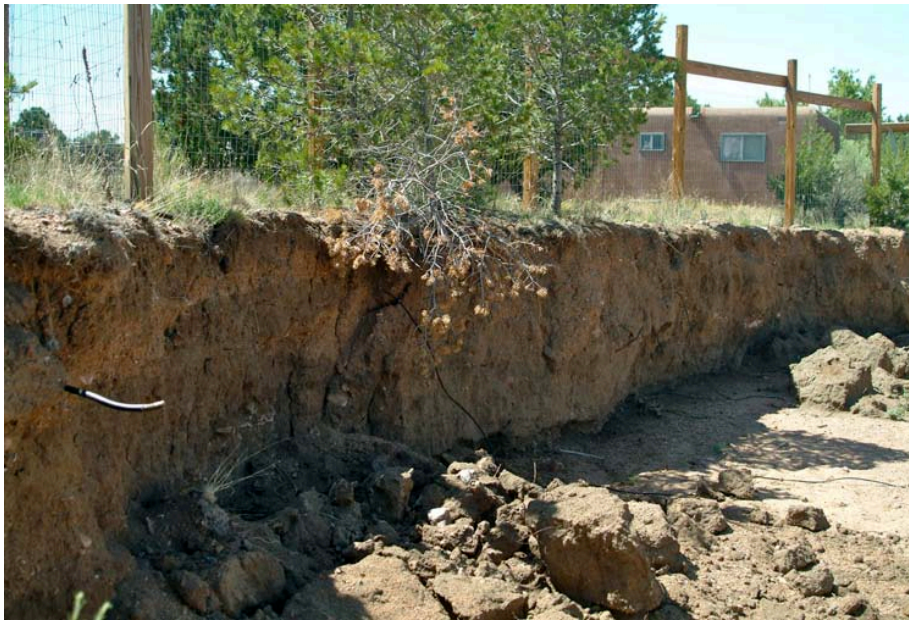
Private property eroding with exposed cables in Arroyo de los Chamisos, Segment B.

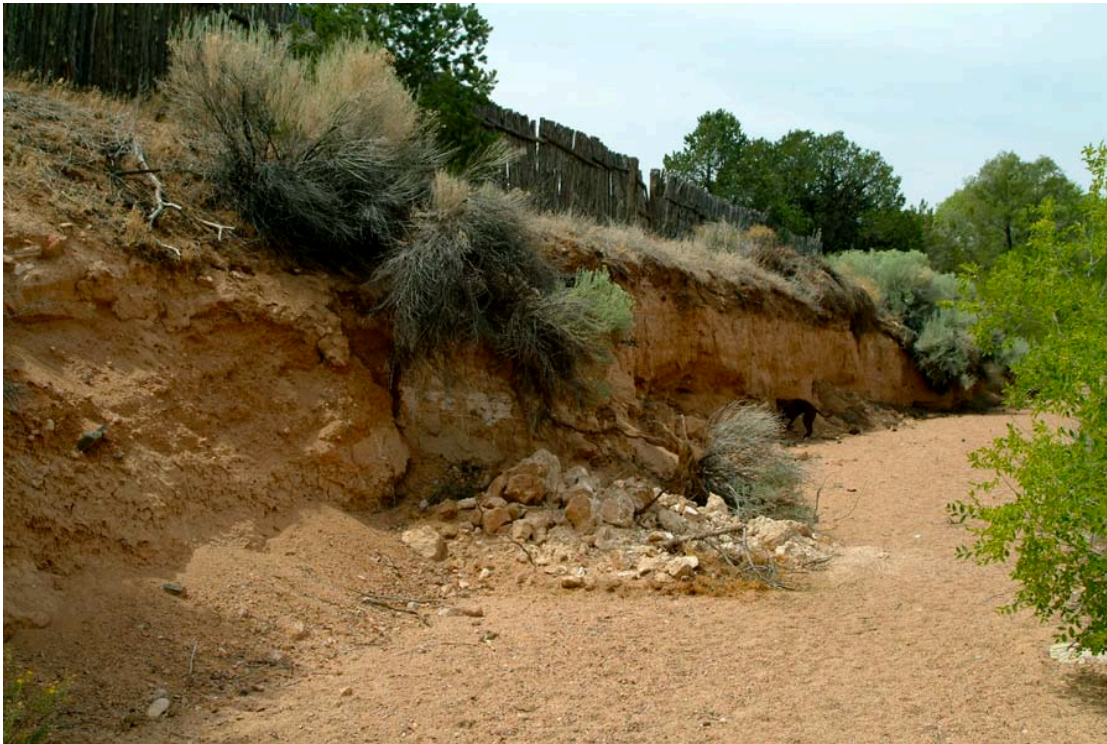
High, vertical, collapsing banks typical of the upper section of Segment C in the Arroyo de los Chamisos.

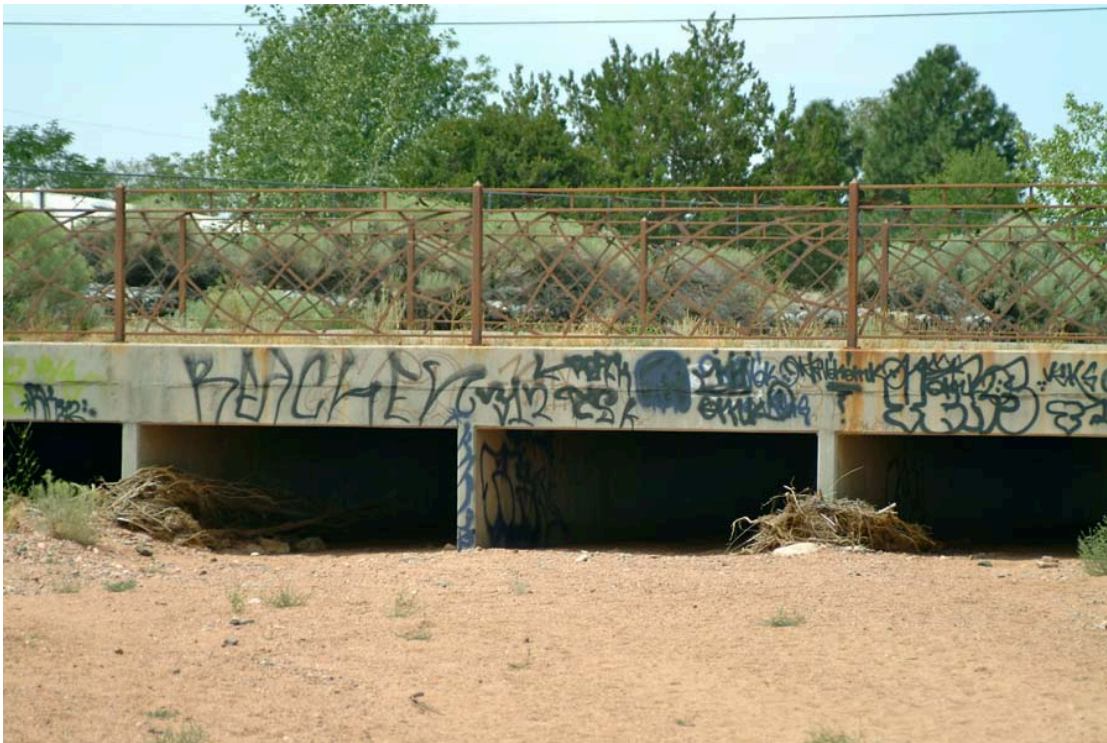
High levels of sediment under Botolph Bridge in Segment C of Arroyo de los Chamisos.

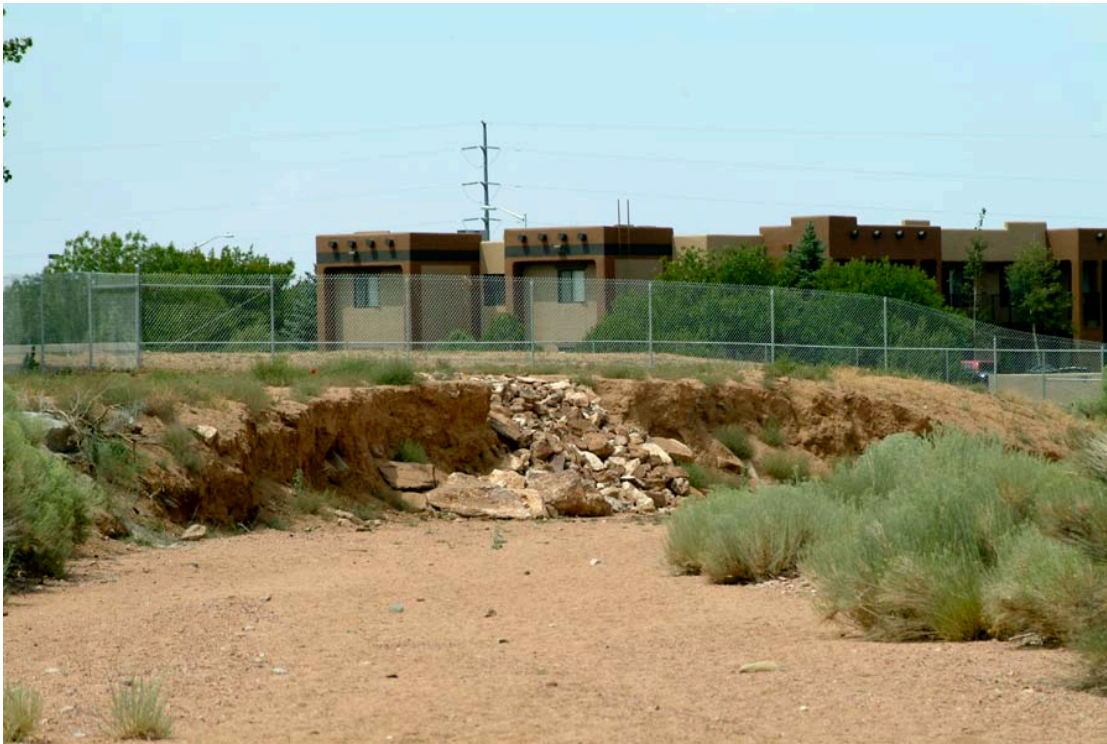
Bank erosion behind Capshaw School in Segment C of Arroyo de los Chamisos.

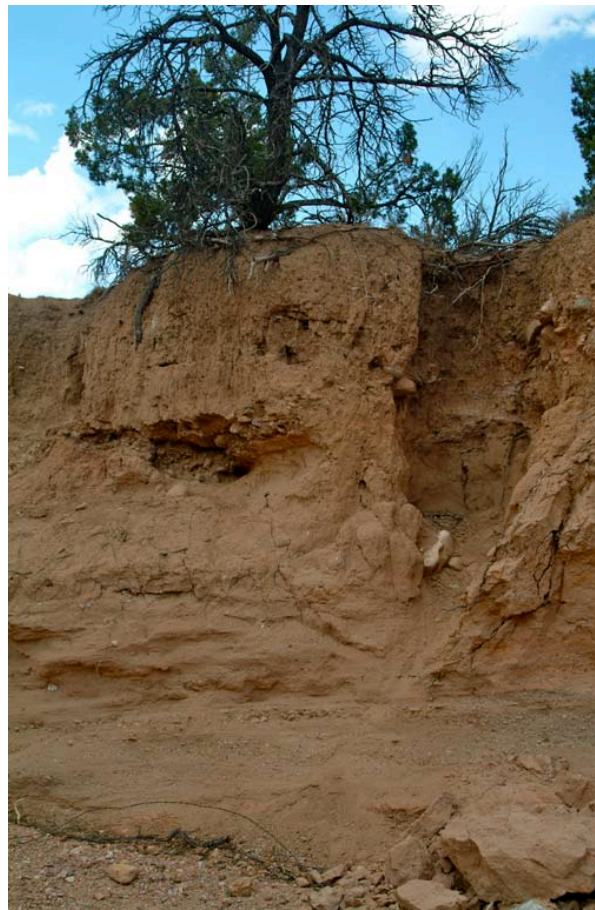
**Notes:** Poor drainage along with erosion control has impacted this segment severely. The extreme deterioration from St. Francis onwards has created hazardous conditions for the community. There is a high frequency of incised channels, constrictions, collapsed banks, and banks in danger of collapsing located within a densely populated area. Established trails, banks, and culverts, concrete footings for vehicle bridges and sewage lines are in extreme need of repair.

High vertical walls typical of Segment D in the Arroyo de los Chamisos below the St. Francis Bridge.

**Segment D of Arroyo de los Chamisos is a high -risk area in much need of remediation. Immediate corrective action is recommended.**

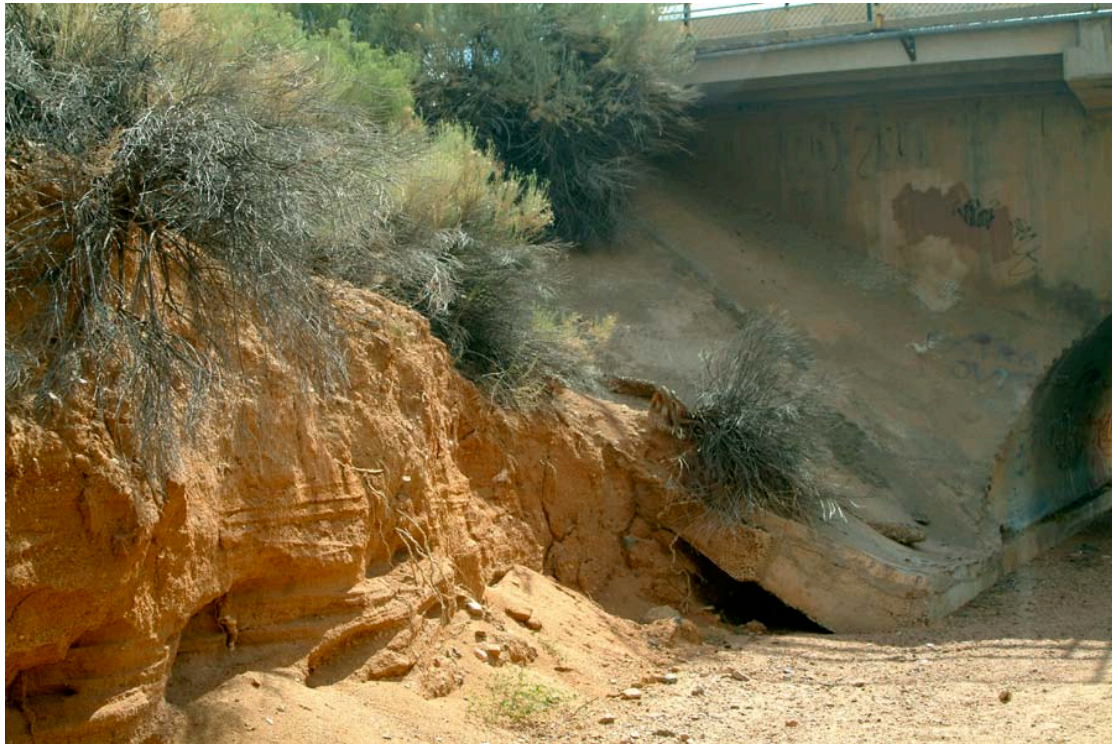
Erosion, collapsing banks and undercut bridge footings are a common sight in Segment D of the Arroyo de los Chamisos .

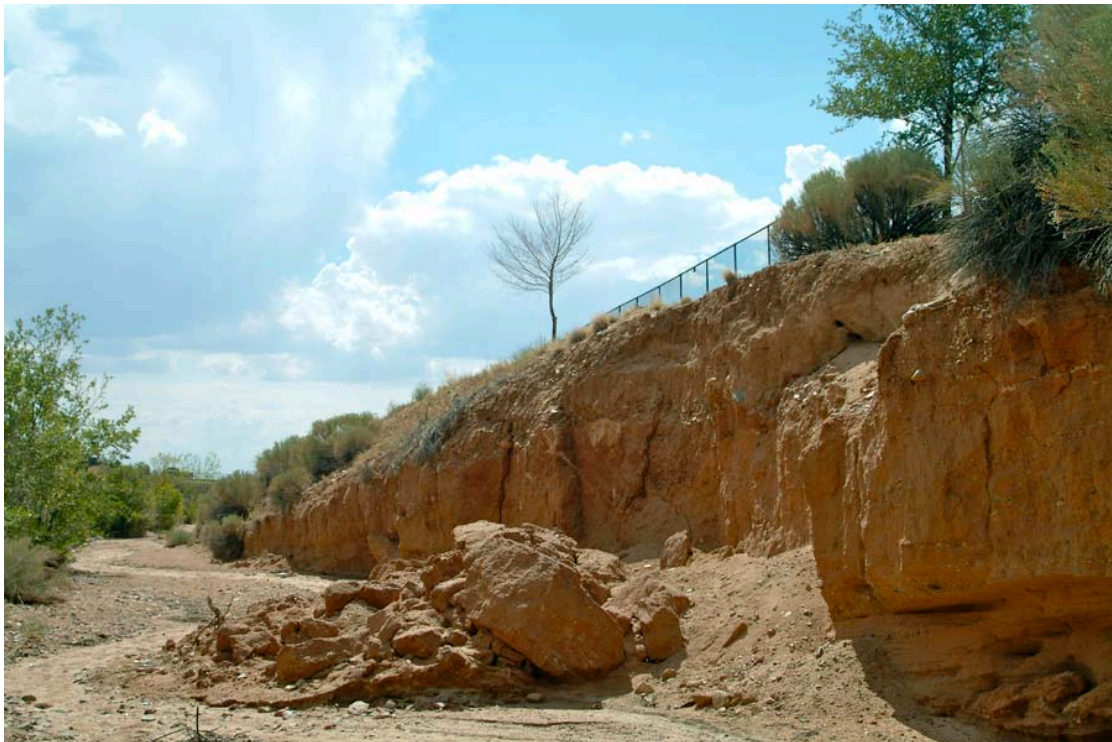
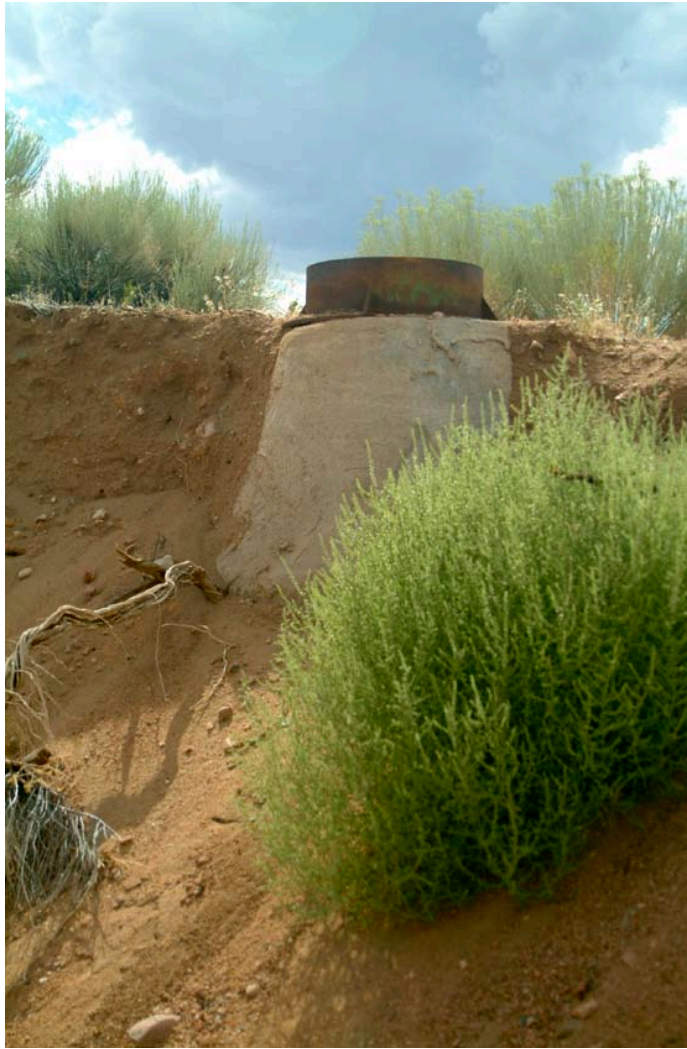
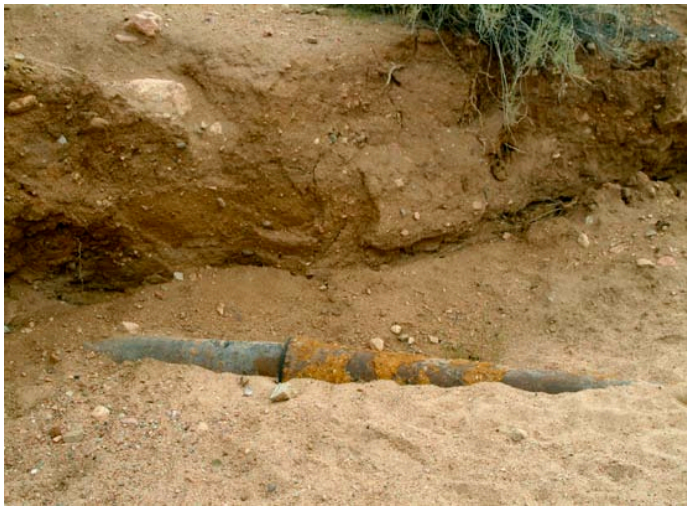
Exposed utilities exist parallel to the Arroyo de los Chamisos Trail in Segment D.

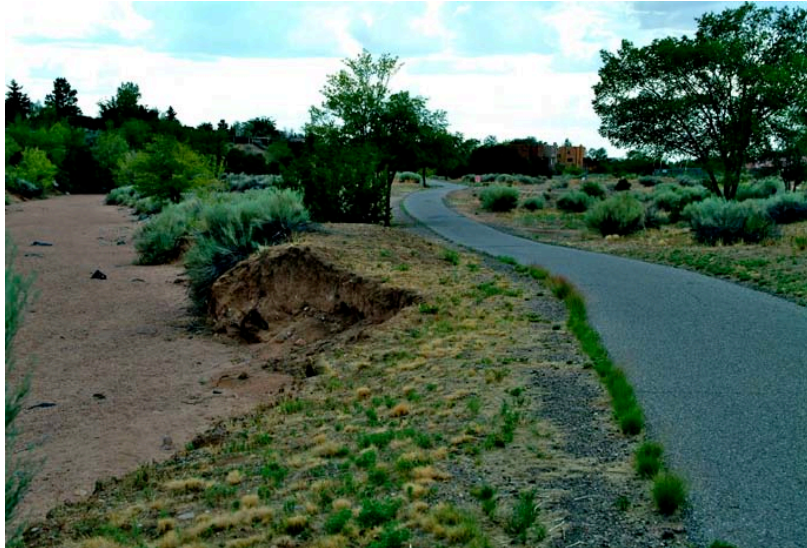
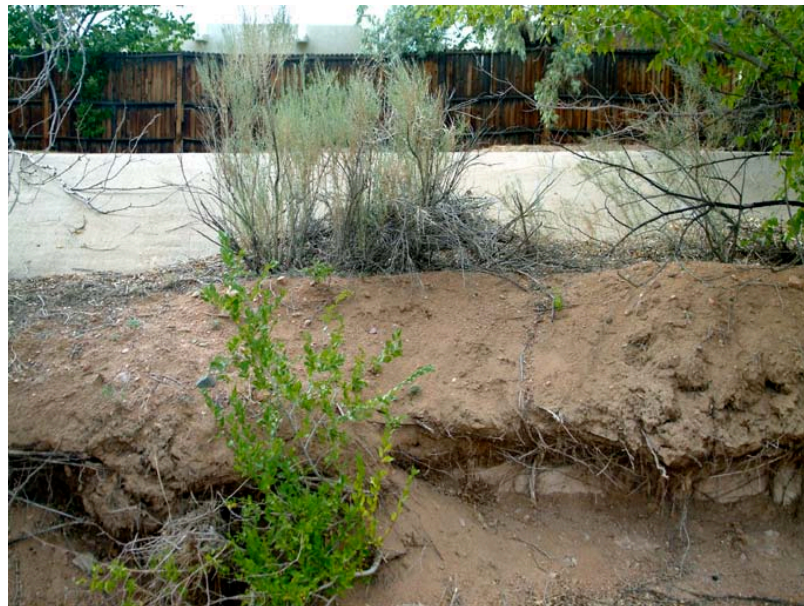
**Notes:** The channel character of the arroyo is broad in this area. There are places along the banks that are severely eroded. The sheathing protecting the banks of the arroyo is even deteriorating.

Severe bank erosion encroaches on the Arroyo de la Chamisos Trail creating hazardous conditions in Segment E.

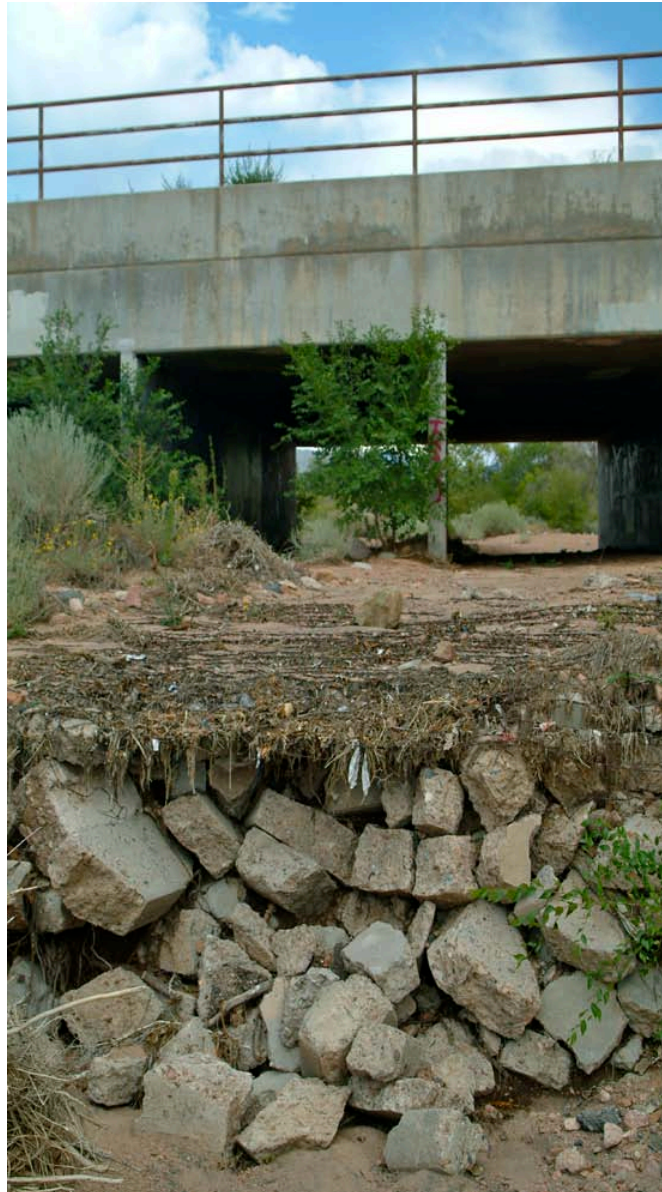
Rip – rap torn away from entire length of an outfall below Camino Carlos Rey Bridge crossing the Arroyo de los Chamisos in Segment F.

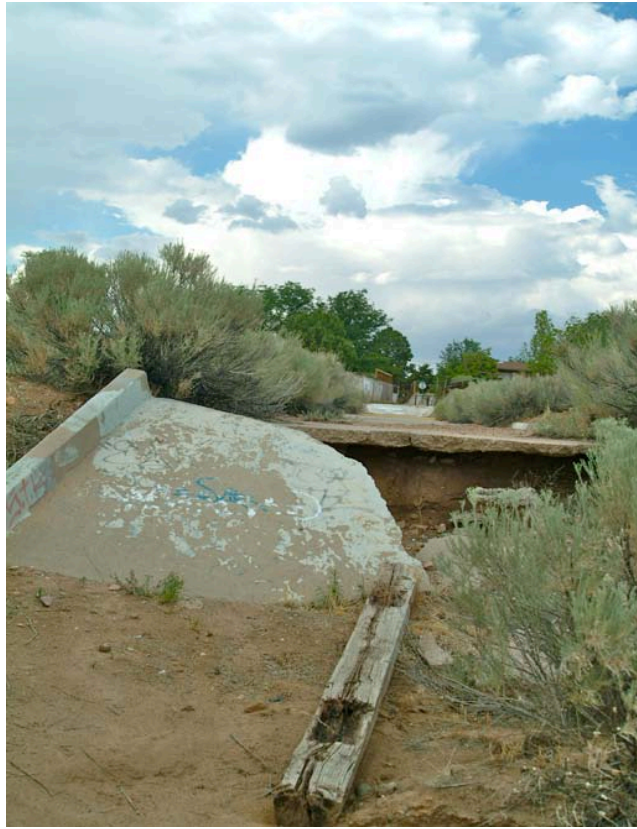
A broken outfall beside the Arroyo de los Chamisos Trail in Segment F.

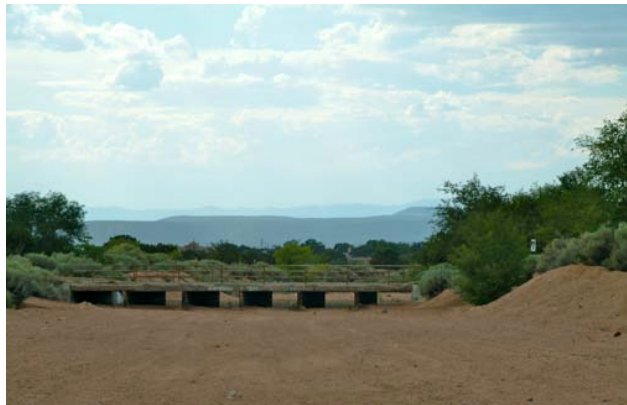
Sediment accumulation under the Ave de la Campana Bridge in the Arroyo de los Chamisos, Segment F.

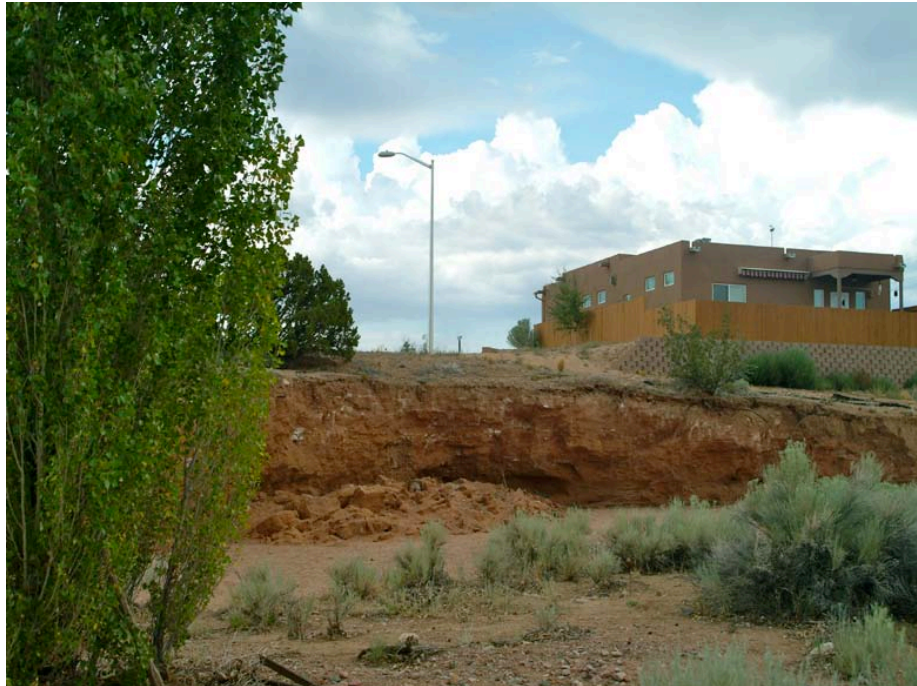
**Notes:** Between the Ave de Las Campanas Bridge and the Rodeo Road Bridge several high cut banks exist that are **seriously threatening** a residential road near the Kachina Heights subdivision. The rip-rap used to stabilize the arroyo banks is undercut. **Extreme amounts of trash exist in this area.**

High vertical walls with collapsing banks in Kachina Heights overlook Arroyo de los Chamisos, Segment G

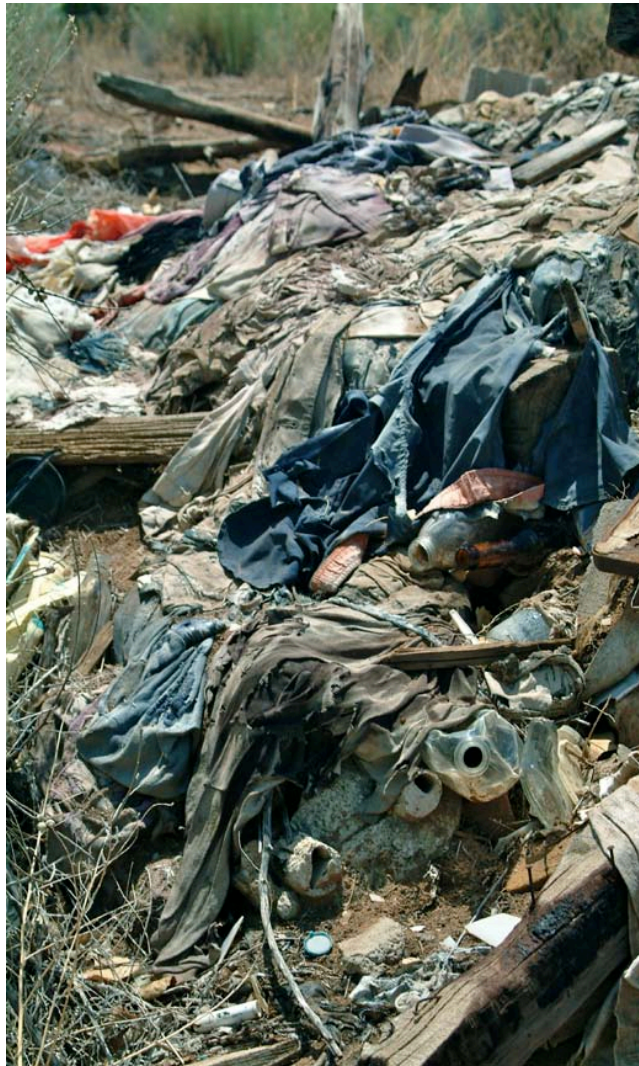
One of five dumps located along the Arroyo de los Chamisos, Segment H.

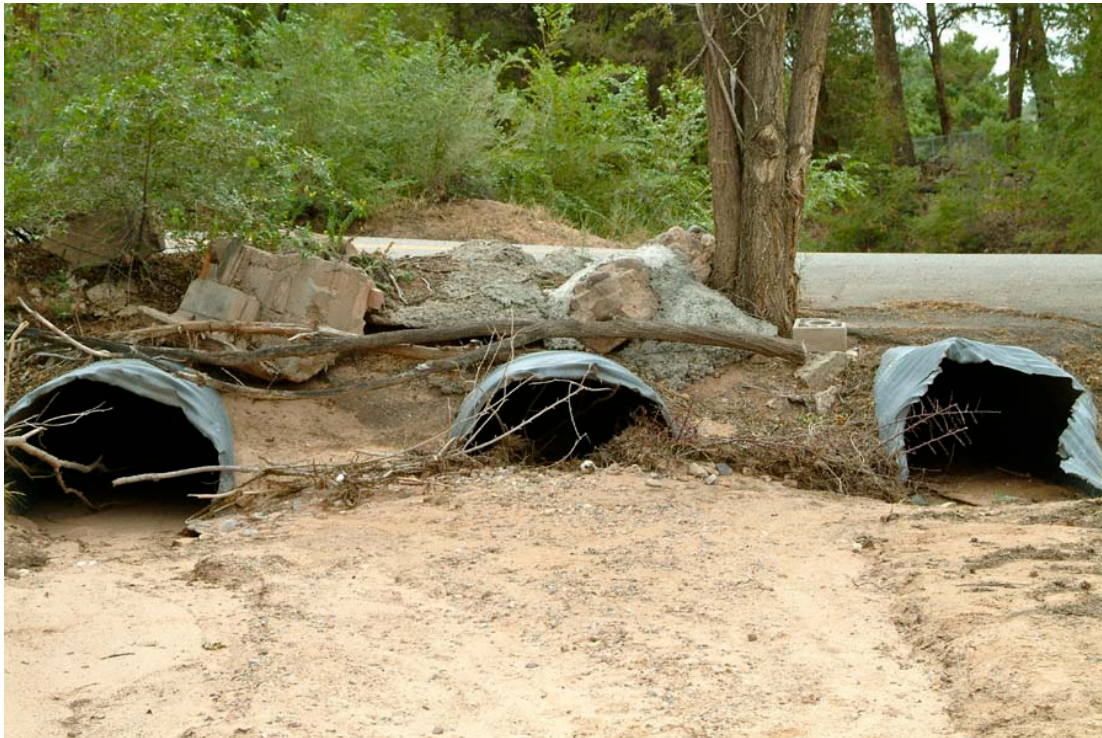
The Griffin Street culverts in Arroyo Rosario.

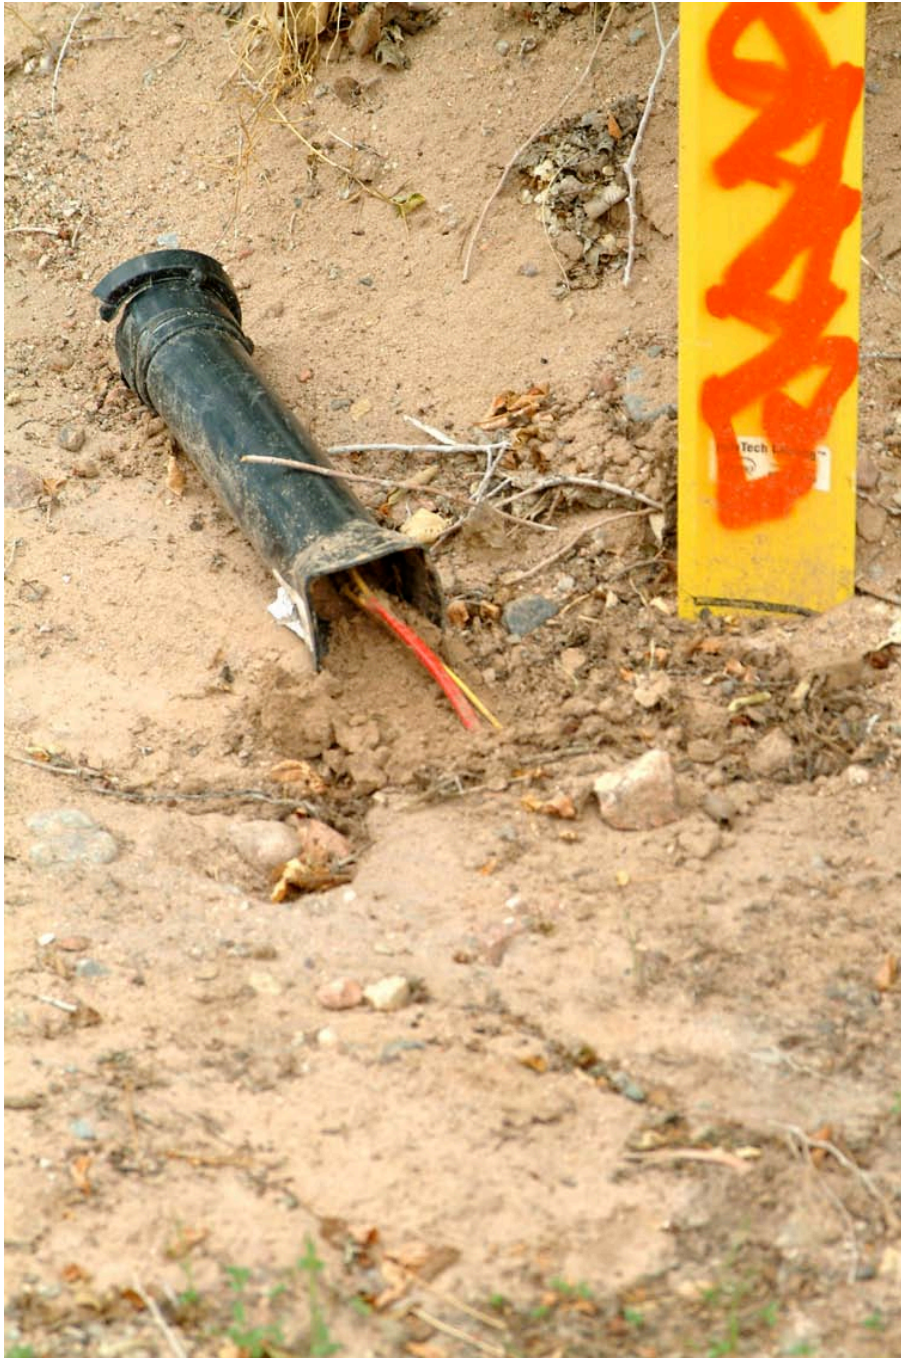
Exposed utility line found in the Arroyo Rosario.

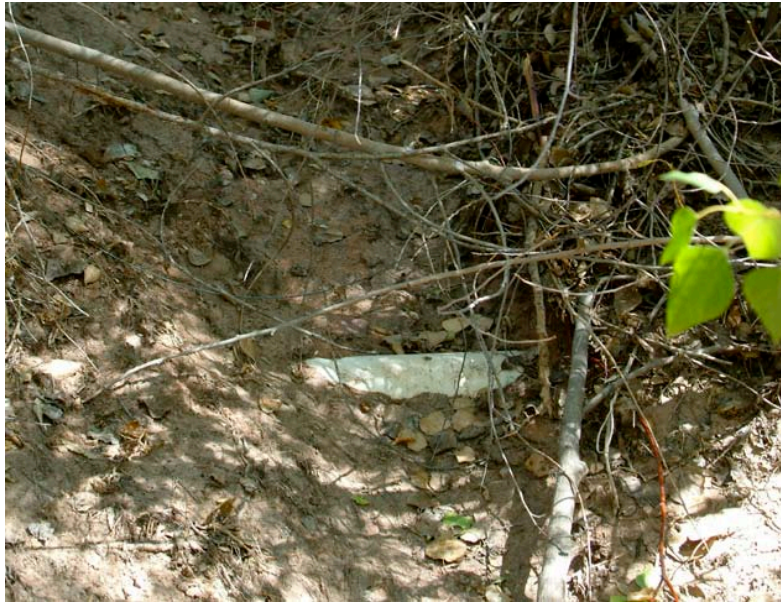
An exposed pipe in Arroyo Saiz.

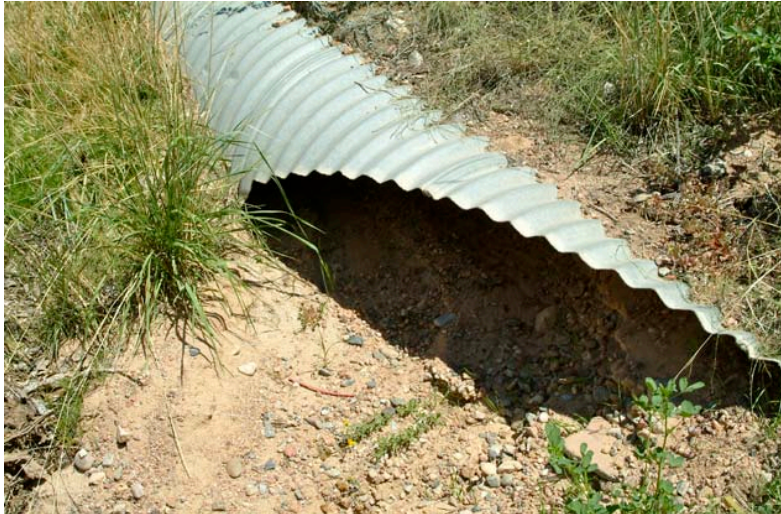
A silt clogged culvert in Arroyo Saiz.

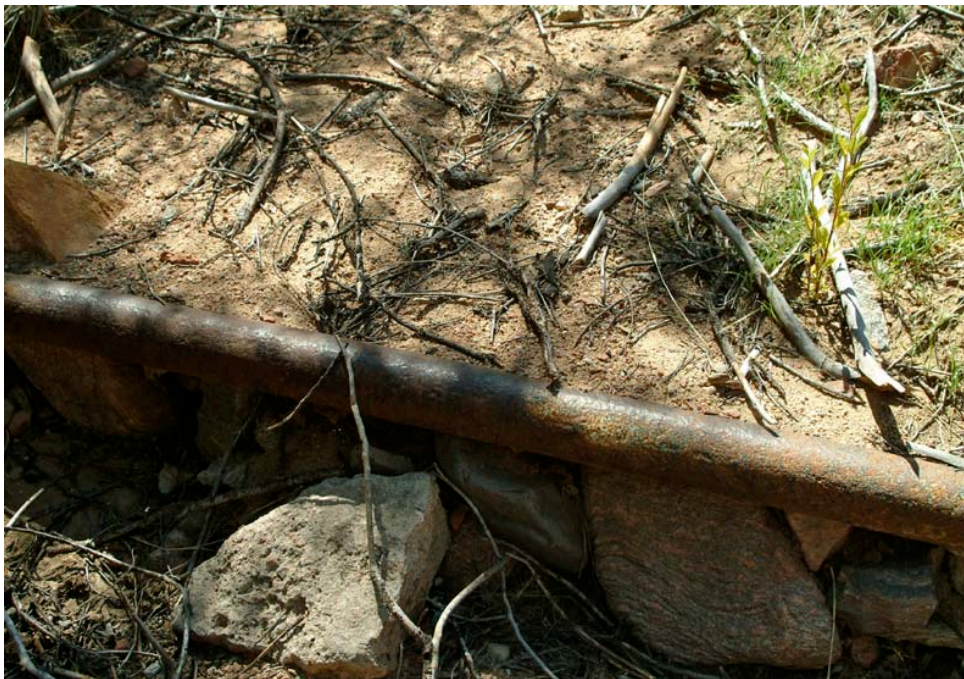
Pipe in the bed of the Arroyo Mora.

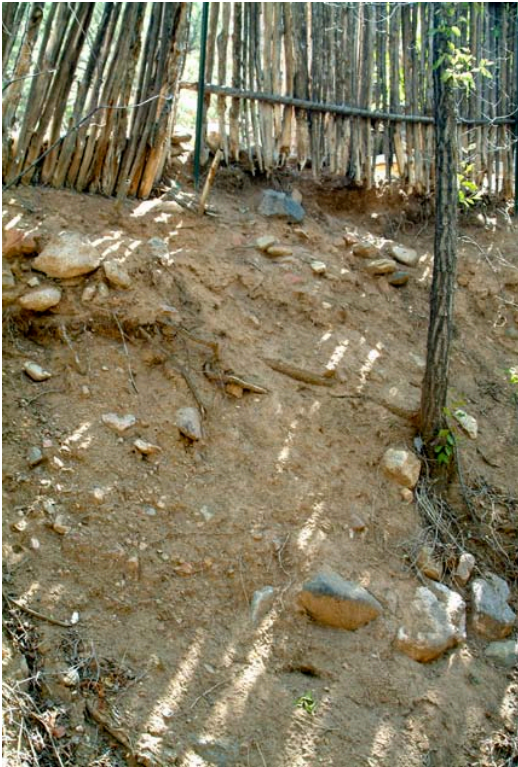
Endangered fence line in the Arroyo Mora.

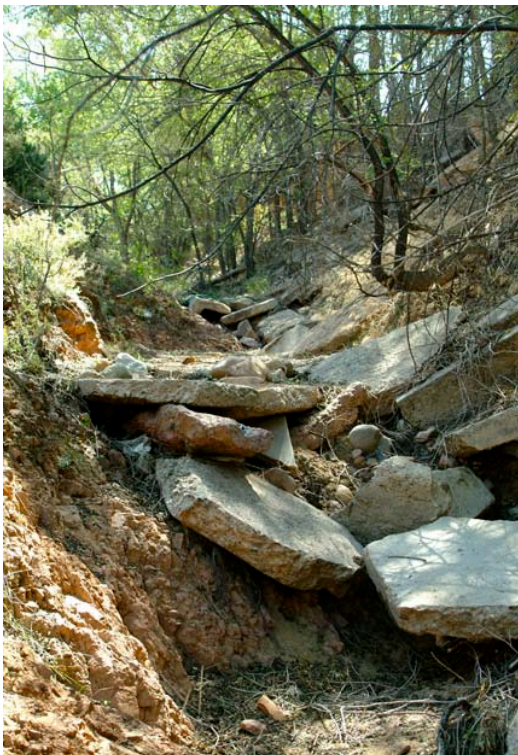
Concrete clogged channel of the Arroyo Mora.

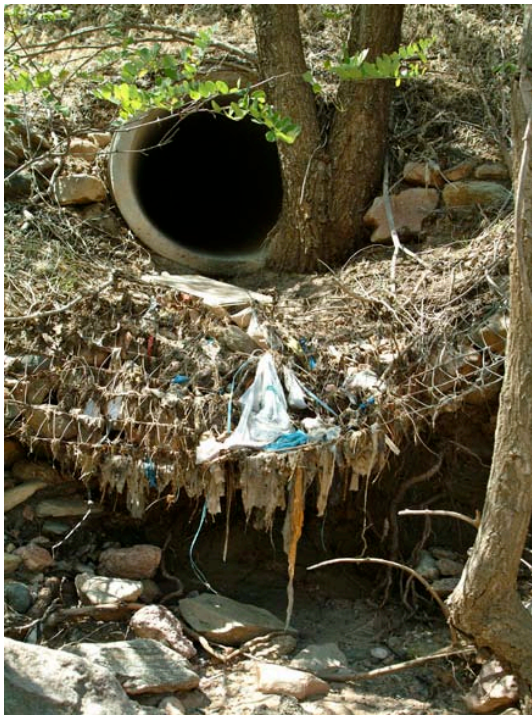
Damaged rip - rap with trash in Arroyo Cabra.

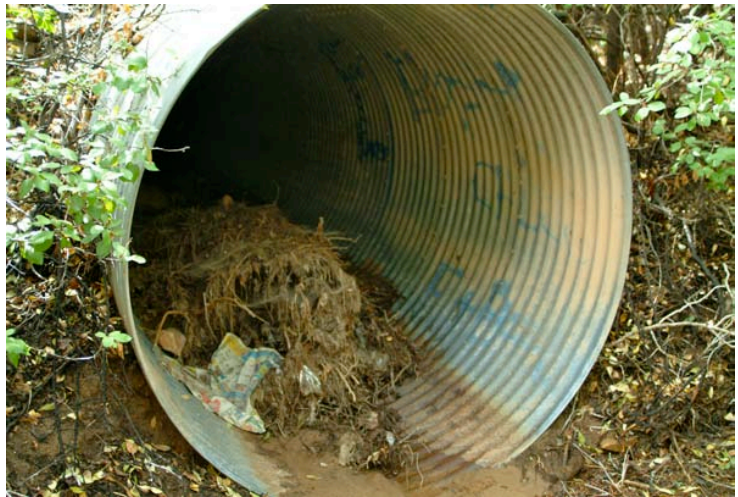
Obstructed culvert in Arroyo Cabra.

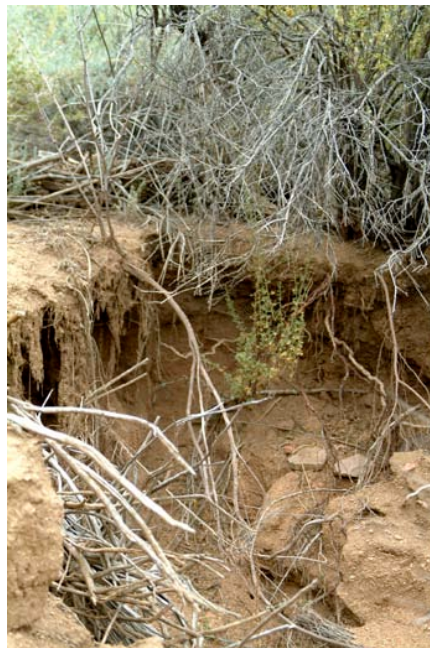
Erosion in Arroyo en Medio, Segment A.

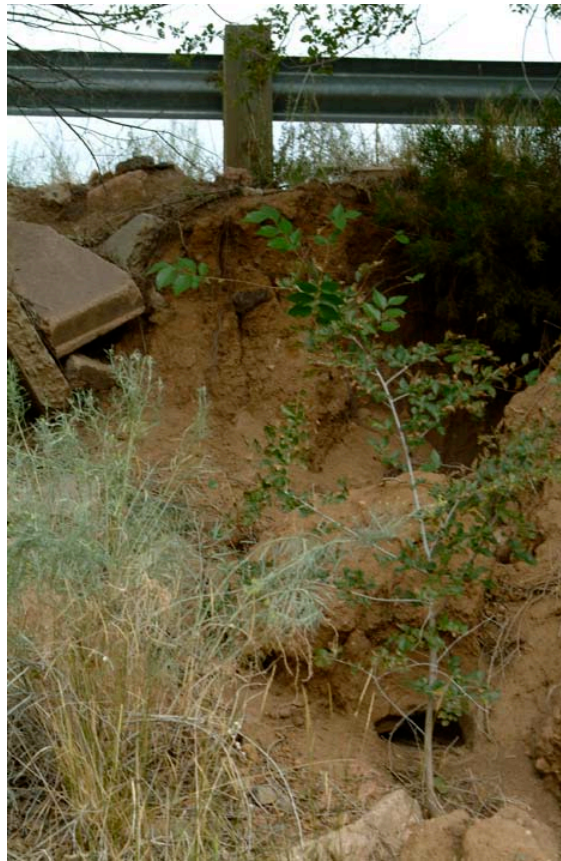
This segment is in good condition. However, above the entrance to the Old Pecos Trail Bridge the bank is in poor condition due to failure of ancient riprap. Heavy erosion is threatening the shoulder of the bridge. **City utility crew needs to asses immediately . A possible motorist hazard exists here.**

Erosion of shoulder off Old Pecos Trail Road, Segment C.

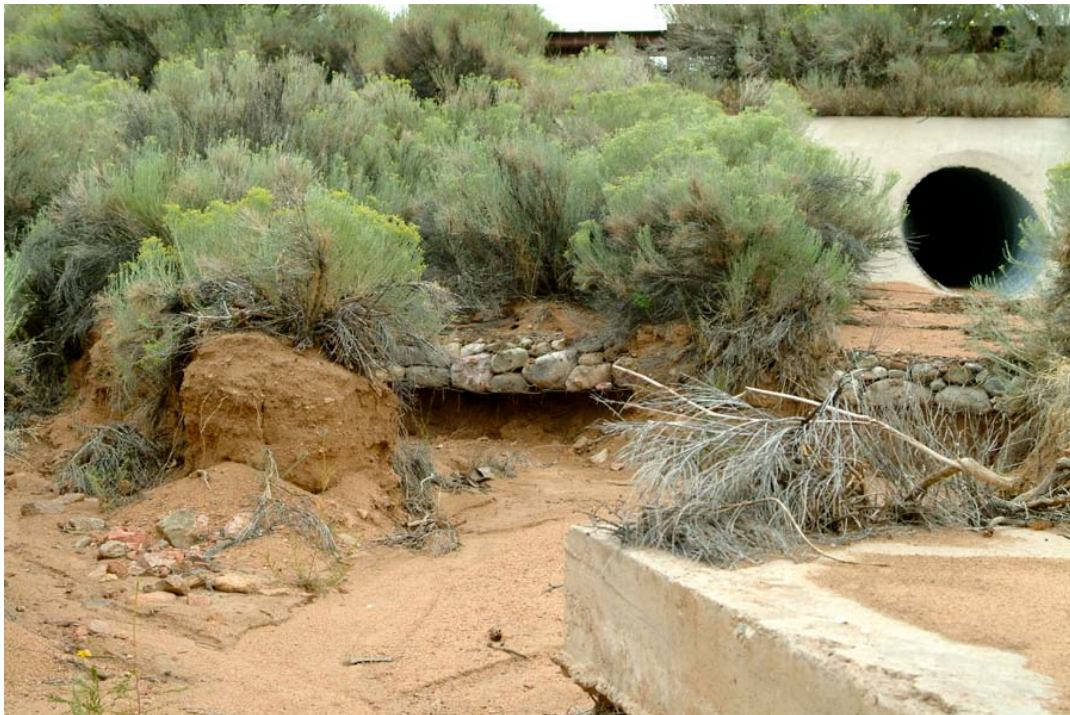
Erosion undercutting rip-rap, banks, and concrete outfall in Arroyo en Medio, Segment D.

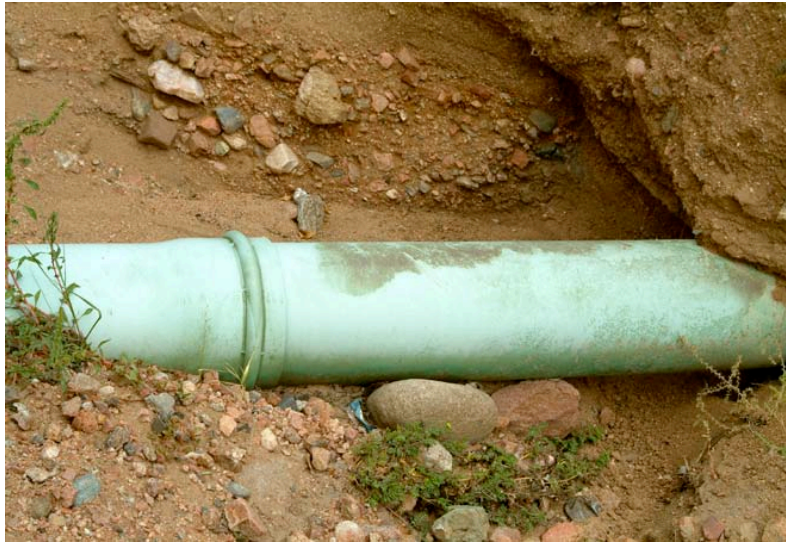
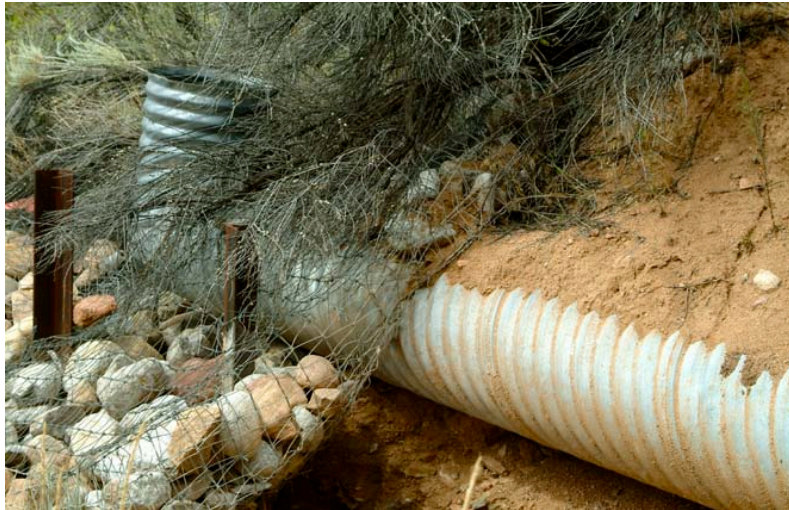
**The condition of this segment is among the poorest in all of the Arroyo en Medio. The extent of erosion has created damage to the surrounding infrastructure. It has uncovered one utility line, caused a culvert to emerge out of a vertical bank, collapsed a wall, and incised the bank along side a gabion wall and concrete crossing. The extensive amount of trash and dog waste is problematic in this area.**

Pipe and culvert in the Arroyo en Medio, Segment E.

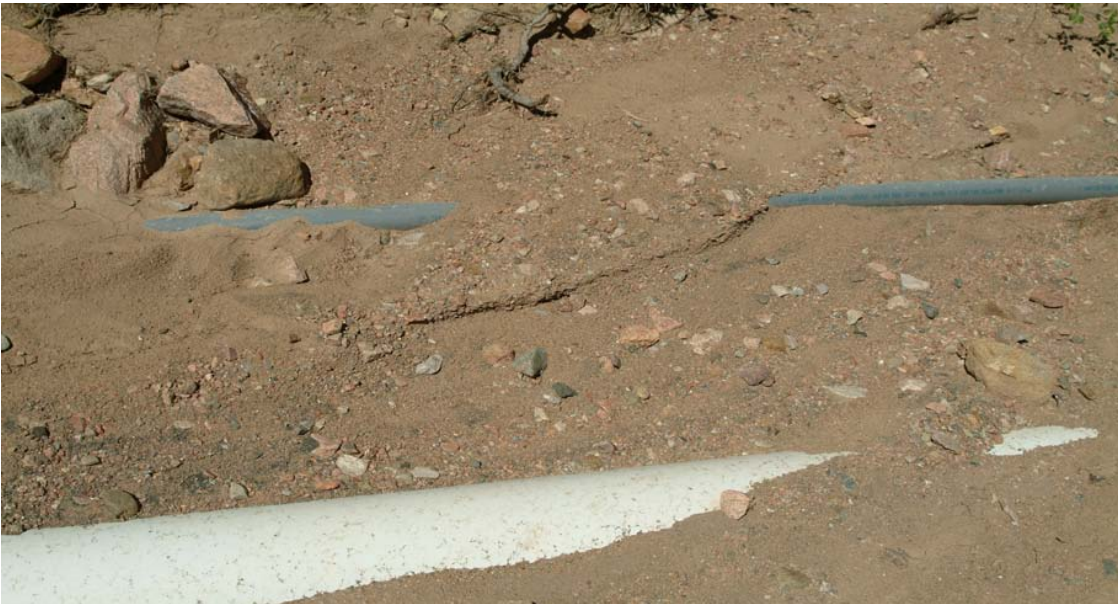
Two exposed pipes in Arroyo Ancha, Segment A.

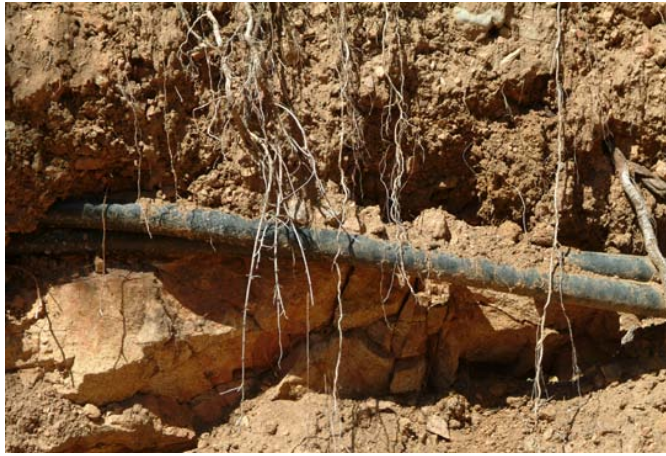
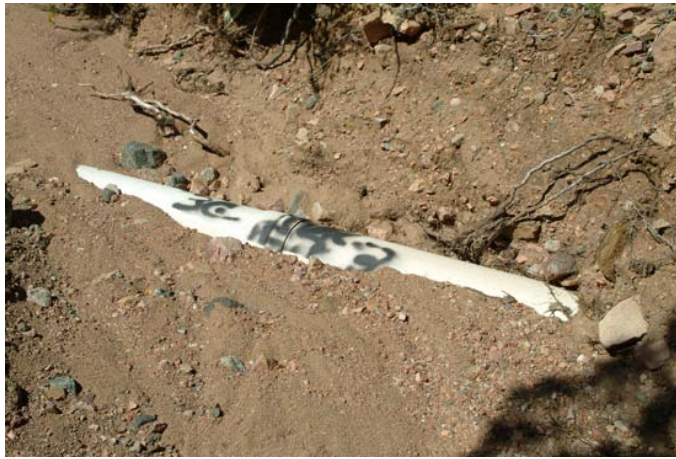
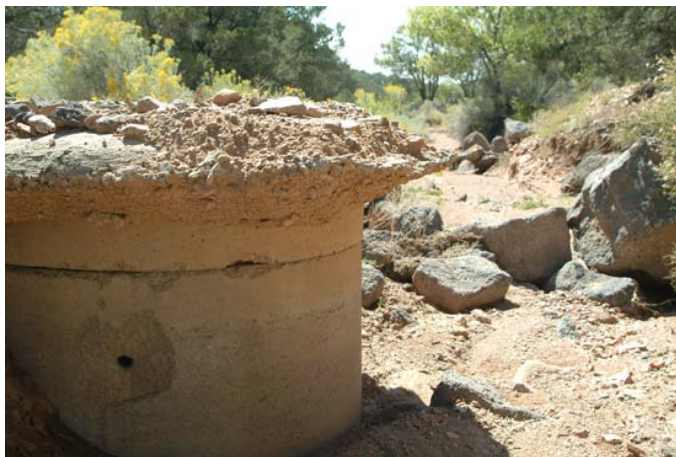
High voltage cables (top), utility line( middle), sewer utility (bottom), in Arroyo Ancha, Segment A.

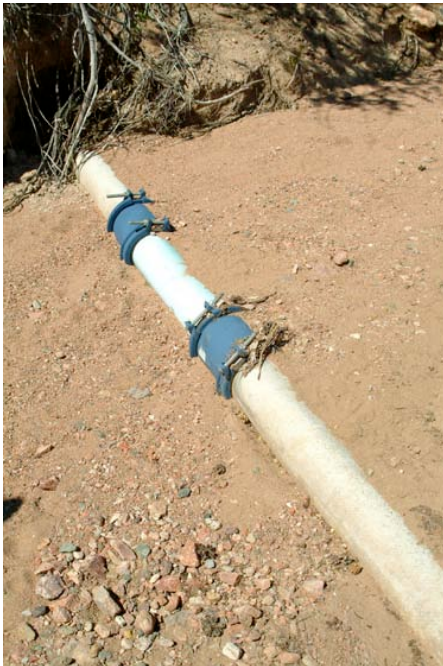
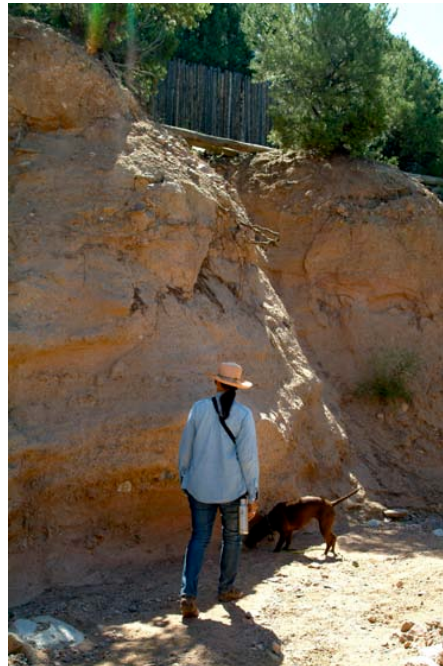
Above the Lejano Bridge crossing, **a cable and a large pipeline were found exposed in the bed of the arroyo.** A fence line is in danger of collapse along the bottom of Lorenzo Road. When entering the arroyo on the other side of Lorenzo Road erosion has undermined the rip-rap structures and created a vertical wall between the outfall and gabion wall. The silt levels of the box culvert emptying into the river are very high.

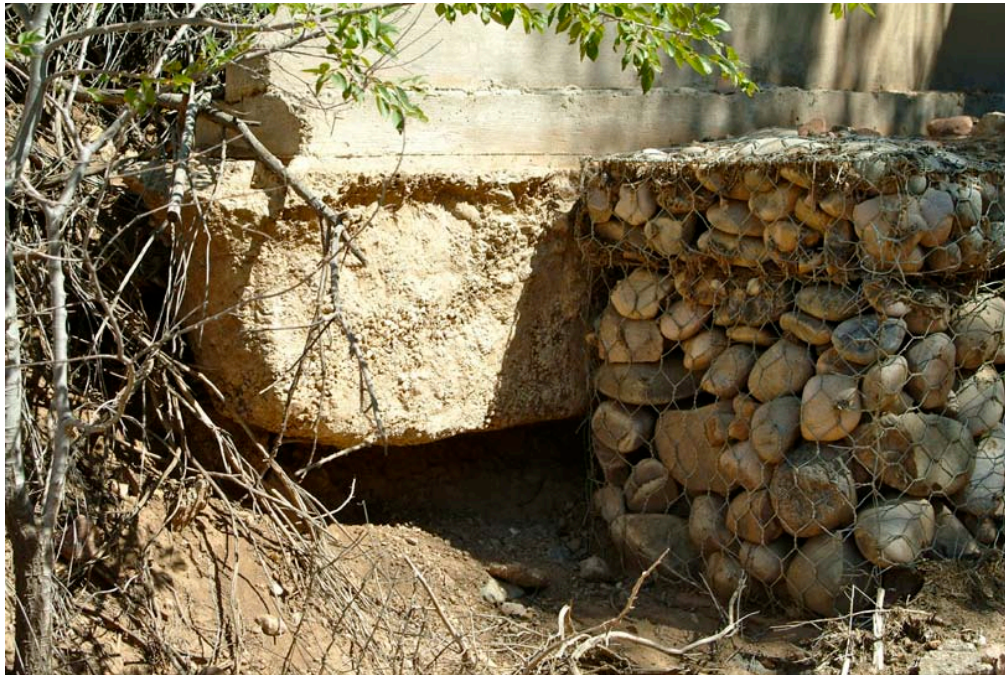
Undercut bridge footing in Arroyo Ancha, Segment B.

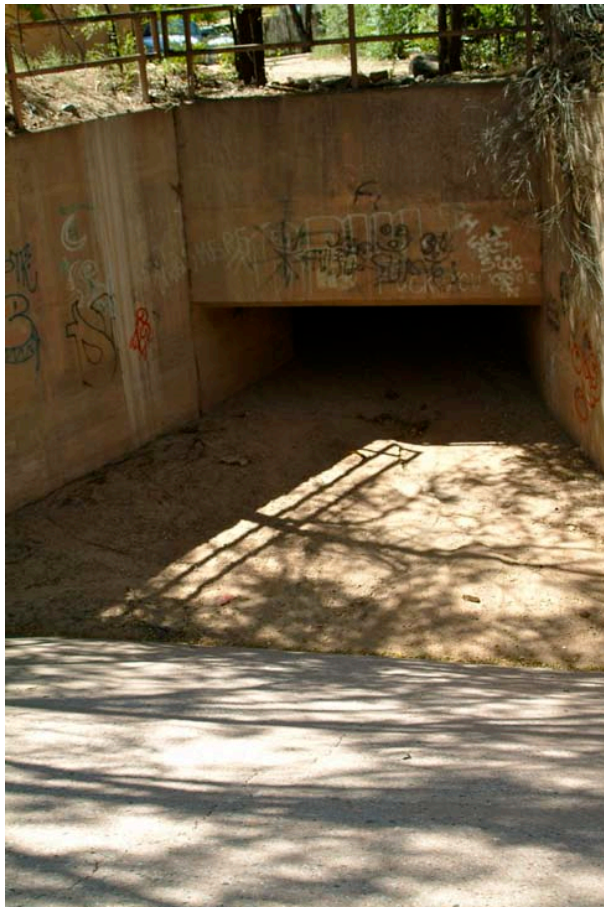
Box culvert trapping sediment beneath E. Alemeda Street, Arroyo Ancha Segment B.
