# **ARROYO ASSESSMENT SURVEYS OF 10 MAJOR ARROYOS IN THE SANTA FE WATERSHED**

November 16<sup>th</sup>, 2012

## **Santa Fe Watershed Association**

**Report to the Public Works Department, City of Santa Fe 2012**

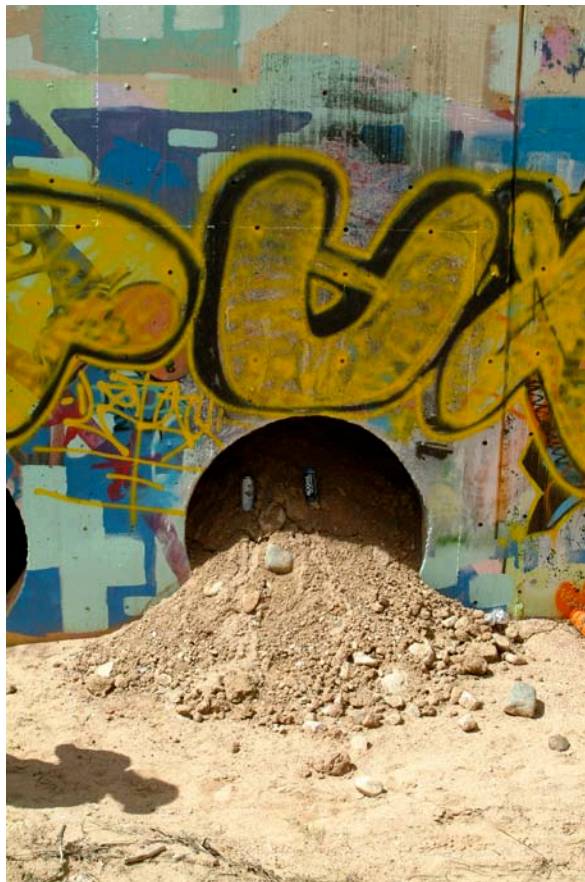
A clogged culvert at Old Pecos Trail, Upper Arroyo Pinos, Segment A.

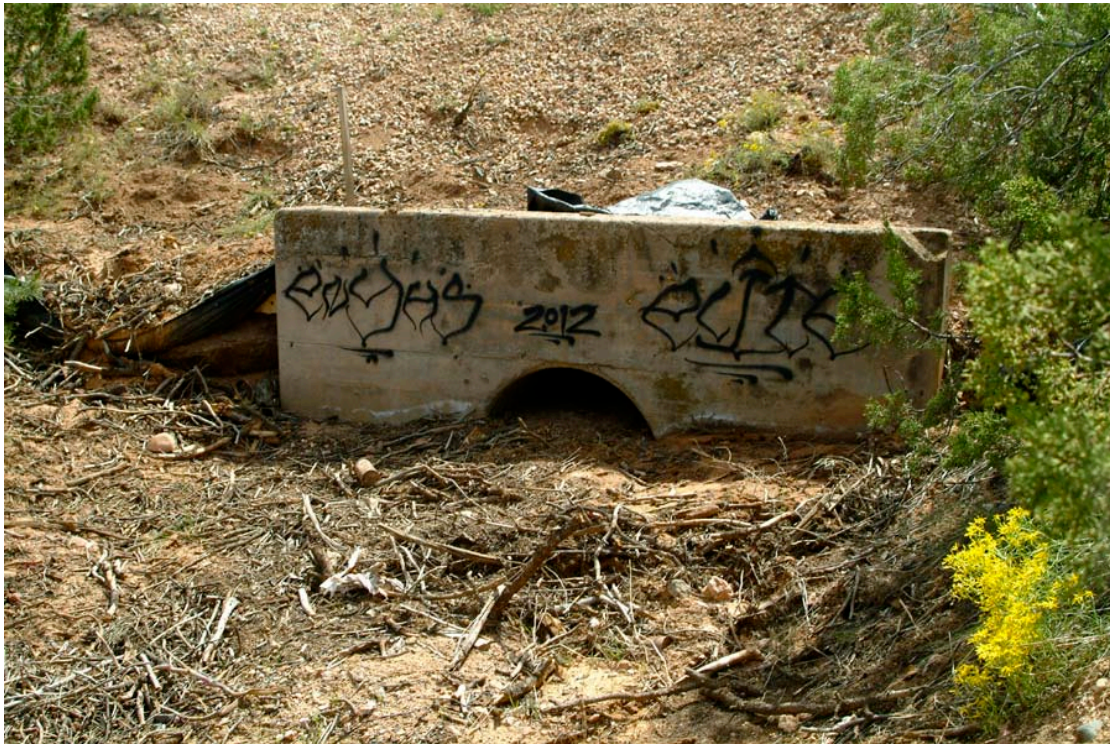
Plugged culvert near Old Pecos Trail in Arroyo Pinos, Segment A.

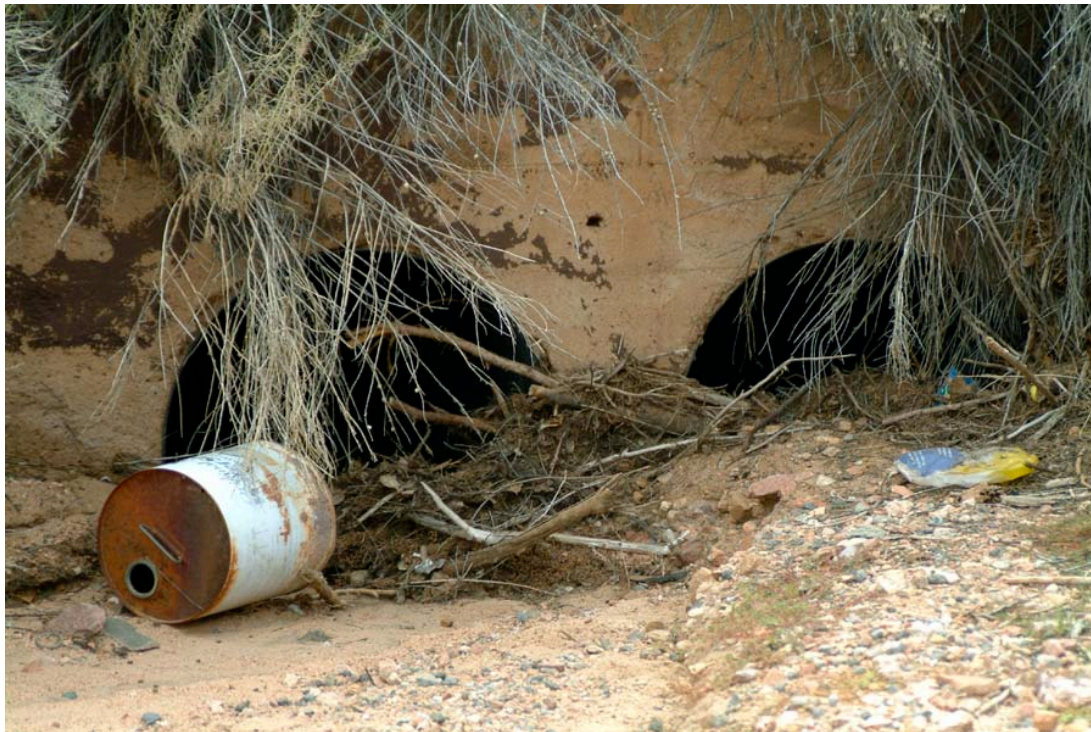
Obstructed culverts in Upper Arroyo Pinos, Segment B.

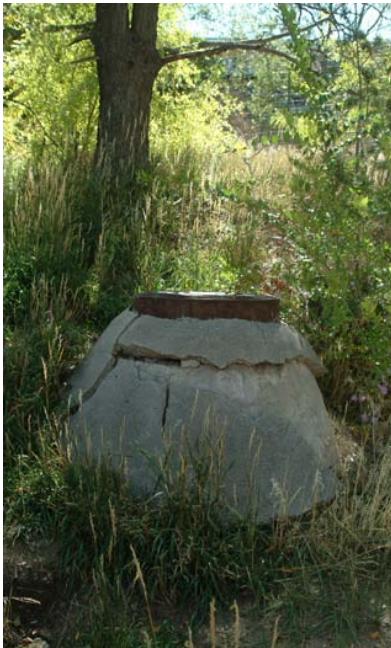
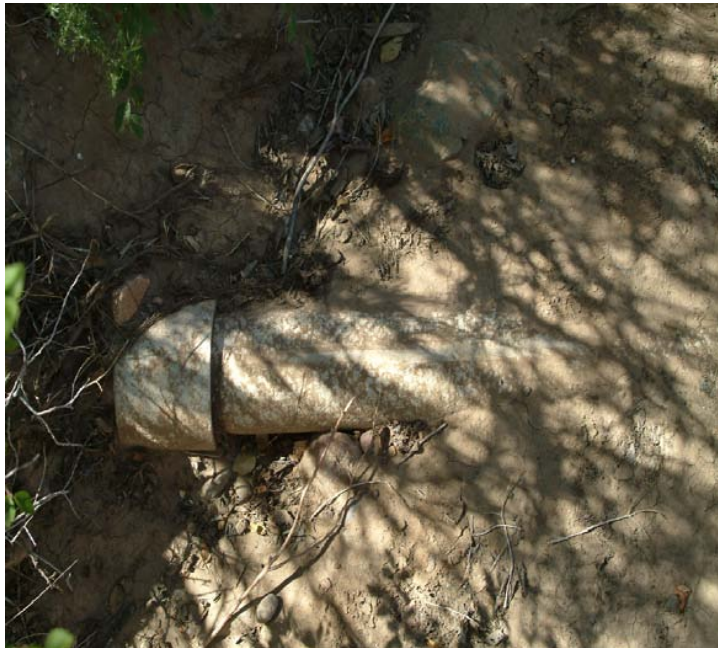
Disrepair encountered in the Lower Arroyo de Pinos, Segment A.

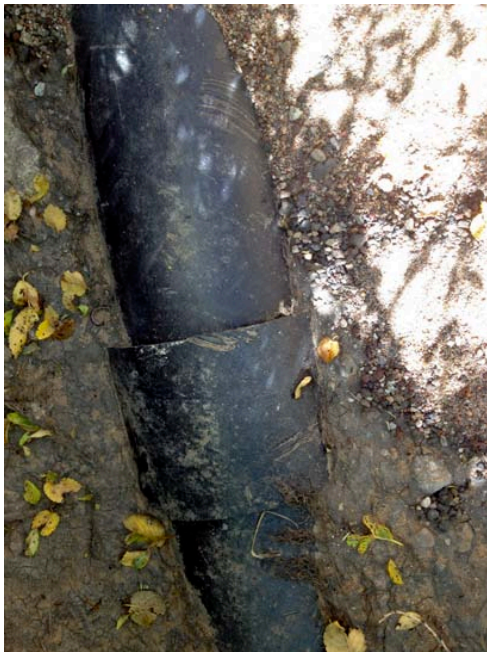
Exposed utility pipe in Lower Arroyo Pinos, Segment B.

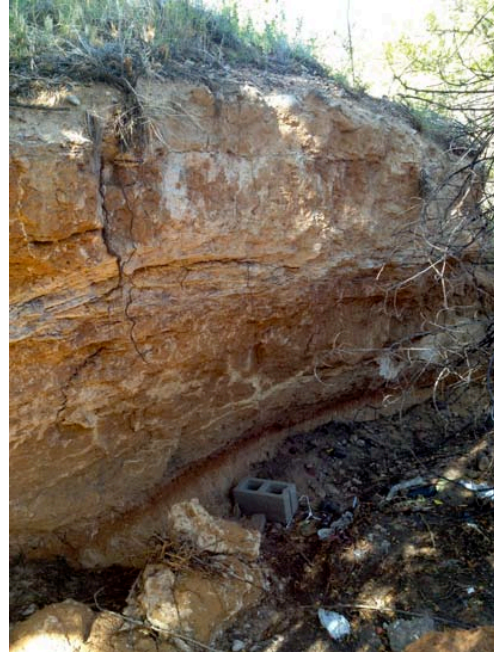
Eroding banks in Lower Arroyo Pinos, Segment B.

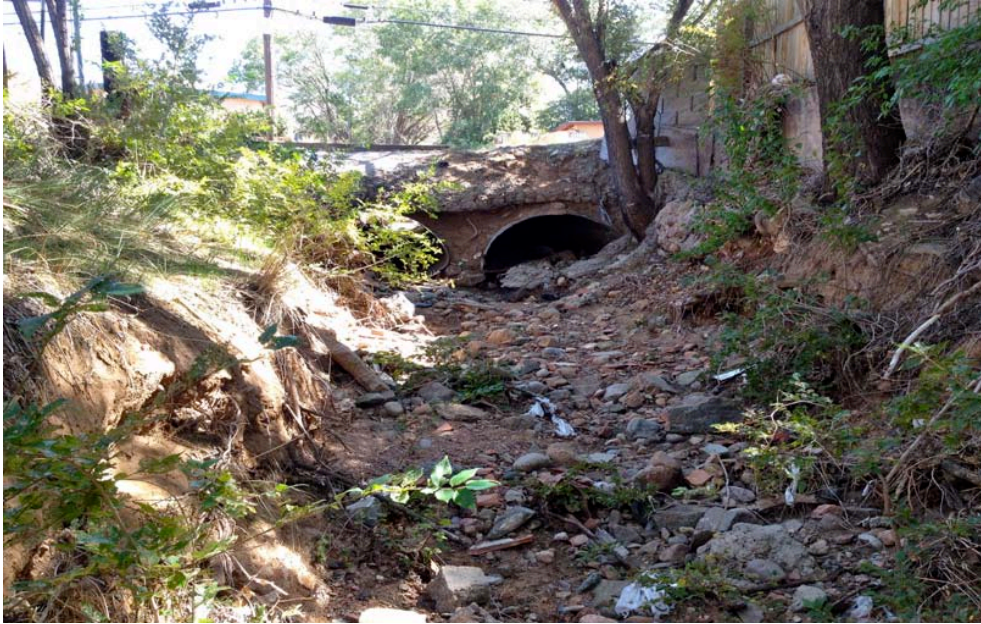
Culvert obstructed by cement dumped into Lower Arroyo Pinos, Segment B.

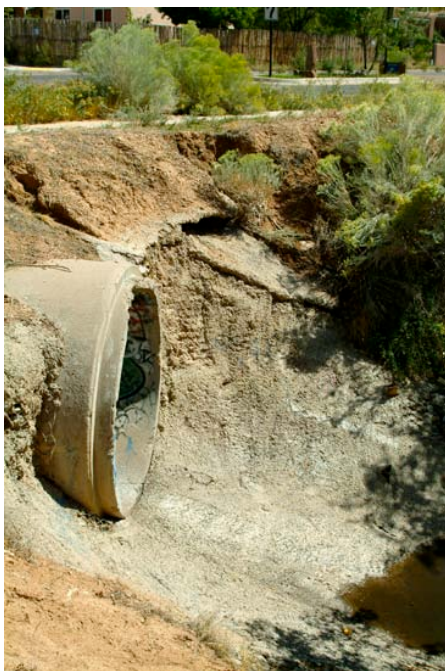
5<sup>th</sup> street sidewalk threatened by erosion Lower Arroyo Pinos, Segment C.

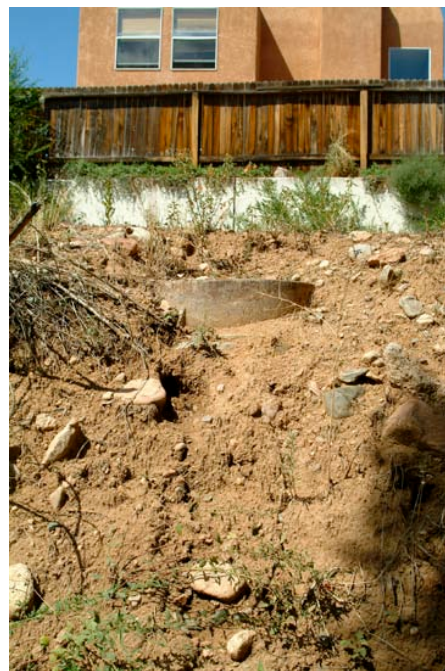
Manhole in bank of Lower Arroyo Pinos, Segment C.

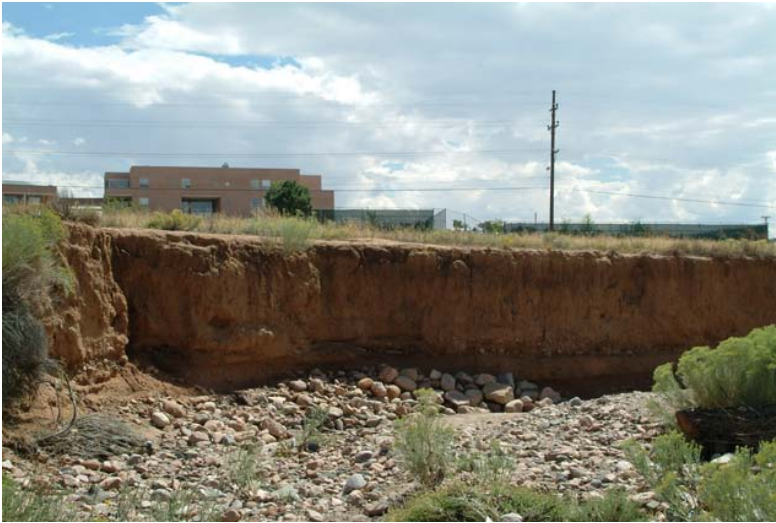
Vertical banks in front of La Farge Library, Lower Arroyo Pinos, Segment C.

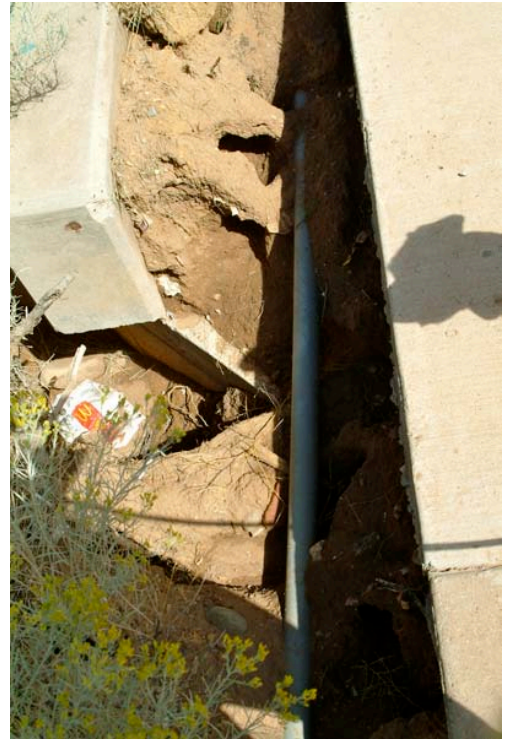
Exposed utility line off of Llano Street Bridge, Lower Arroyo Pinos, Segment C.

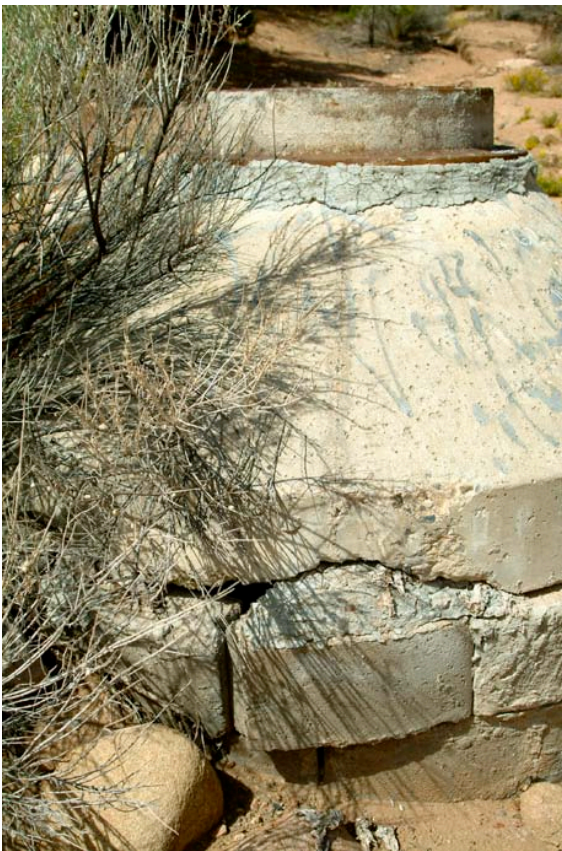
Sewer utility decaying, Lower Arroyo Pinos, Segment C.

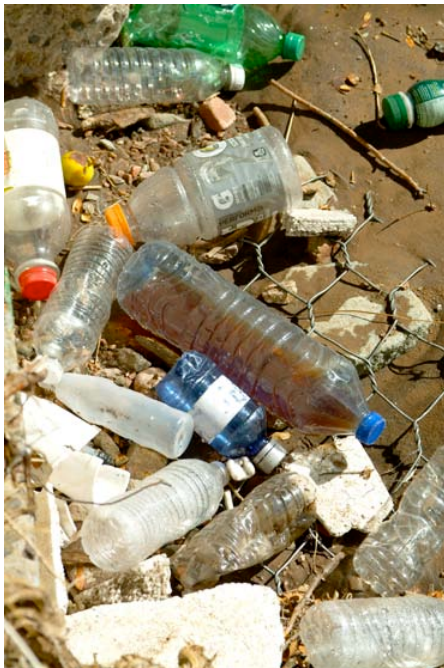
Trash in Lower Arroyo Pinos, Segment D.

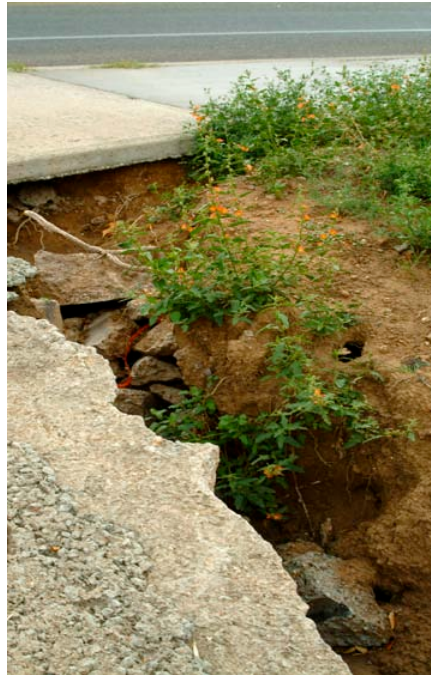
Erosion at Camino Carlos Rey Bridge, Lower Arroyo Pinos, Segment D.

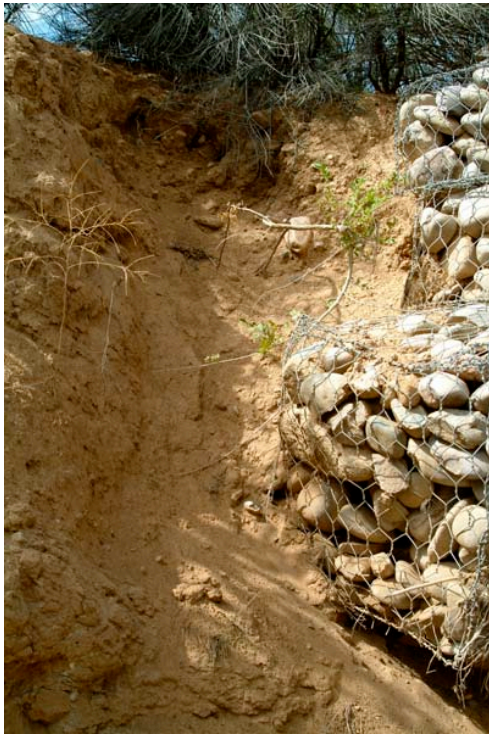
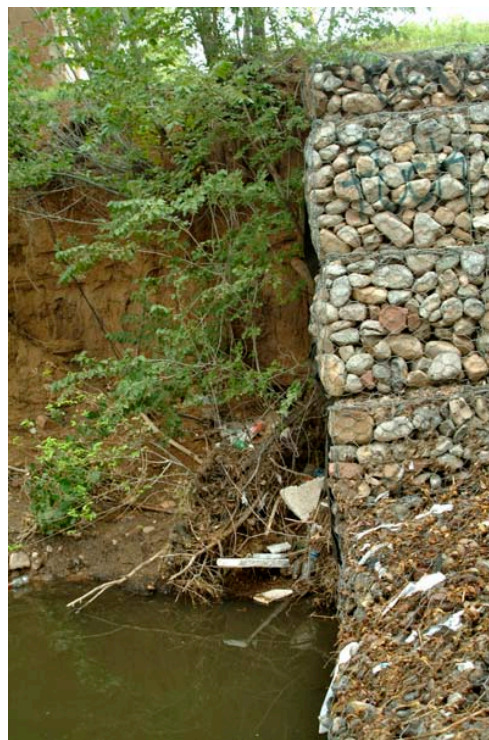
Erosion at edges of gabion walls, Lower Arroyo Pinos, Segment E.

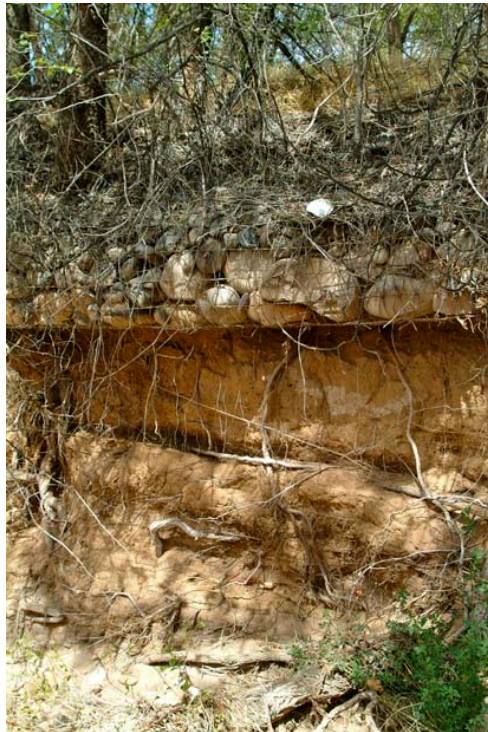
Undercut rip-rap in Lower Arroyo Pinos, Segment E.

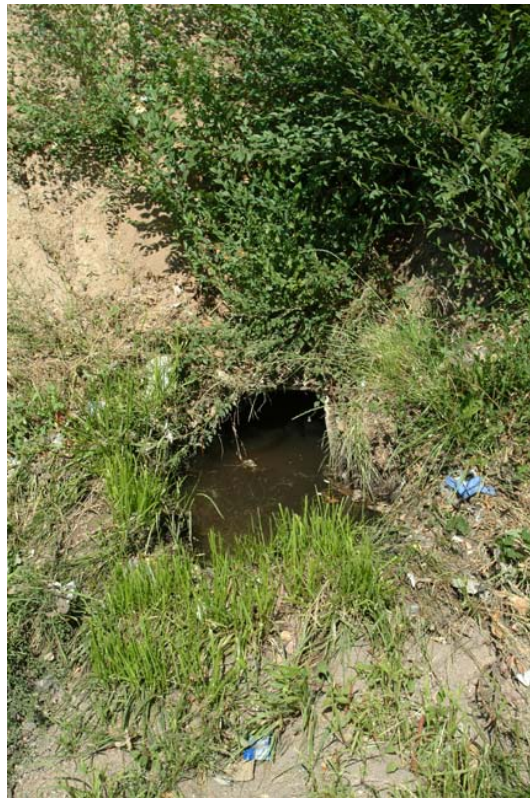
Clogged culvert, Lower Arroyo Pinos, Segment X.

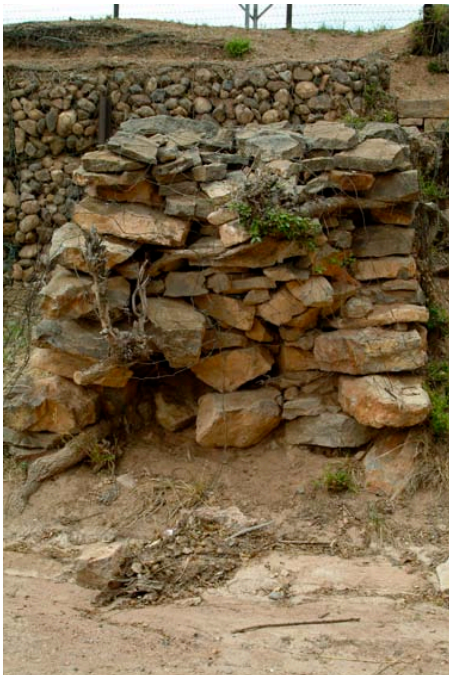
Damaged wall in bottom of Arroyo Mascaras.

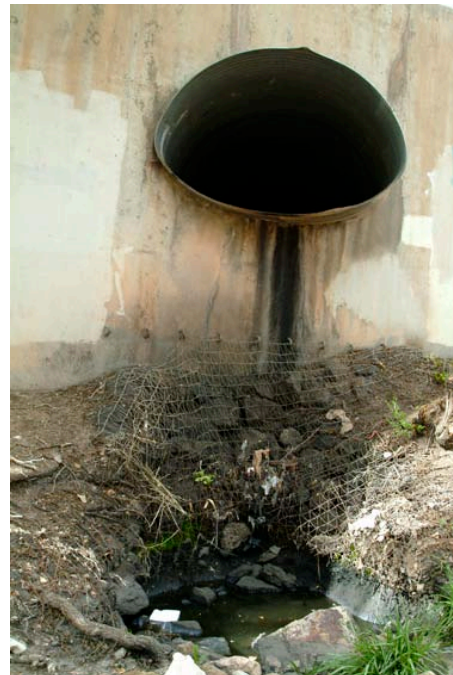
Damaged rip-rap in Arroyo Mascaras.

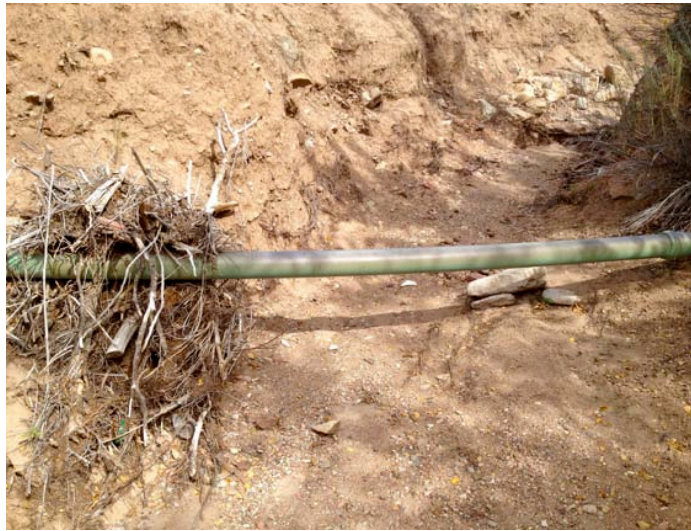
Exposed utility lines in Arroyo Piedra East, Segment A.

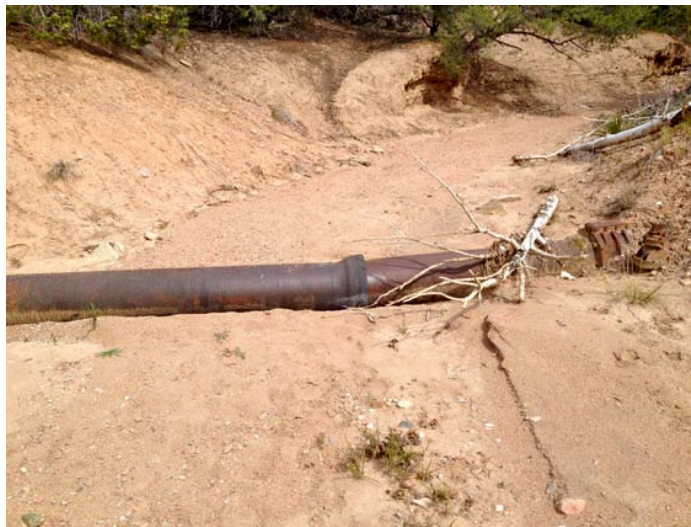
Exposed utility in Arroyo Piedra East, Segment A.

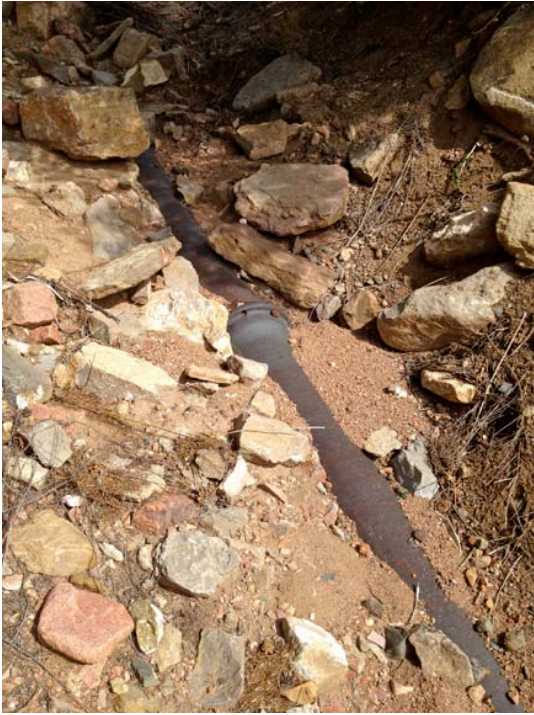
Obstructed culverts crossing Arroyo Piedra East, Segment A.

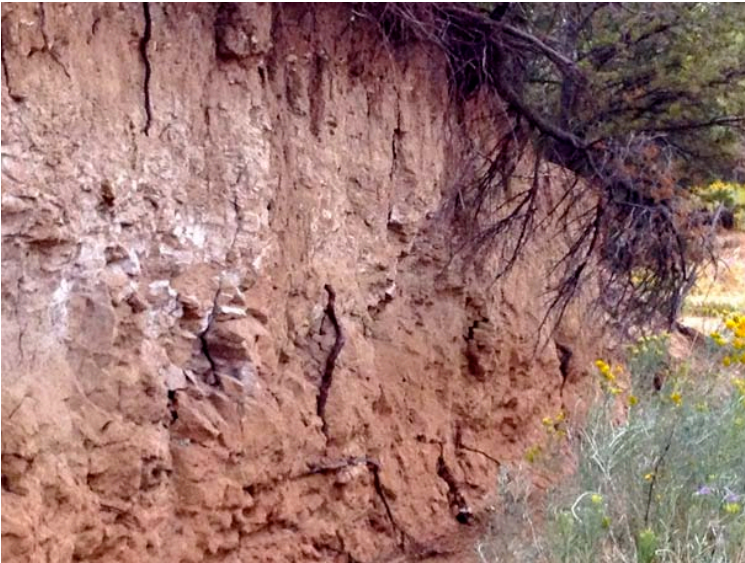
Eroded banks in Arroyo Piedra East, Segment A.

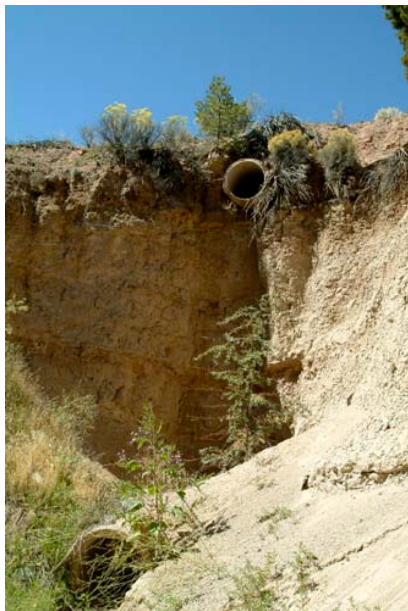
Damaged culverts, Arroyo Piedra West, Segment B.

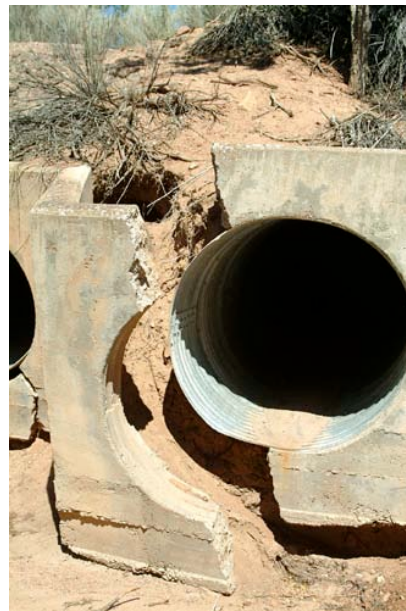
Damaged Culverts, Arroyo Piedra West, Segment B.

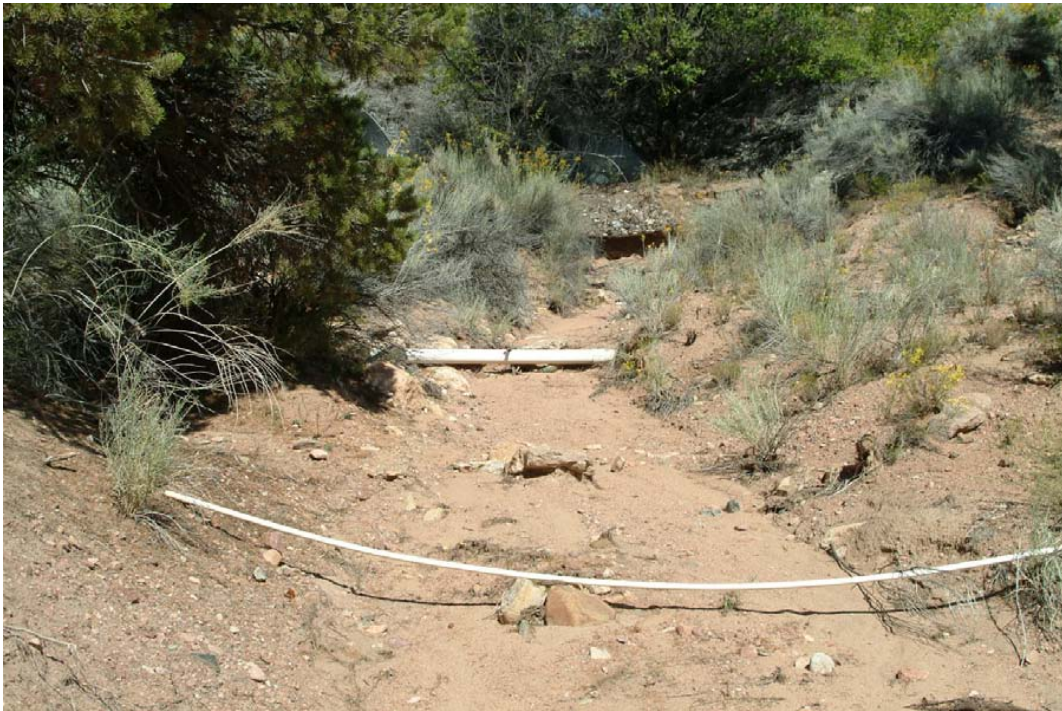
Exposed utility lines in the bed of Arroyo Piedra East, Segment B.
