VI. Arroyo en Medio – Old Santa Fe Trail to Arroyo Chamisos

VII. Arroyo Ancha Headwaters to Cañada Sur

VIII. Arroyo de los Pinos North

VIII. Lower Arroyo de los Pinos

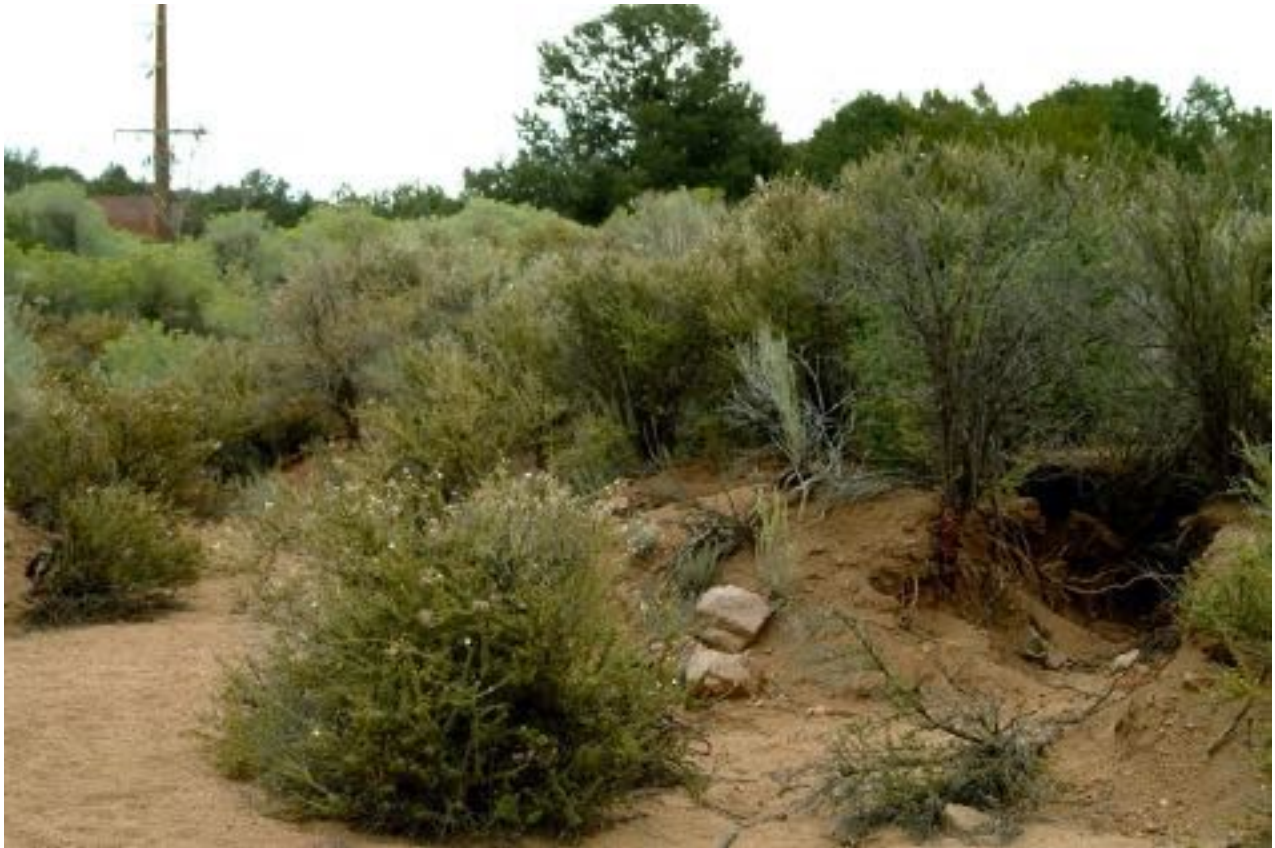
Segment A/ Incising of Upper Arroyo en Medio, 2016.

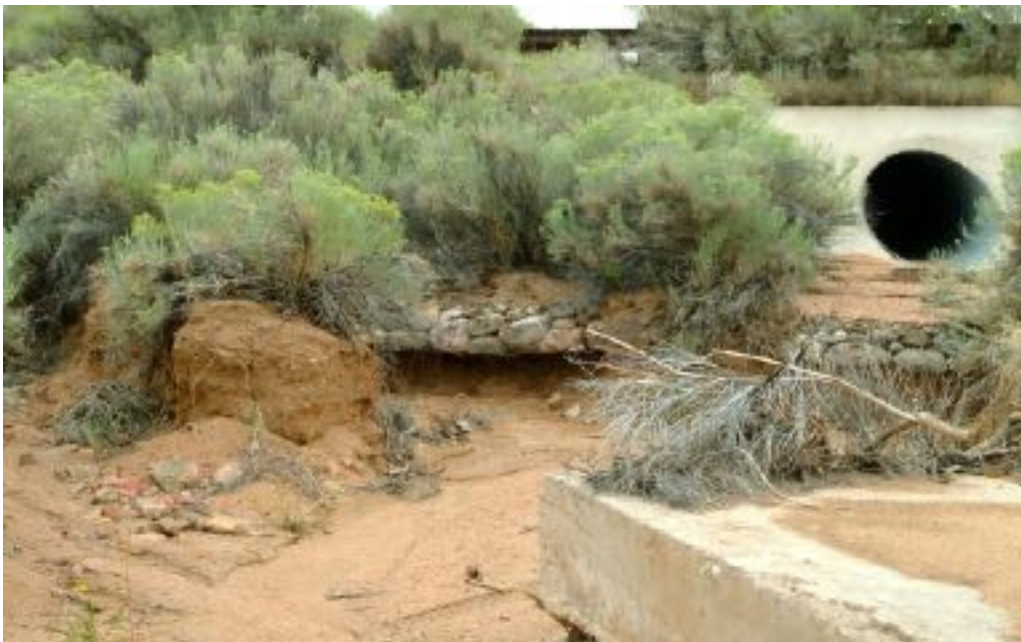
Notes: The Arroyo en Medio becomes the most constricted and incised between Rodeo Road and frontage road homes. Intermittent, vertical walls up to eight feet in height have developed in this segment. Erosion is affecting the condition of culverts, rip rap and out falls that were installed to allow residents to access their homes. These areas were marked with GPS coordinates for further examination. Also an exposed cable was located within this area.

Segment D/ Example of one of many undercut rip rap, banks, in Arroyo en Medio, 2012.

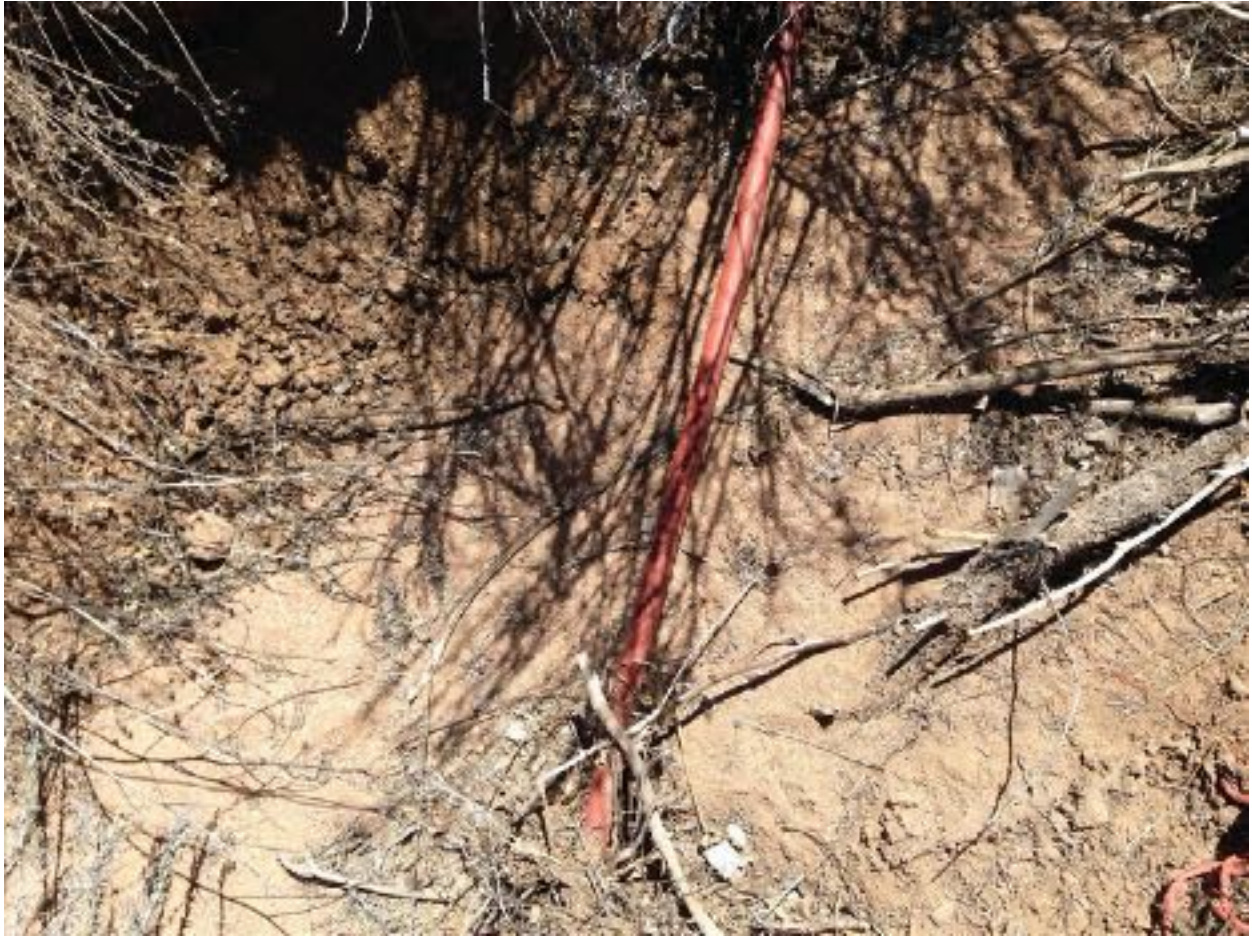
Segment D/ Exposed cable in Arroyo en Medio,2016.

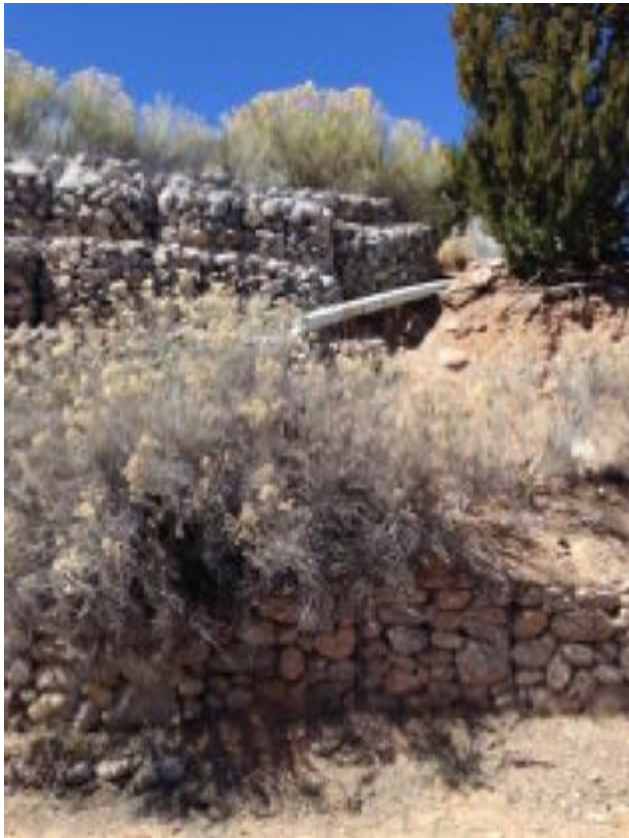
Segment F/Questionable drainage lines into Arroyo en Medio, 2016.

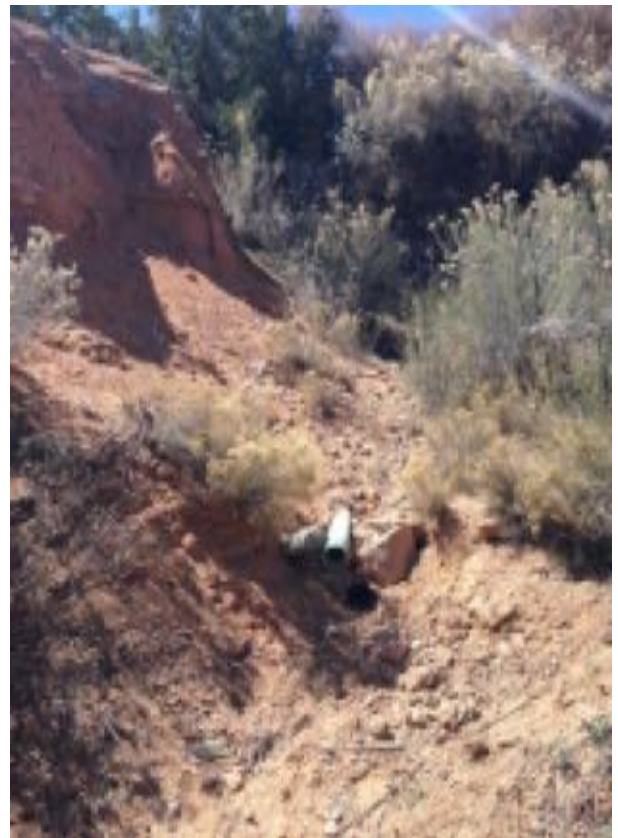
Segment F/Drain pipes in Arroyo en Medio, 2016.

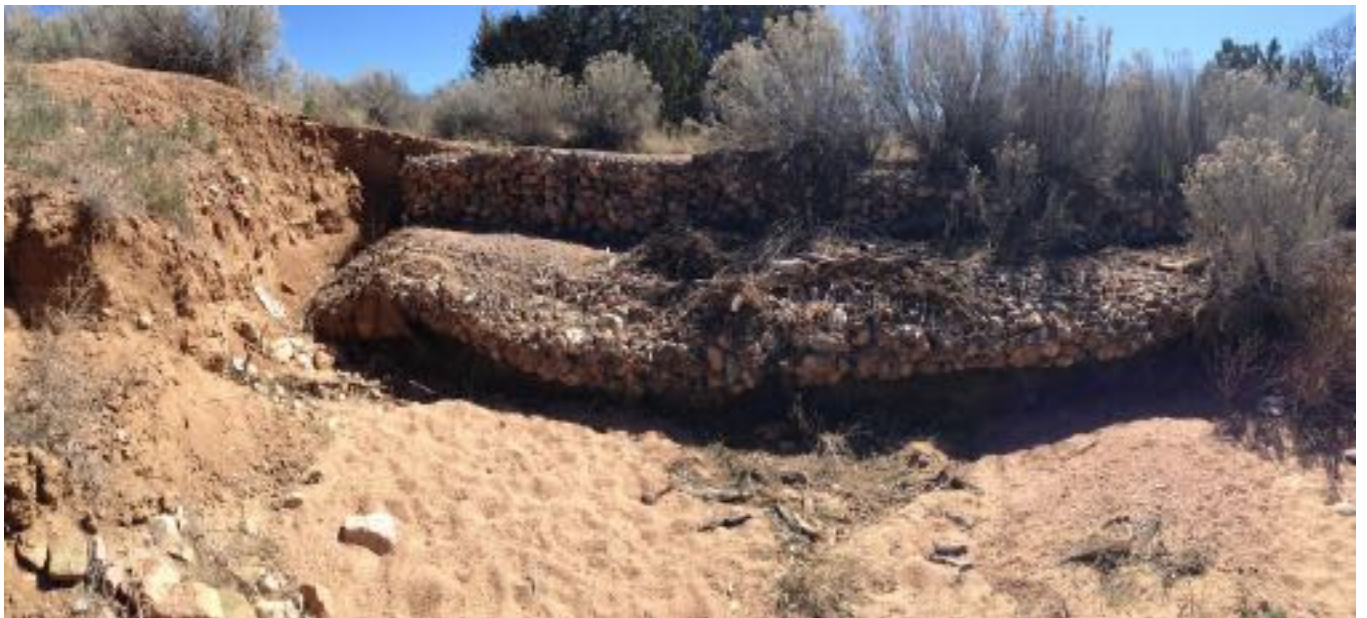
Segment G/Undercut rip rap mat, Arroyo en Medio, 2016

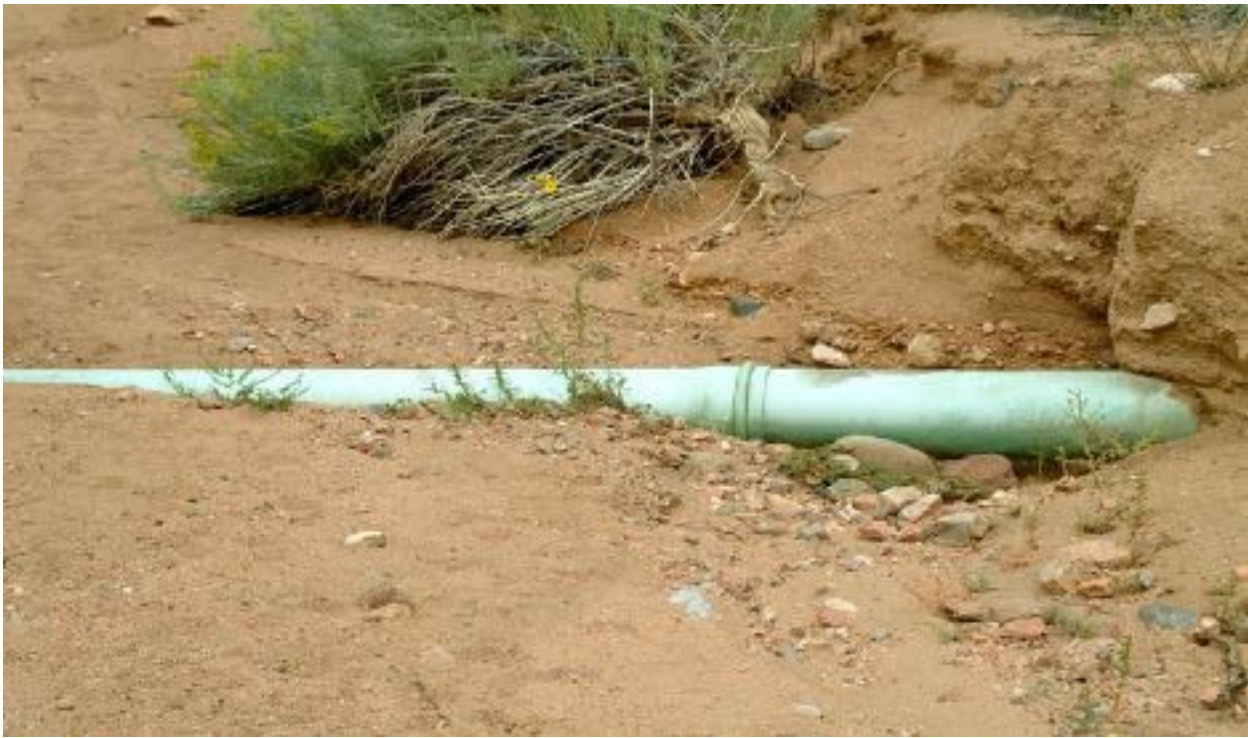
Segment G/A partially exposed pipeline, Arroyo en Medio, 2012

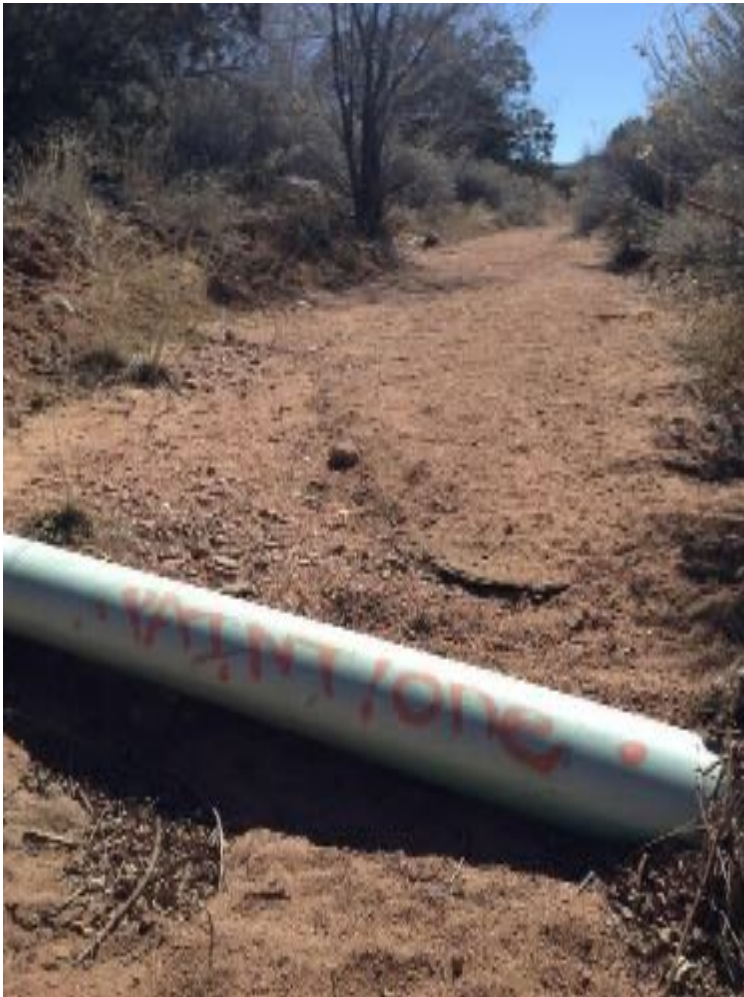
Segment G/Disconnected storm culvert in Arroyo en Medio ,2016.

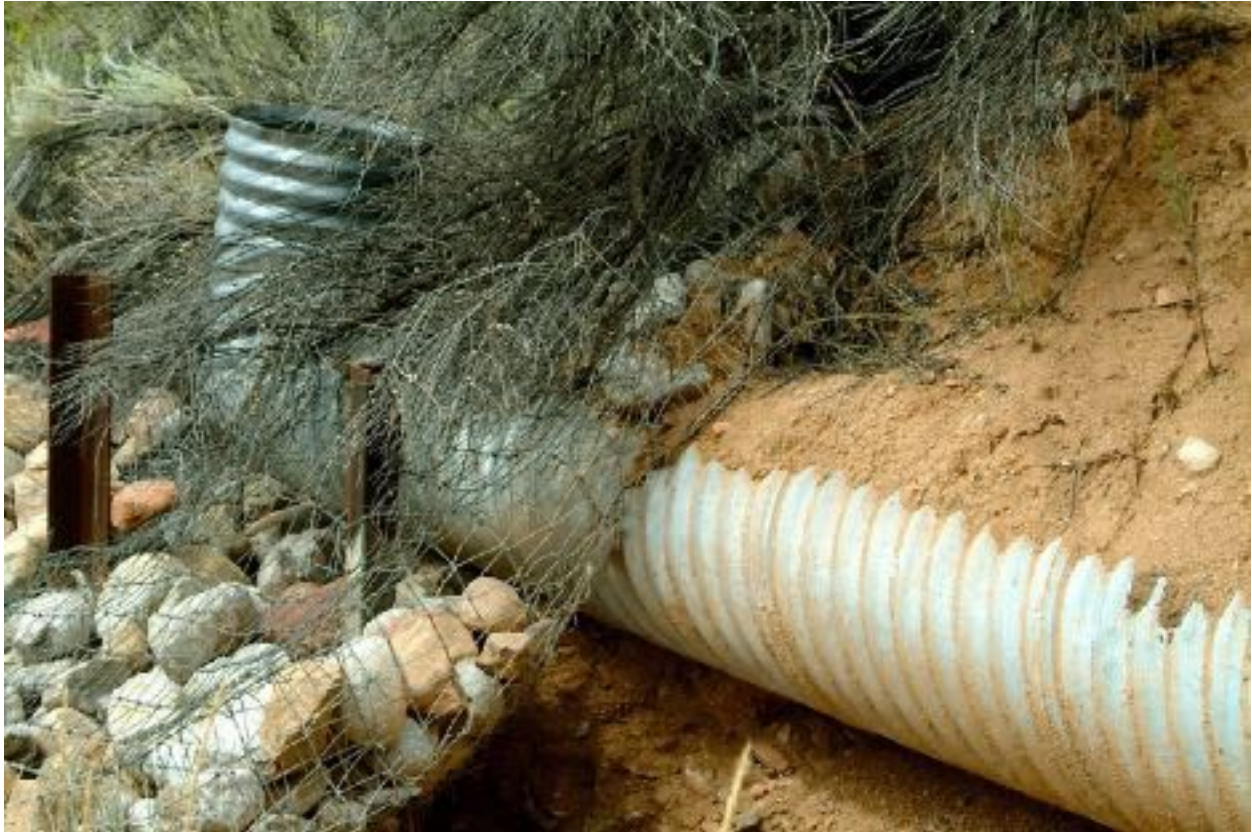
Segment G/Storm culvert in Arroyo en Medio 2012.

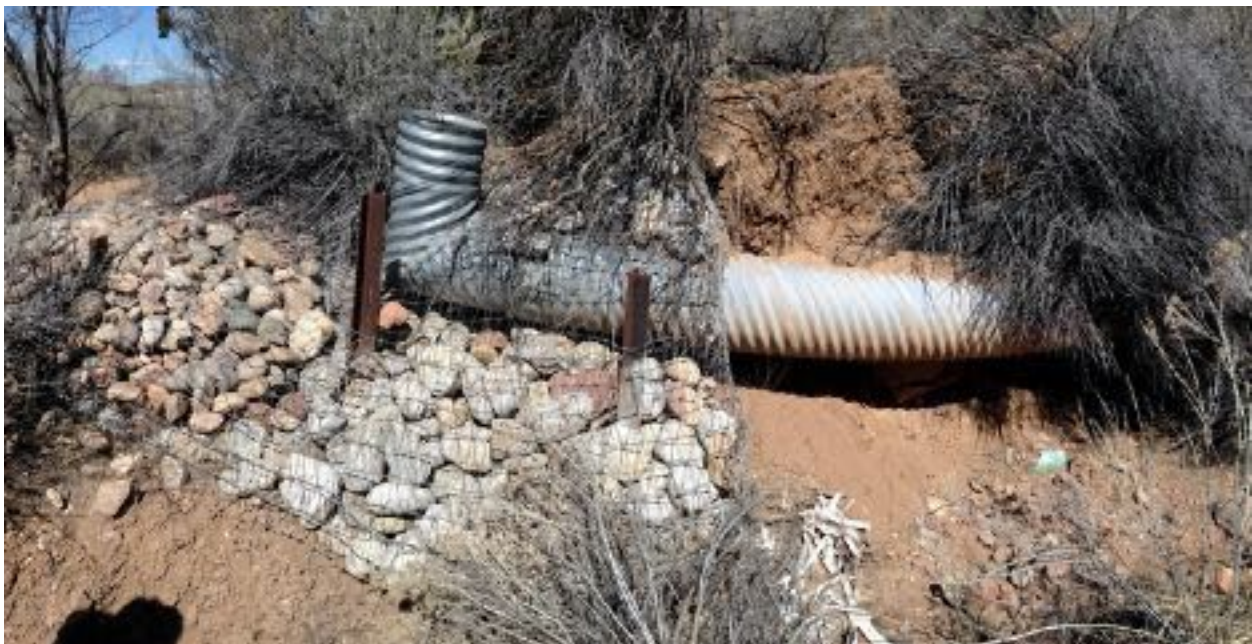
Segment G/Photo of the same storm culvert as pictured above in 2016, Arroyo en Medio.

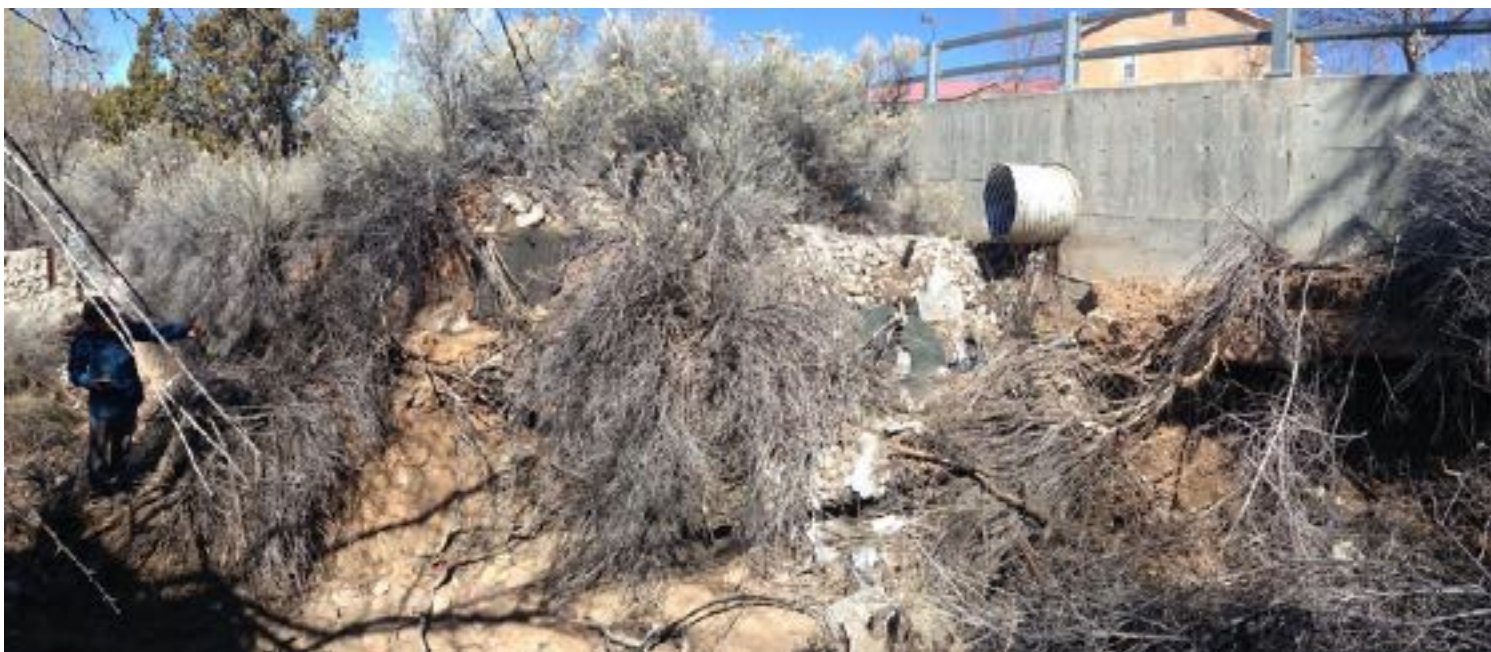
Notes: Infrastructure conditions in this segment are very poor in the Arroyo en Medio. Conditions noted in 2012 have since declined, further exposing a pipeline, exposing more cable, putting an important culvert out of service and dissolving a bank supporting a retaining wall and its system of rip rap and gabion walls. The breakdown of storm water infrastructure has caused major deterioration in this section of the arroyo. After passing S. St. Francis Drive the arroyo changes its name and becomes Arroyo Chaparral. Trash from the highway, surrounding properties (especially the shopping complex) and transient camps are common in this area.

Segment G/Over view of multiple problems, Arroyo en Medio, 2016

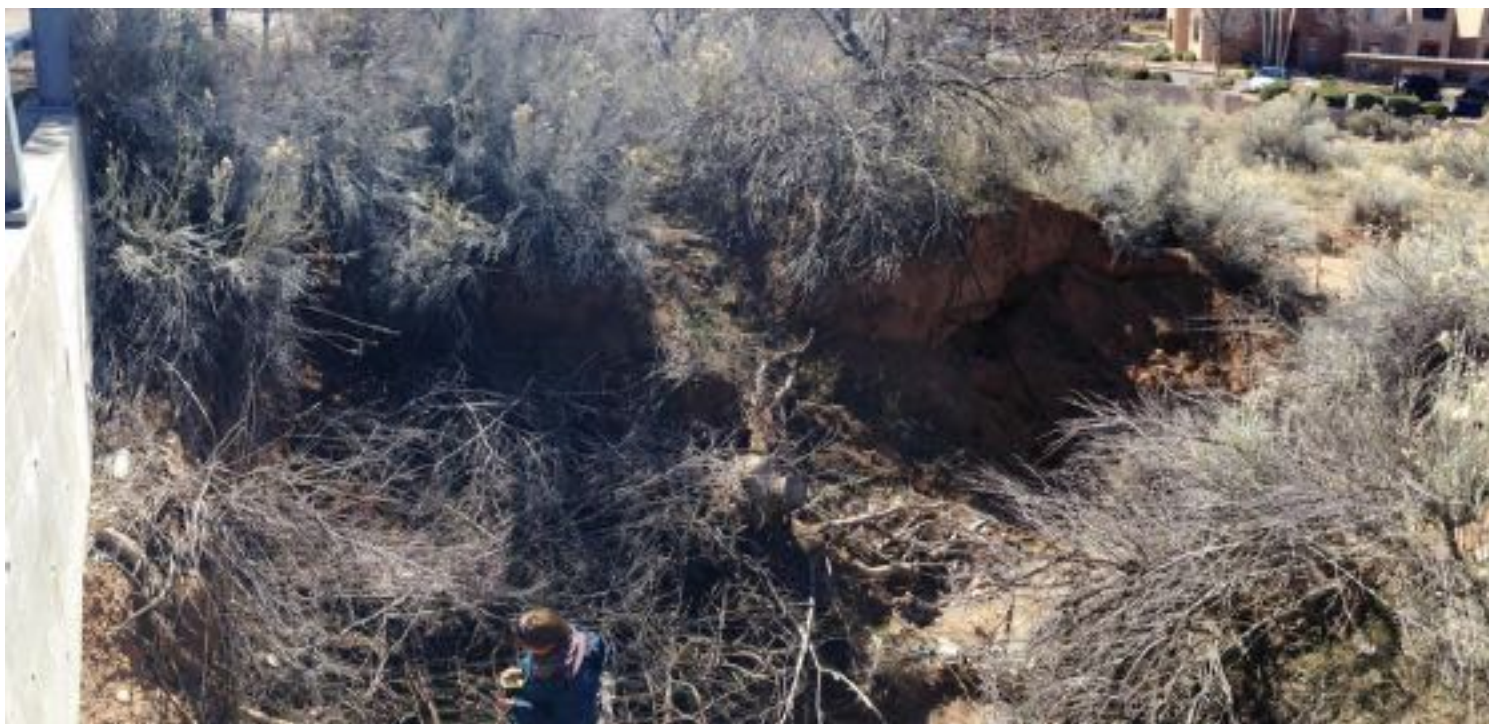
Segment G/Overview of multiple problems, Arroyo en Medio,2016

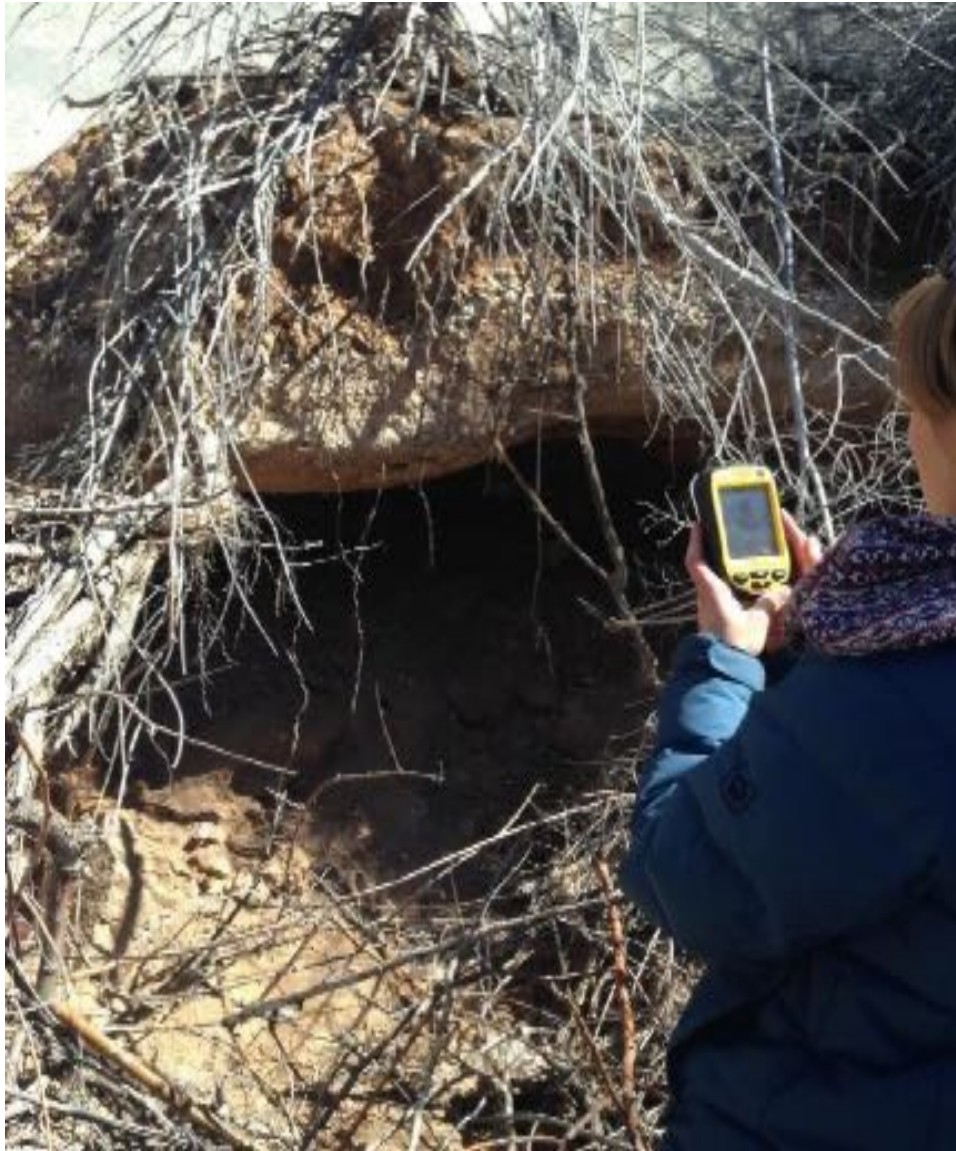
Segment G/ Undercut retaining wall, Arroyo en Medio, 2016, as pictured above.

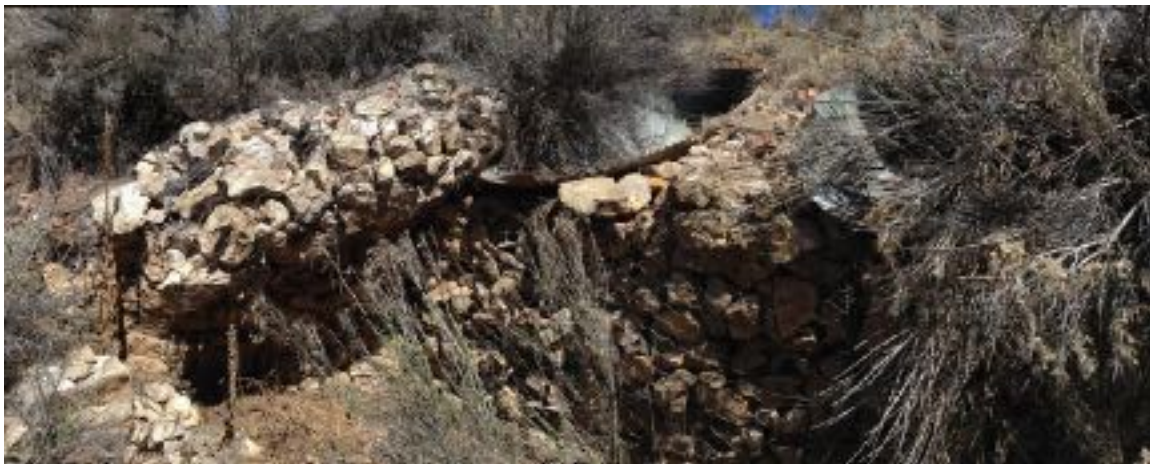
Segment A/Gabion askew, Arroyo Ancha, 2016.

Below Kachina Heights Drive, a gabion wall is hanging precariously off of the arroyo bank. Here water from the arroyo channel drops 10 feet below this culvert/gabion system expanding the arroyo bed in width and impacting infrastructure and channel characteristics.

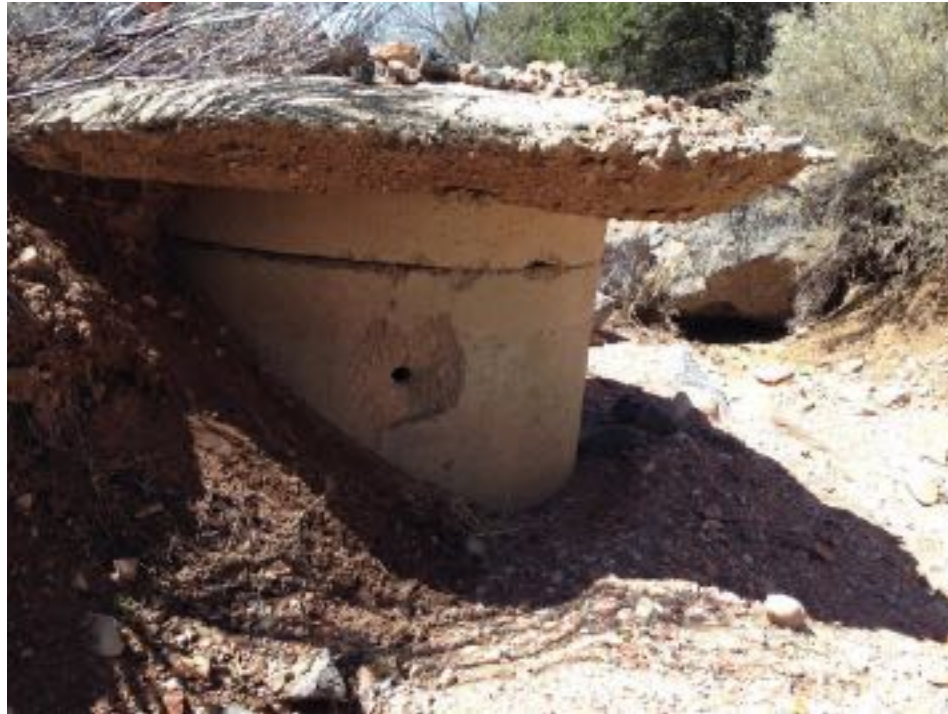
From this point, the condition of the arroyo is very poor due to extreme erosion. The sewage outlets found above ground were all emanating a noxious odor. Nearby, an above ground pipe labeled sewer was found. Corrective actions to protect infrastructure in this area are highly recommended and may be urgent. Foot and bike traffic is also frequent in this area.

Segment A/One of four sewage outlets emanating noxious odors, Arroyo Ancha, 2016

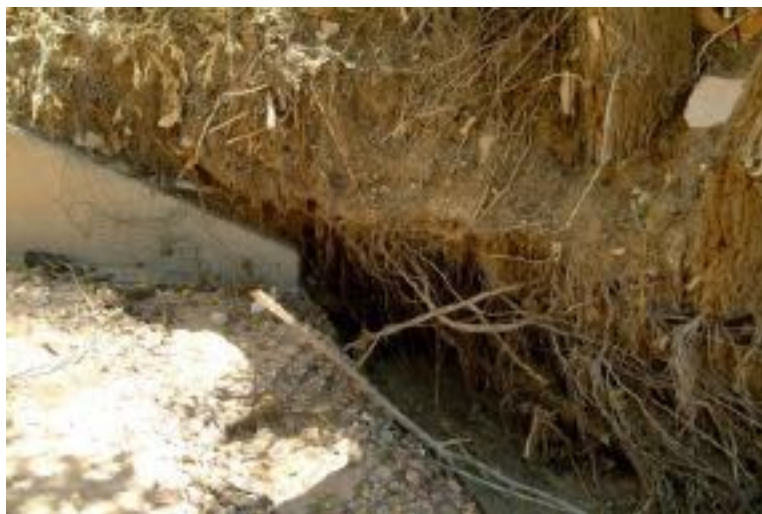
Segment B/ Bank erosion by check dam, Arroyo Ancha, 2016

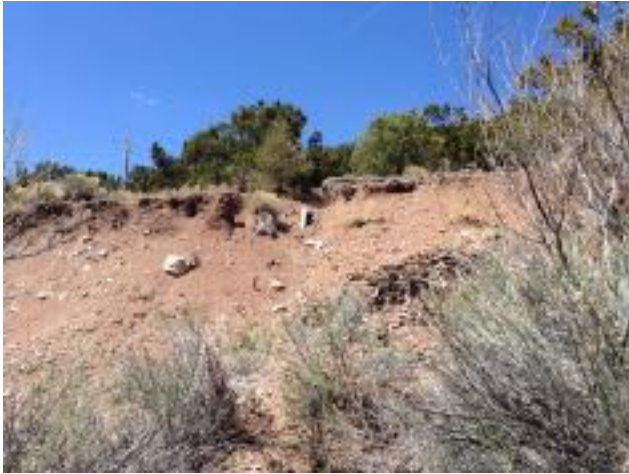
Segment B /Expose pipe at crest of bank, Arroyo Ancha 2016.

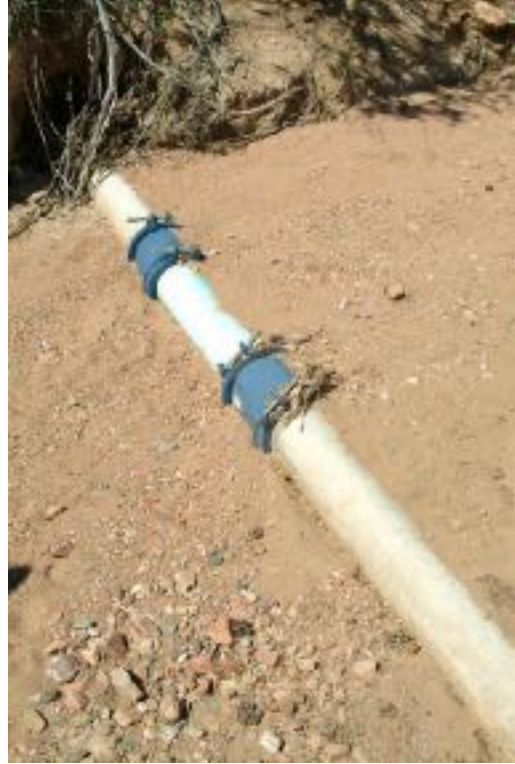
Segment B/ Utility line in bed of the arroyo, appears to be in the same condition, Arroyo Ancha 2012 – 2016 .

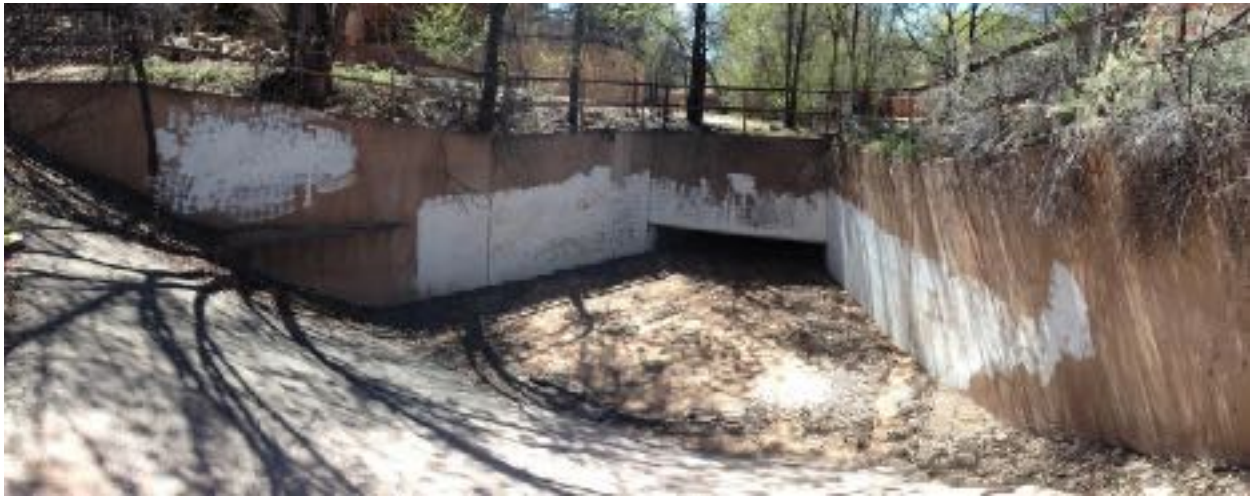
Drainage from this arroyo continues to wear on infrastructure such as rip rap mats, footings around concrete check dams and private property. The sediment in the box culvert at the junction of the arroyo and the Santa Fe River has increased.

Segment B/ Sediment level rises beneath box culvert E. Alameda St. in Arroyo Ancha, 2016

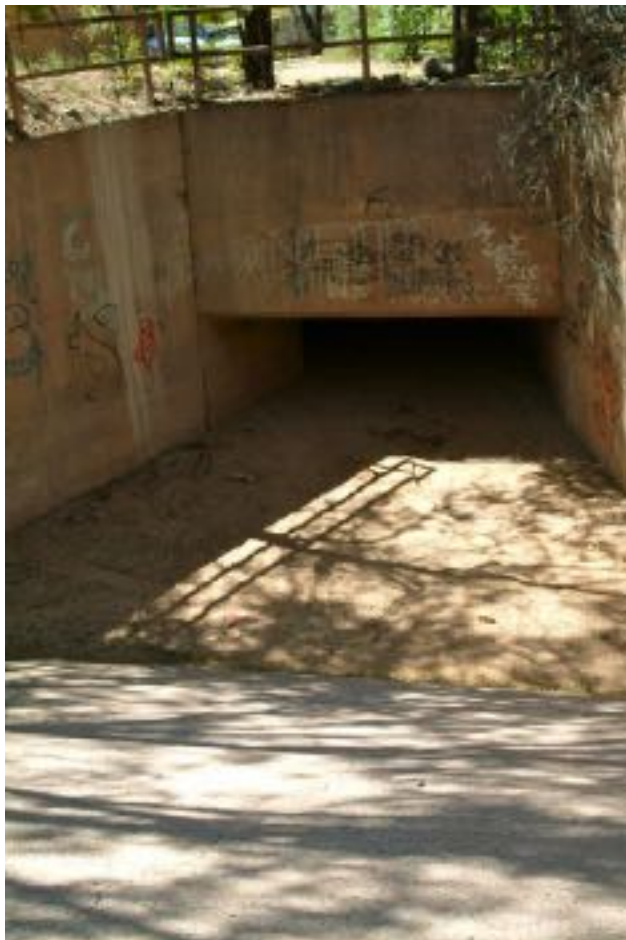
Segment B/ Box culvert trapping sediment beneath E. Alameda St., Arroyo Ancha, 2012.

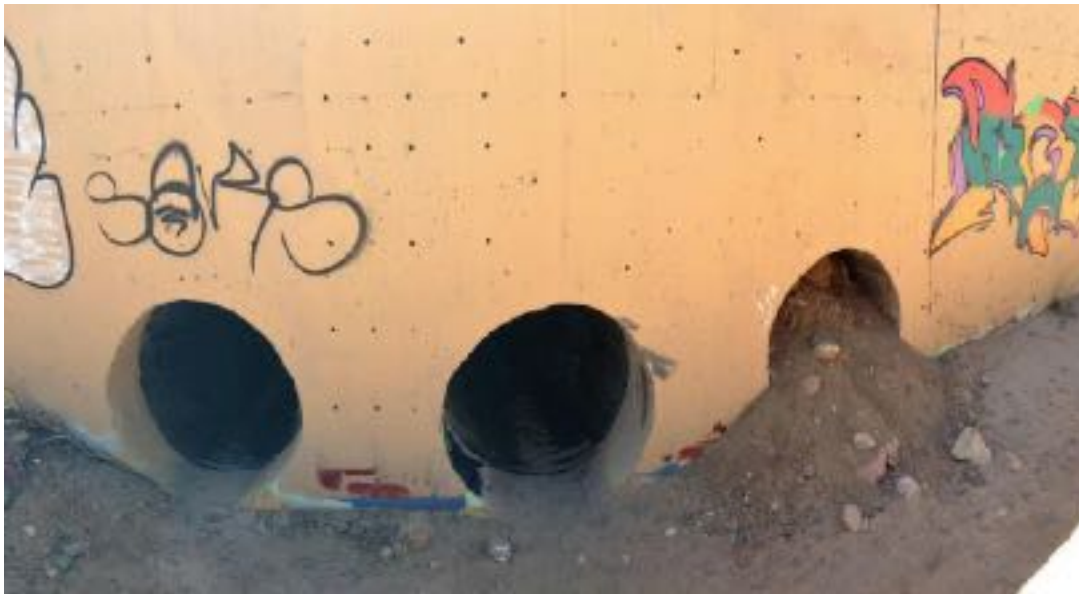
The infrastructure in this area seems secure. The obstructed culvert noted in 2012 remains obstructed. Residential density increases at the lower end of this segment.

Segment A/ Obstructed culvert, Old Pecos Trail, Upper Arroyo Pinos North, 2016

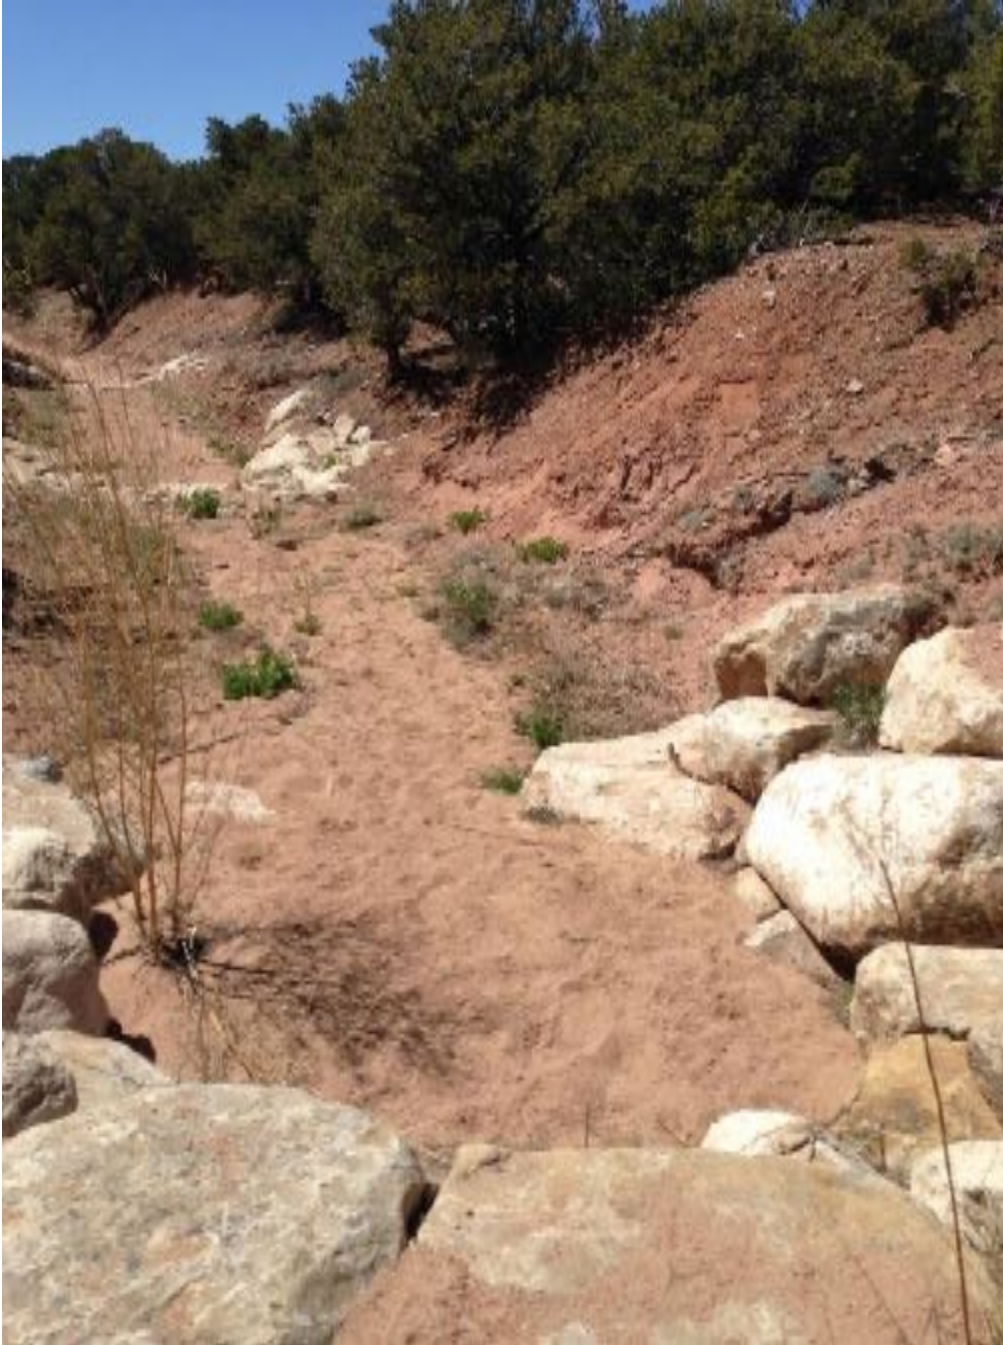
Segment A. One rock check dams, Upper Arroyo Pinos North, 2016.

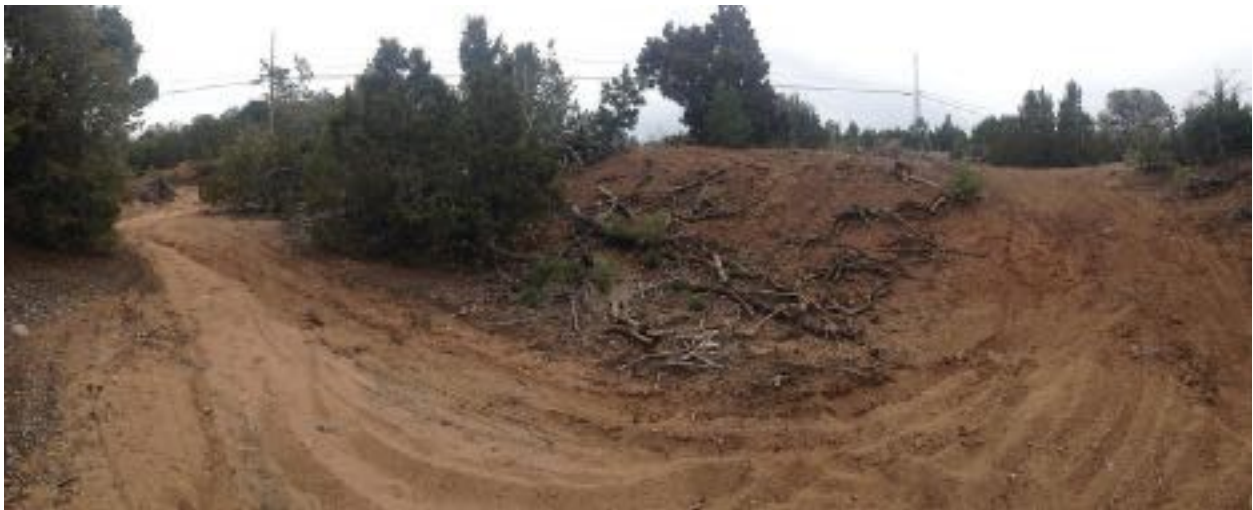
Segment B/New road entering Upper Arroyo Pinos South, 2016.

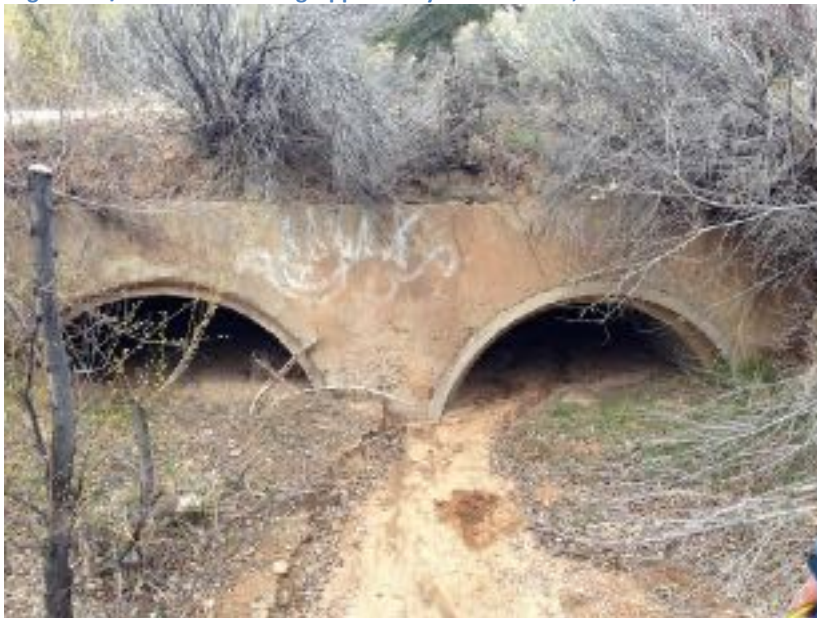
Segment B /Obstructed culvert Upper Arroyo Pinos South, 2016.

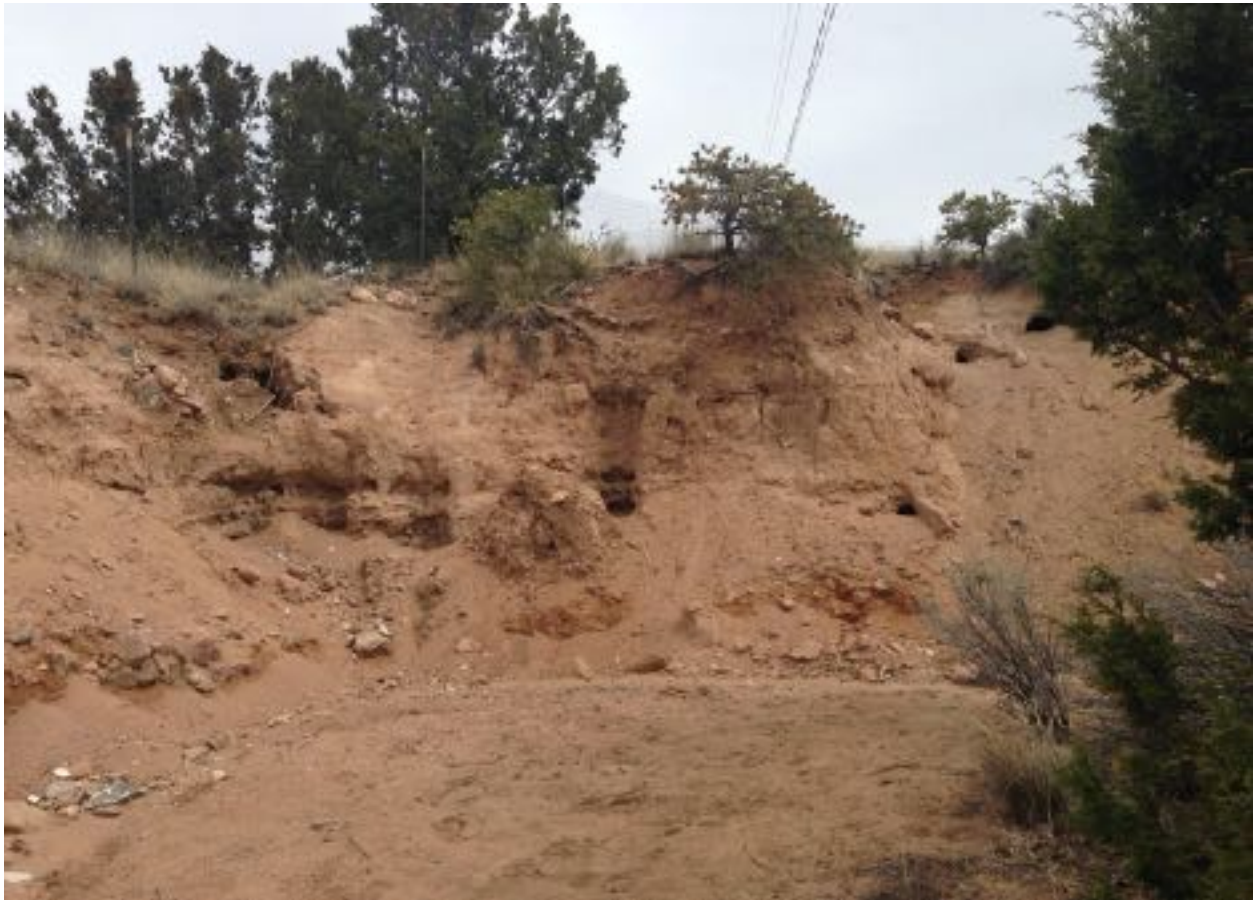
Segment B /Vertical banks Upper Arroyo Pinos South, 2016.

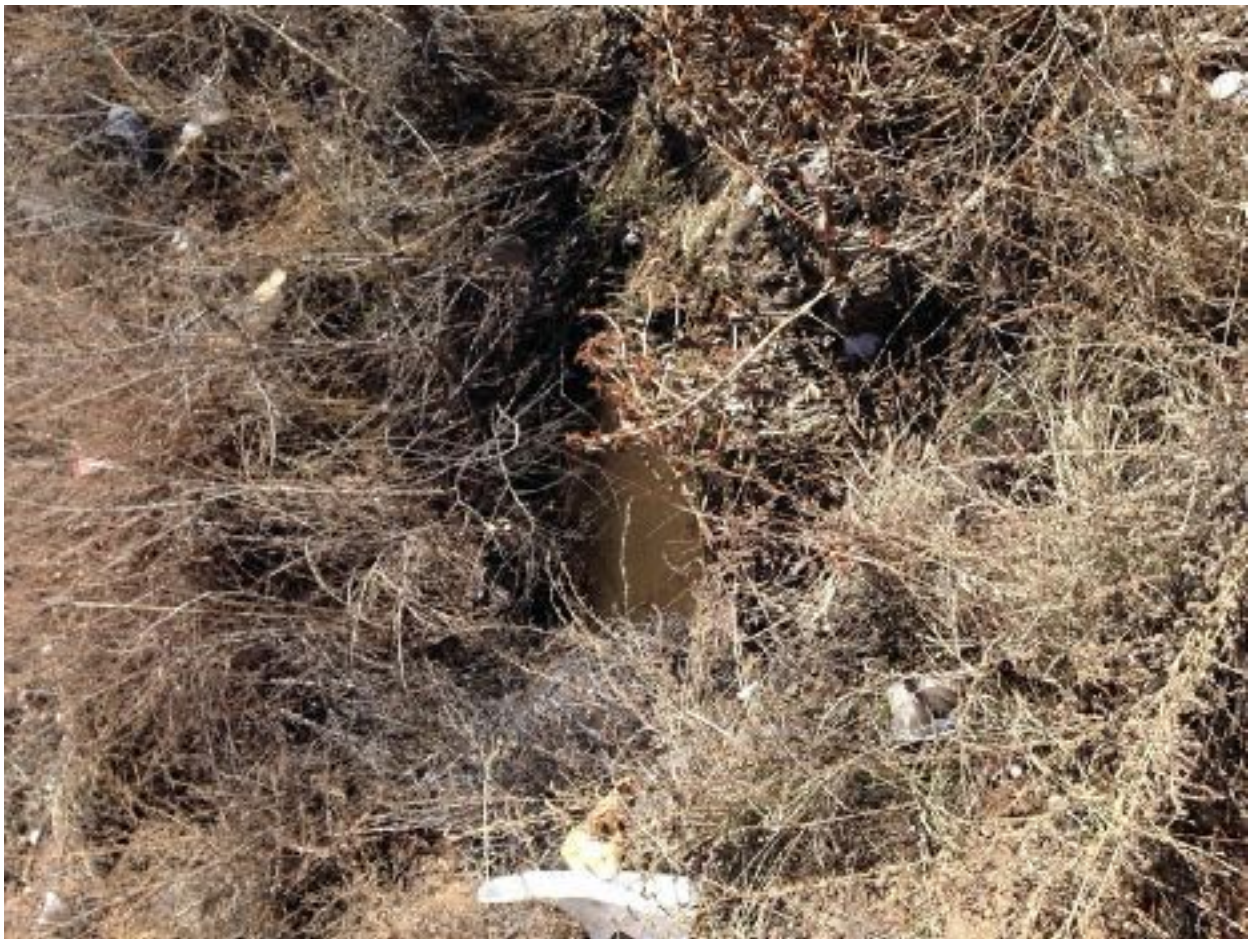
Notes: The entrance into this segment of arroyo is poorly drained due to an occluded, culvert. This culvert remains in its 2012 condition. An infiltration basin located here could be successful. The channel characteristics in this location are constricted yet shallow. Segment X is an engineered ditch that empties into the Lower Arroyo Pinos below La Farge Library. New to the landscape is the recently built HEC building. The “ditch” is used as a pathway between Santa Fe High and the campus of the School for Art and Design. Trash accumulation is prevalent along the entire ditch as are many transient camps with in the ditch and below the La Farge library.

Segment X/ Restricted, sunken culvert, Lower Arroyo Pinos, 2016.

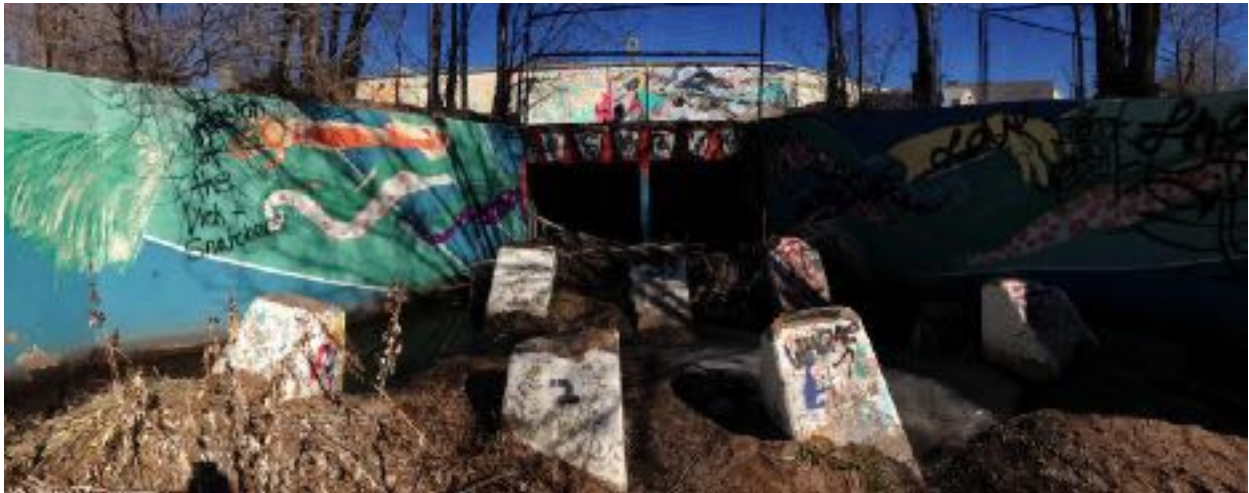
Segment X/ Storm outlet , Lower Arroyo Pinos, 2016.
