VI. Arroyo en Medio – Old Santa Fe Trail to Arroyo Chamisos

VII. Arroyo Ancha Headwaters to Cañada Sur

VIII. Arroyo de los Pinos North

VIII. Lower Arroyo de los Pinos

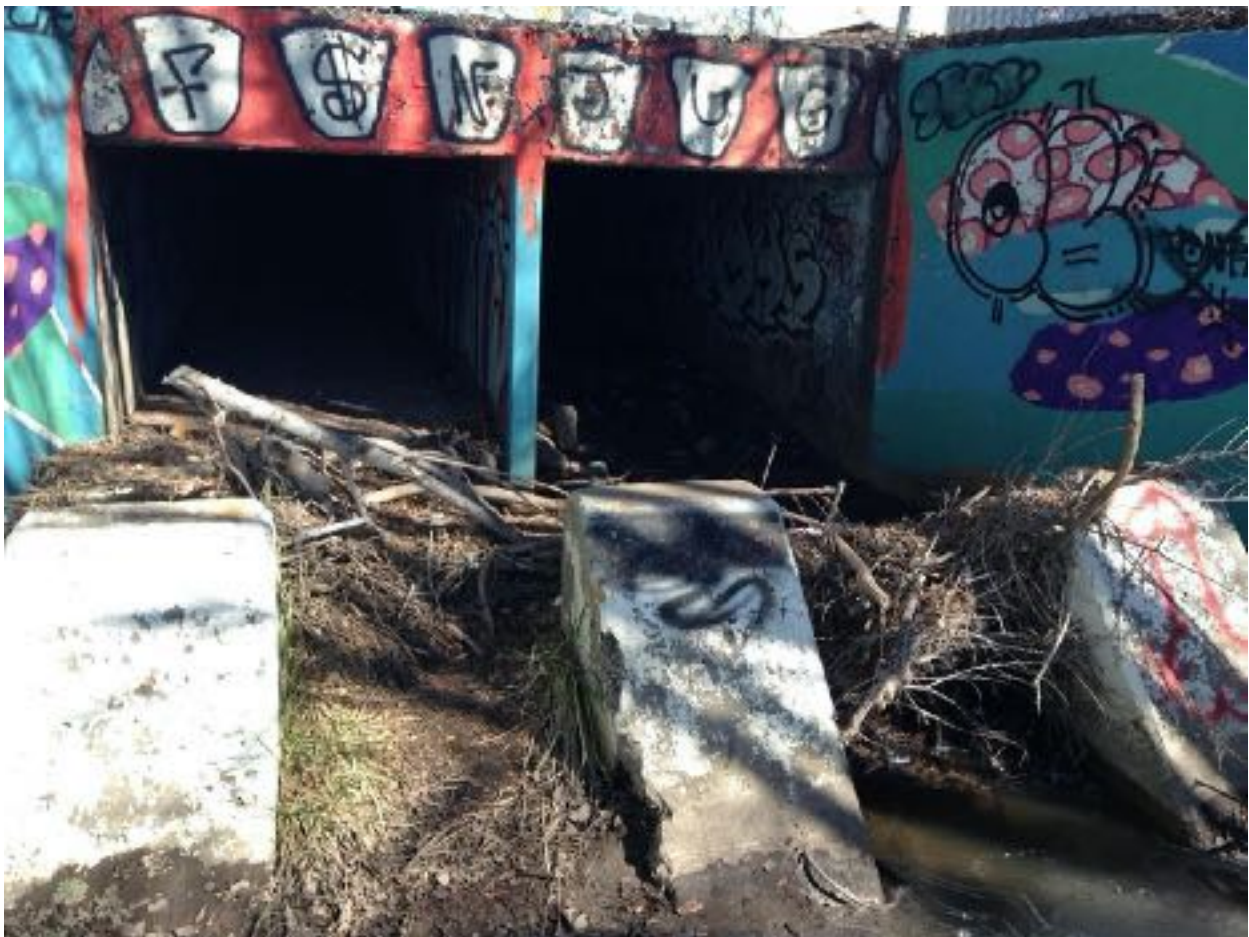
Segment X/ Debris caught in storm outlet , Lower Arroyo Pinos, 2016.

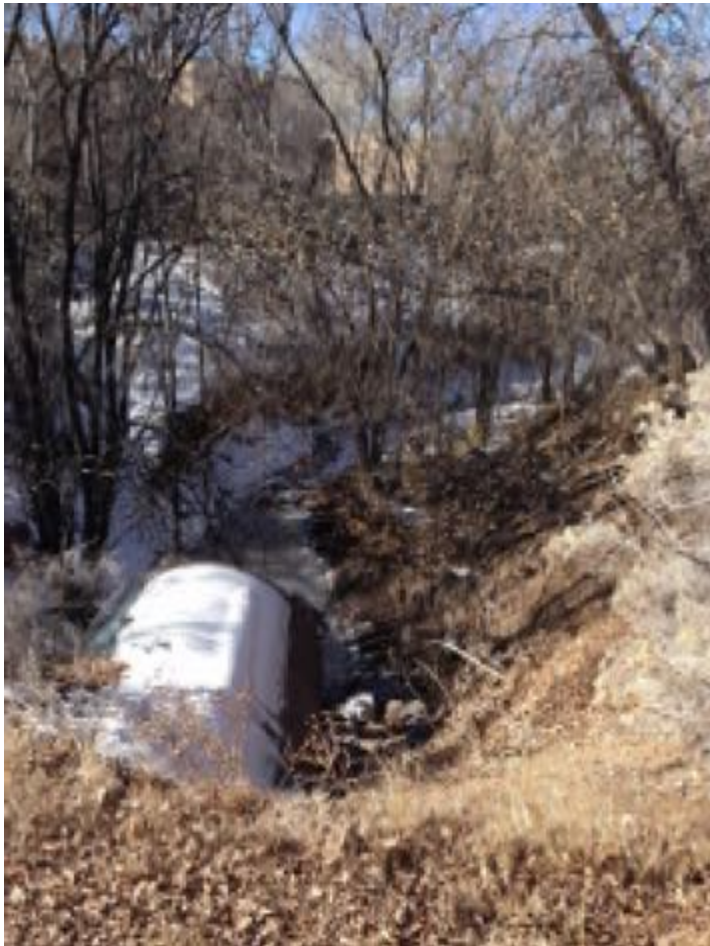
Segment A/Arroyo Pinos culvert located below St. Francis Drive, 2016

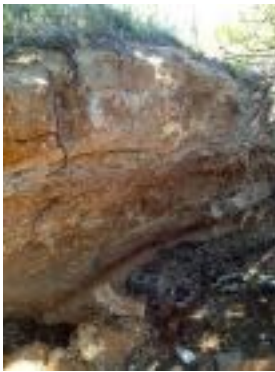
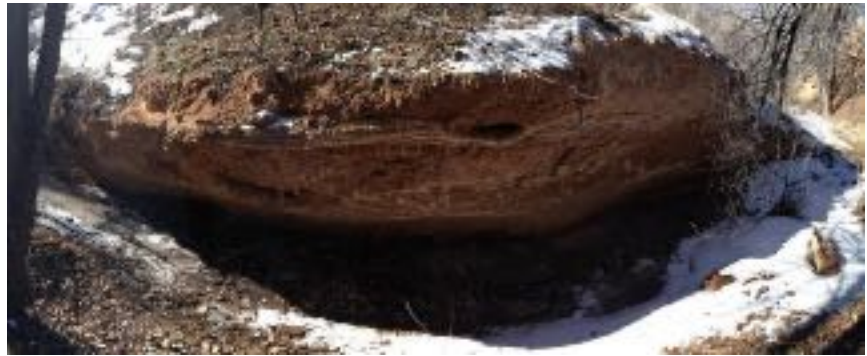
Segment A /Left photo 2012 bank erosion ; photo right 2016 bank erosion same location. Lower Arroyo de los Pinos,2016.

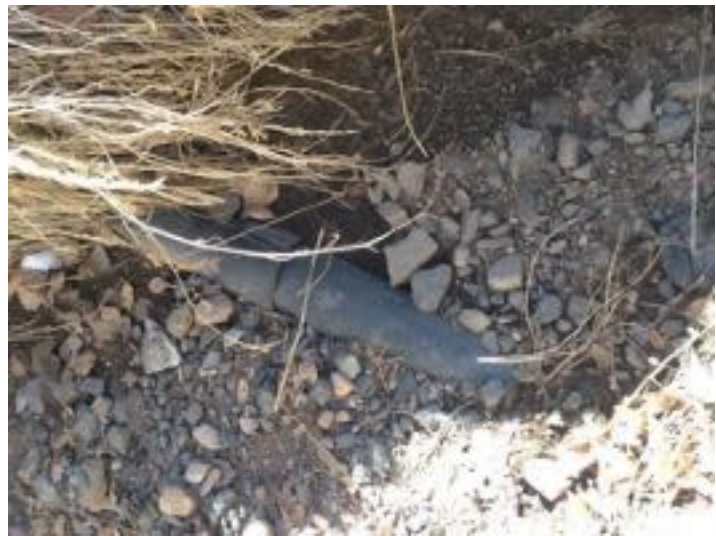
Segment B/ Exposed pipe same location, Lower Arroyo Pinos, 2016.

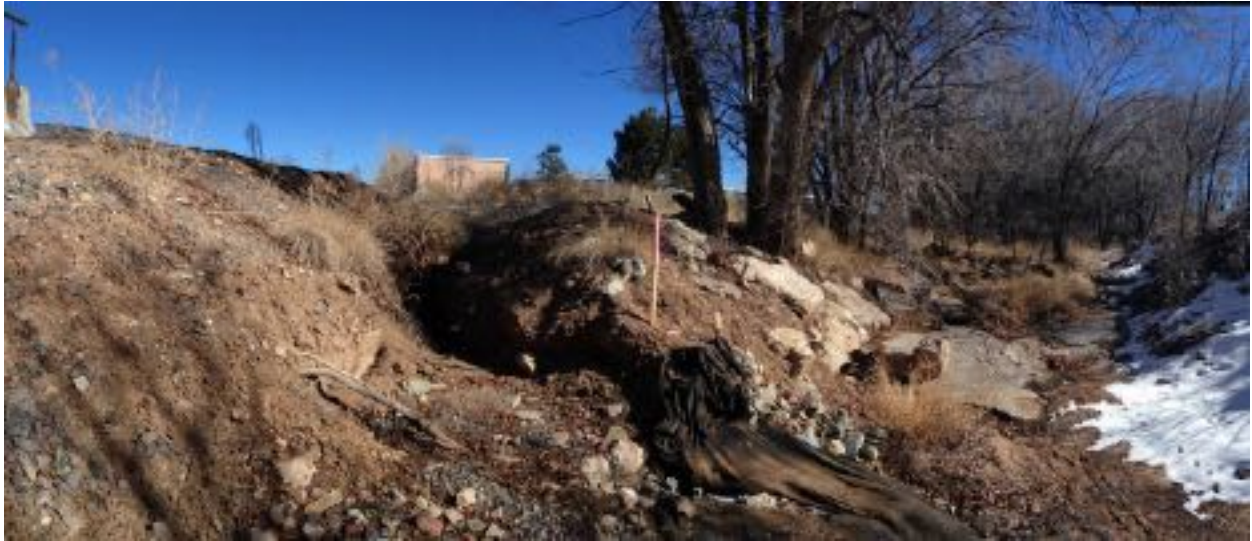
Segment B/ Heavy erosion on RR property into the Pinos, 2016.

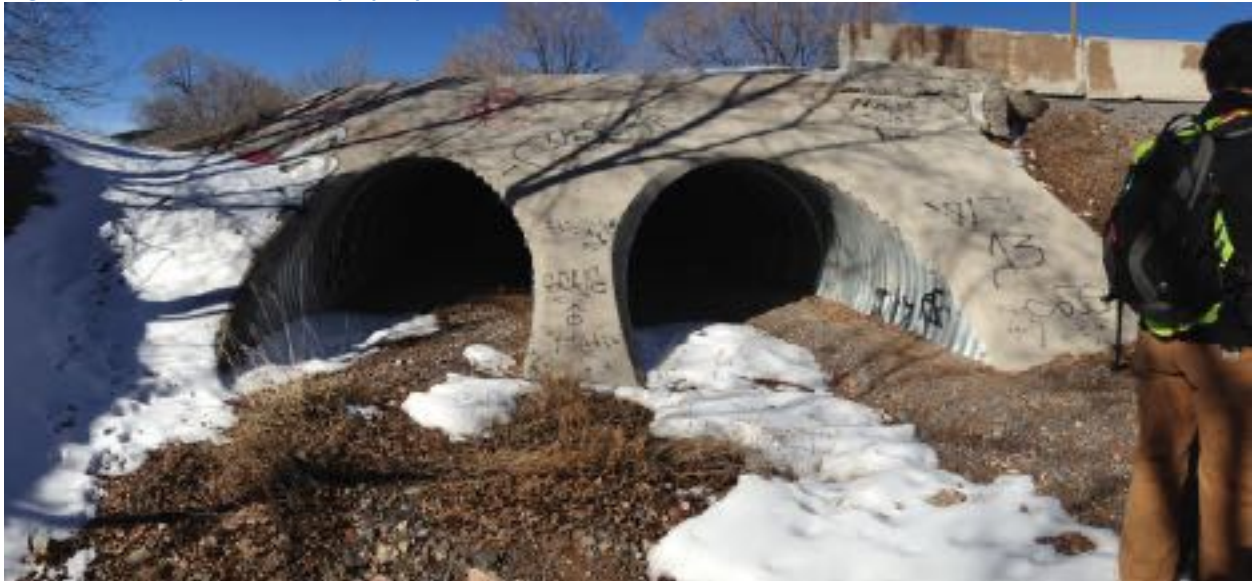
Segment B/ Culverts under Rail Runner tracks, Lower Arroyo Pinos, 2016.

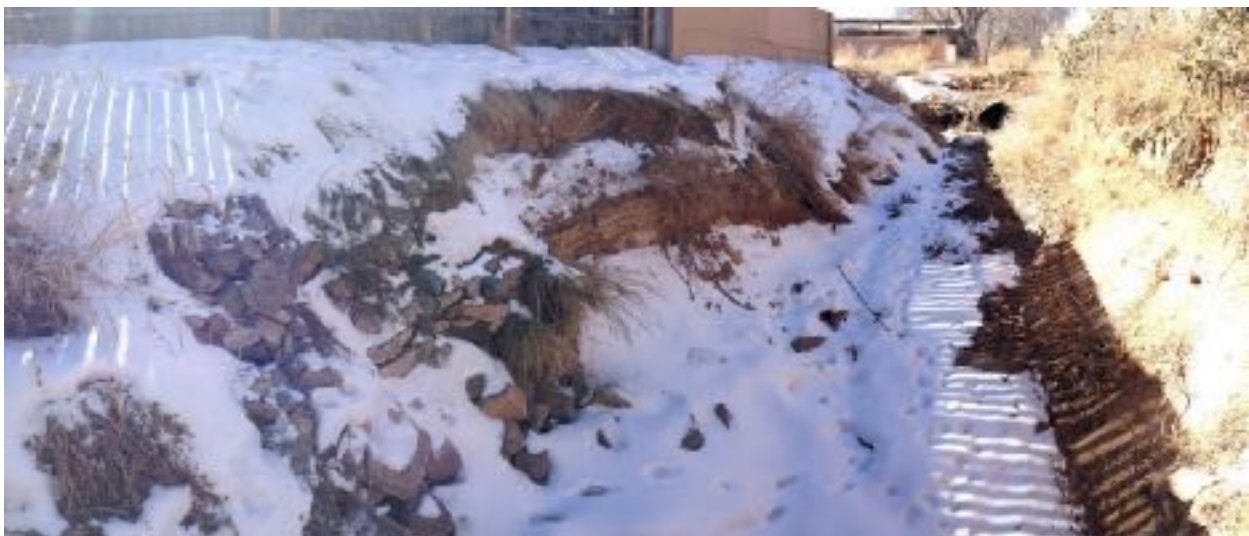
From Hopewell Street to 6th Street Arroyo de los Pinos transforms into a long, constricted ditch traveling through several neighborhoods. It is strewn with trash and concrete. Banks are undercut and are usually high in areas. The arroyo is encroaching on private property at the 5th street crossing.

Segment B /Bank erosion below private property, Lower Arroyo Pinos, 2016.

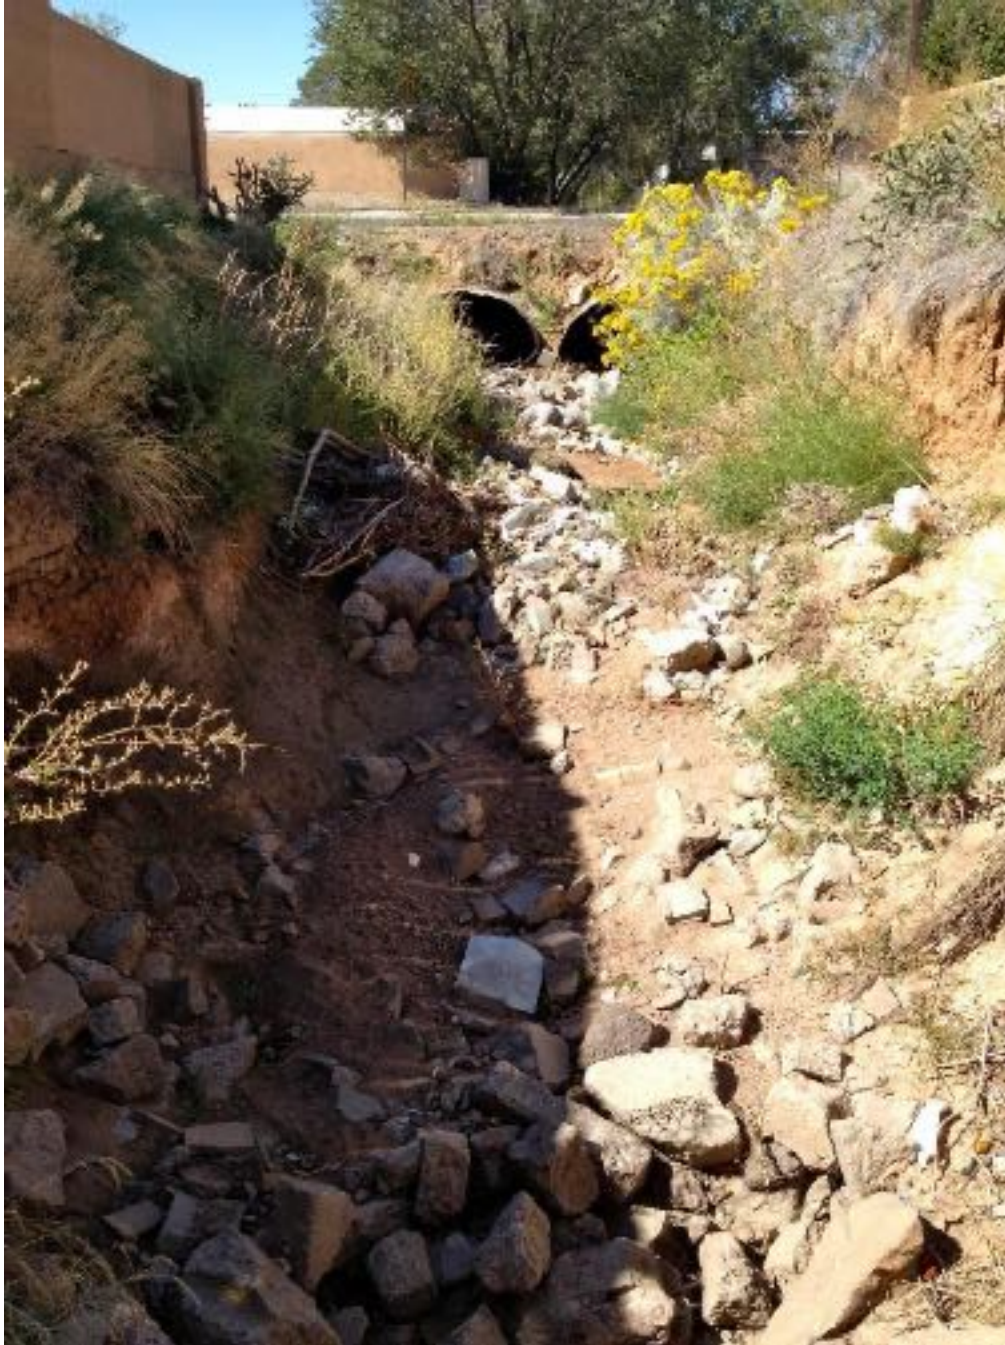
Segment B /Bank erosion below private property, Lower Arroyo Pinos, 2012.

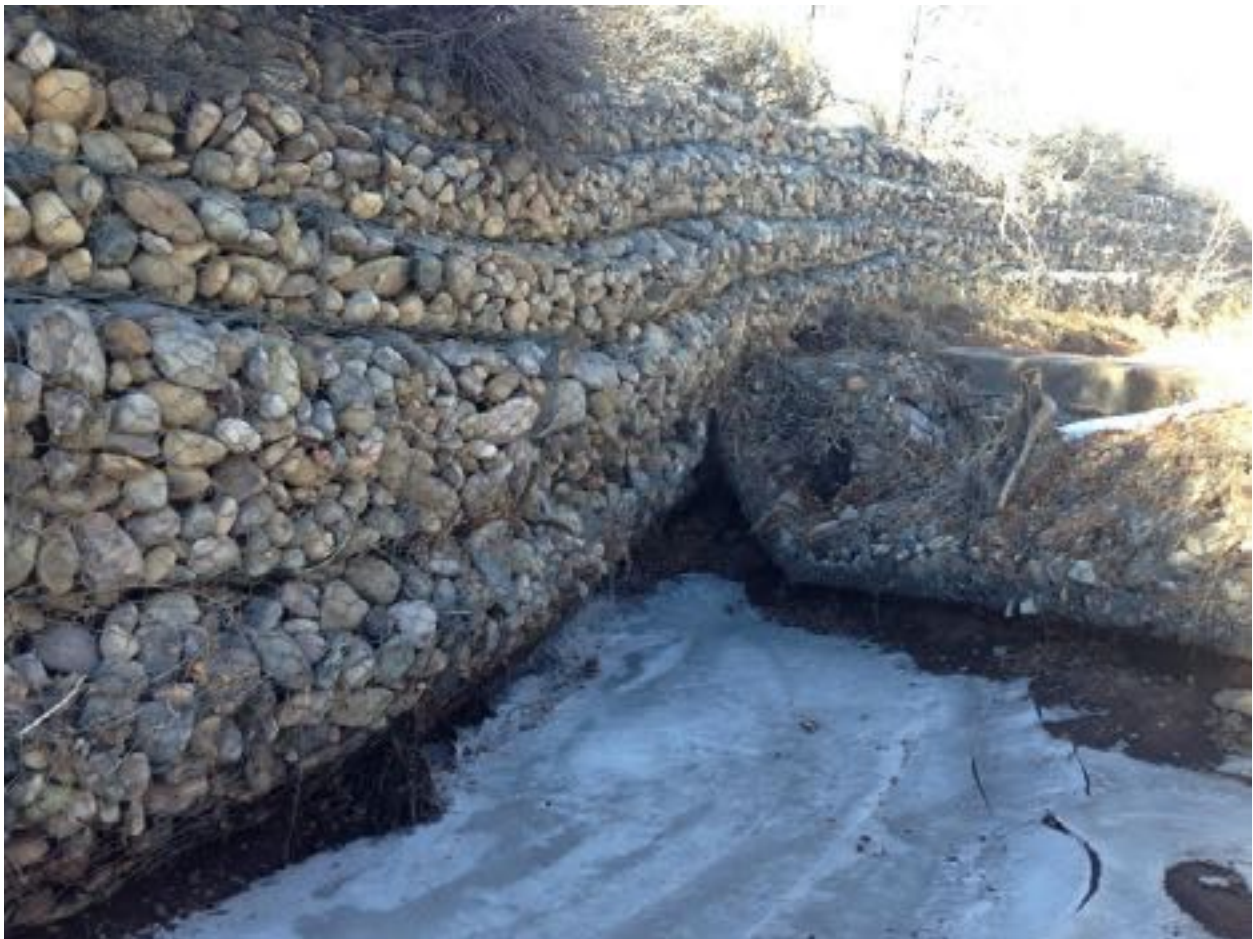
Segment C/, Gabion walls sagging, Lower Arroyo Pinos, 2016.

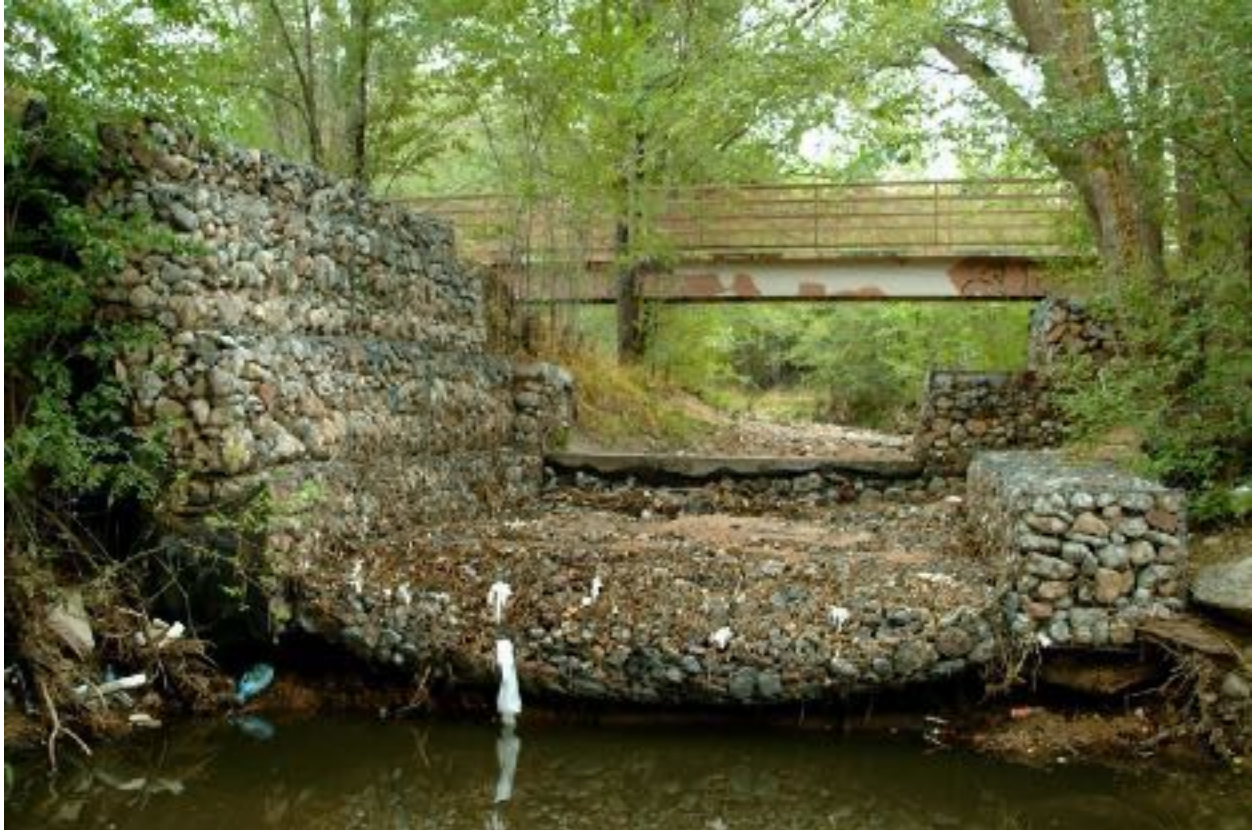
Segment C/ Water standing in deep scour below undercut rip rap mat, Lower Arroyo Pinos, 2016.

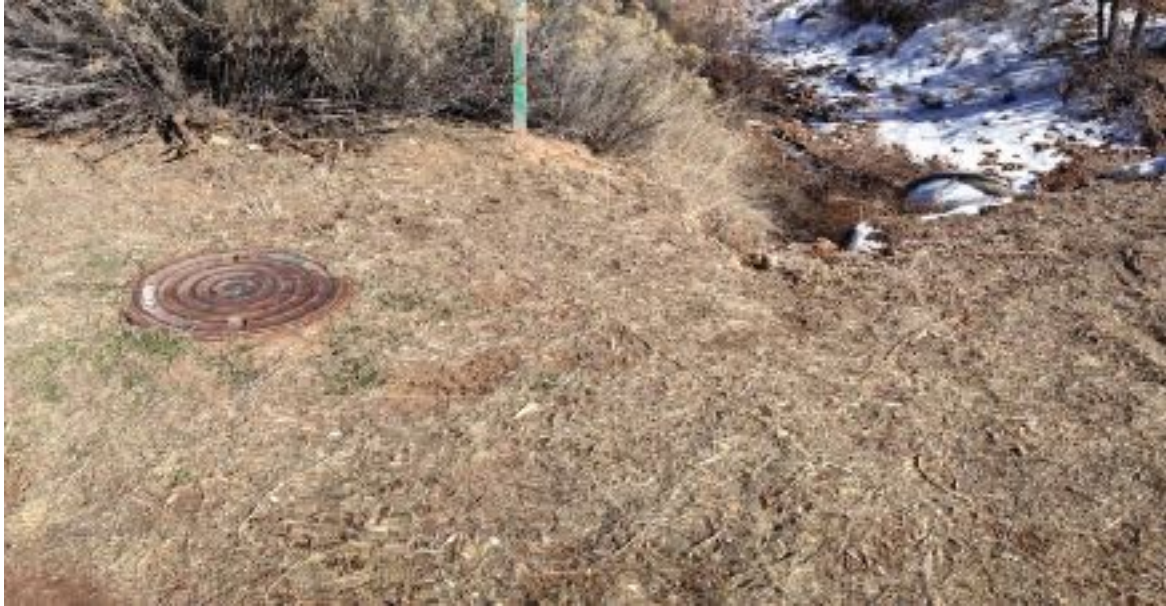
Segment C/ Bank erosion to right of manhole, Lower Arroyo Pinos, 2016.

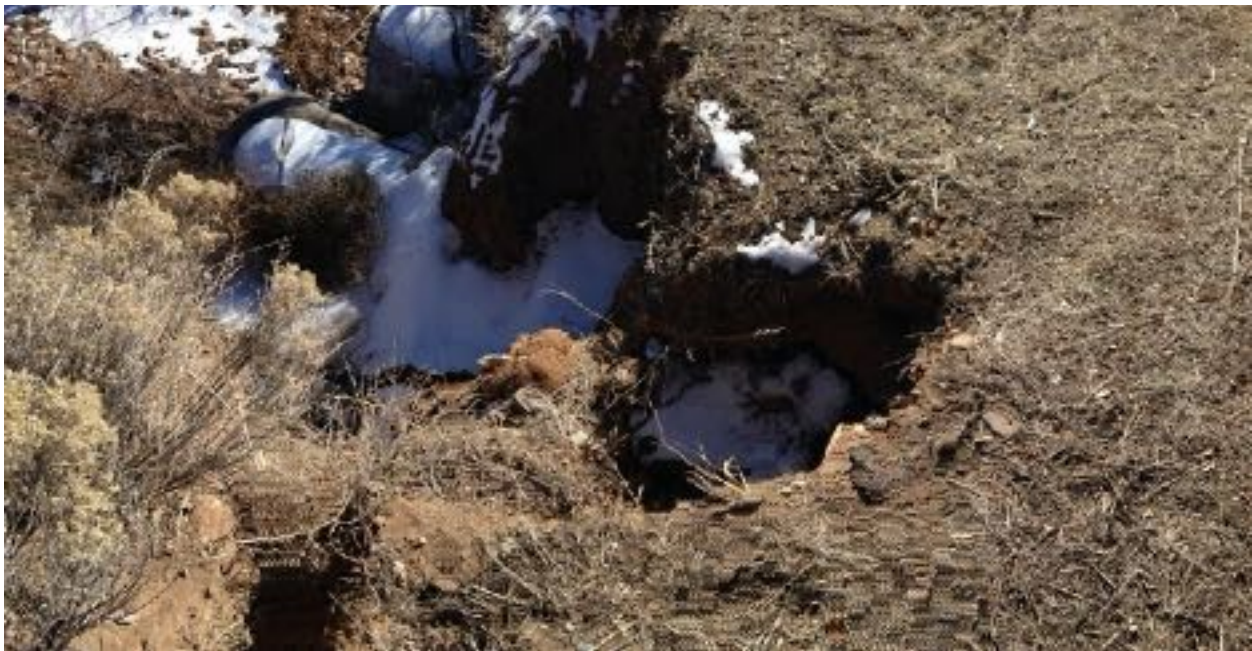
Segment C/ Bank erosion ~2 feet from manhole, Lower Arroyo Pinos, 2016.

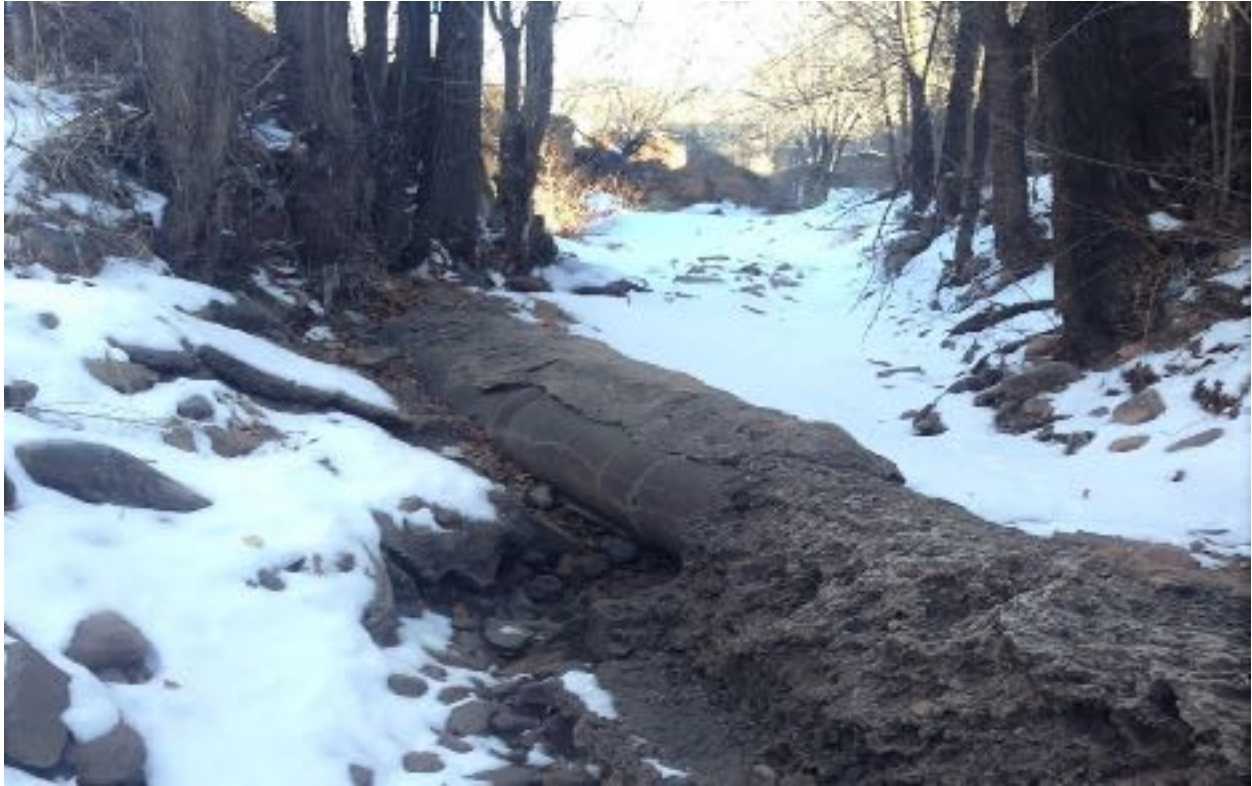
Segment C/Cracked concrete pipeline, Lower Arroyo Pinos, 2016.

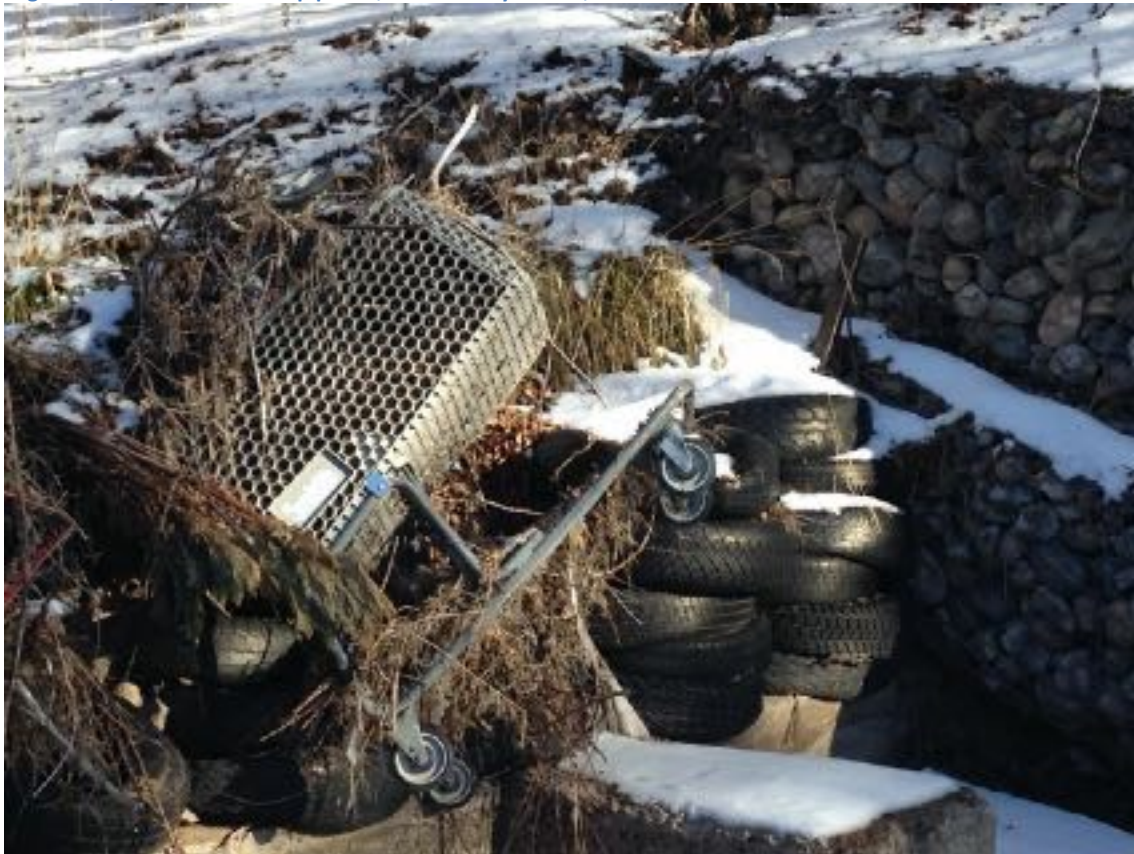
Segment C/ Trash caught in tire check dam, Lower Arroyo Pinos, 2016.

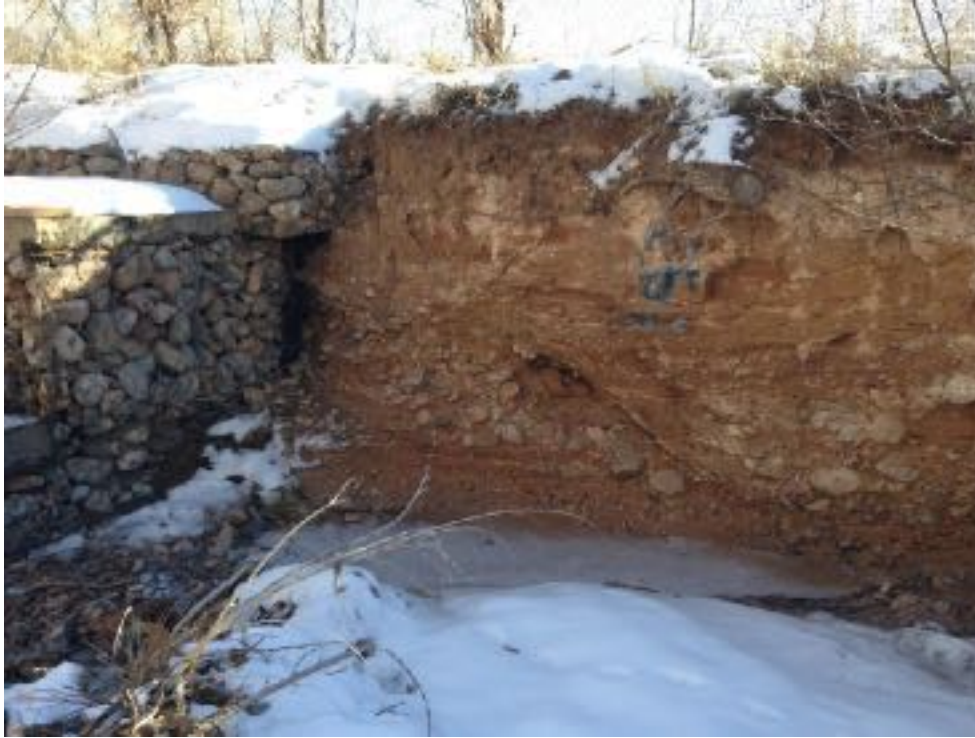
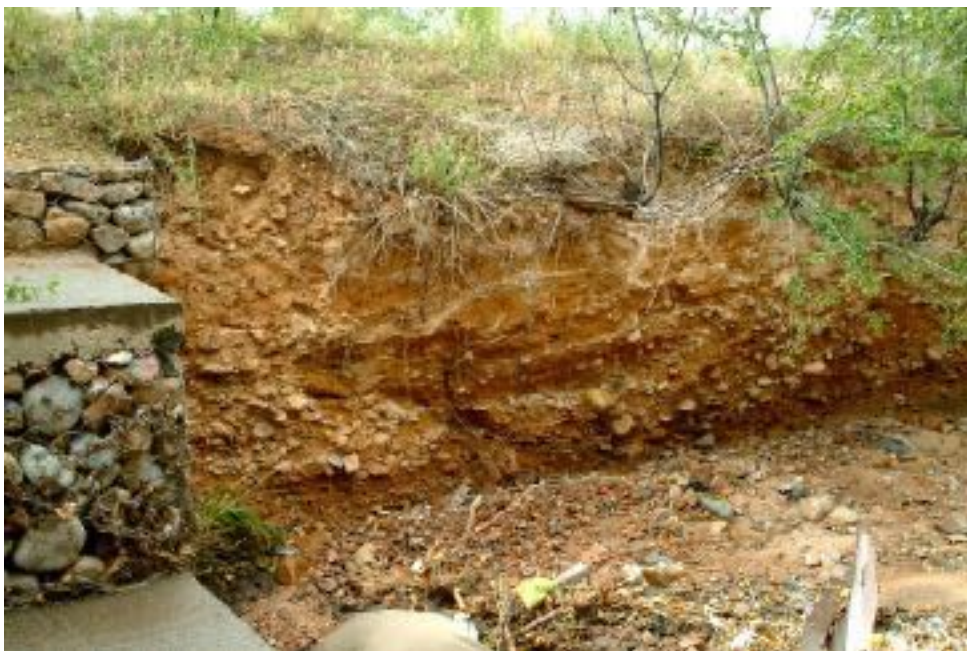
Segment D/ Bank erosion; upper photo 2016, lower photos 2012, Lower Arroyo Pinos.

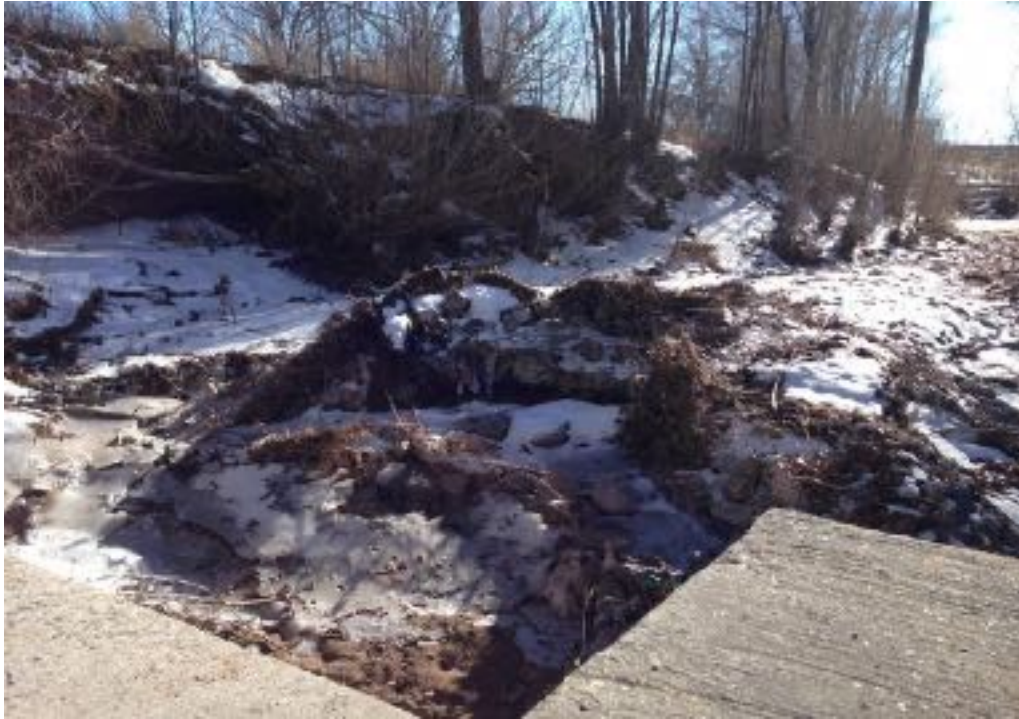
Segment D/ Damaged rip rap mat 2016, Lower Arroyo Pinos.

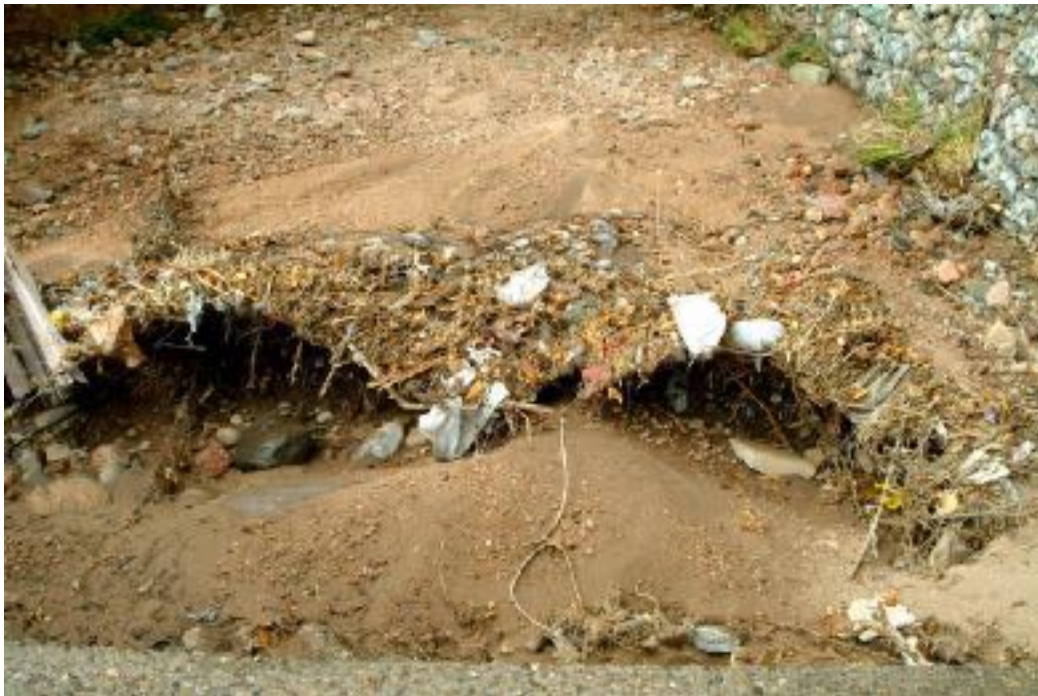
Segment D/ Damaged rip rap mat 2012, Lower Arroyo Pinos.

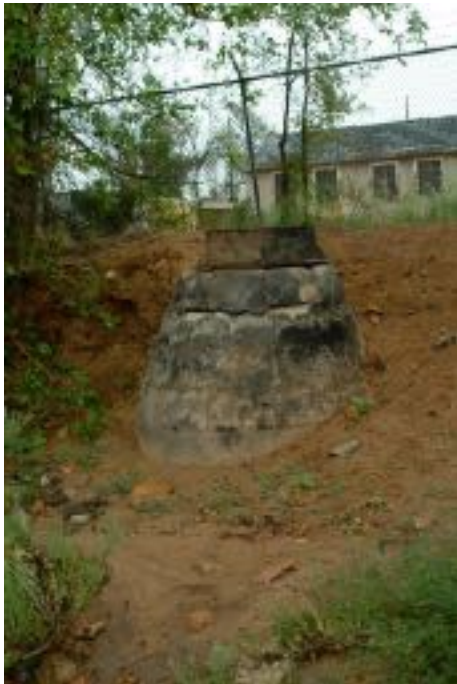
Segment E/ Unprotected Sewer utility, Lower Arroyo Pinos, 2012.

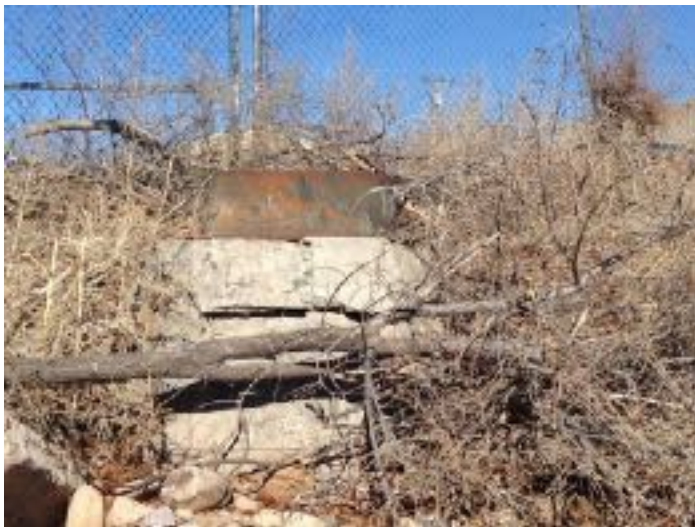
Same sewer outlet with protection, Lower Arroyo Pinos, 2016 .

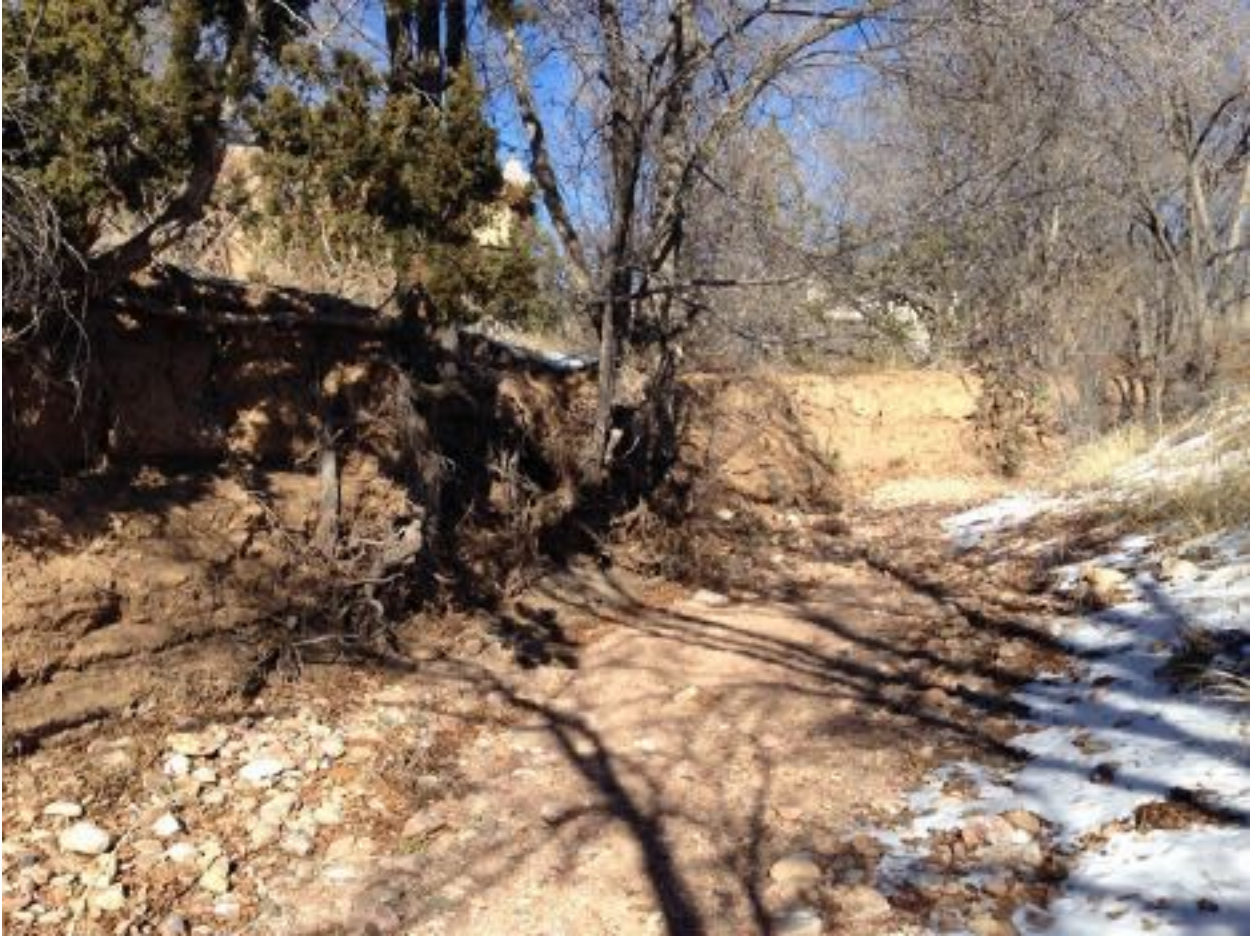
Segment E/ Bank erosion, Lower Arroyo Pinos, 2016 .

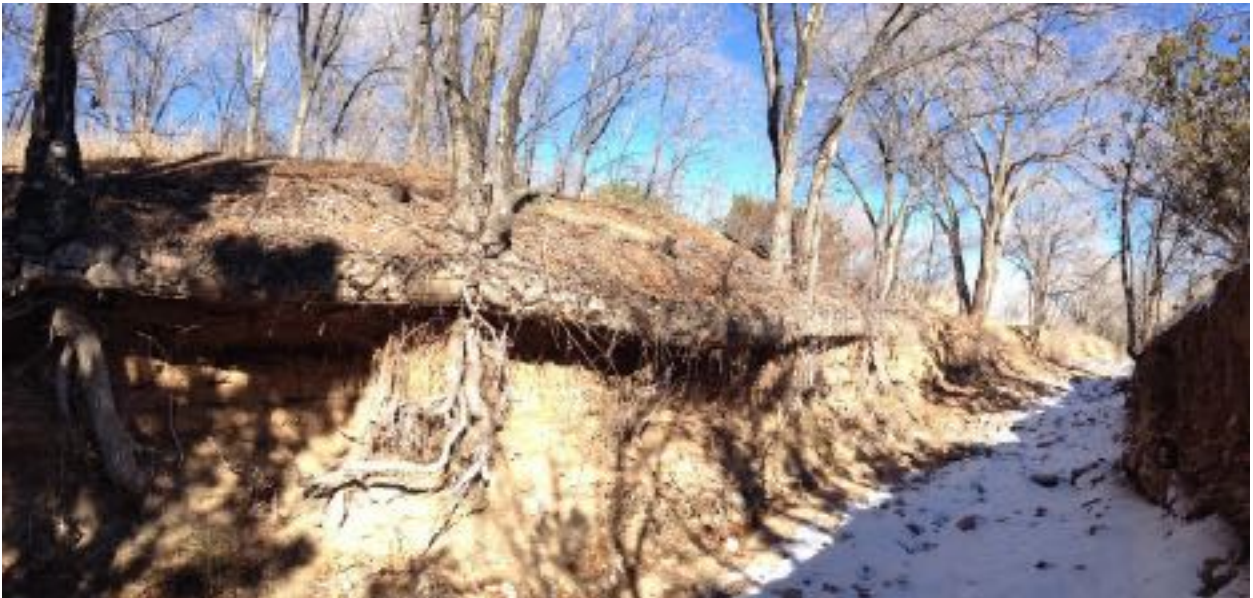
Segment E/ Bank erosion, Lower Arroyo Pinos, 2016 .

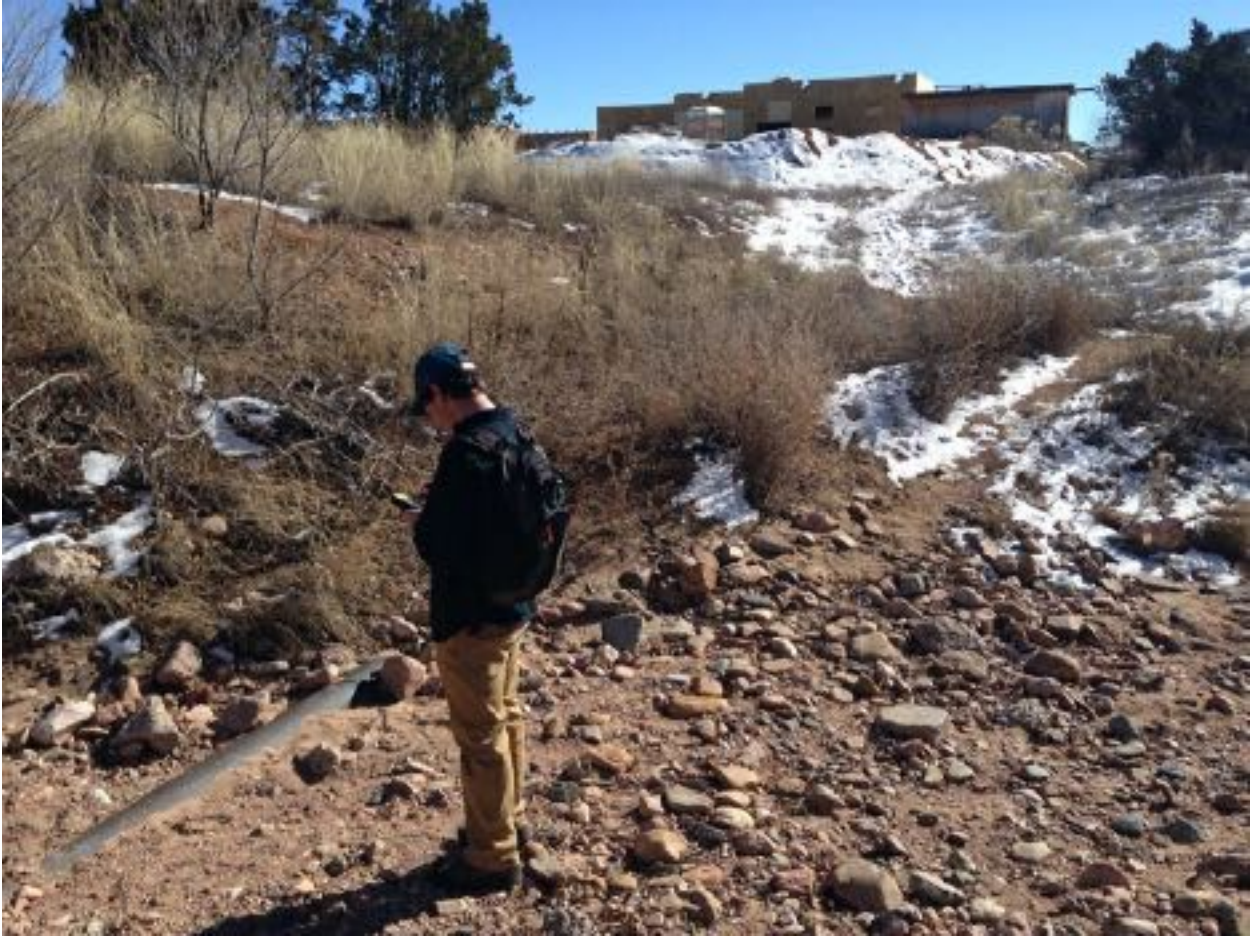
Segment E/ Exposed utility, Lower Arroyo Pinos, 2016.

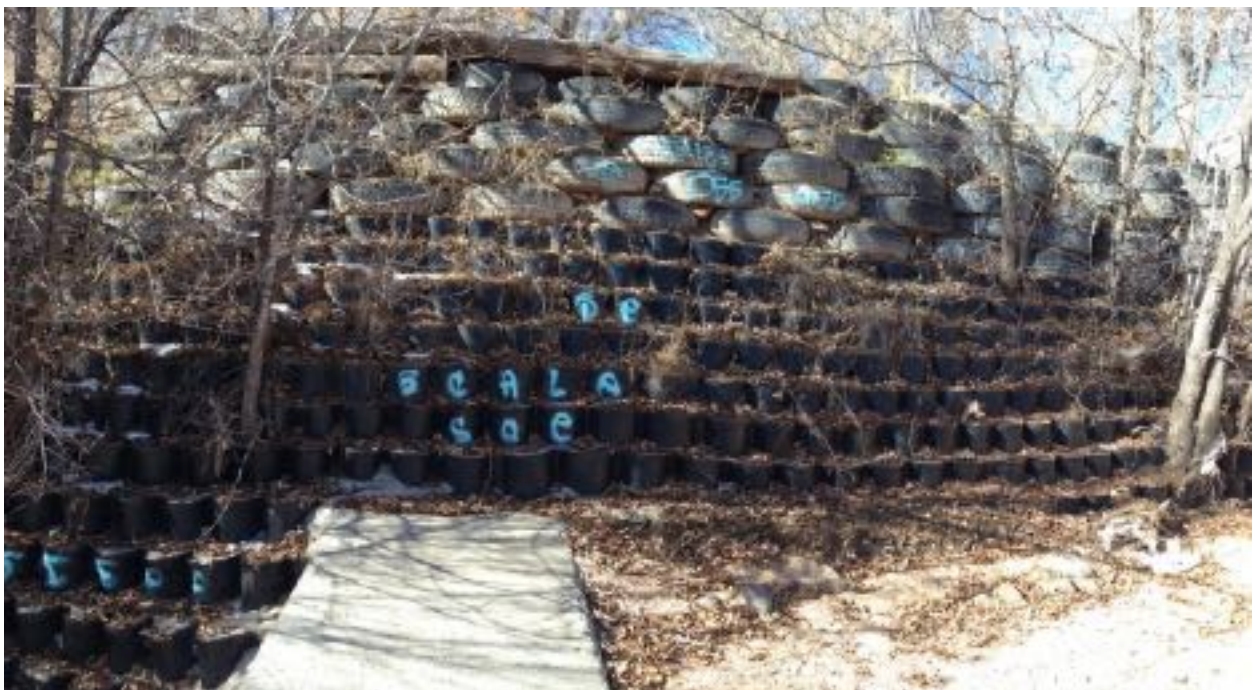
Segment E/ Young trees anchor bank stabilization materials, Lower Arroyo Pinos, 2016.
