IX. Arroyo Mascaras

X. Arroyo de la Piedra

XI. Foothills Arroyo

XII. Arroyo Cloudstone

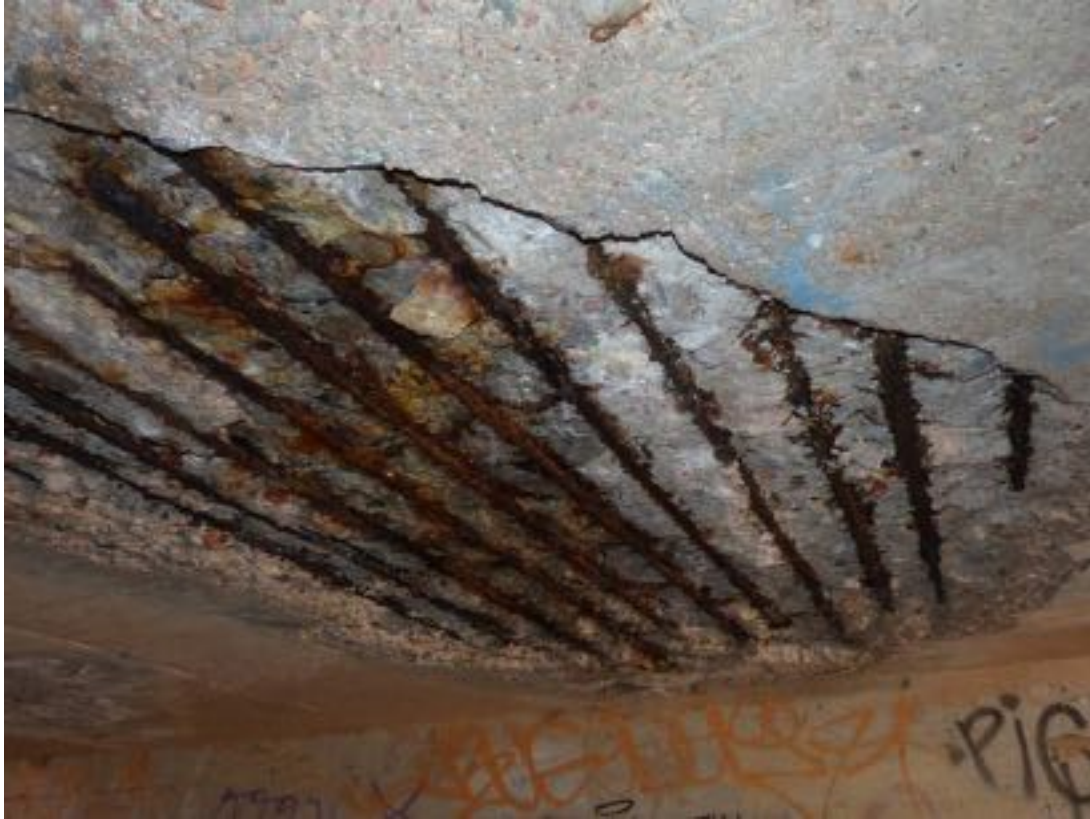
Notes: The arroyo channel in this segment widens and the banks are not steep. The Old Taos Highway Bridge crosses the arroyo. The concrete underside of this bridge is decaying exposing rebar. Also the bridge provides shelter for transient populations. From this segment to the Santa Fe River numerous transient camps can be found. Trash is common in this area as a result of these camps.

Segment B/Underside of concrete damage, Old Taos Bridge Arroyo Mascaras ,2016.

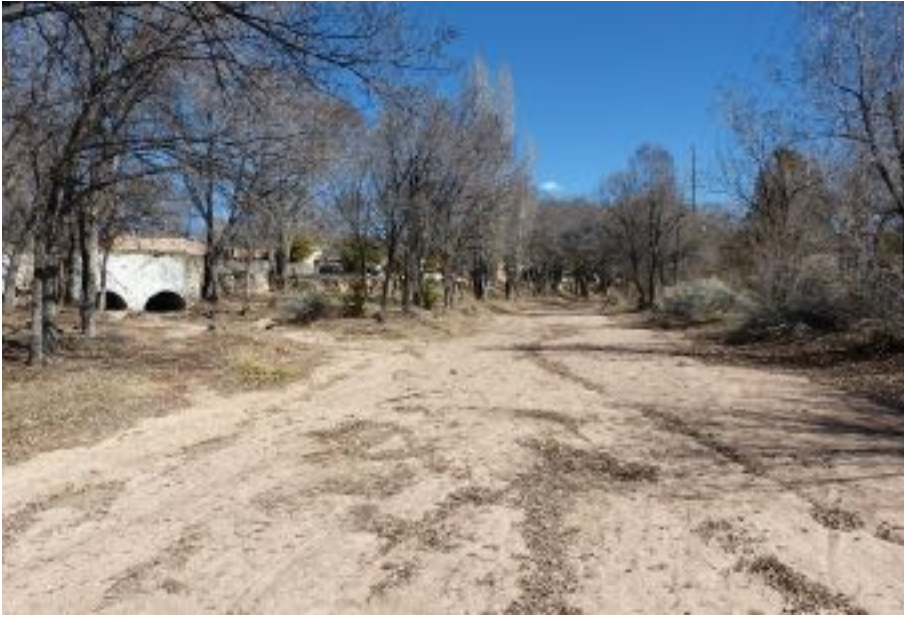
Segment C/Arroyo bed above Paseo de Peralta culvert, Arroyo Mascaras ,2016.

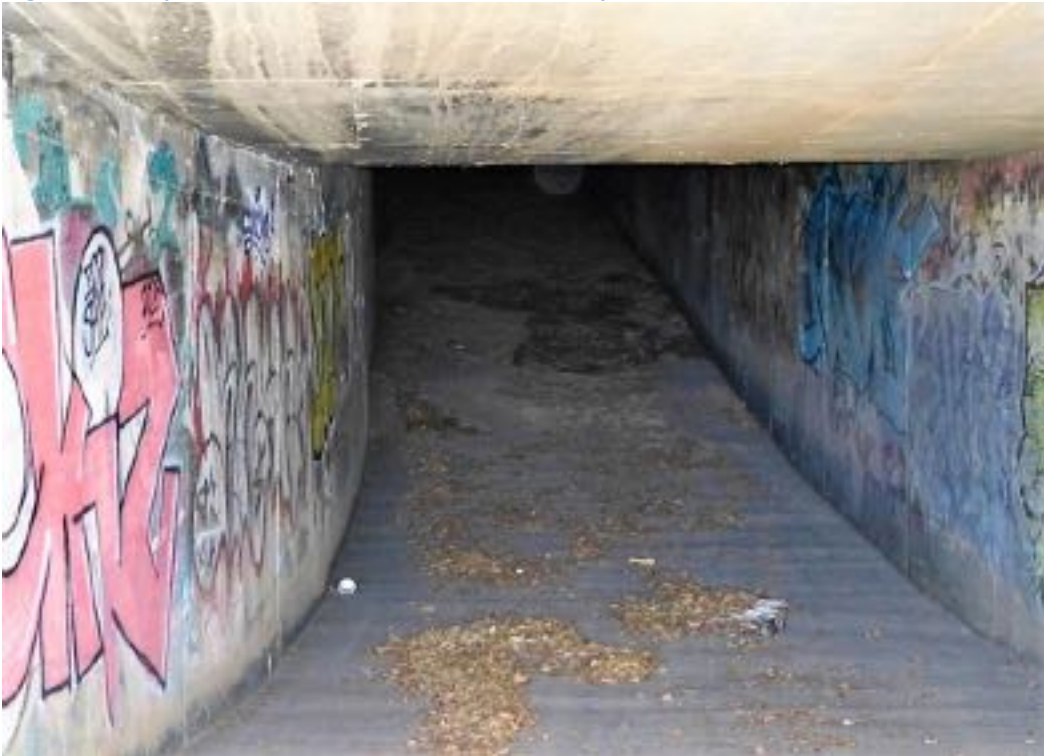
Segment C/ Paseo de Peralta culvert, Arroyo Mascaras, 2016.

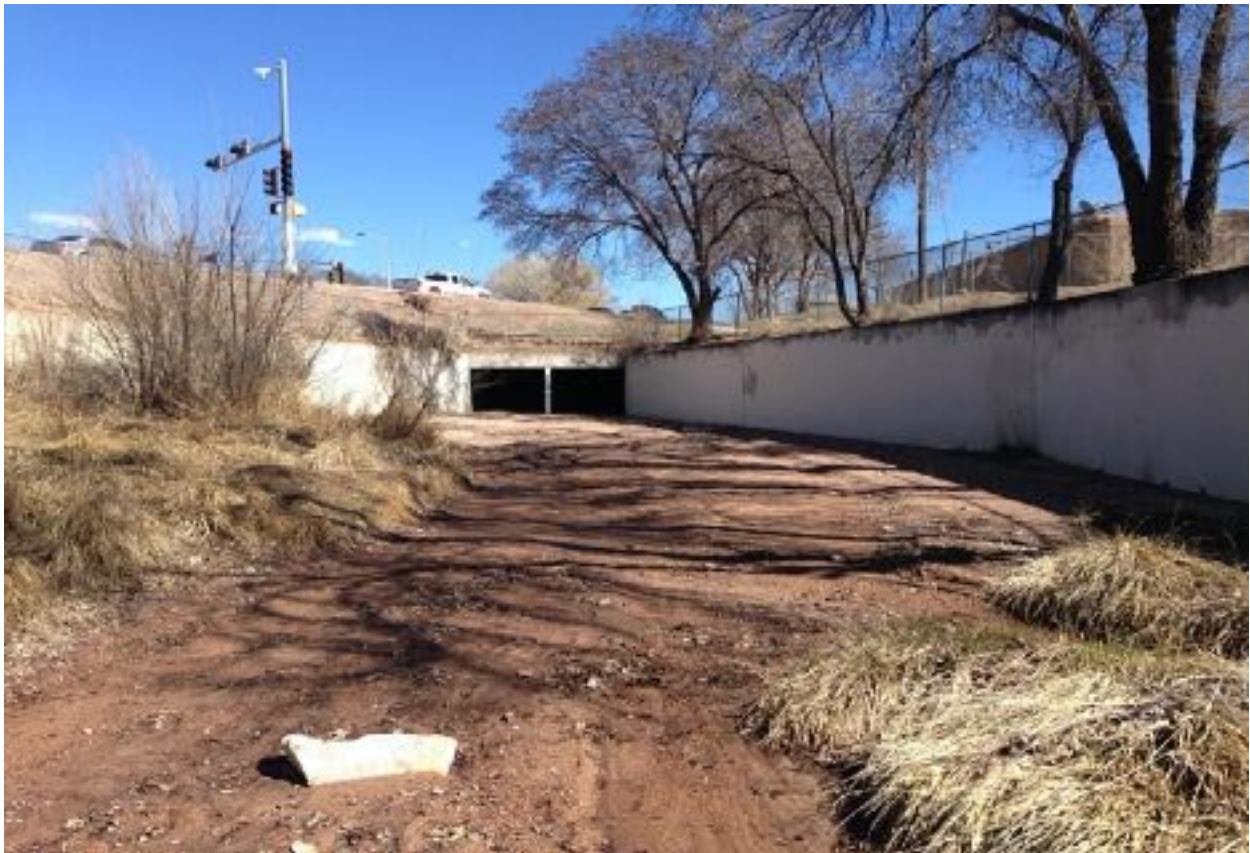
Since 2012, the majority of the arroyo has remained the same. Infrastructure in disrepair is found in the rip rap mats located beneath the culverts. Unique to this arroyo is an area that remains wet all year round. The cause for the unusual amount of standing water is not apparent in this area. The occurrence of bridges to shelter transient residents increases as does the amount of trash. Through the Santa Fe Watershed's Adopt an Arroyo program Santa Fe Prep has officially adopted this section of this arroyo.

Segment D/Perineal wet area below culvert, Arroyo Mascara , 2016.

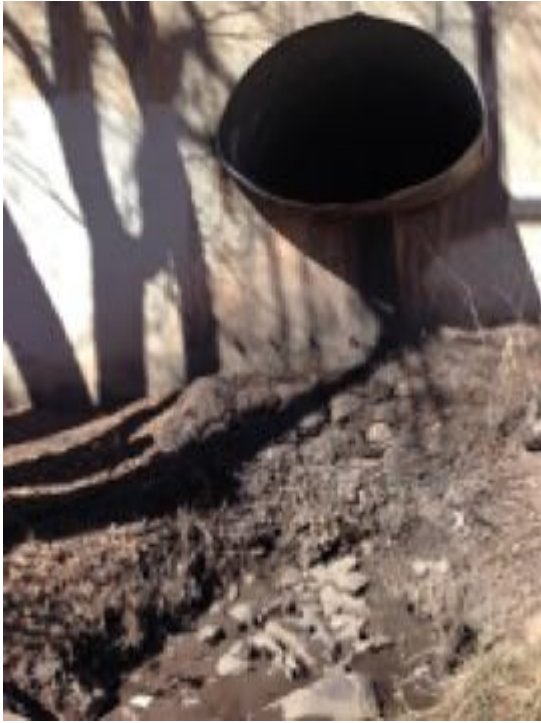
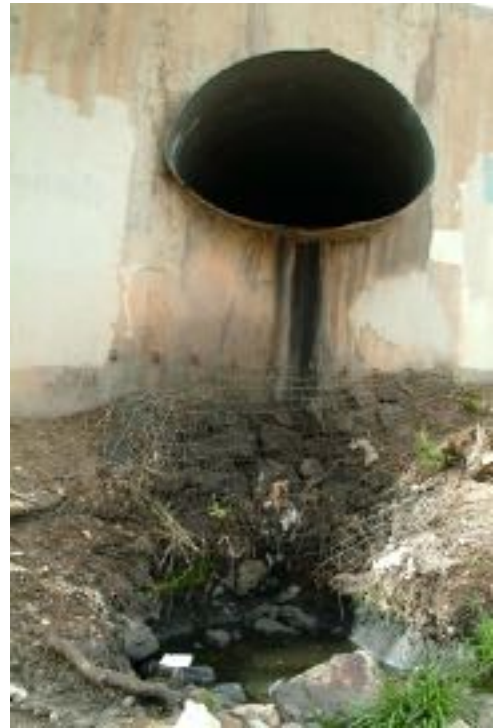
Segment D/Comparison of rip rap damage below culvert, Arroyo Mascaras , 2016.

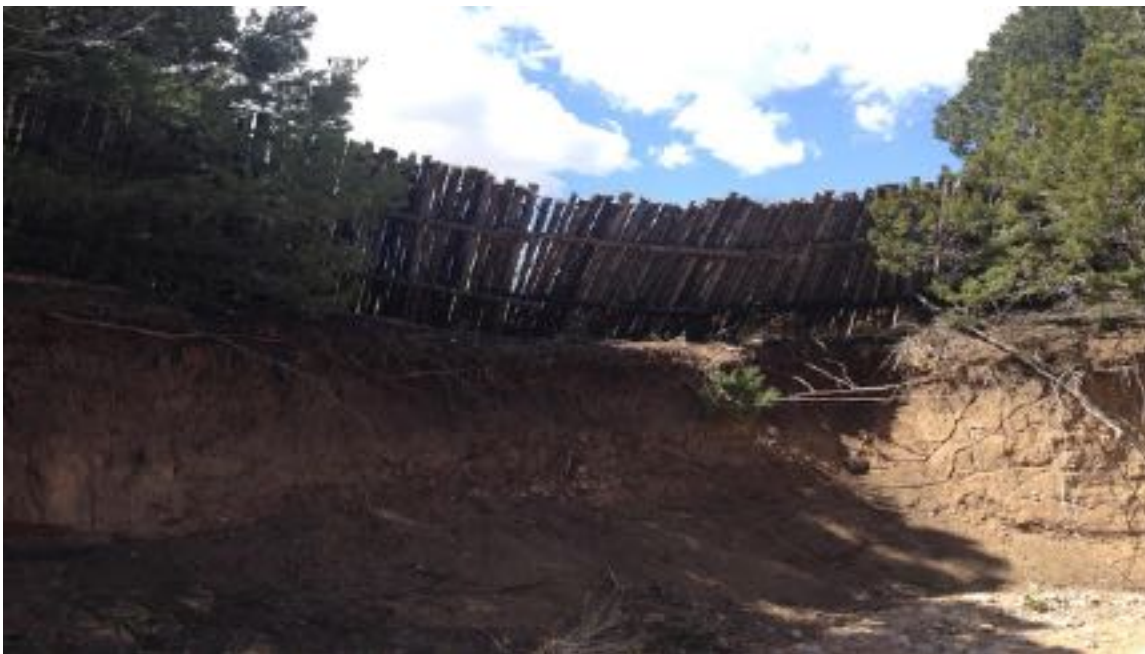
Segment A/ Bank erosion, Arroyo Piedra, 2016.

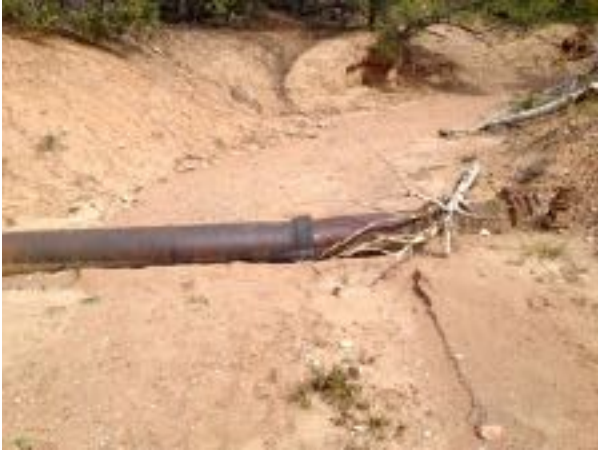
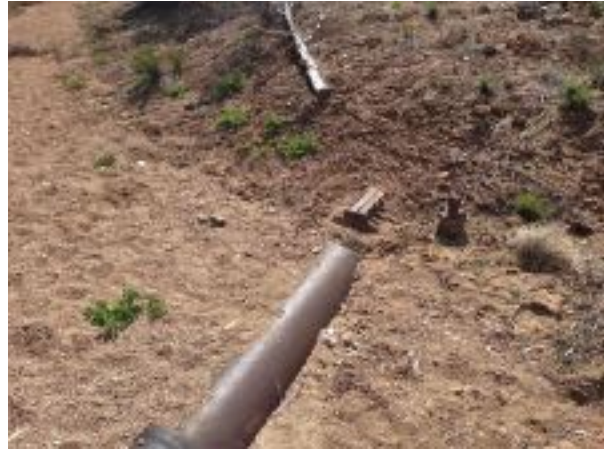
Segment A/ Comparison of exposed iron pipe. Left 2016 condition/ Right 2012 condition, Arroyo Piedra, 2016.

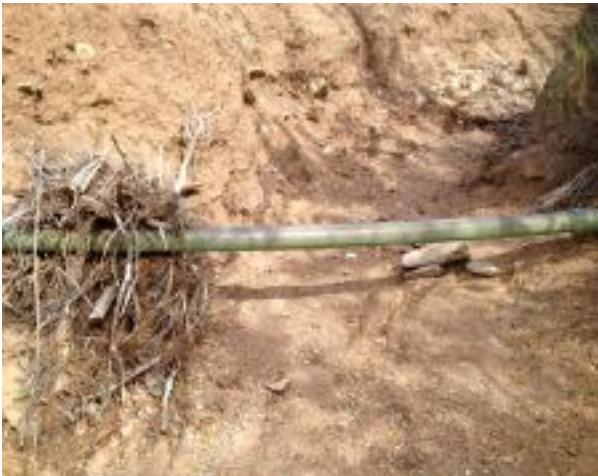
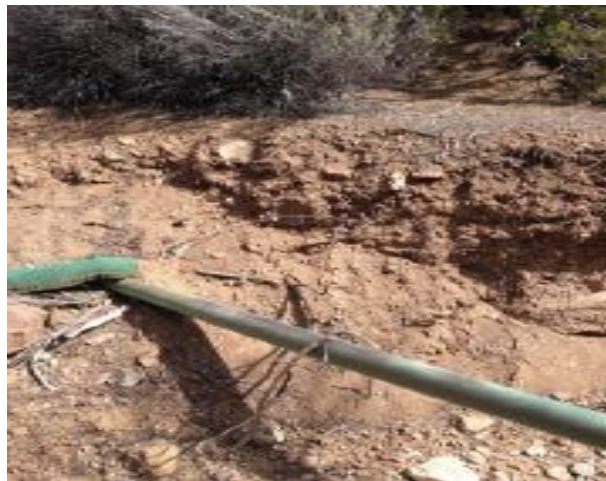
Segment A/ Comparison of exposed green pipe. Photo left 2012 condition and photo right 2016 condition, Arroyo Piedra, 2016.

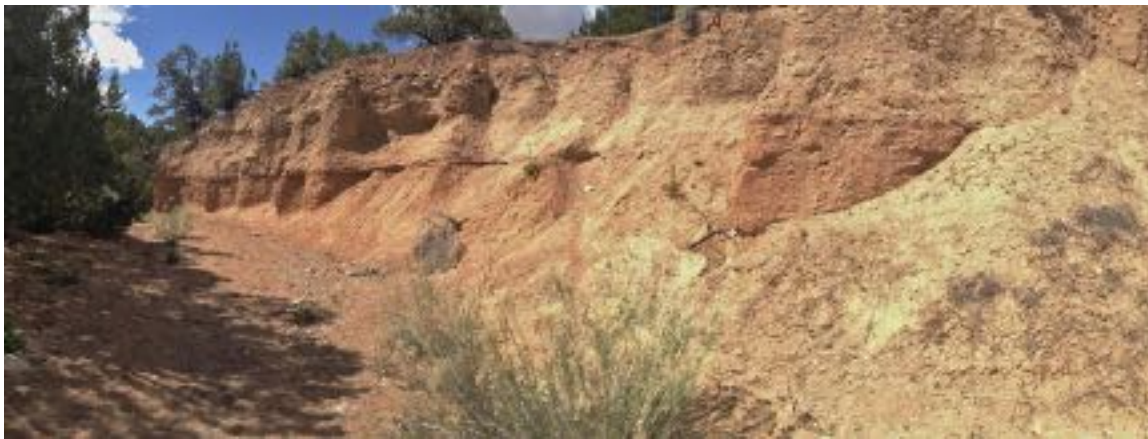
Eroded banks in Arroyo Piedra East, segment A.

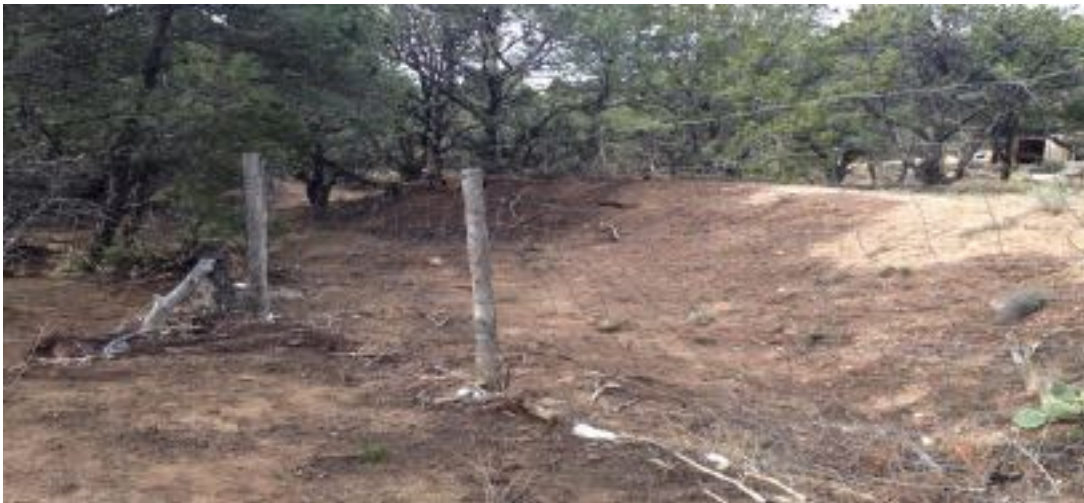
Segment B/Fence across the arroyo bed, Arroyo Piedra, 2016.

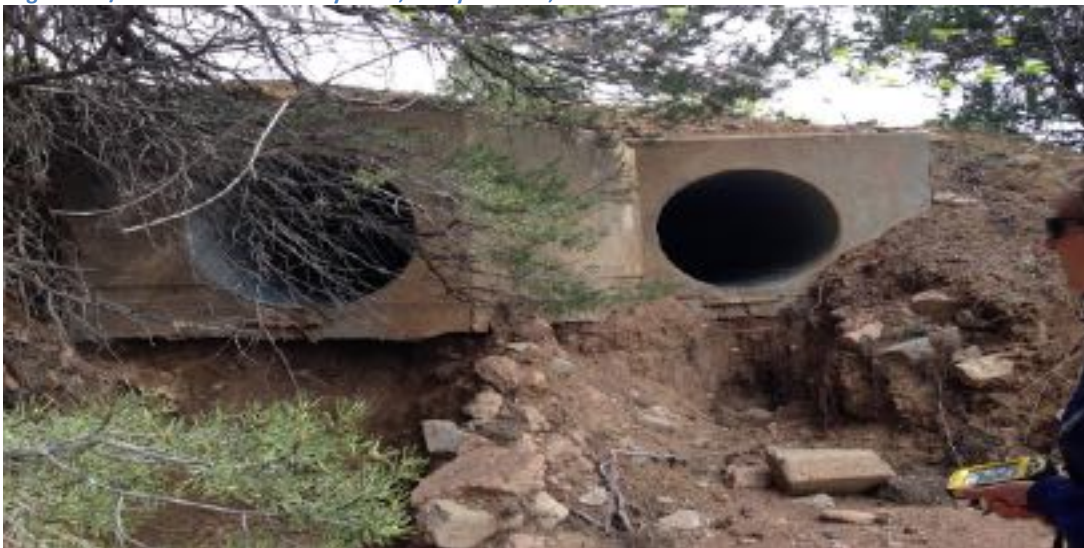
Segment B/Bank deterioration below culverts, Arroyo Piedra, 2016.

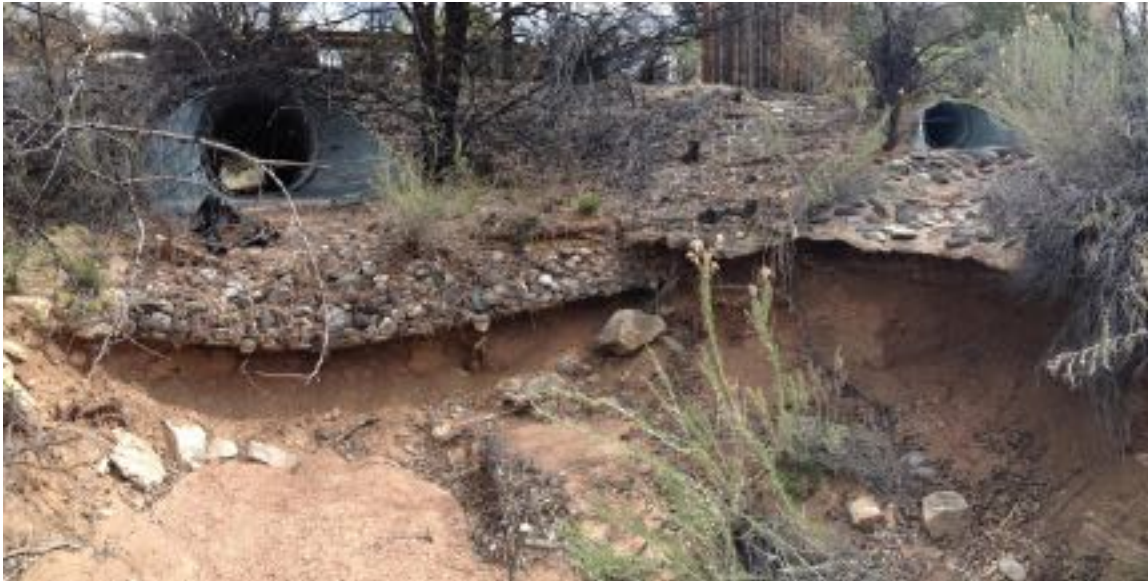
Segment B/ Rip rap mats undermined , Arroyo Piedra, 2016.

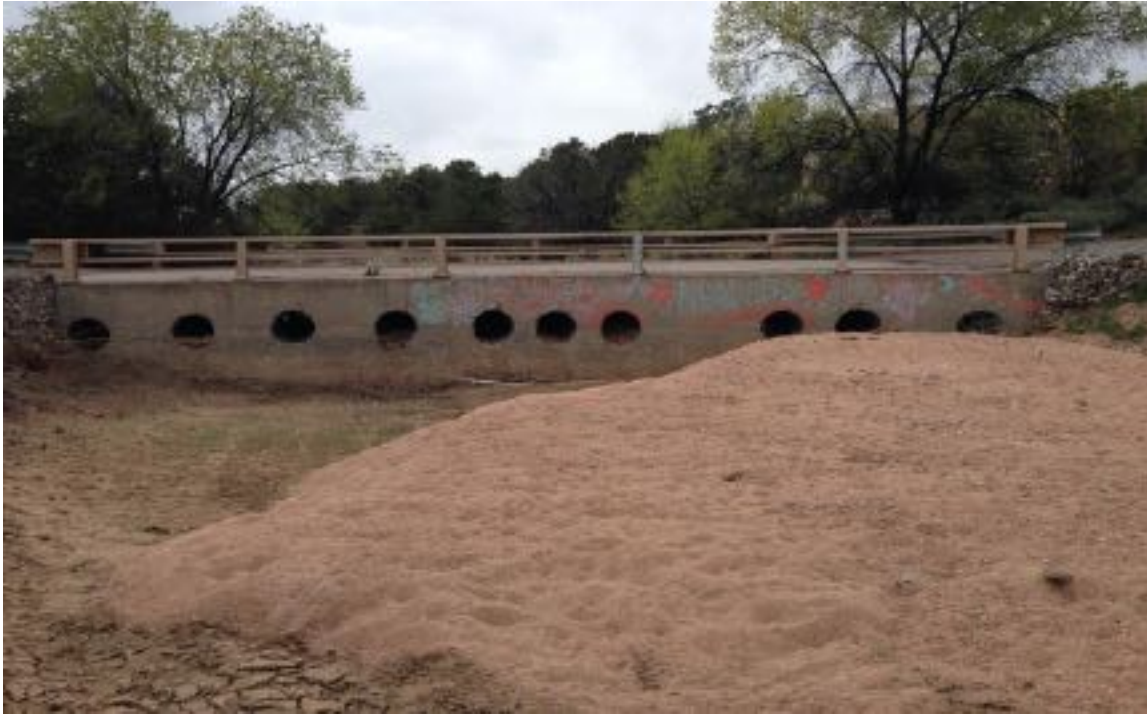
Segment B/ Upstream side of restricted culverts with sediment displacement , Arroyo Piedra, 2016.

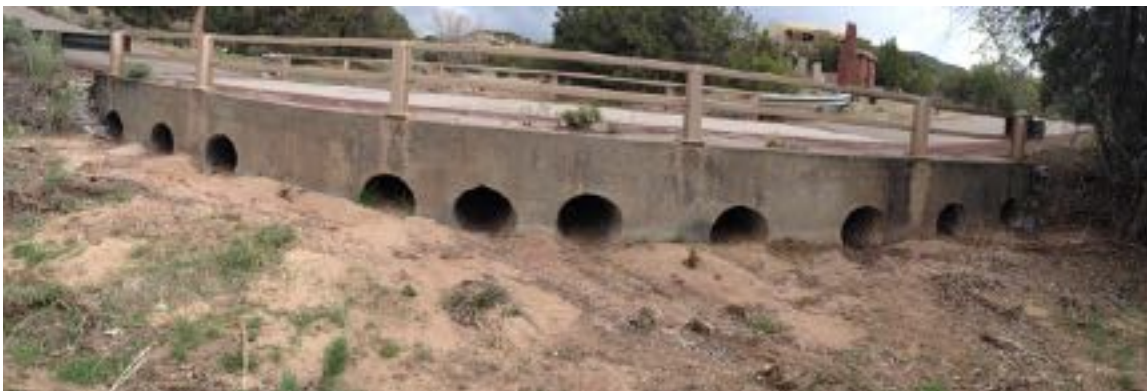
Segment B/ Downstream side of restricted culverts , Arroyo Piedra, 2016.

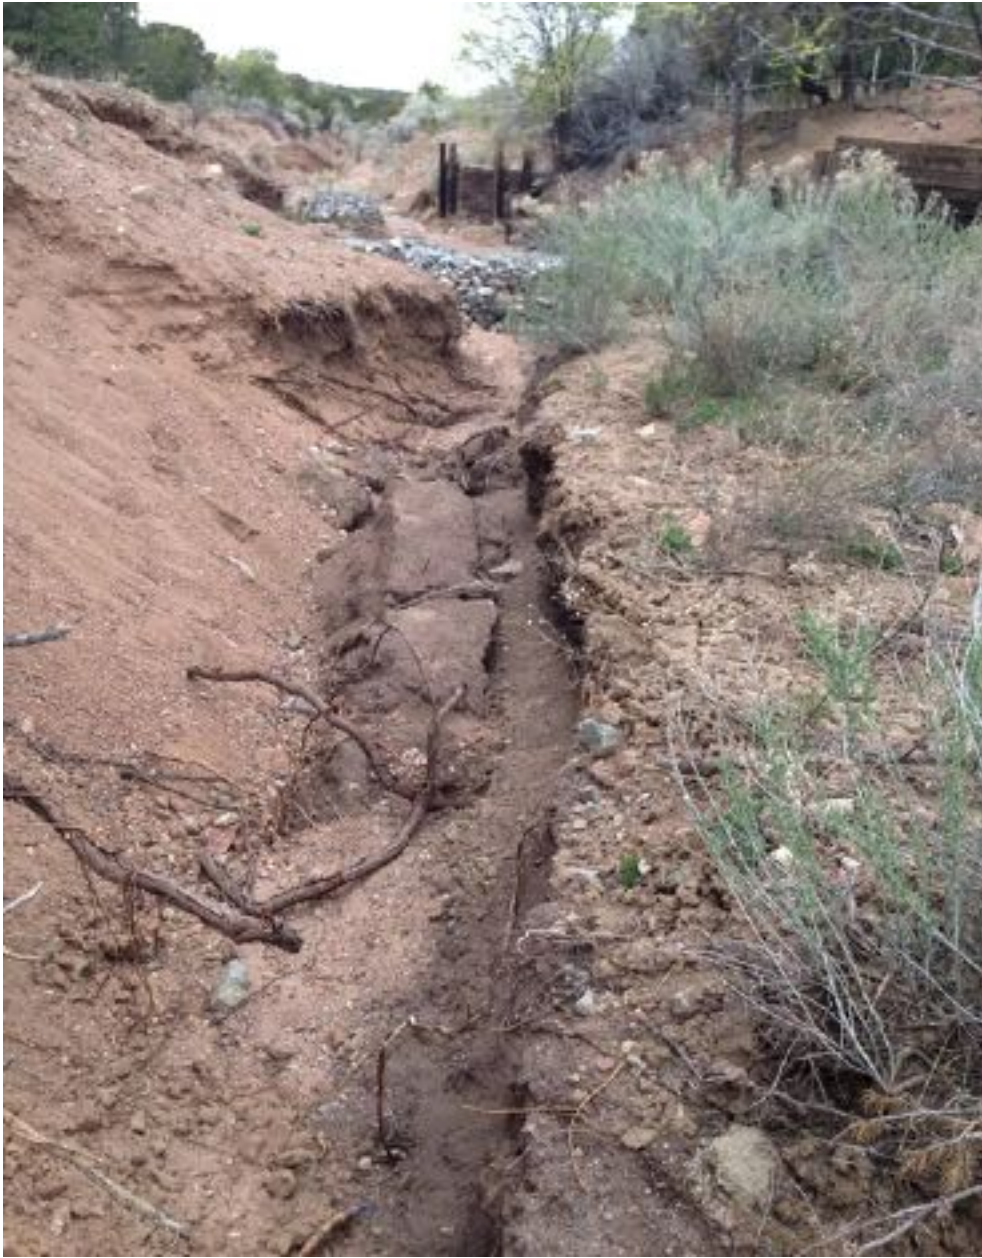
Segment B/ Incising of the arroyo bed and bank deterioration, Arroyo Piedra, 2016.

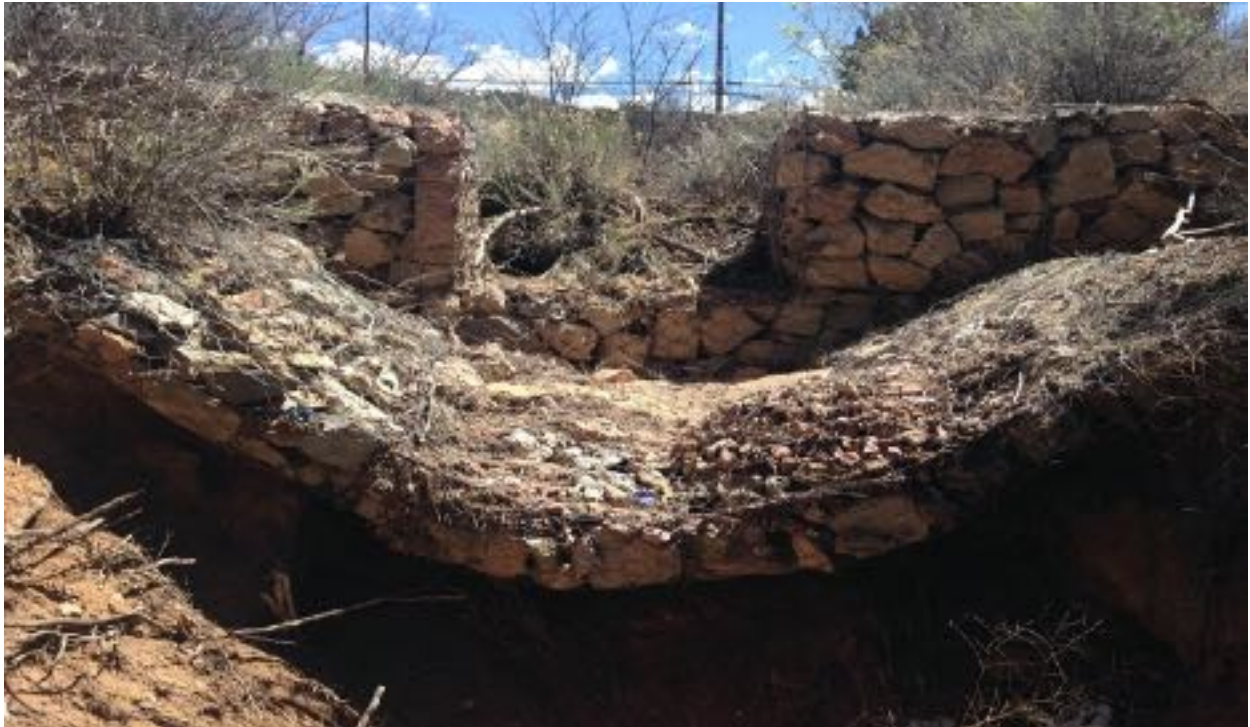
Segment A/ Rip rap mat undermined, Foothills Arroyo, 2016.

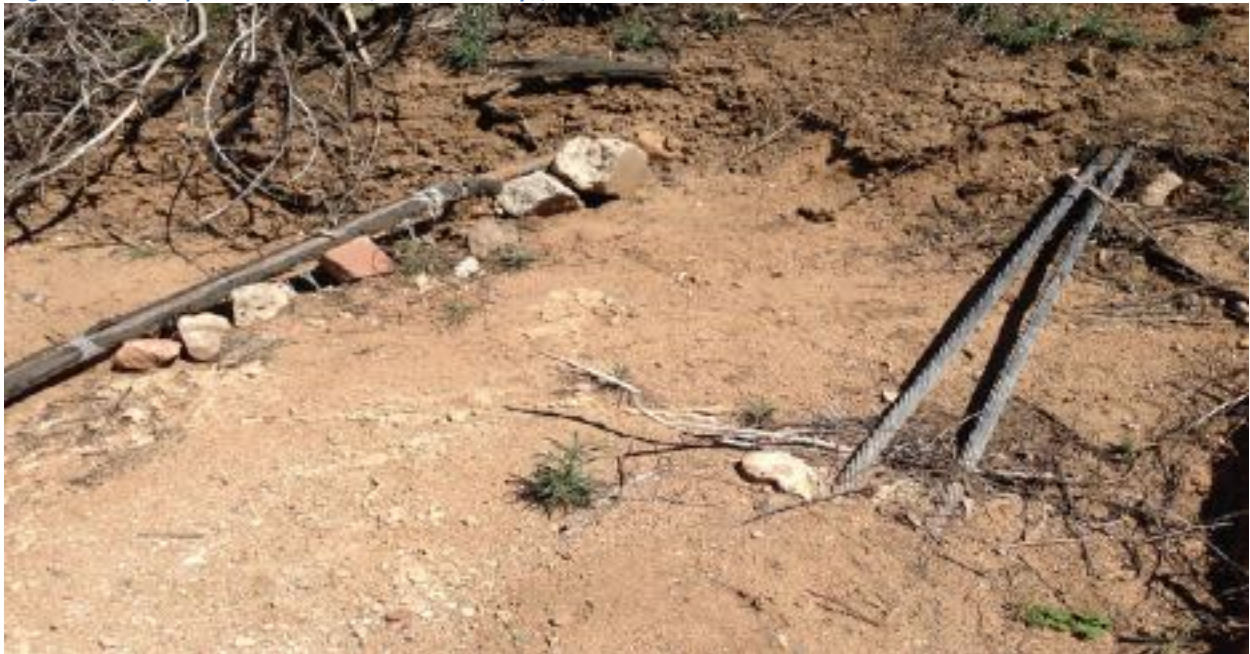
Segment A/ Exposed cables, Foothills Arroyo, 2016.

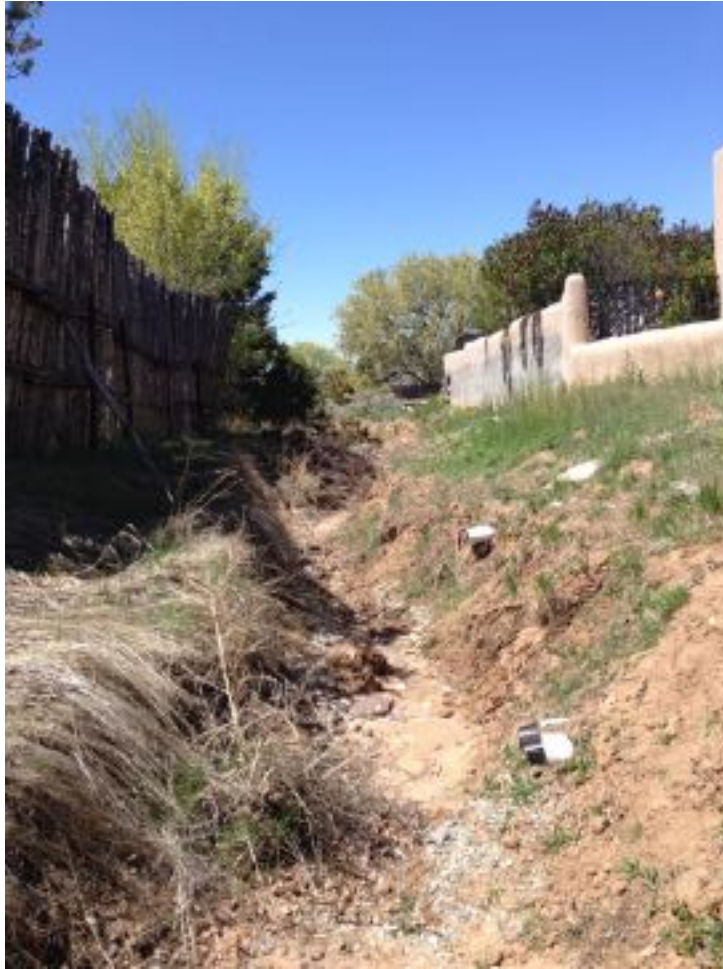
Segment A/ Drain pipes protrude into arroyo from private property, Foothills Arroyo, 2016.

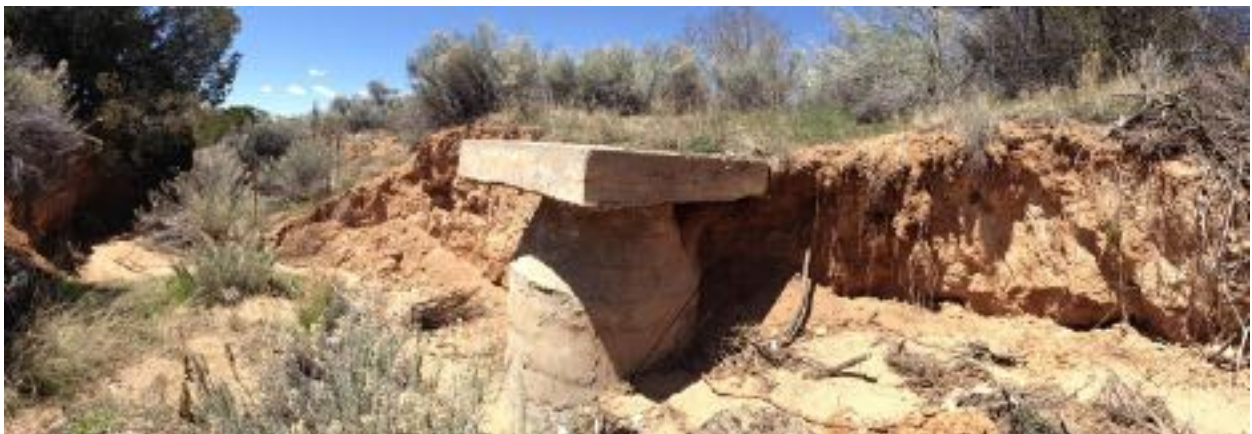
Segment A/ Exposed cables, deteriorating banks and sewer outlet, Foothills Arroyo, 2016.

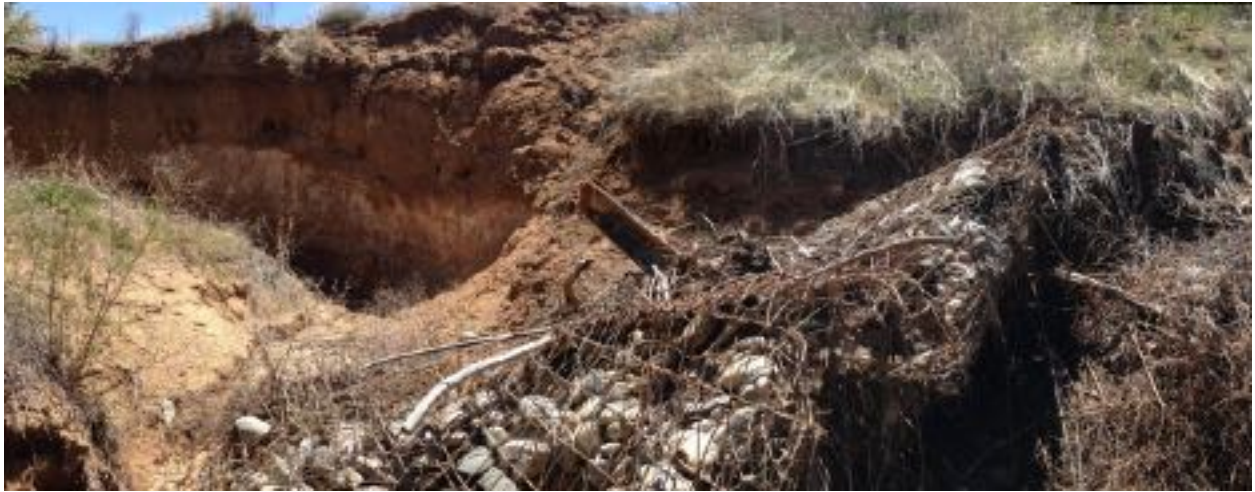
Segment A/ Vertical walls with rip rap mat folded back from flooding, Foothills Arroyo, 2016.

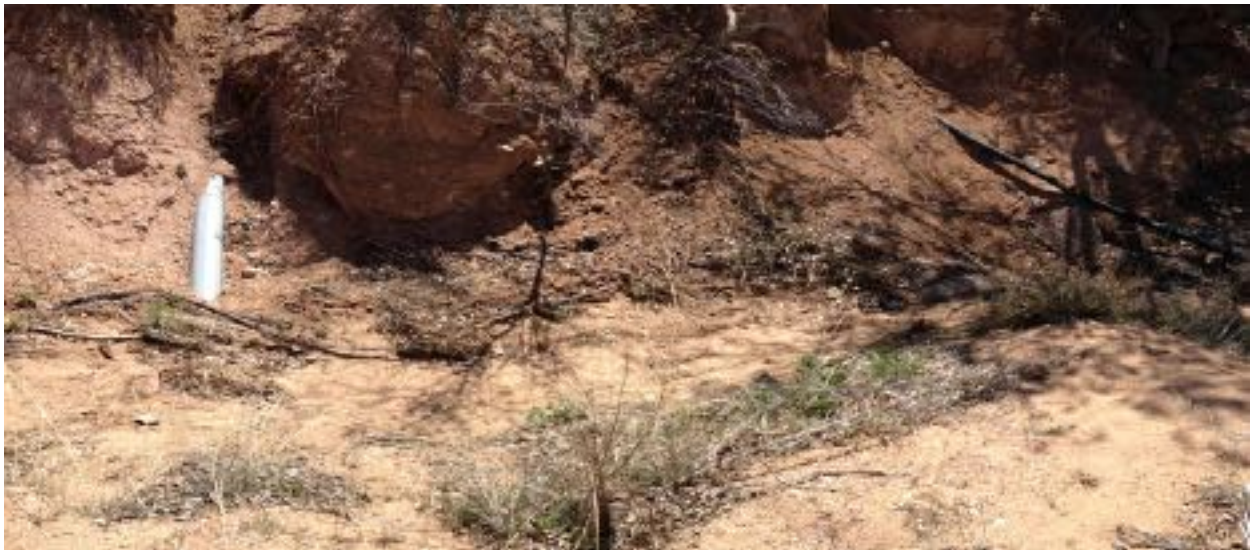
Segment A/ Two exposed utilities, Foothills Arroyo, 2016.

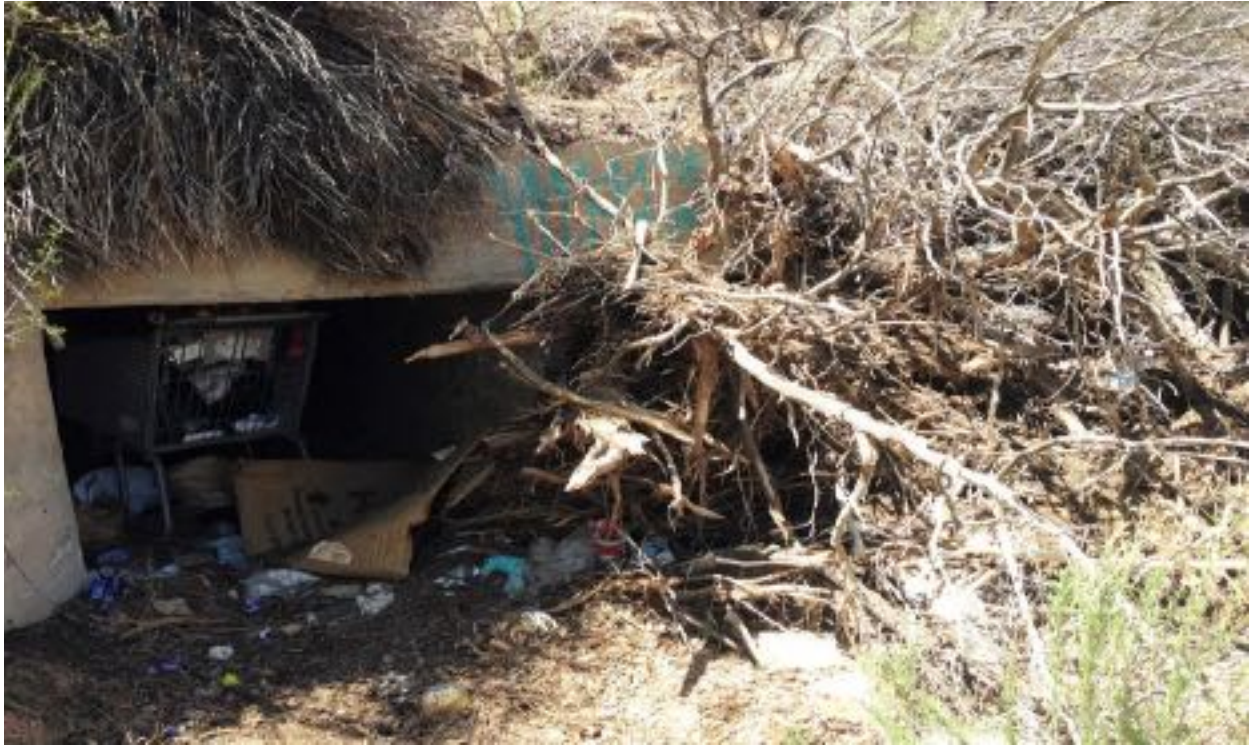
Segment A/ Obstructed box culvert with transient camp, Foothills Arroyo, 2016.

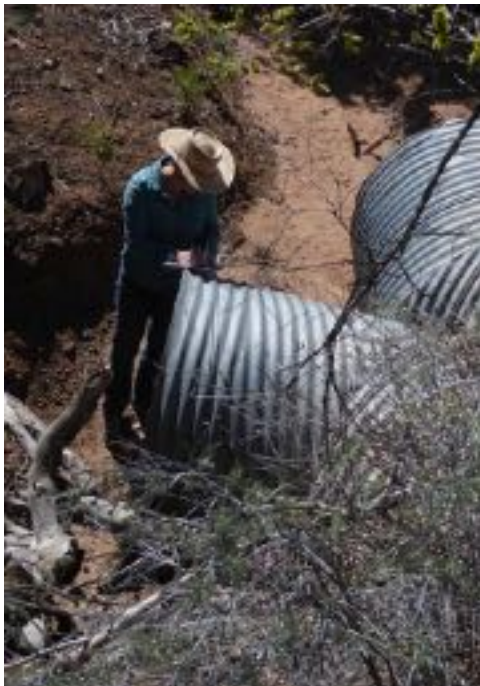
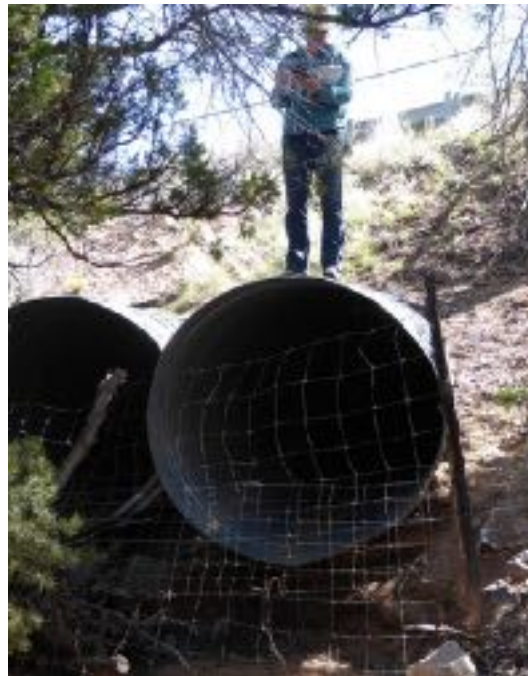
Notes: Arroyo Cloudstone, located near the base of Moon Mountain, empties into the larger Arroyo Chamisos. Run off from precipitation flows through a Y shaped culvert under Old Santa Fe trail where dead and down wood collects on either side of the culvert. A fence located on the downstream side of the culvert causes the debris to build up and obstruct the culvert. The upper length of Arroyo Cloudstone meanders freely from a lightly populated area to that of a densely populated area. Although the channel is shallow it vacillates between constricted sections, to braided, sandy, broad, open spaces in the upper reaches. It is possible for upper sections of the arroyo to meander freely before reaching Old Pecos Trail. It is not possible for natural meanders to occur since development up to its banks has been allowed. Below this point the sandy channel of the arroyo becomes deep, narrow and constricted.

Segment A/Upstream (left) and downstream right) of culvert, Old Santa Fe Trail, Arroyo Cloudstone, 2016.

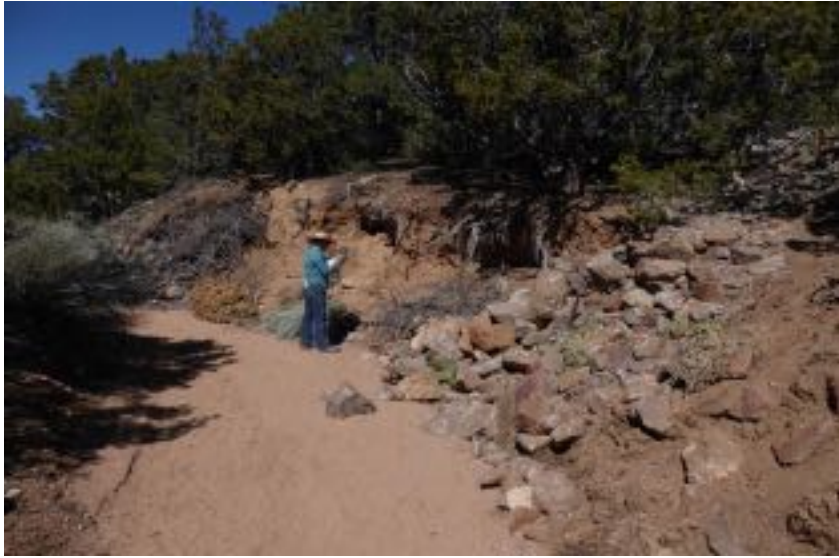
Segment A/Erosion of bank, Arroyo Cloudstone,2016.

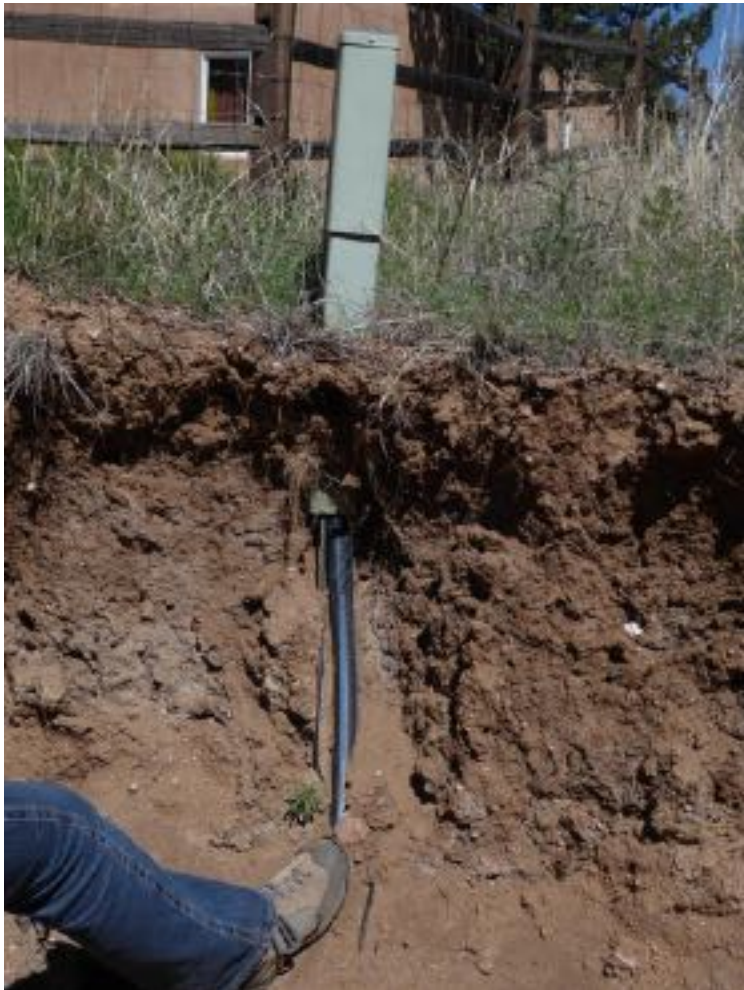
Segment A/Exposed cable, Arroyo Cloudstone, 2016.

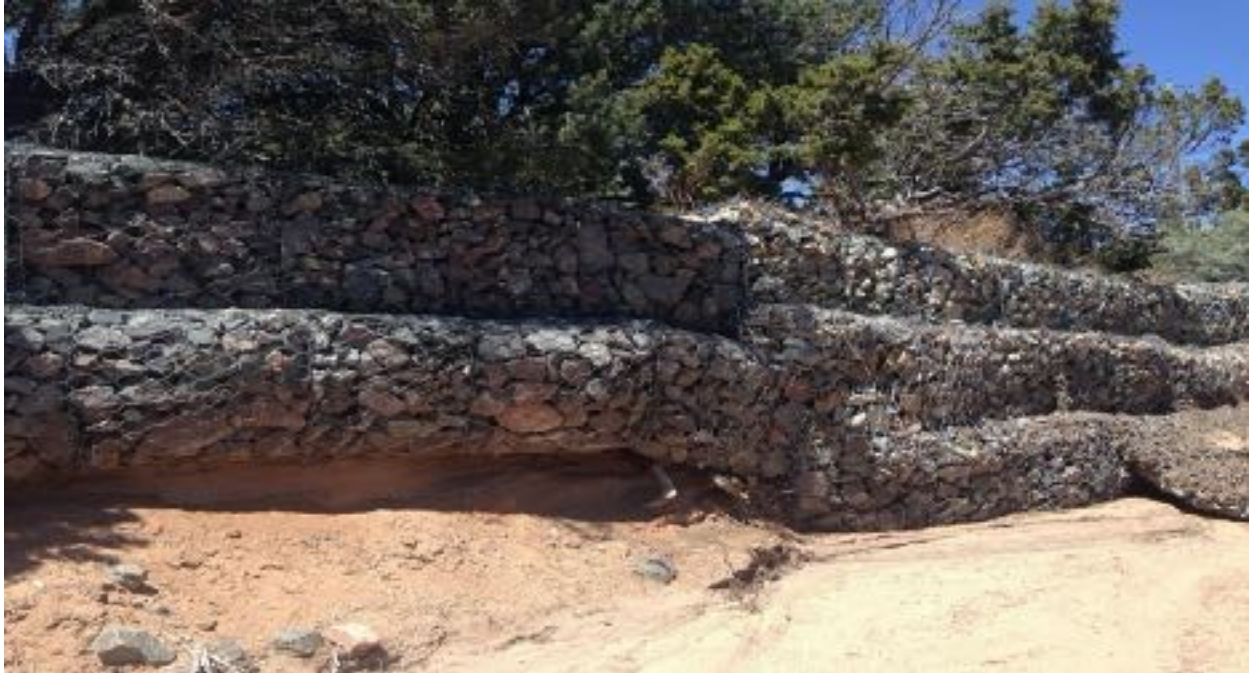
Segment B/Erosion below gabion walls, Arroyo Cloudstone, 2016.

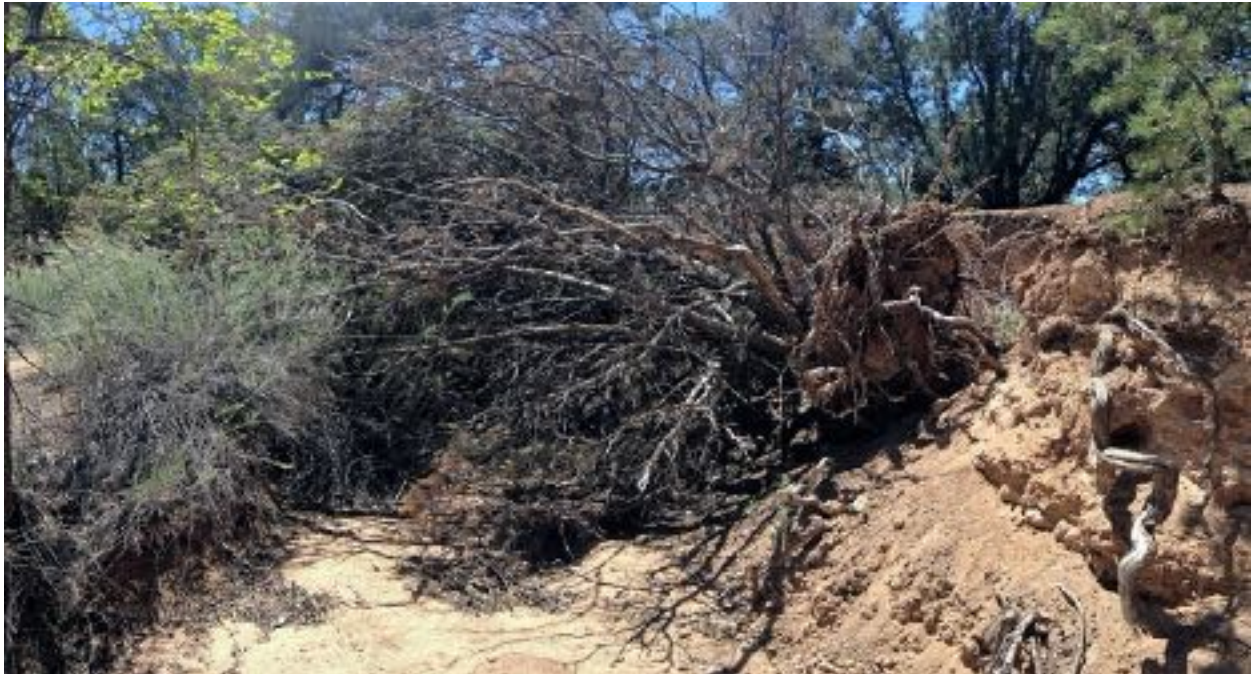
Segment B/One of several tree obstructions in the narrow constricted section of Arroyo Cloudstone, 2016.

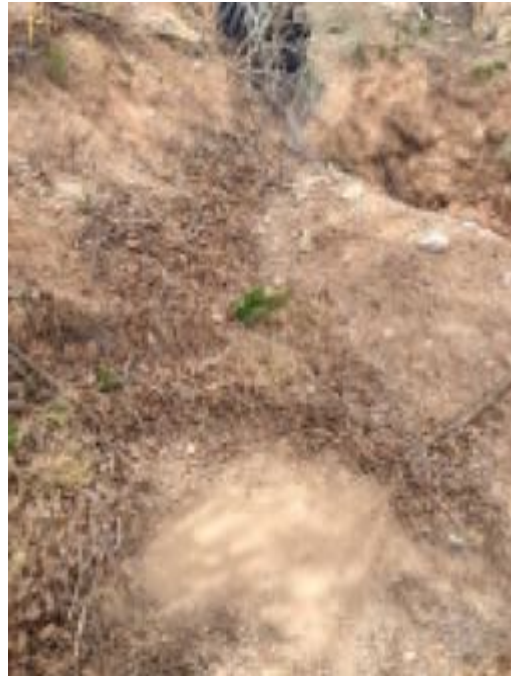
Detail of sewage outlet next to incised bank, Arroyo Nopal, 2016

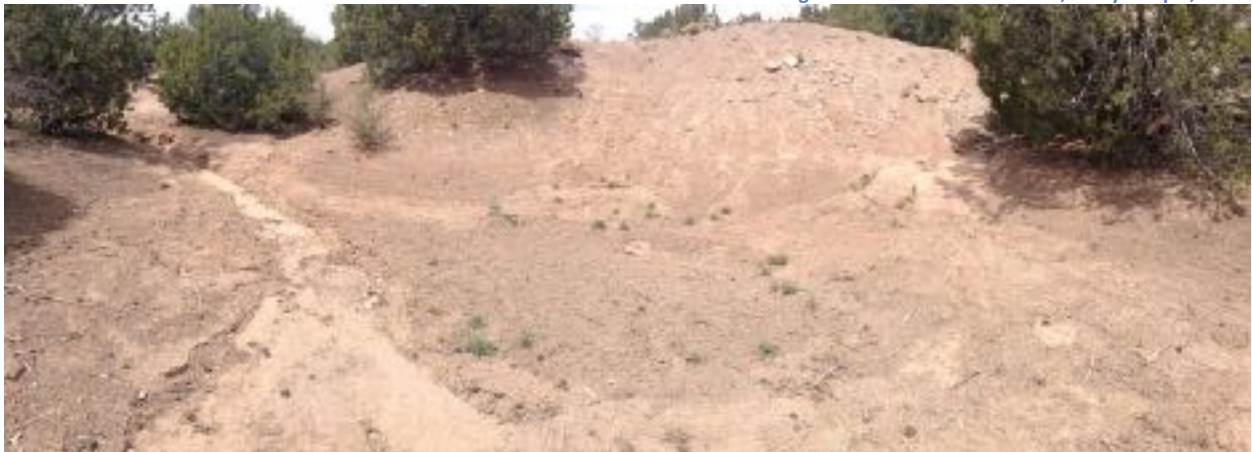
An upper and lower system of check dams and basins over filled with sediment, are unable to accommodate large volumes of water. Rather than slowing the water, these check dams are often by passed. As a result, damage to the arroyo channel and property has increased. Beyond the catch basins the arroyo becomes extremely incised as it flows toward W. Alameda.

Example of storm water bypassing upper catchment basin as it enters the lower basin, Arroyo Nopal, 2016.

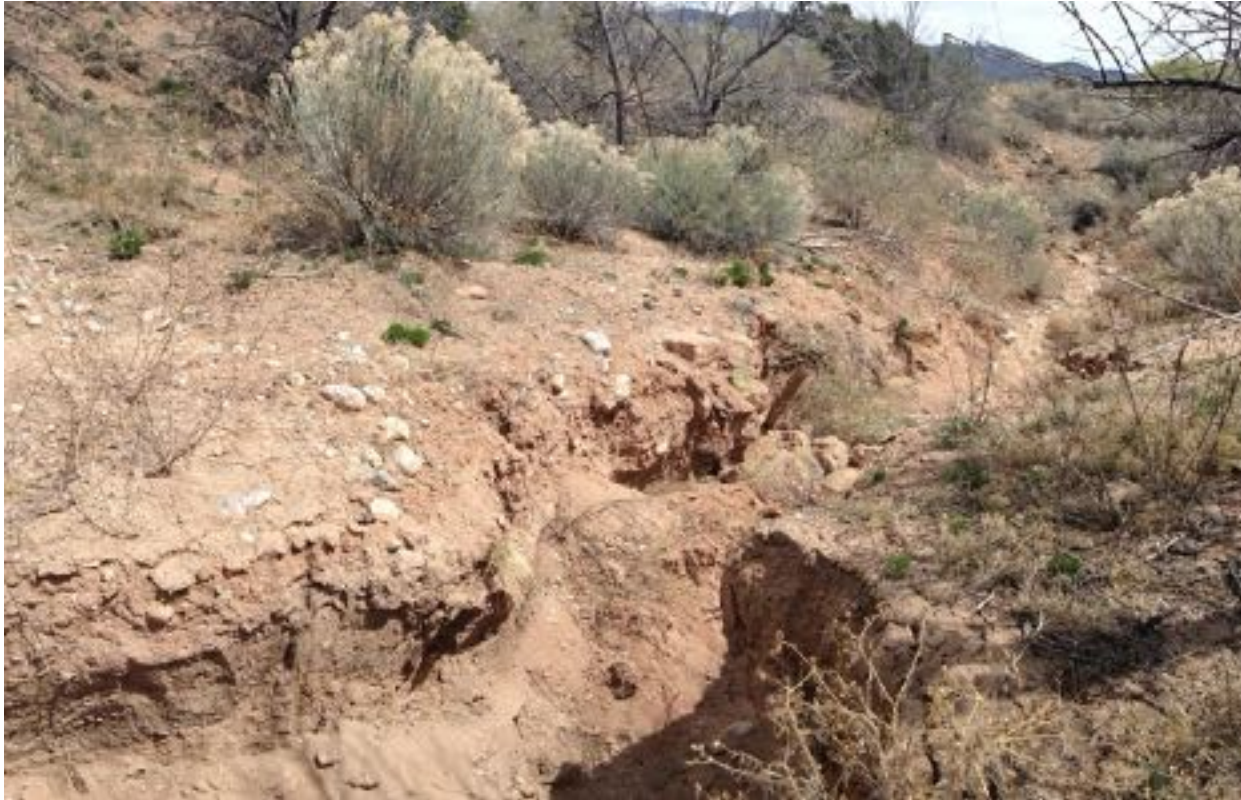
Example of incision created by run off, Arroyo Nopal, 2016.

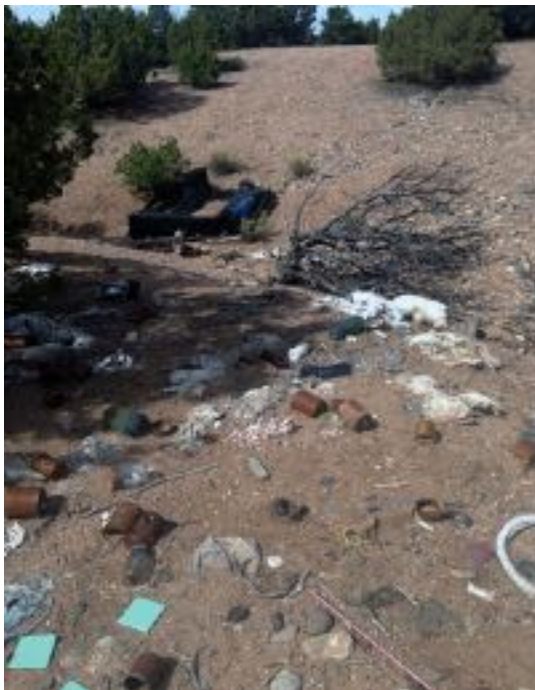
Segment A/Example of one of many trash sites in Arroyo Torreon, 2016.
