IX. Arroyo Mascaras

X. Arroyo de la Piedra

XI. Foothills Arroyo

XII. Arroyo Cloudstone

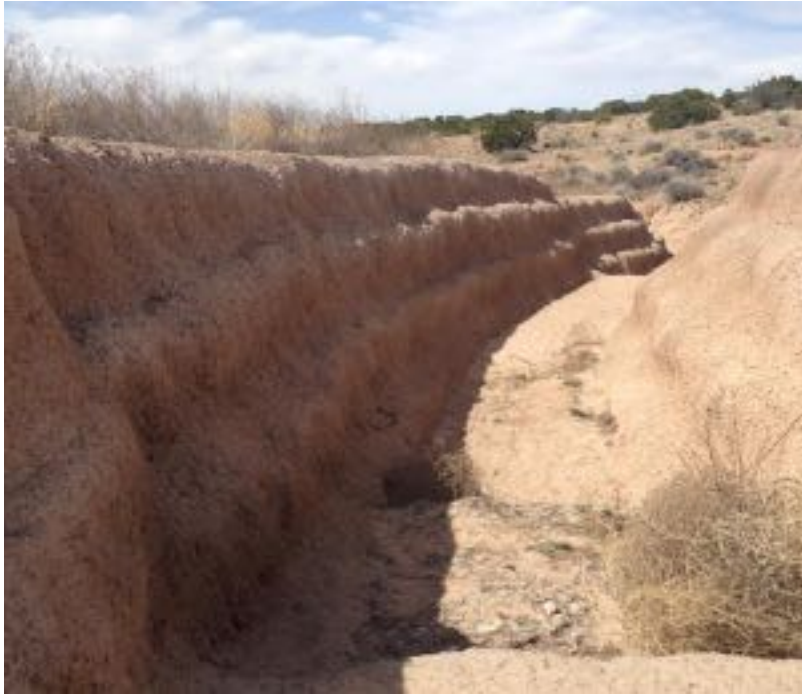
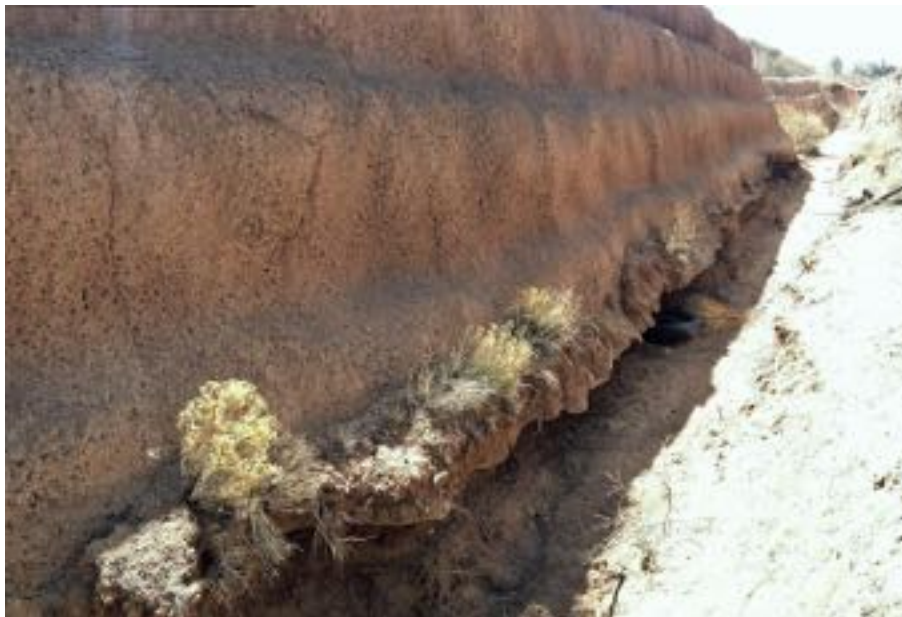
Segment B/Two views of engineered walls made of tire and adobe with undercutting, Arroyo Torreon, 2016.

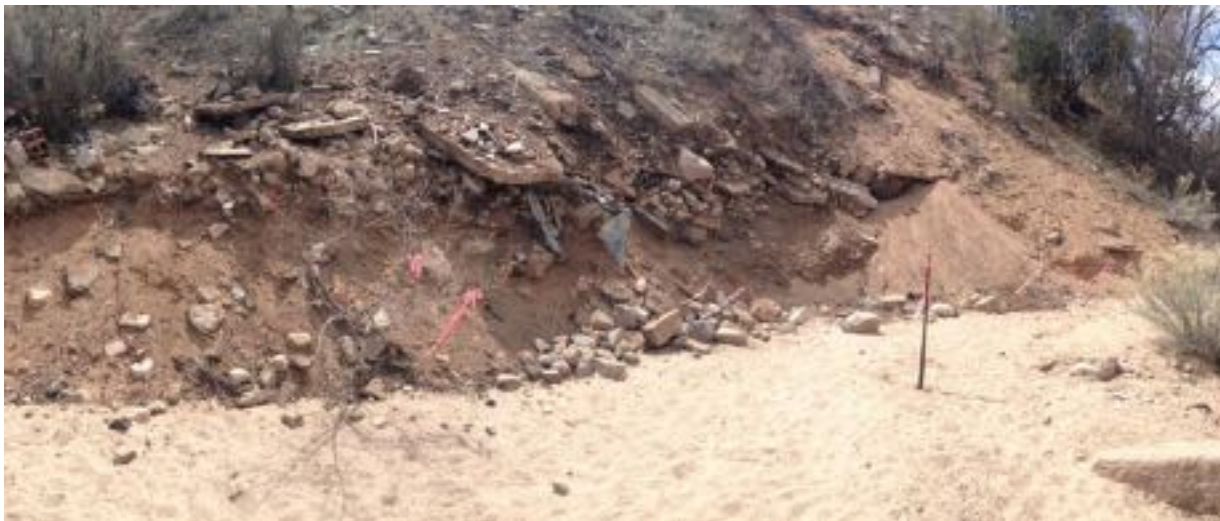
Segment B/Collapsing debris from steep bank, Arroyo Torreon, 2016.

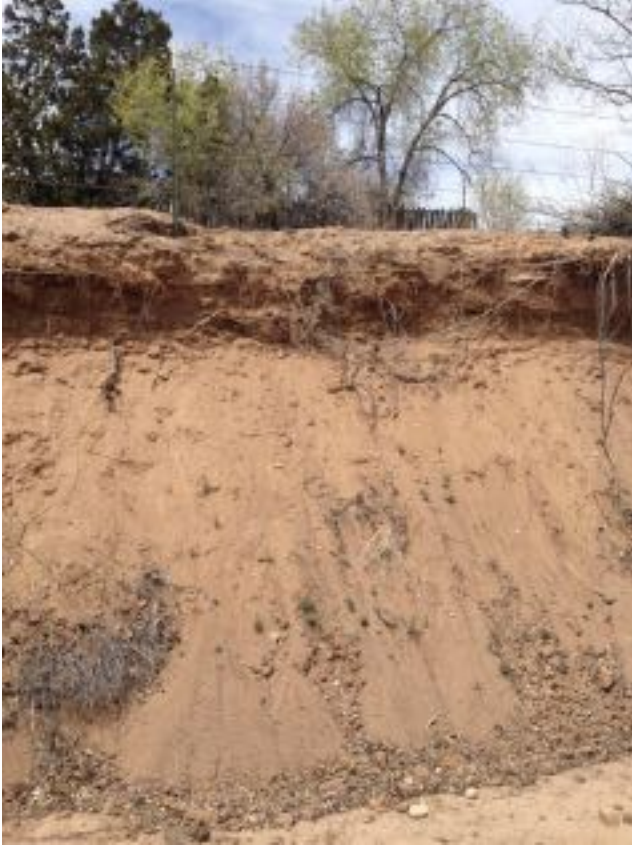
Segment B/Collapsing bank against Rincon de Torreon, Arroyo Torreon, 2016.

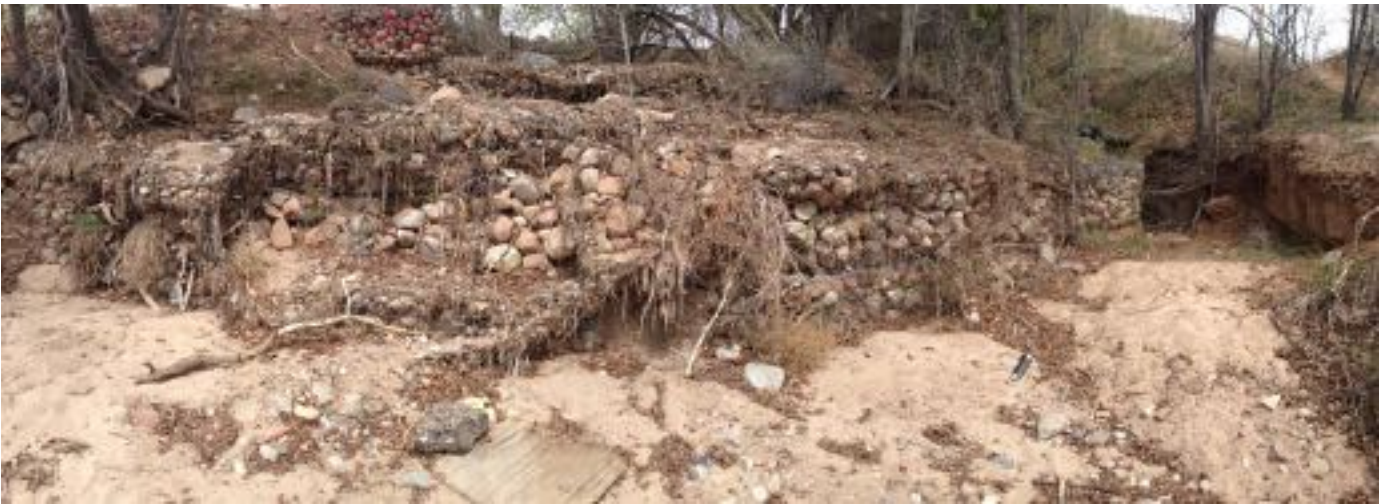
Segment B/Collapsing gabion and bank collapse (far right), Arroyo Torreon, 2016.

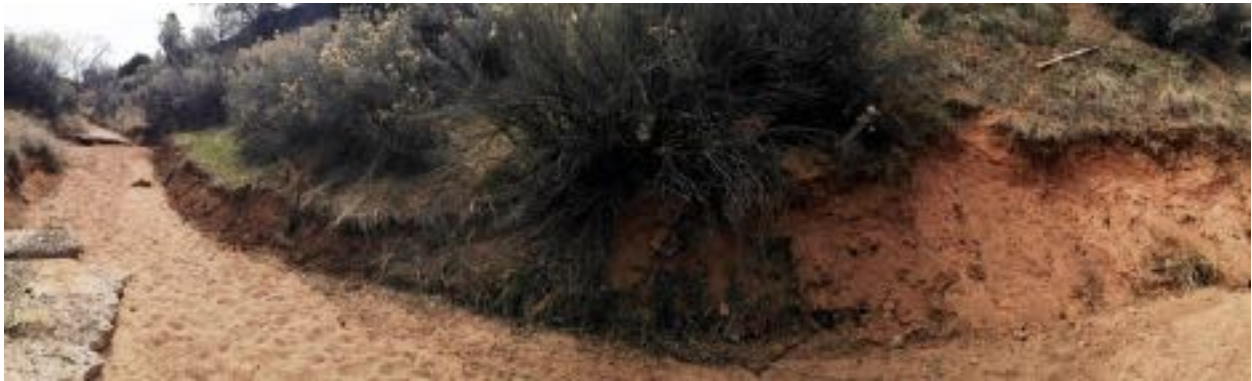
Segment B/ View of upper arroyo with bank deterioration, Arroyo Chaparral ,2016.

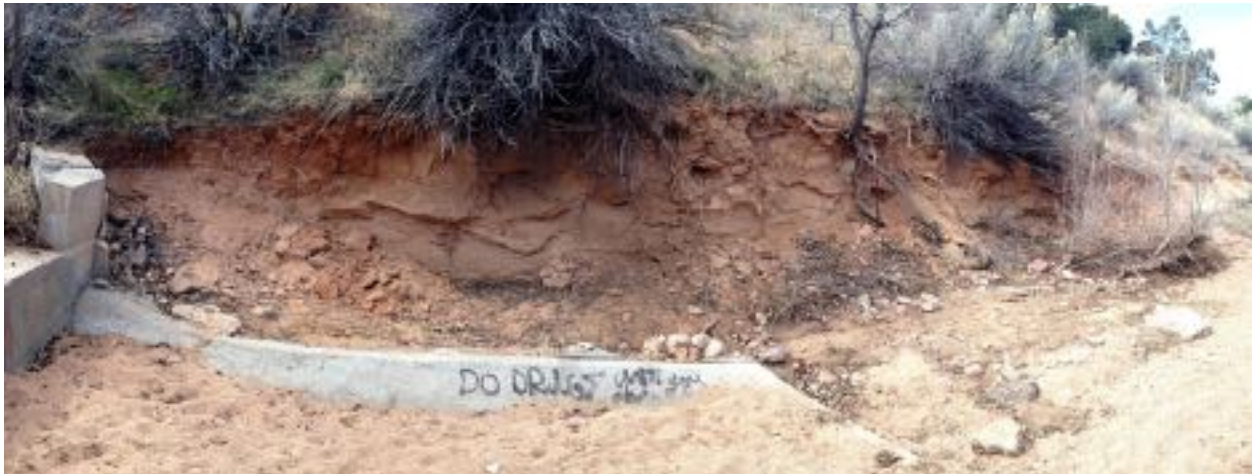
Segment B/ Bank deterioration at check dam, Arroyo Chaparral ,2016.

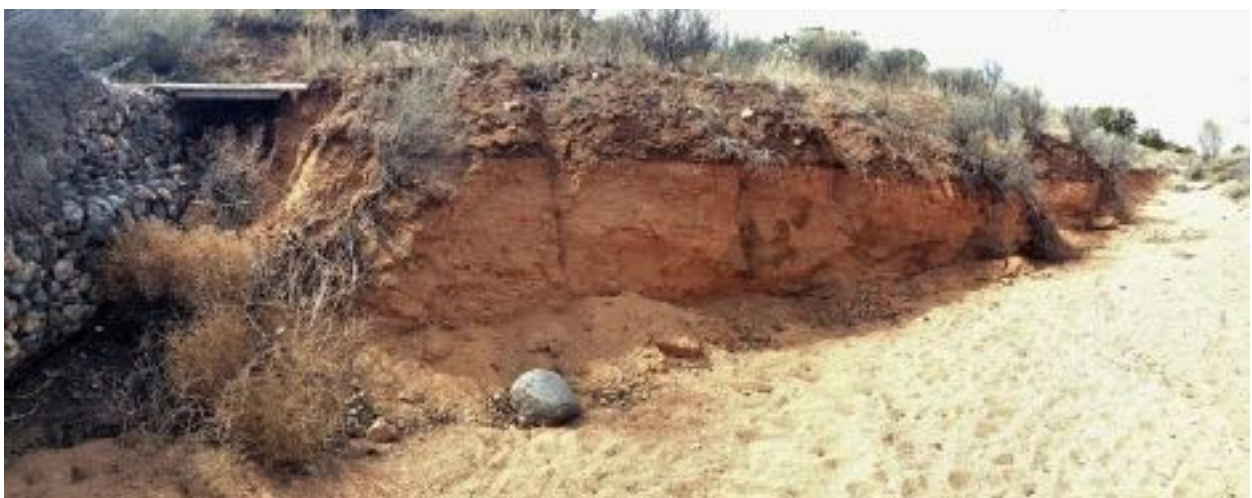
Segment B/ Bank deterioration at gabion wall check dam, Arroyo Chaparral ,2016

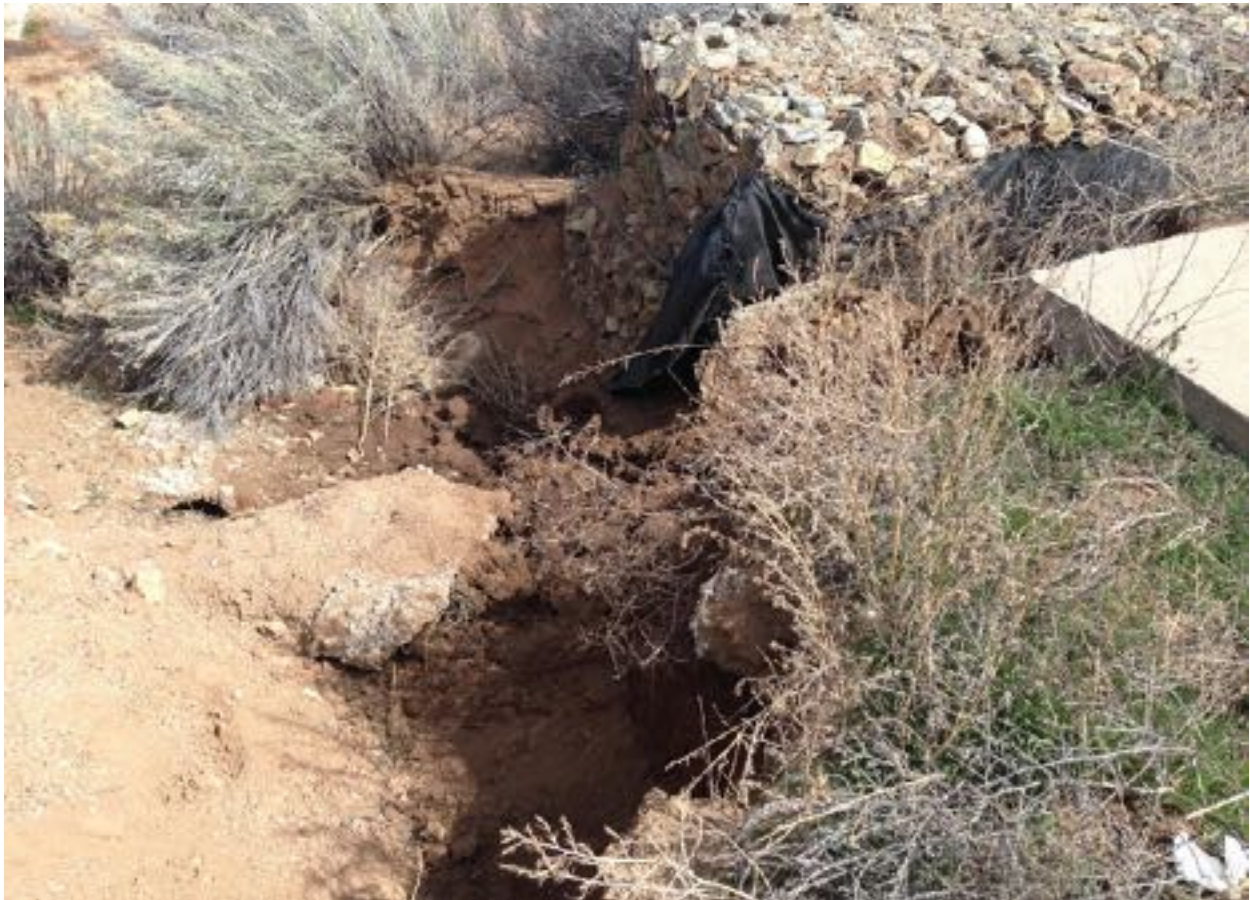
A sudden drop in arroyo bed elevation (head cut) near Chaparral Elementary School has caused storm water to undermine the soil from beneath rip rap and gabion structures placed to protect the arroyo bank and a nearby sewer line should be marked as a high priority area. Raw sewage was found leaking into the bed of the arroyo from this sewer outlet. Past this severely damaged infrastructure the arroyo passes through a highly incised canyon like segment until it flows beneath W. Zia Rd. into the Arroyo de los Chamisos.

Segment B/ Erosion below sewer outlet, Arroyo Chaparral, 2016.

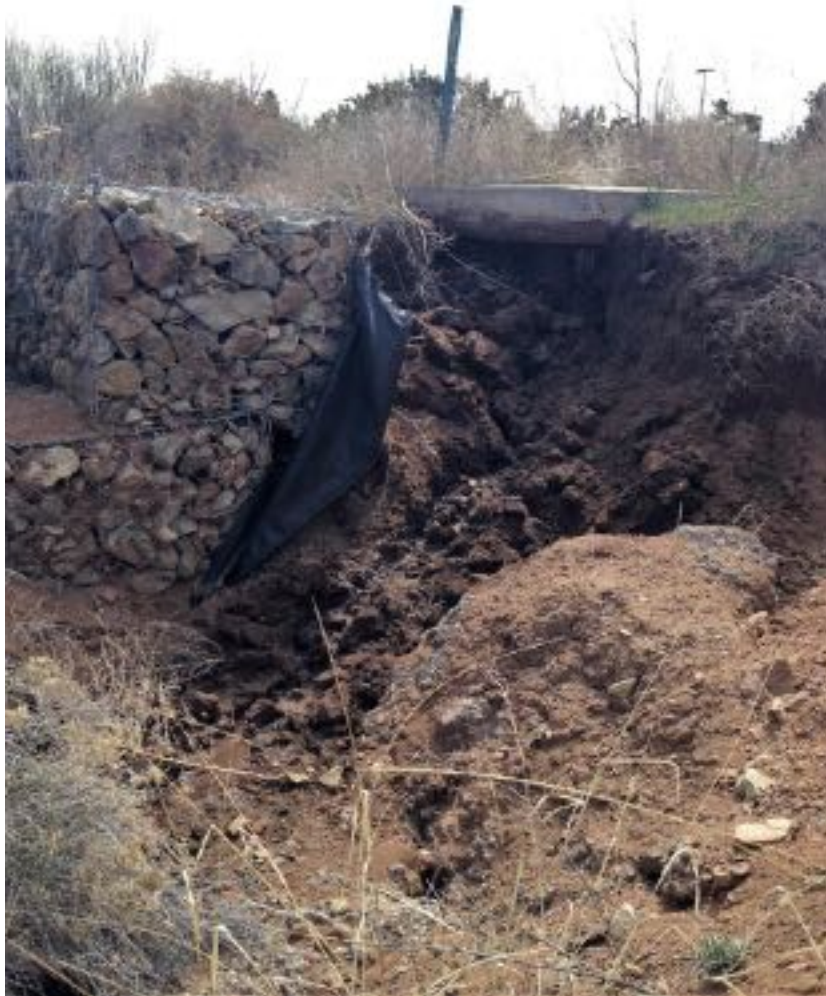
Segment B/ Leaking sewage outlet, Arroyo Chaparral, 2016

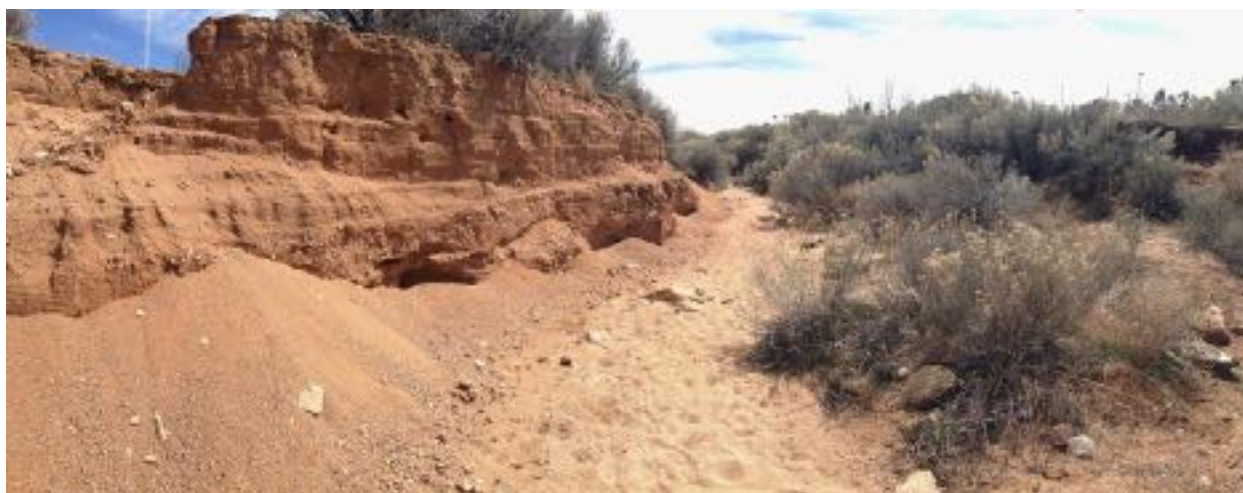
Segment B/ View of banks below leaking sewage outlet, Arroyo Chaparral, 2016
