Arroyo Threat Assessment Surveys of 15 Major Arroyos in the Santa Fe River Watershed

June 21, 2016

Santa Fe Watershed Association

Report to Melissa McDonald, River & Watershed Coordinator, Public Works Dept., City of Santa Fe 2016

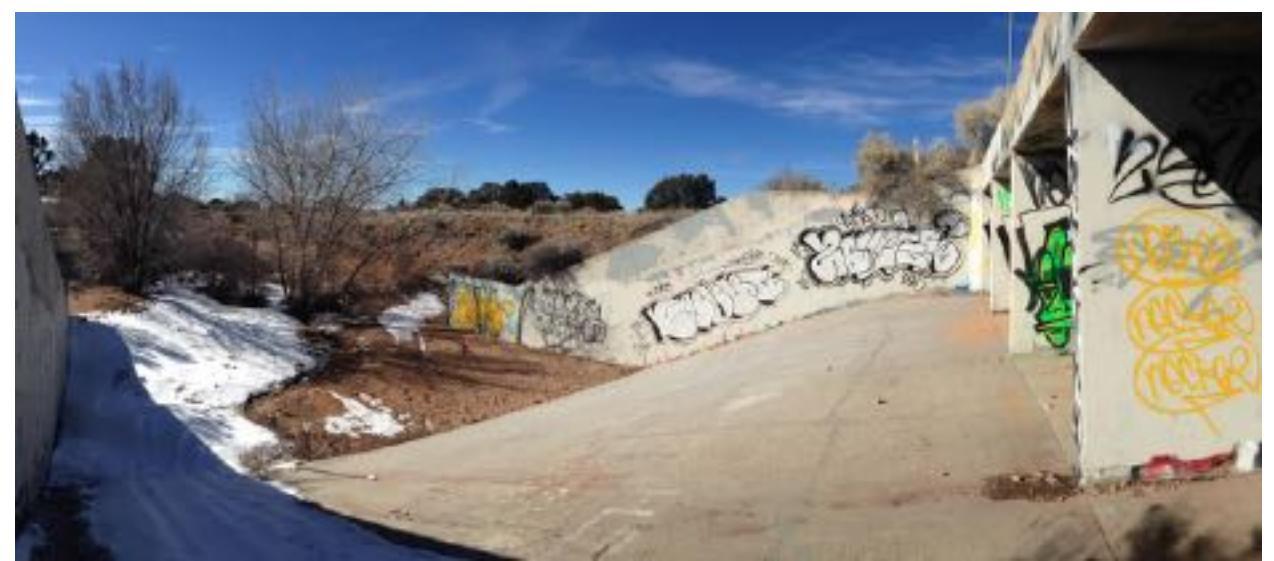
The arroyo flows beneath the Old Pecos Trail Bridge, over a concrete spillway and into a small riparian habitat of willow and cottonwood. Since the instance of bank erosion heightens beyond this growth, the riparian area that is currently stable, could be expanded upon to remediate further destruction of these banks.

Segment C/ Cottonwoods at base of spillway beneath Old Pecos Trail, 2016.

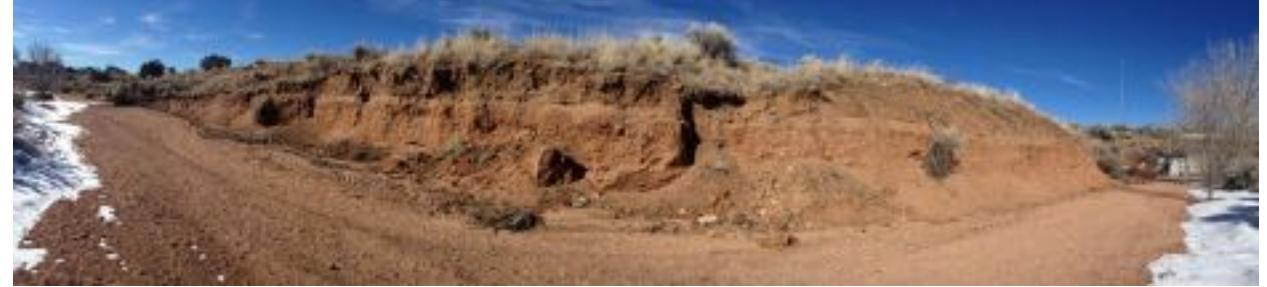
In 2012 the bank erosion was considered severe. As of 2016, storm water continues to erode away 75 feet of a ~15 foot high vertical wall. Located on top this eroded bank is a sewage outlet. Bank loss continues to lessen the distance between this utility and the arroyo.

Segment C/ ~75 feet of eroded bank below spillway, Arroyo de los Chamisos, 2016.

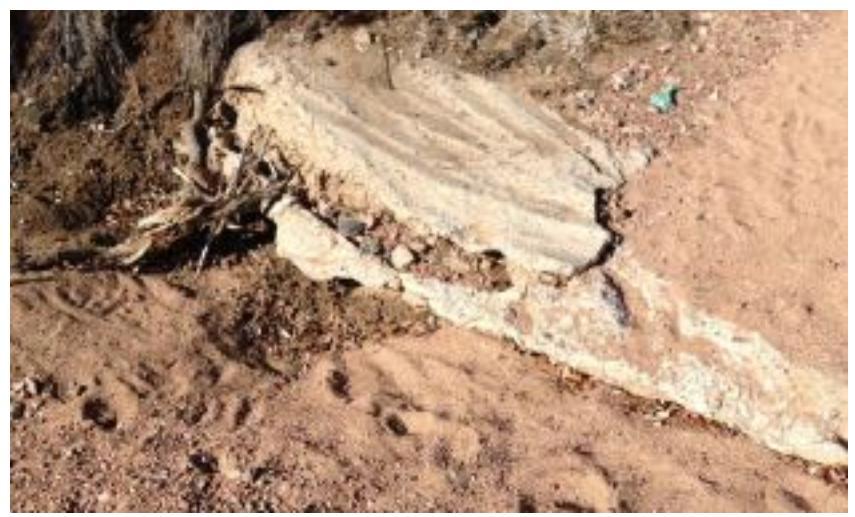
Approximately 1,000 feet downstream from the Old Pecos Trail Bridge, a concrete encased utility appears to be eroding from the bed of the arroyo.

Segment C/ Encased utility line, Arroyo de los Chamisos, 2016.

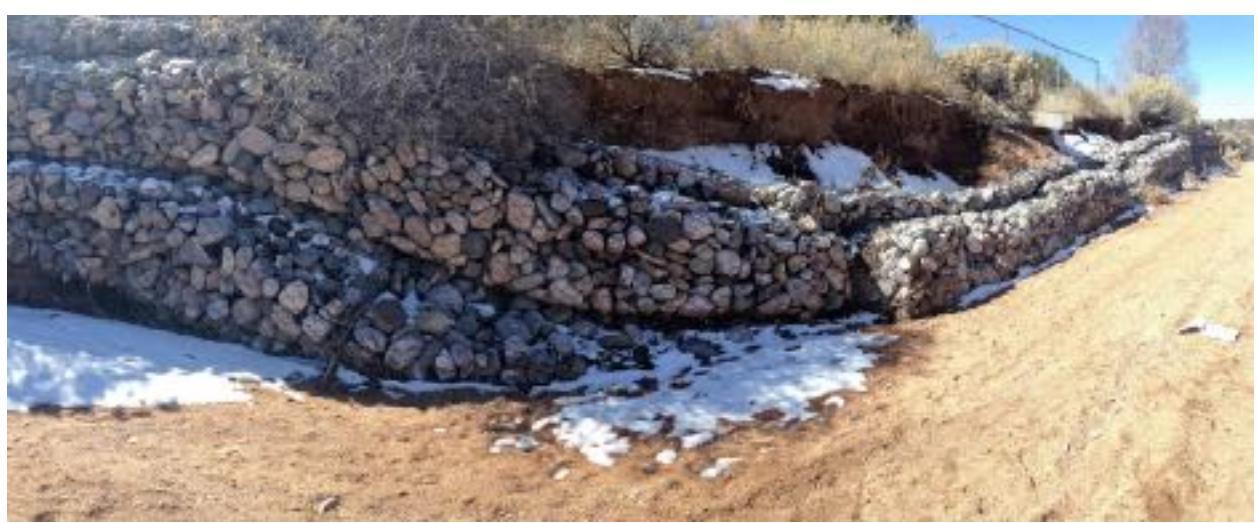
Segment C/Gabion walls coming off arroyo bank, 2016.

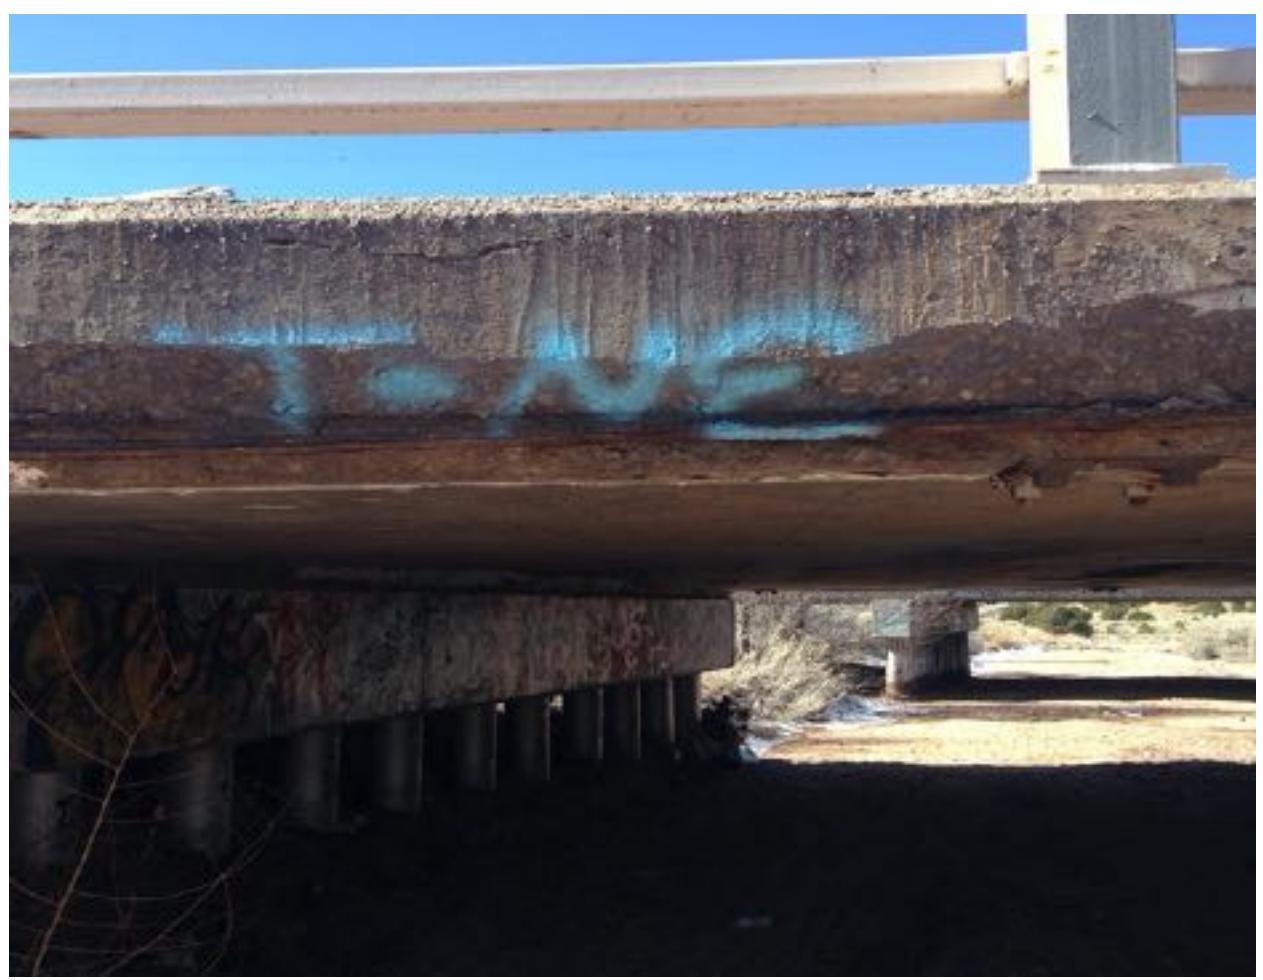
The arroyo passes beneath Botulph Road where the channel widens. Several bridges that serve the Gail Ryba trail system span the Arroyo de los Chamisos. Approximately 175 feet beyond the southern foot bridge, a protective gabion wall has separated from the arroyo bank to sag into the channel. Segment C ends beneath the S. St. Francis bridges. Sometime between 2012 and 2016 the concrete supporting the roadbed has become rotten enough below the guardrails to expose rebar.

Segment C/ S. St. Francis Bridge with damage in 2016, Arroyo de los Chamisos, and 2016.

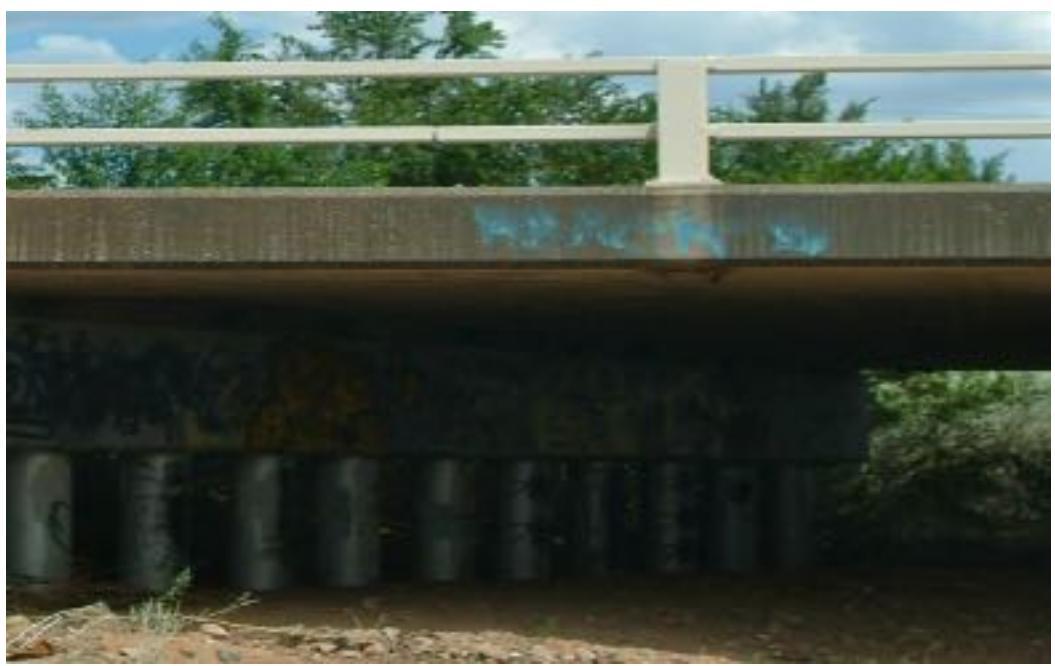
Segment C/ 2012 S. St. Francis Bridge same location as above photo, 2012 Arroyo de los Chamisos.

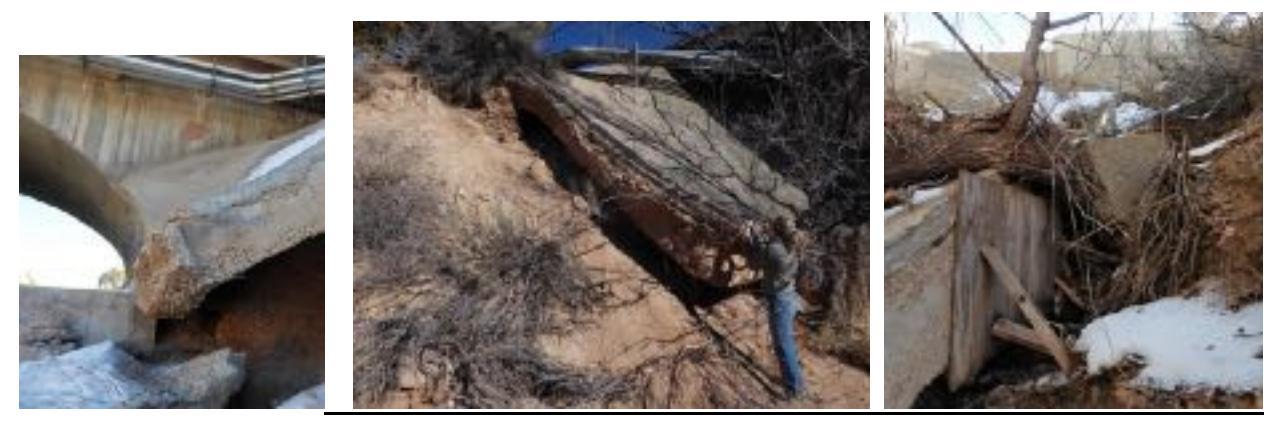
Notes: The arroyo segment has been severely incised due to poor drainage, soil type, natural and artificial constrictions. The height of an intermittent system of vertical walls increases as the arroyo channel drops in elevation. The corridor of these highly eroded vertical walls begins about 145 feet below the Santa Fe Rail Trail. The longest, continual, vertical wall system in the arroyo is approximately 1,300 feet in length. It is found in here. Although it is the longest corridor, the 1,150 foot section of vertical bank between the two Vo-Tech bridges is the most dangerous regarding trail safety and infrastructure stability.

Segment D/ Vo-Tech Bridges with examples of eroding banks and footings, Arroyo Chamisos, 2016.

Improvements since 2012 have helped protect sewage lines and minimized the impact of storm water in some areas. Segment D of Arroyo de los Chamisos is a high -risk area in much need of remediation. Immediate corrective action to the vertical banks along the Arroyo Chamisos trail between the Vo-Tech bridges is recommended.

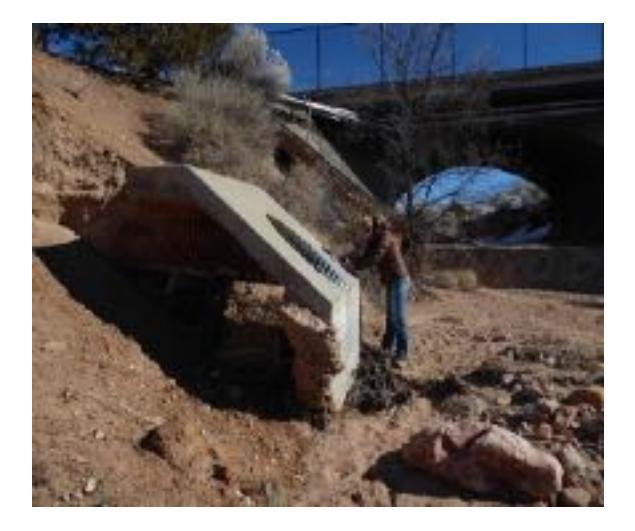
Segment D/ Bank erosion, Arroyo de los Chamisos, 2016.

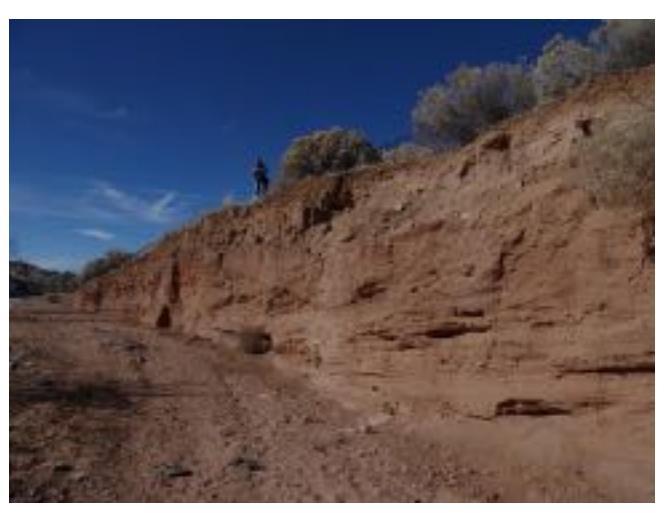
Segment D/ Corridor of vertical banks, Arroyo Chamisos, 2016.

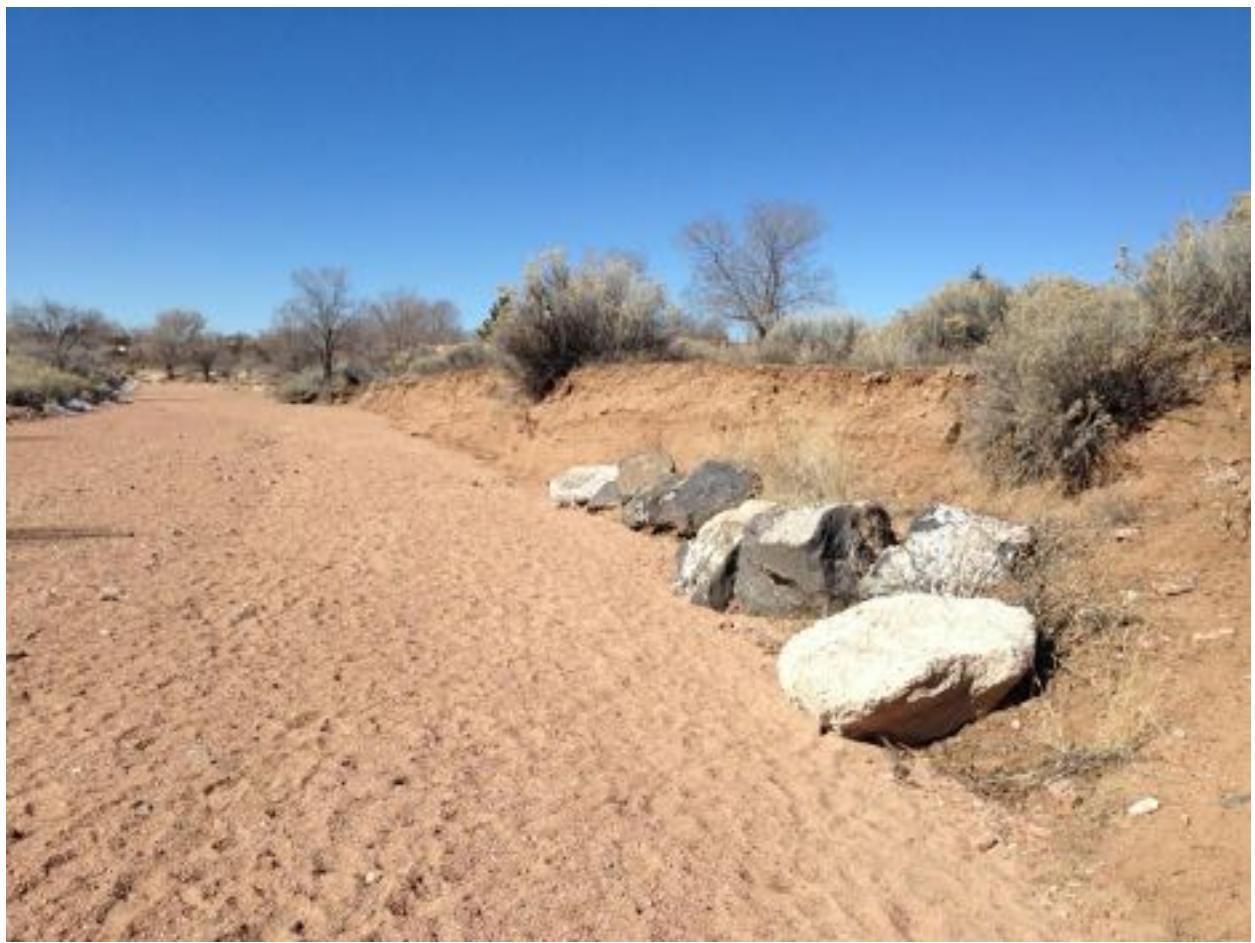
Notes: The arroyo in segment E is broader than Segments C and D. As expected, erosion continues throughout the entire length of the Arroyo de los Chamisos. Natural obstructions since 2012 have entered the arroyo bed and will affect the flow of storm water. The narrowest part of the entire Arroyo de los Chamisos is located in this segment. It measures roughly 20 feet across.

Segment E/ Erosion along arroyo bank, Arroyo de los Chamisos, 2016.

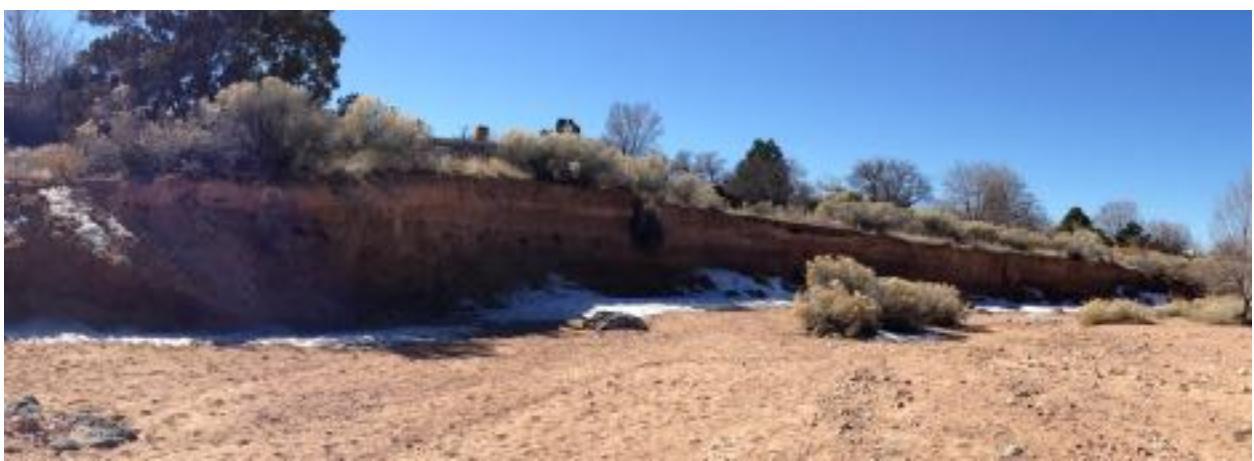
Notes: The arroyo continues to be broad in nature maintaining this characteristic through to Governor's Miles Road. Below the Camino Carlos Rey Bridge the damaged rip rap of 2012 is being replaced in 2016. Storm water has increased the number of vertical banks in this section. The Ave de Las Campanas Bridge suffers from deteriorating concrete sides.

Segment F/ Bank erosion, Arroyo de los Chamisos, 2016.

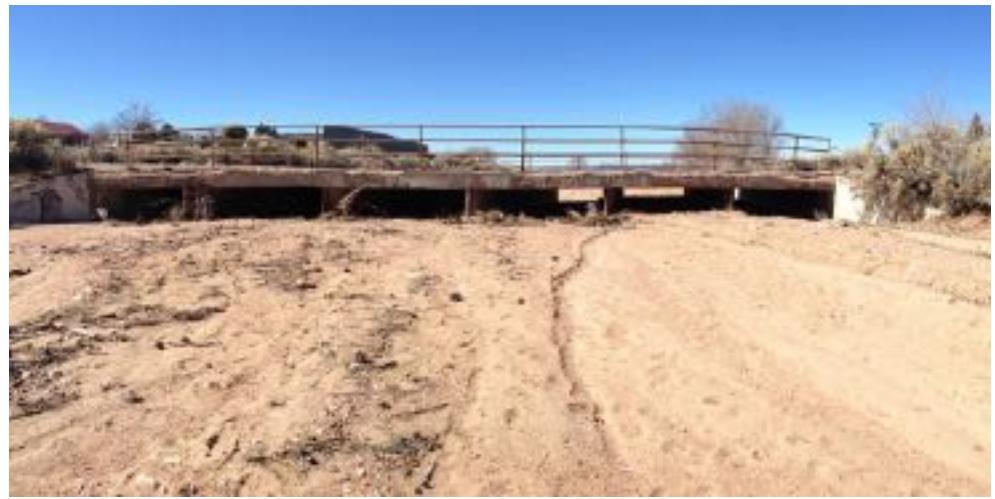
Segment F/ Rotting concrete on Ave. de las Campanas Bridge, Arroyo de los Chamisos, 2016.

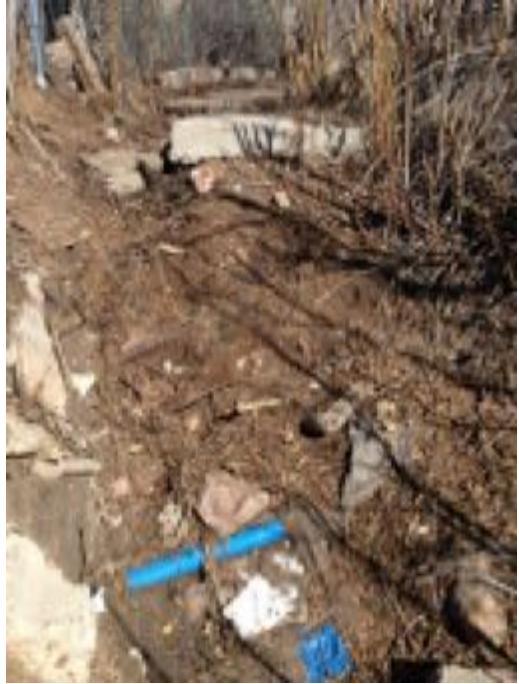
Notes: Between the Ave. de Las Campanas Bridge and the Rodeo Road Bridge several high cut banks exist that continue to threaten private property near the Kachina Heights subdivision. Rip rap used to stabilize the arroyo banks is undercut. Since 2012, a public utility, 300 feet upstream from a state maintenance yard has emerged from the arroyo bank. The chain link fence at this facility is flush with the arroyo bank. Also a steel culvert extends further into the arroyo than observed in 2012. It is in danger of being damaged by storm water. Active transient use is common in this area thus creating unusually large amounts of trash to be prevalent in this segment. A concrete culvert beneath Camino de los Arroyos and Vegas Verdes Road and the west side over pass of Rodeo Road Bridge are continually inhabited producing biohazards, trash and safety issues to the public. Part of this section of the arroyo has been adopted by The Masters Program an early college charter high school and sponsored by Sam's Club.

Segment G/ Exposed utility pipe, Arroyo de los Chamisos, 2016.

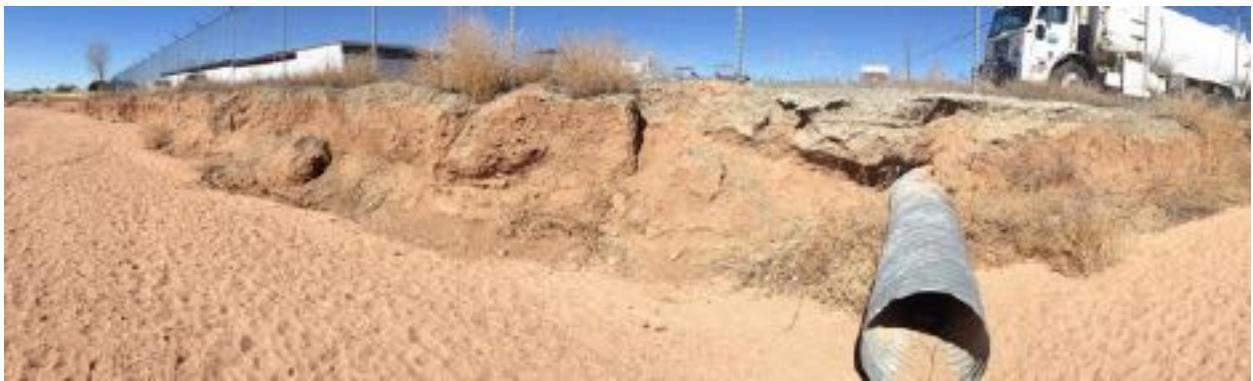
Segment G/Bank erosion at State facility, Arroyo de los Chamisos, 2016.

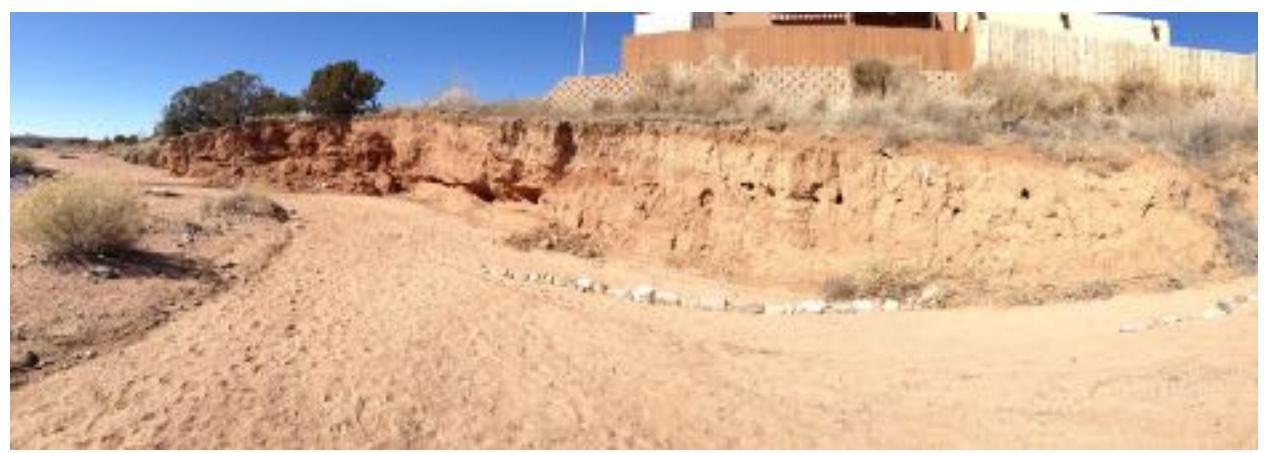
Segment G/ Erosion below private property in Kachina Heights, Arroyo de los Chamisos, 2016.

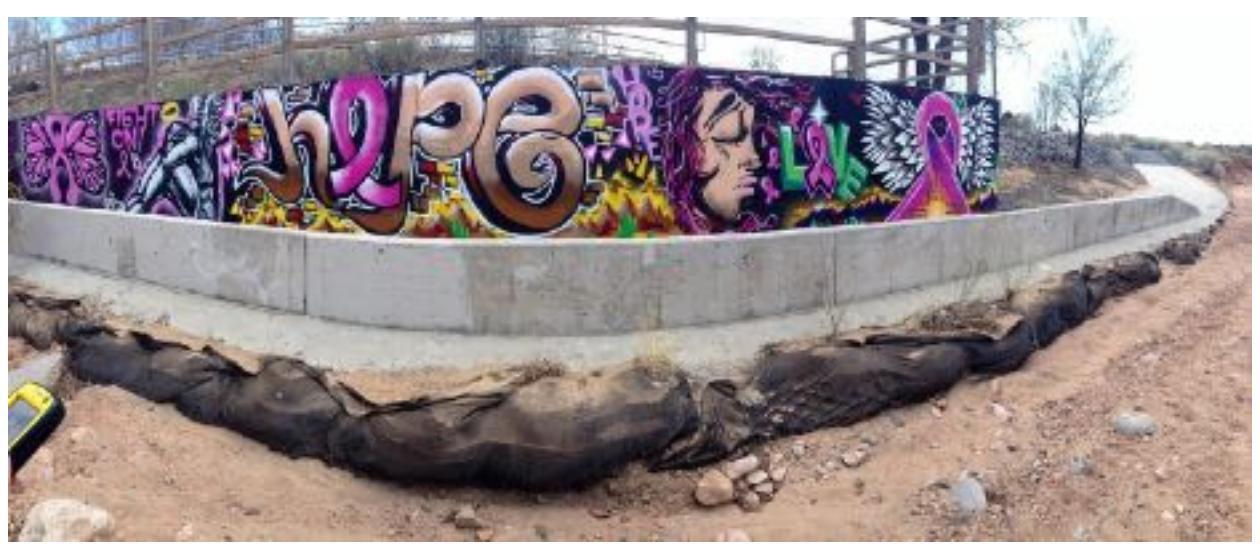
Notes: The Arroyo de los Chamisos bike trail below Rodeo Road Bridge has suffered from more erosion since 2012. Soil is eroding from the footing of the foot bridge closest to the Villa Linda Park. Also the grate of a large culvert located near the mall parking lot is restricted by a huge volume of trash. Another drainage ditch flowing from Santa Fe Place into the Arroyo de los Chamisos has bypassed a check dam control point to erode a large channel into this arroyo. Storm floods since 2012 have removed a considerable amount of sediment from the base of a gabion wall. The last point of erosion from a storm drainage pour off pad belonging to a tenant of the auto park has carved a deep channel into the arroyo bank. The arroyo continues to be a popular place for dumping trash. More transient camp sites were encountered throughout this arroyo segment. This arroyo segment is heavily used by off road vehicles. There are many places for vehicle access from the Governor Miles Road Bridge to the Villa Linda Park as noted in 2012.

Segment H/Erosion threatens sidewalk, Arroyo de los Chamisos, 2016.

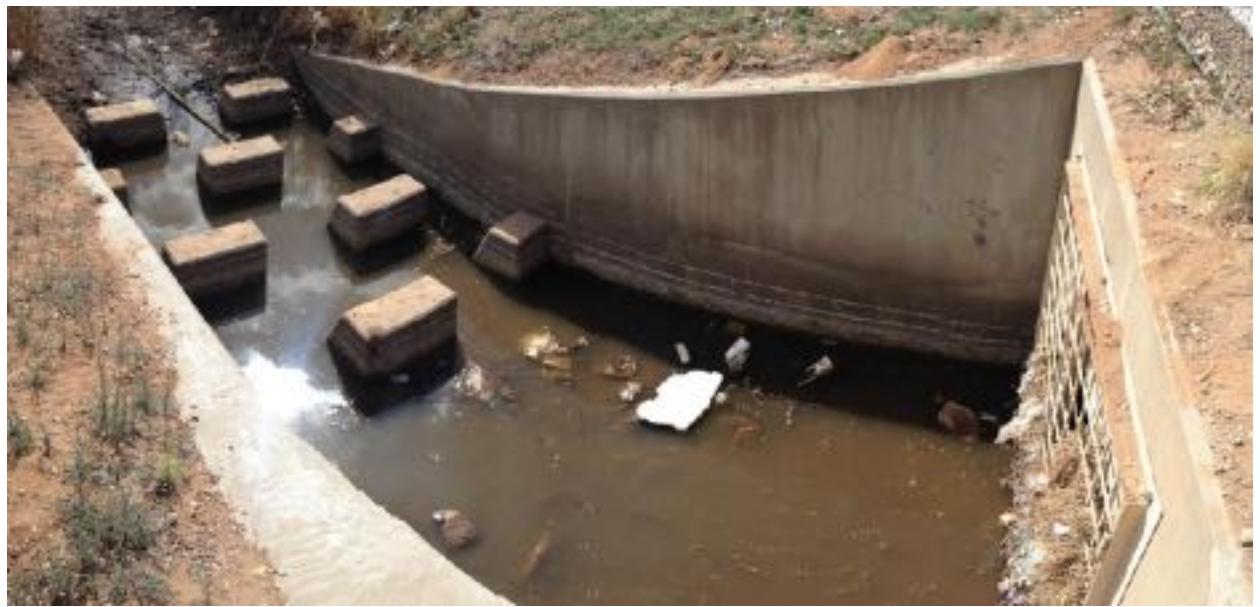
Segment H/Culvert obstructed with trash, Arroyo de los Chamisos, 2016.

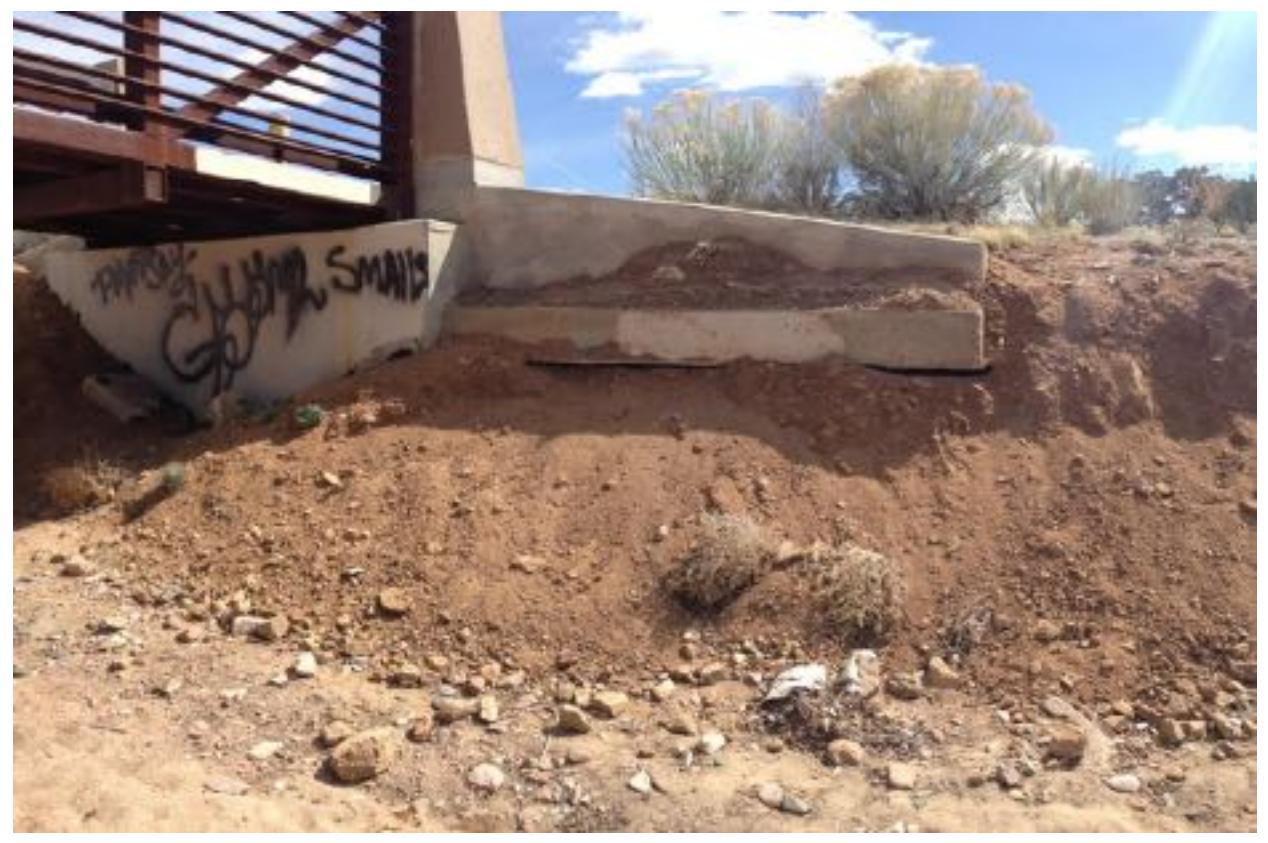
Segment H/Pedestrian bridge with exposed footing, Arroyo de los Chamisos, 2016.

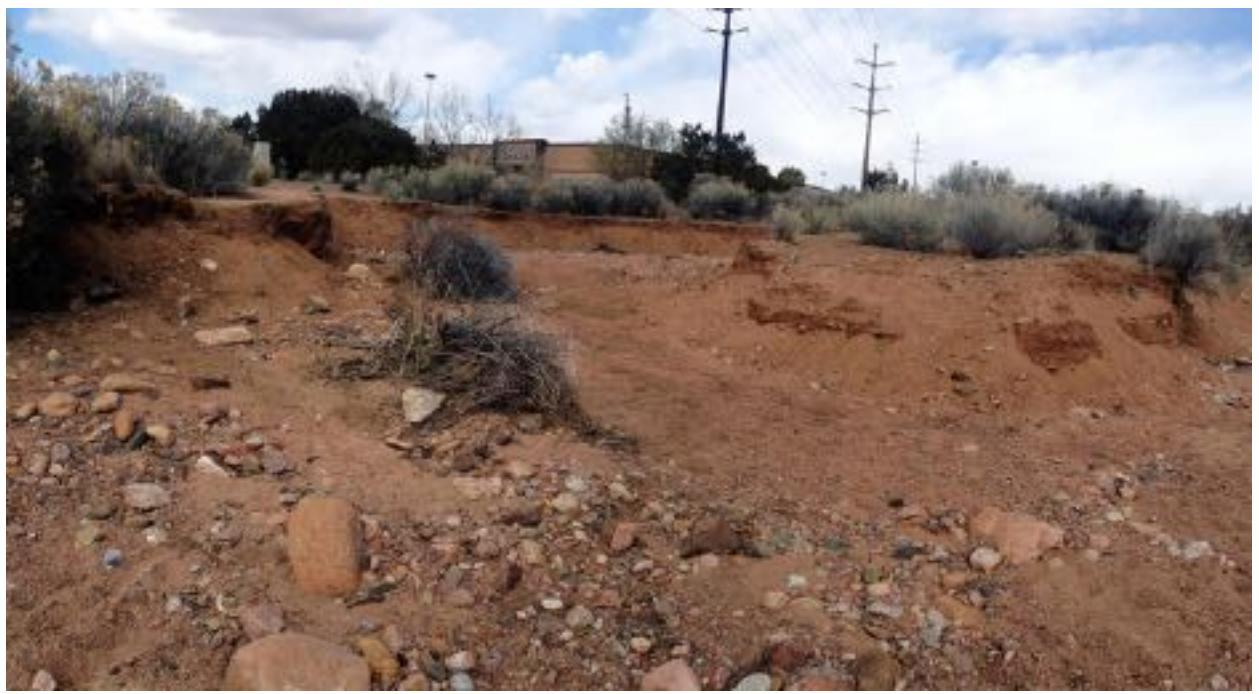
Segment H/Side channel bypasses gabion wall, Arroyo de los Chamisos, 2016.

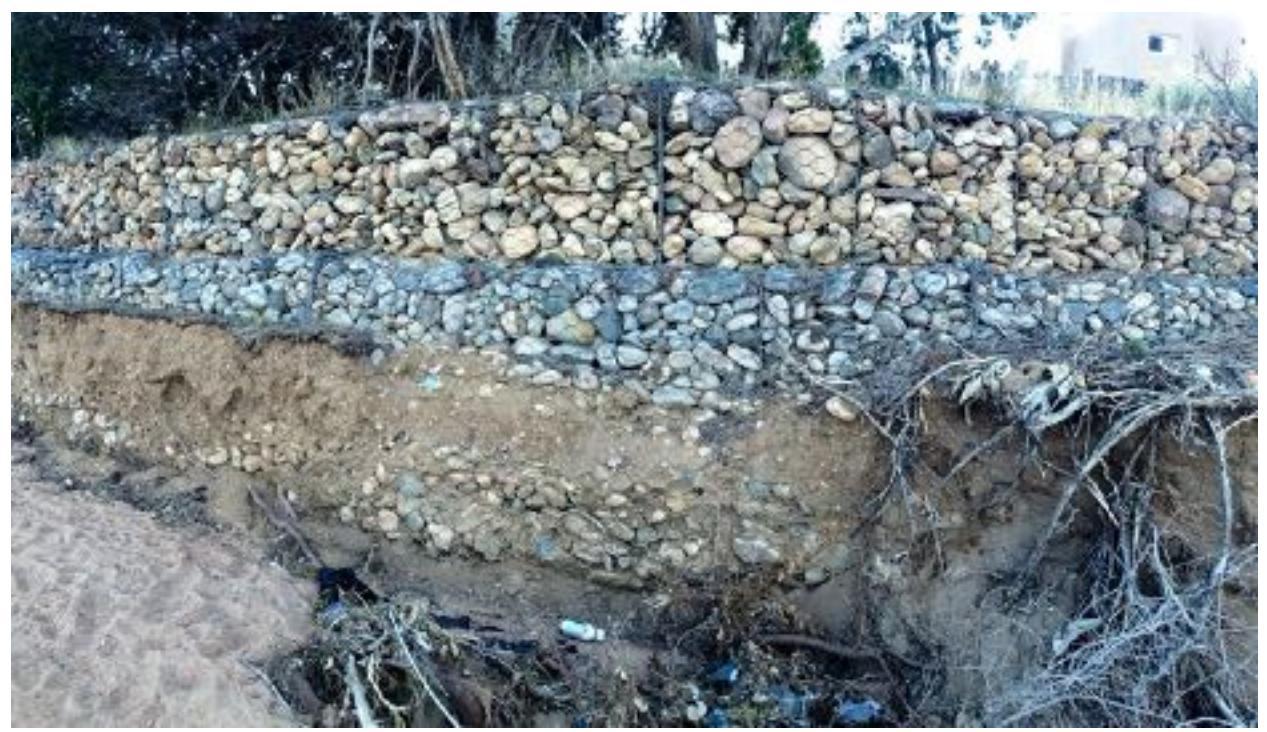
Segment H/ Illustration of sediment fluctuations. Sediment levels remain intact against gabion wall at far right of photo while left and center sediment no longer exists, Arroyo de los Chamisos, 2016.

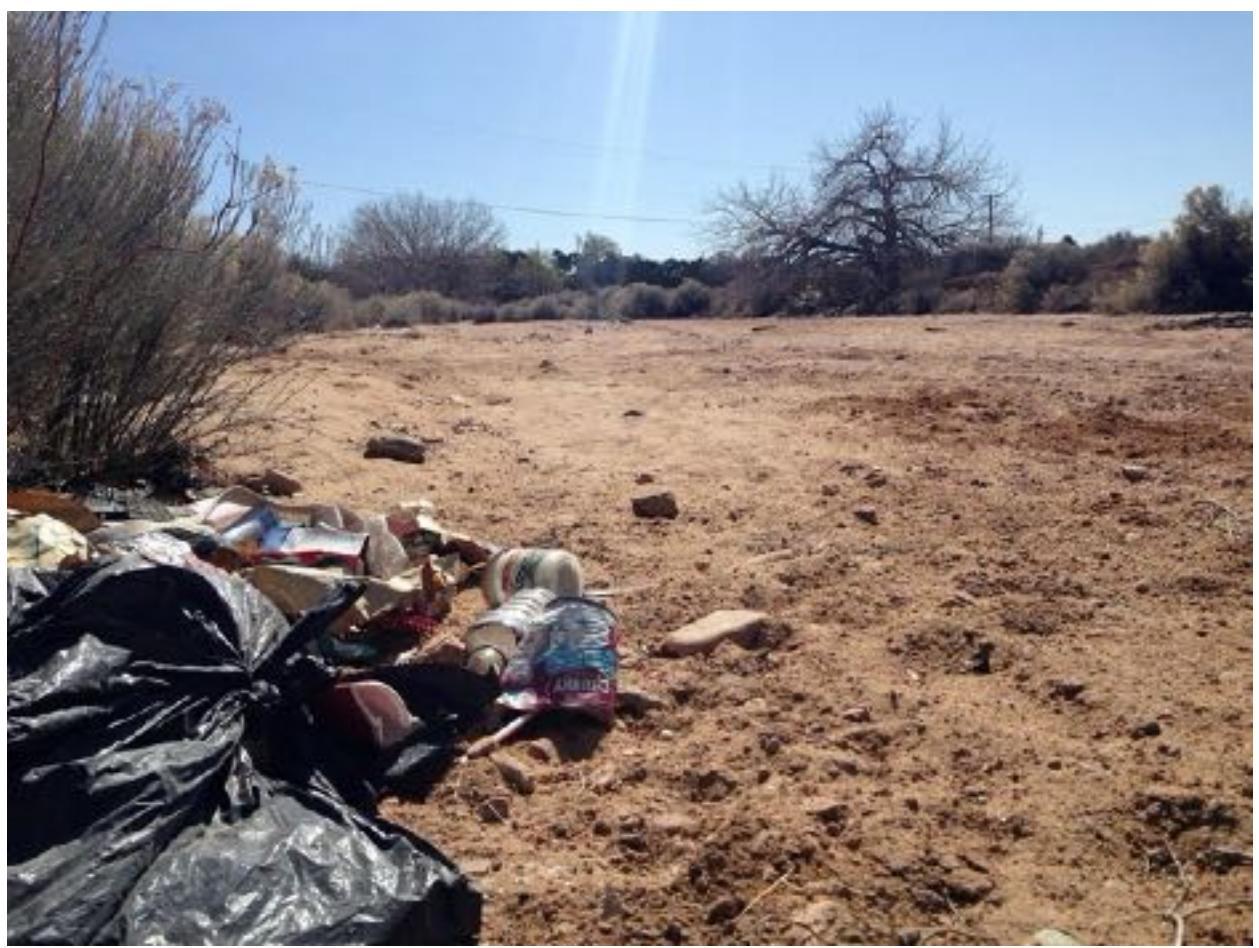
Segment H/ Trash a common presence from Segment G through Segment H, Arroyo de los Chamisos, 2016.

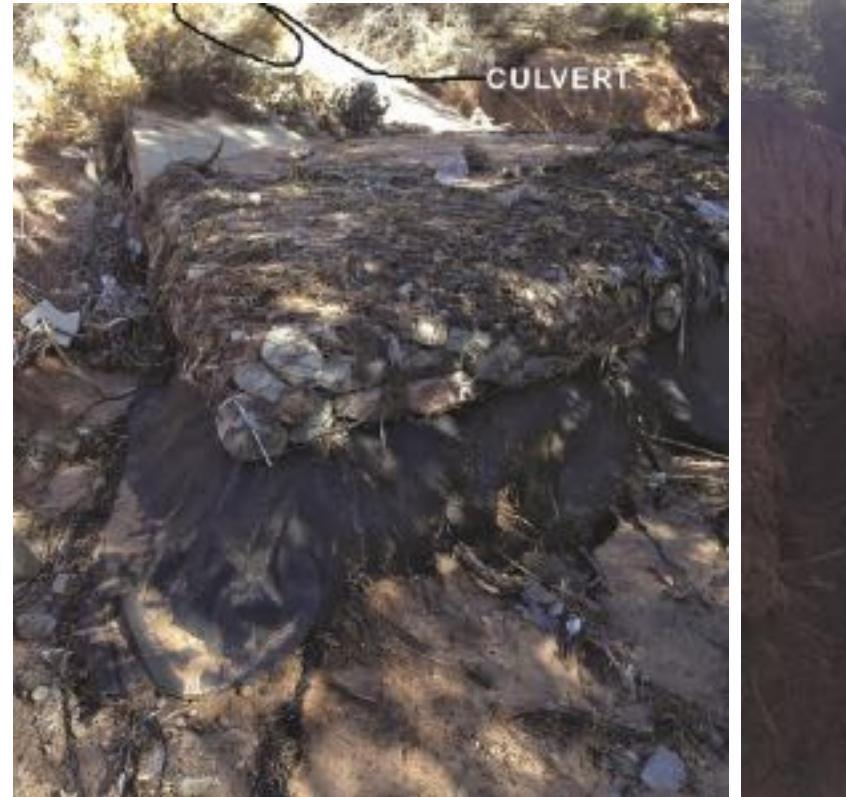
Notes: The "head" of the Rosario is highly impacted by two sources of storm runoff coming from the surrounding landscape and the culvert placed at the base of a steep grade that supports Hwy. 285 south. As a result, drainage infrastructure and the arroyo channel itself are negatively impacted. The drainage system consists of a steel culvert, concrete footing surrounding the culvert, a grate, and a rip rap mat at the base of the outlet. Earth beneath the concrete footing and rip rap mat system is eroding rapidly. Since 2012, a significant change in the arroyo channel and the elevation of these two systems is apparent. The arroyo channel is ~ 2 feet below the rip rap mat's original elevation. Remediation measures are highly recommended since further erosion to these important components will bring about structural failure in the culvert which will adversely affect drainage from both the arroyo and the road bed of Hwy. 285.

Segment A/ Erosion beneath rip rap mat, Arroyo Rosario, 2016.

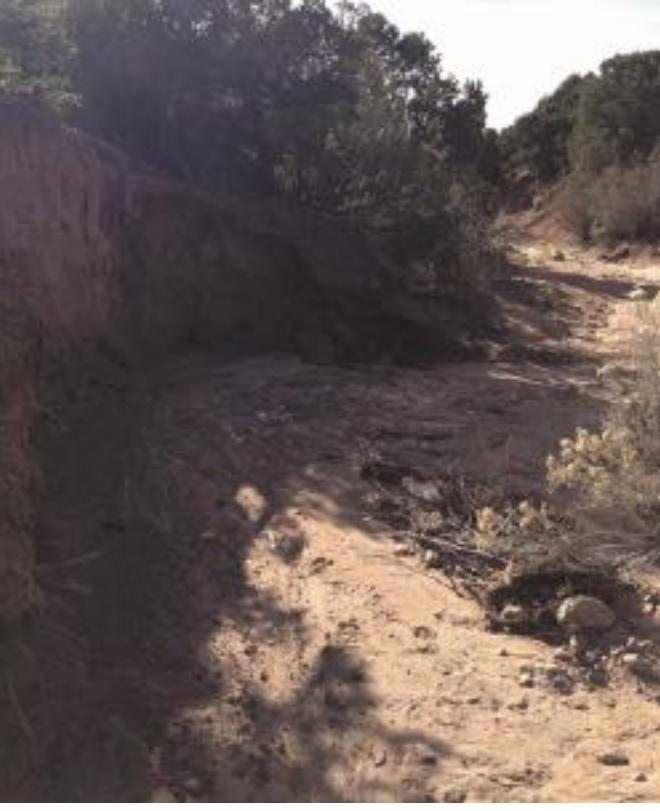
Storm runoff has significantly changed the characteristics of this area of the Arroyo Rosario. Common to this area are constrictions, deep incisions, collapsed banks that have left natural obstructions such as trees that have caught debris, vertical walls and tight meanders in the arroyo. Erosion along the western banks in this area is common.

Segment A/ Eroded bank, Arroyo Rosario, 2016

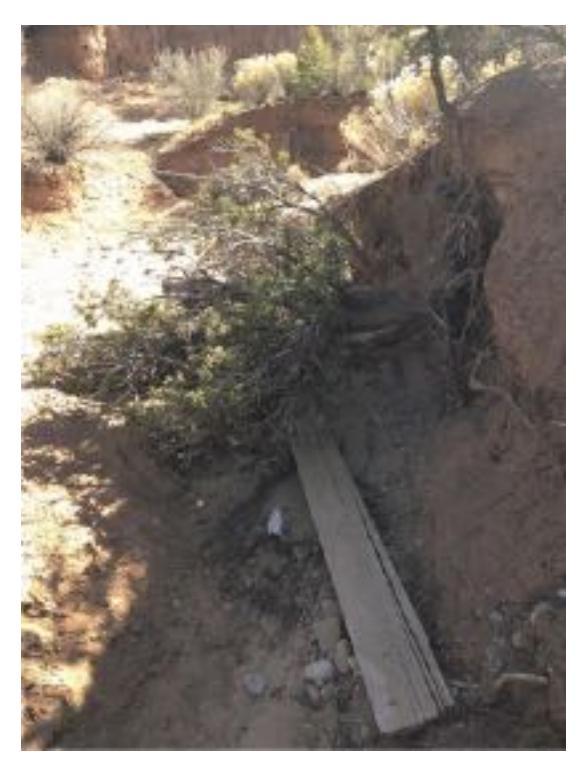
Segment A/ Tree blocking channel, Arroyo Rosario, 2016

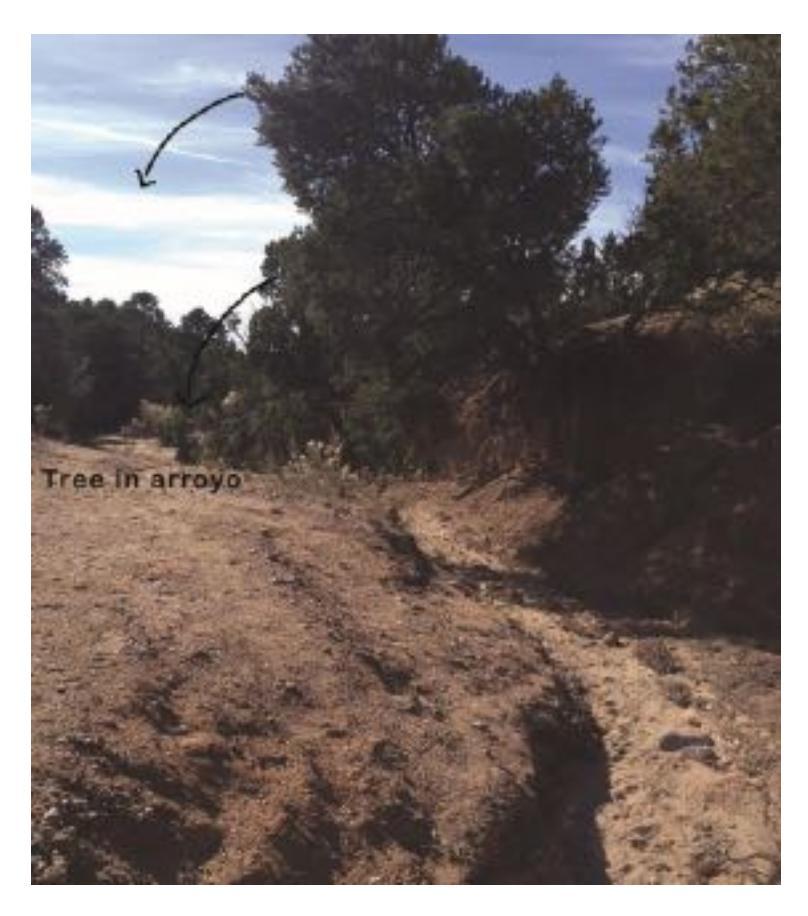
Notes: The arroyo channel in part of segment B continues to have deep incisions and tight meanders before it flows into segment C. As shown in Figure 6, banks are collapsed bringing trees into the channel. As debris is caught in the trees and builds a barrier the arroyo may back up and cause flooding.

Segment B/Trees become natural barriers, Arroyo Rosario, 2016.

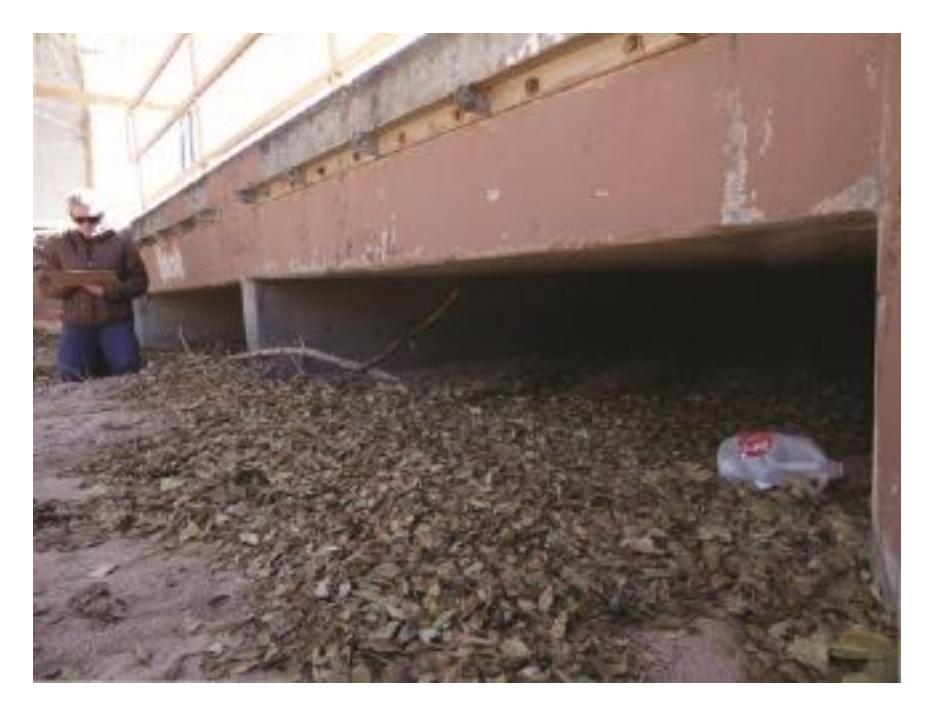
Notes: Notable areas of concern appear in close proximity of the Paseo de Peralta box culvert bridge. The box culvert itself continues to gain sediment from each storm event. Two feet of head room exist between the sandy bed of the arroyo and the top of the box culvert. Next to this structure is a concrete, 18", culvert extremely full of sand. There are approximately 7 "of head room left in this culvert. Another condition affecting this same culvert is erosion around its footings. Since the original rip rap barely remains, pedestrian traffic and water is wearing away the surrounding bank. Lastly, on the east bank of the arroyo above these places is a storm water outlet into the arroyo. Here, the culvert is recessed into the arroyo bank. The outlet is blocked by brush piled above and across it. This segment of the arroyo Rosario has been adopted by the Historic St. Catherine Neighborhood Association through the Santa Fe Watershed's Adopt and Arroyo program.

Segment E / Paseo de Peralta box filled with sand, Arroyo Rosario, 2016.

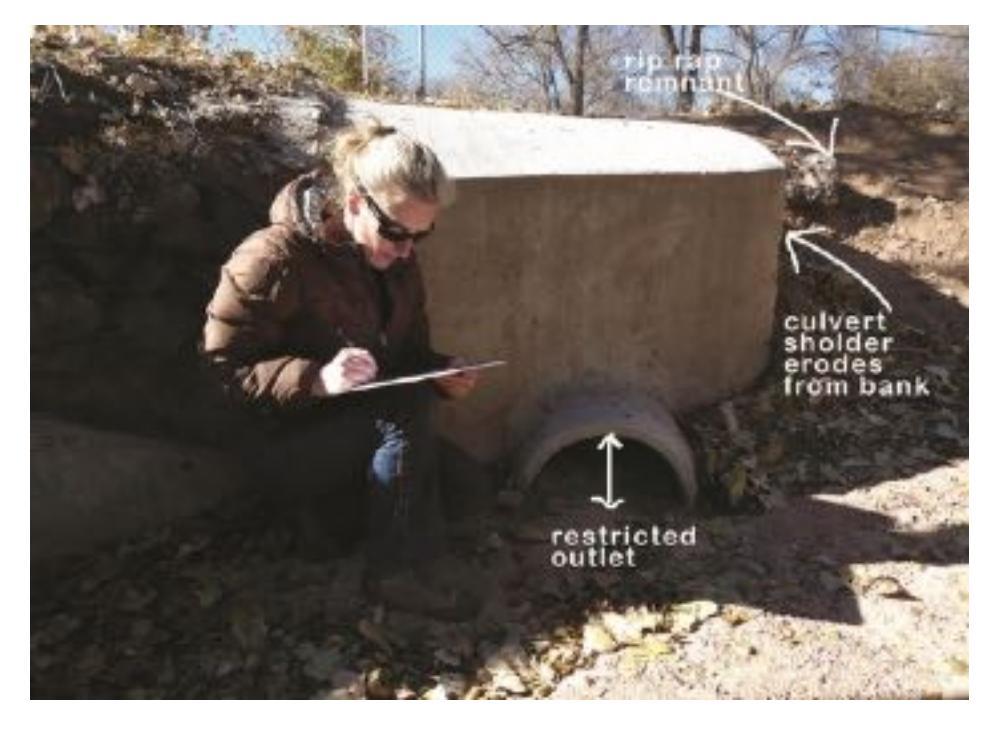
Figure 1 Segment E/ View of restricted outlet and eroded west bank,2016

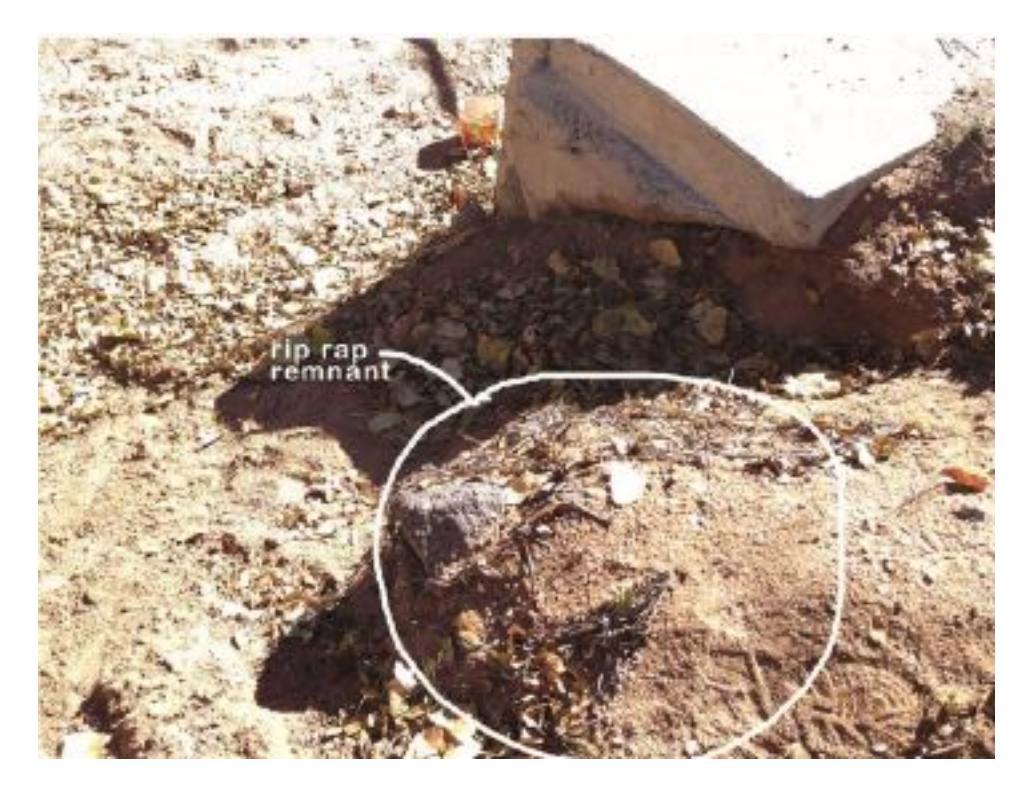
Figure 2 Segment E / Birds eye view of eroded west bank and culvert shoulder, 2016

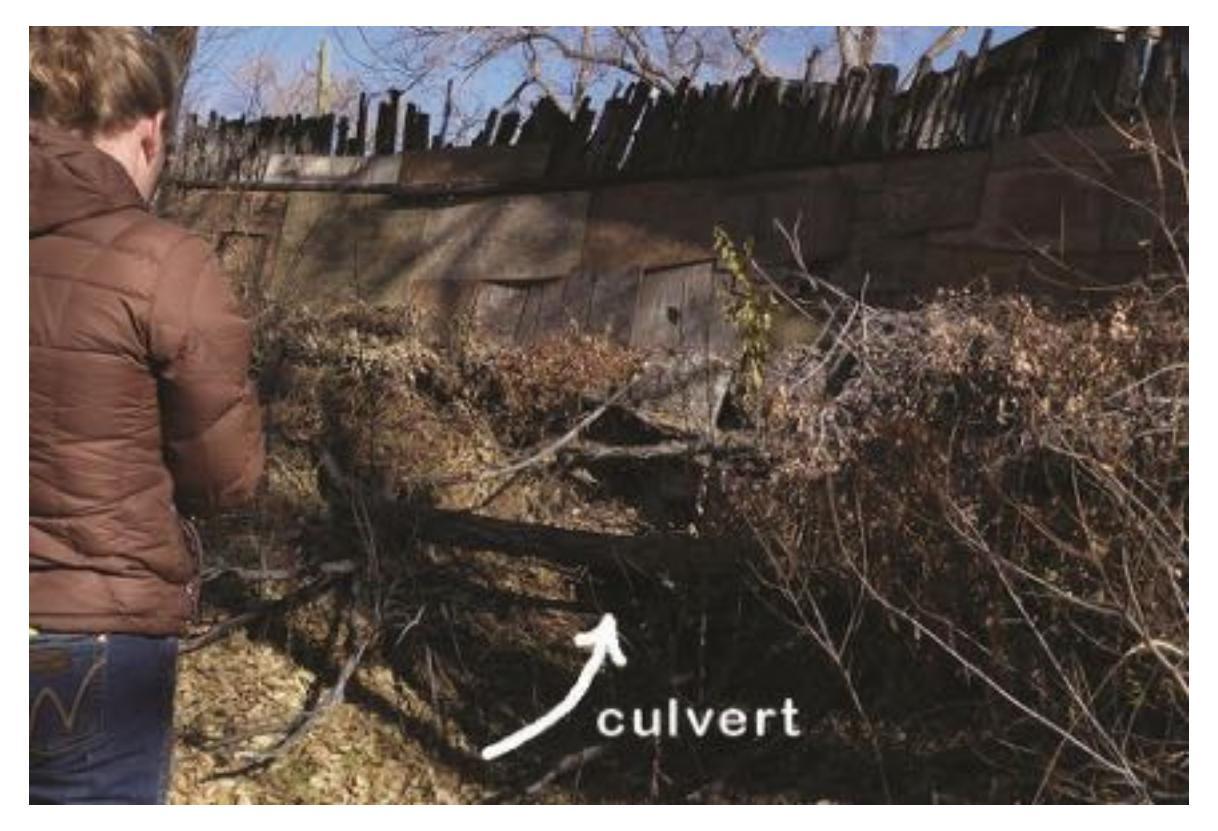
Segment E / East bank recessed, blocked storm outlet, 2016.
