Arroyo Threat Assessment Surveys of 15 Major Arroyos in the Santa Fe River Watershed

June 21, 2016

Santa Fe Watershed Association

Report to Melissa McDonald, River & Watershed Coordinator, Public Works Dept., City of Santa Fe 2016

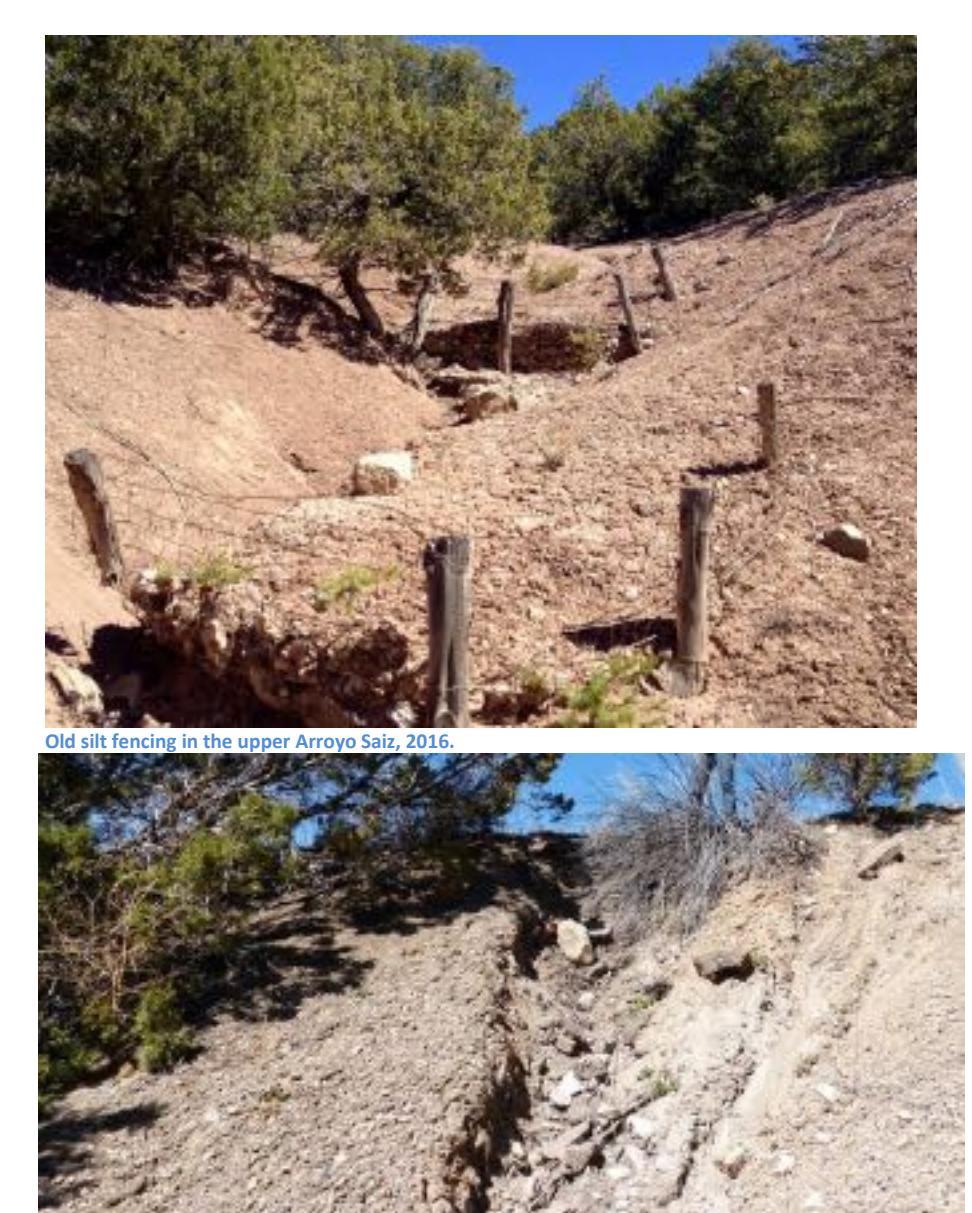
Notes: Arroyo Saiz begins at the intersection of Gonzales and Hyde Park roads. The main channel is fed by a network of small tributaries that flow through piñon/juniper. Great attention in the past was put into this network of incised drainages running both parallel and opposite of Hyde Park Road by the placement of silt fences and superbly built stone check dams. Storm water run-off from Hyde Park road is eroding the road shoulder (arroyo bank) noted in 2012.

Erosion of f Hyde Park road into the Arroyo Saiz, 2016.

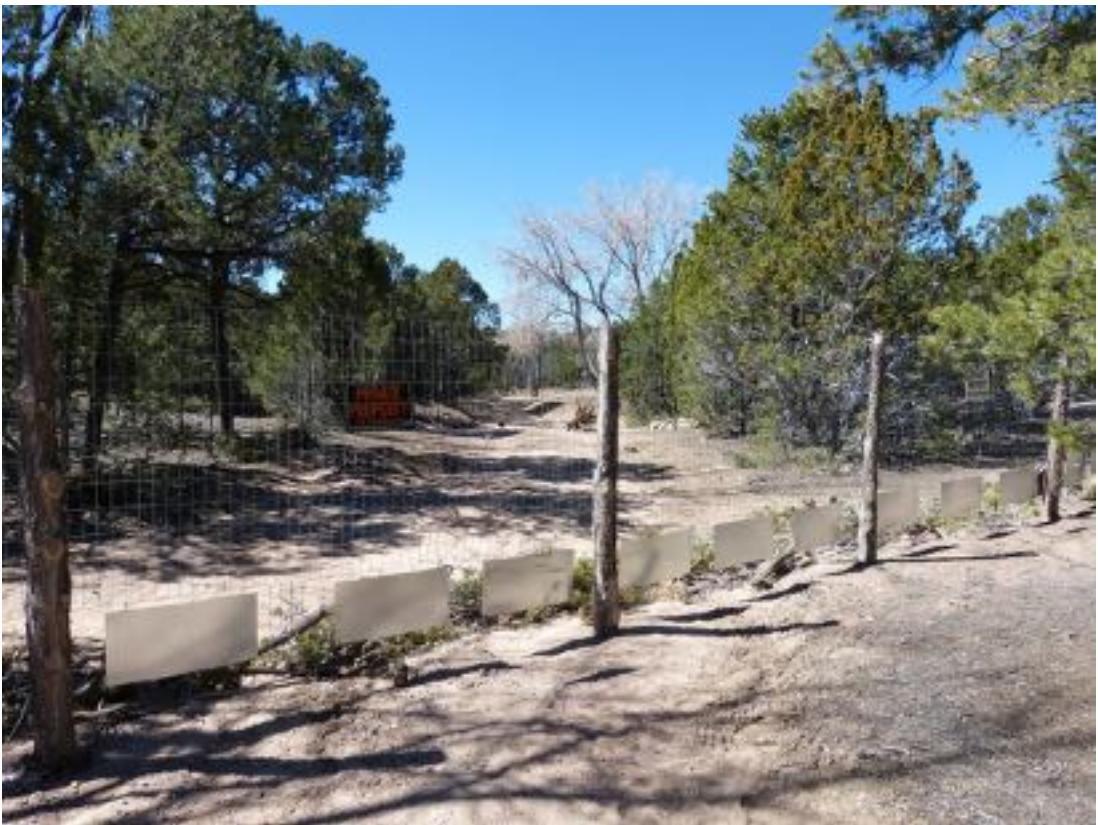
Two separate areas in the arroyo have been fenced off. These fences span the arroyo which may impede storm water flow and are questionable regarding public/private right of ways.

Fencing across the Arroyo Saiz,2016.

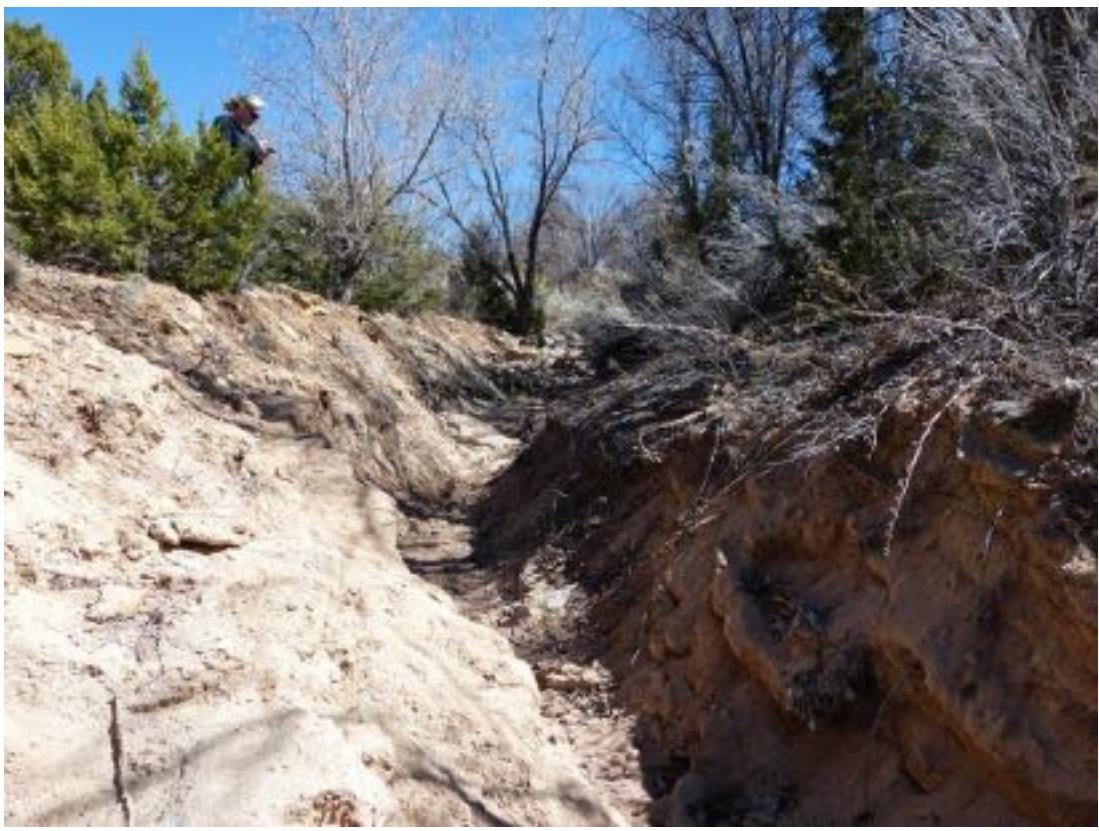
Below the last Avenida Primavera crossing the Arroyo Saiz passes through the City Storm Water Infiltration Gardens built by Earthworks. Below the gardens, the arroyo begins to cut through hard, sandstone like substrate. As a result, the channel switches from a wide, sandy channel to a severely constricted, incised, corrido. Rock run downs and willows are common through this stretch. The most dramatic vertical walls dramatic appear in this section.

An incised area in the Arroyo Saiz, 2016.

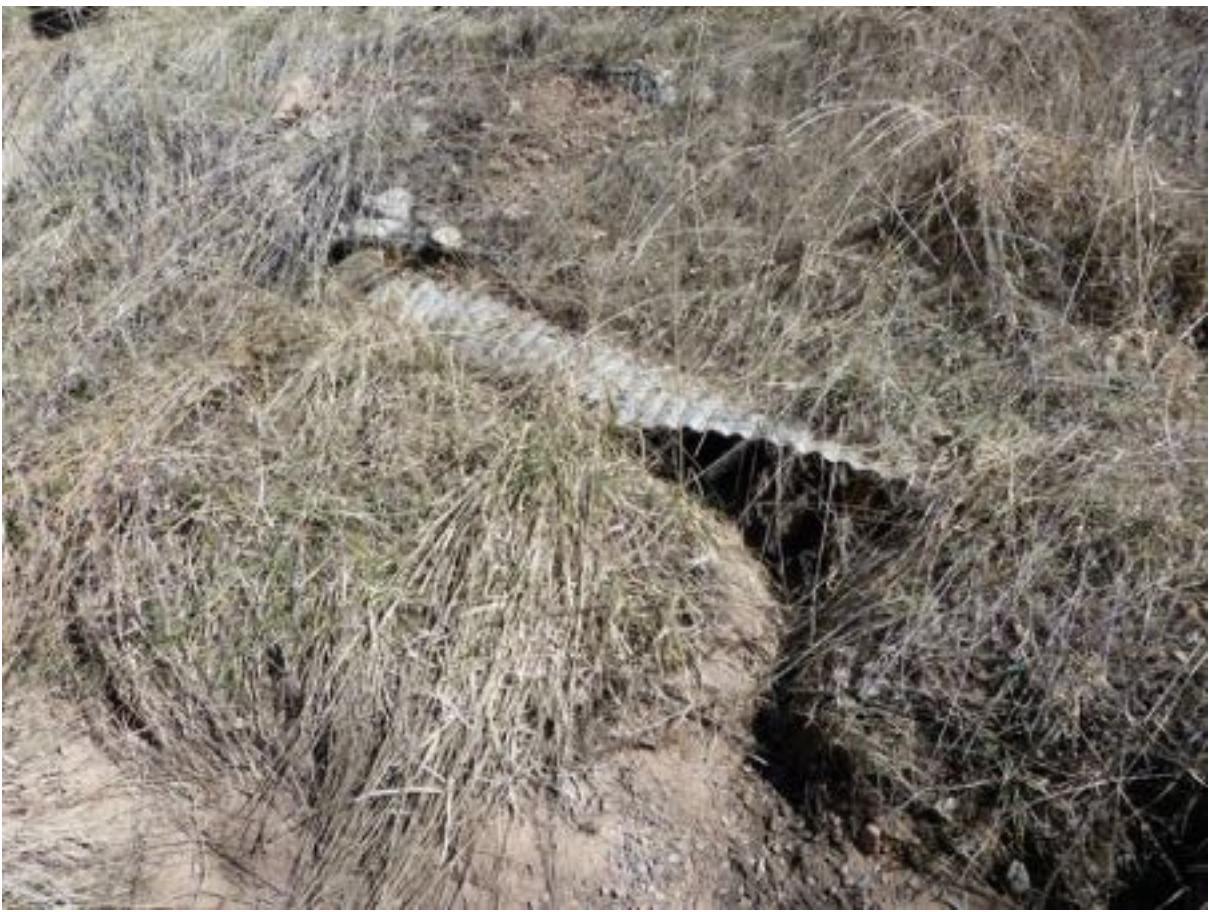
The arroyo then drops down into the Lorenzo Road area. The existing culverts and bridges are silted in. Again, the arroyo is constricted as it passes between homes. One culvert remains restricted however it may no longer be in service.

Silt clogged culvert in the Arroyo Saiz, 2016.

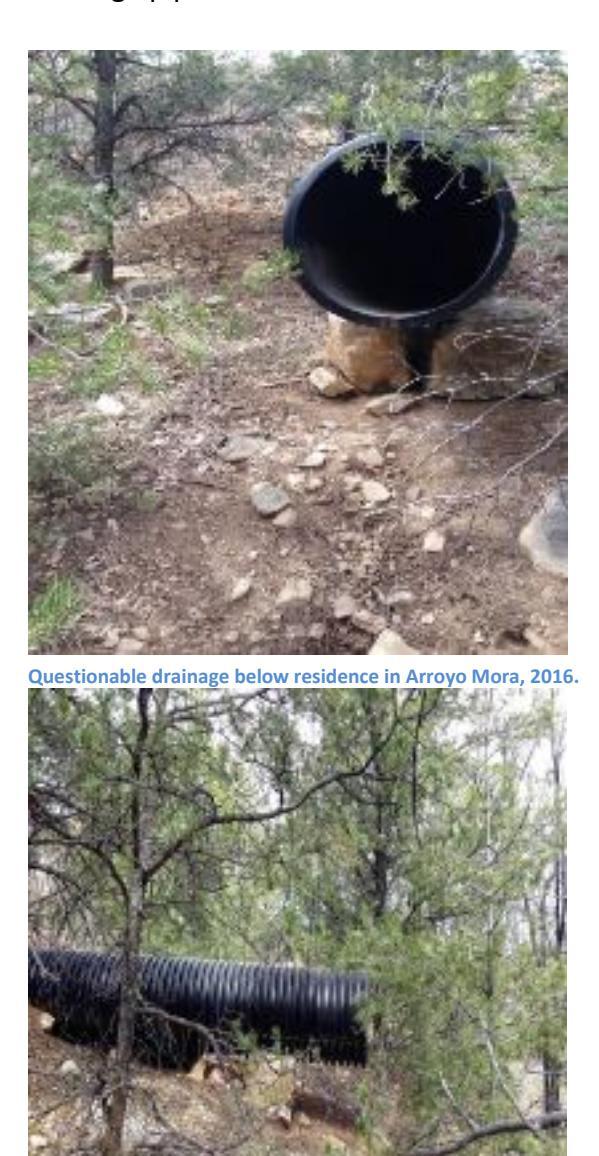
Notes: The narrow Arroyo Mora begins above Apodaca Hill where it flows closely between homes that have been built on either side of it. Many property owners have extended their borders into the arroyo with buildings, dumped earth, yard trash and trimmings, fences and drainage pipes.

Questionable drainage below residence in Arroyo Mora, 2016.

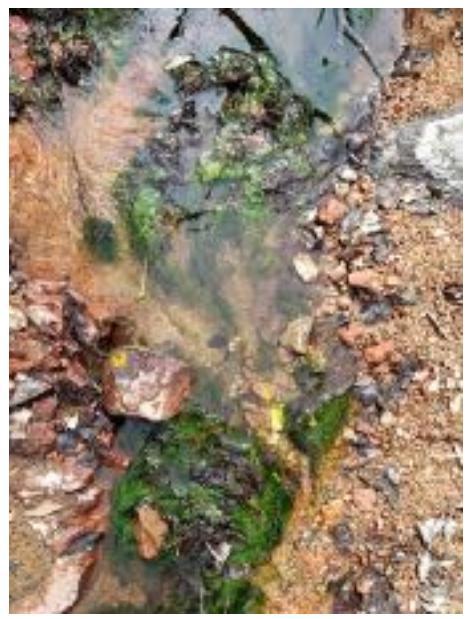
Running water with algae, Arroyo Mora, 2016.

The Mora quickly ends on the banks of the Santa Fe River. At the time of the field assessment in the early spring of 2016, running water with algal blooms was present at the time as were the presence of game trails. The arroyo Mora's channel can be characterized as a narrow, constricted, occasionally deeply incised arroyo with intermittent vertical walls. An iron pipe remains in the same condition that was noted in 2012. The dumps along the steep hillsides of the Arroyo Mora have remained the same and in some cases have been enlarged. The impacts of the arroyo used as a dumping ground of solid and liquid materials effects the quality of the water that enters the Santa Fe River.

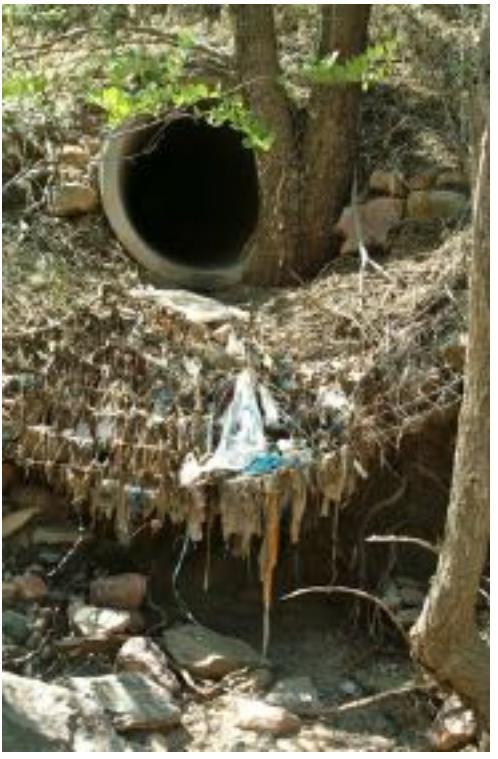
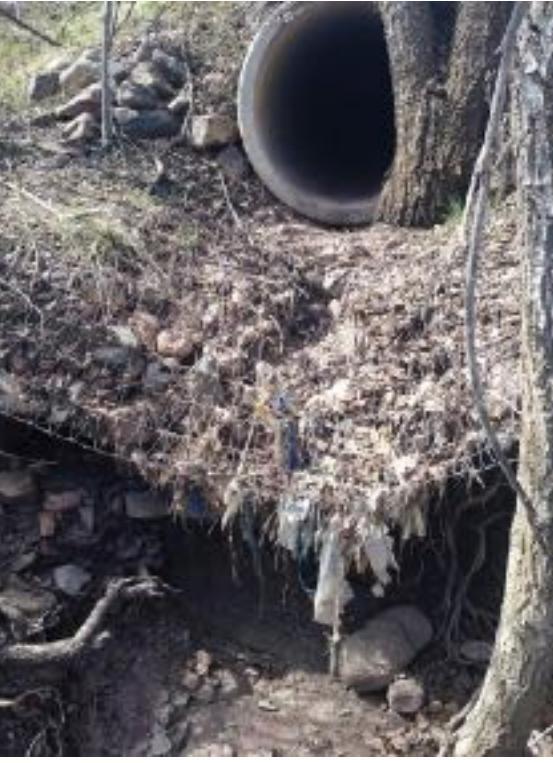
A bank along the Arroyo Cabra continues to rapidly deteriorate in the same location as noted in 2012. Storm water, directed into the arroyo through a culvert, falls onto a rip rap mat that is no longer supported by an earthen bank. The high flow from this water will continue to aid in the rapid deterioration of the bank. The lower arroyo has been officially adopted by Desert Montessori through an Adopt an Arroyo program with the Santa Fe Watershed Association.

Undercut rip rap 2012 and trash below a culvert off Camino Cabra vs 2016, Arroyo Cabra, 2016
