Arroyo Threat Assessment Surveys of 15 Major Arroyos in the Santa Fe River Watershed

June 21, 2016

Santa Fe Watershed Association

Report to Melissa McDonald, River & Watershed Coordinator, Public Works Dept., City of Santa Fe 2016

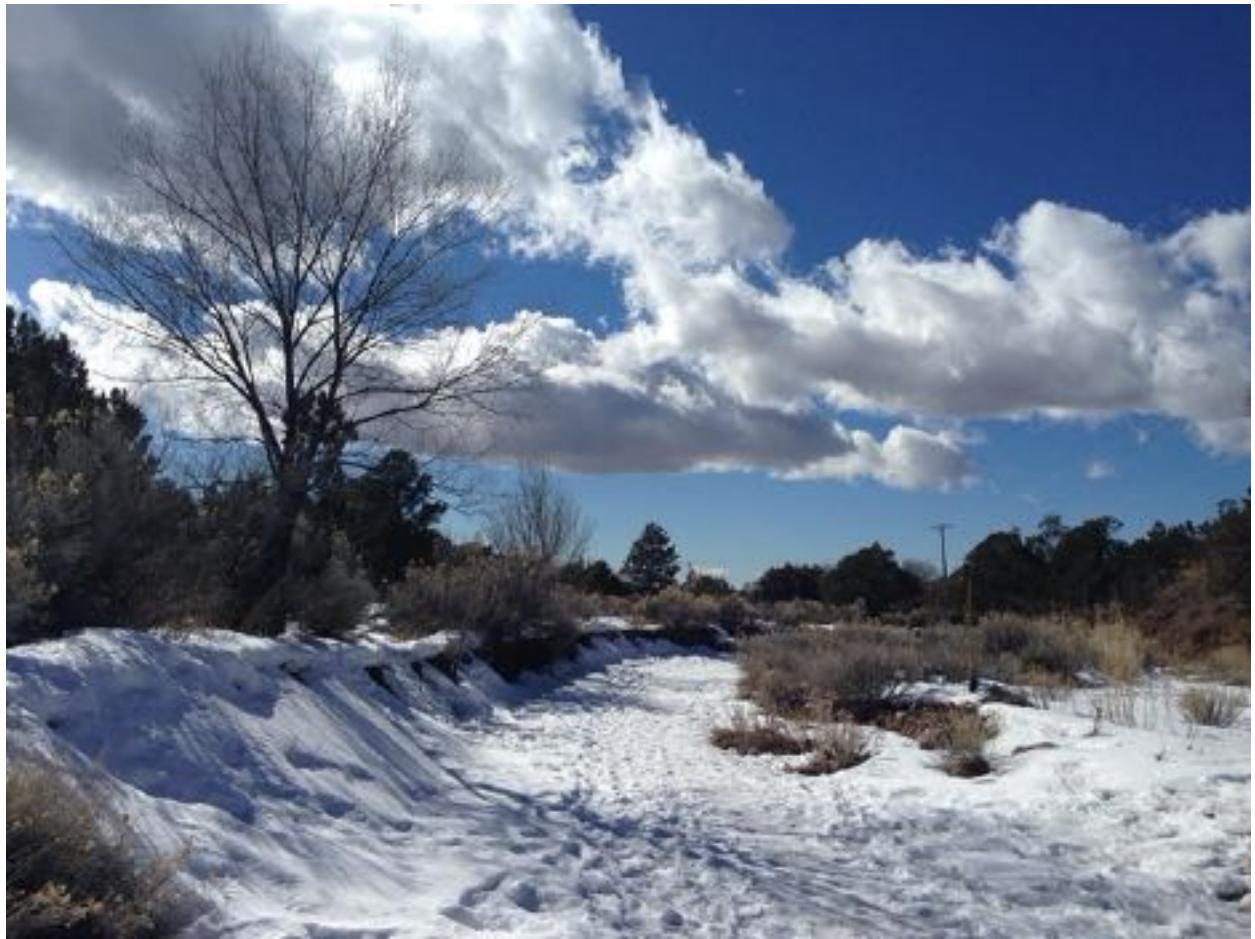
Notes: Bank erosion is common in this segment of the arroyo despite its width. As a result of the arroyo's proximity to the mountains a suitable habitat for wildlife is provided. The arroyo is also popular for recreation. An exposed metal pipe spans part of the arroyo upstream from the Old Santa Fe Trail Bridge. Along a cut bank, downstream from the pipe, is a manhole. It was approximately 10-12" from the edge of the arroyo. An old dumpsite lies beneath the building of the Carmelite Sanctuary. As in 2012, minimal erosion continues to impact the upstream side of the arroyo bank adjacent to the bridge. If it were not for the Old Santa Fe Trail road crossing, this segment would be free of artificial constrictions.

Segment A/ Upper Arroyo de los Chamisos, 2016.

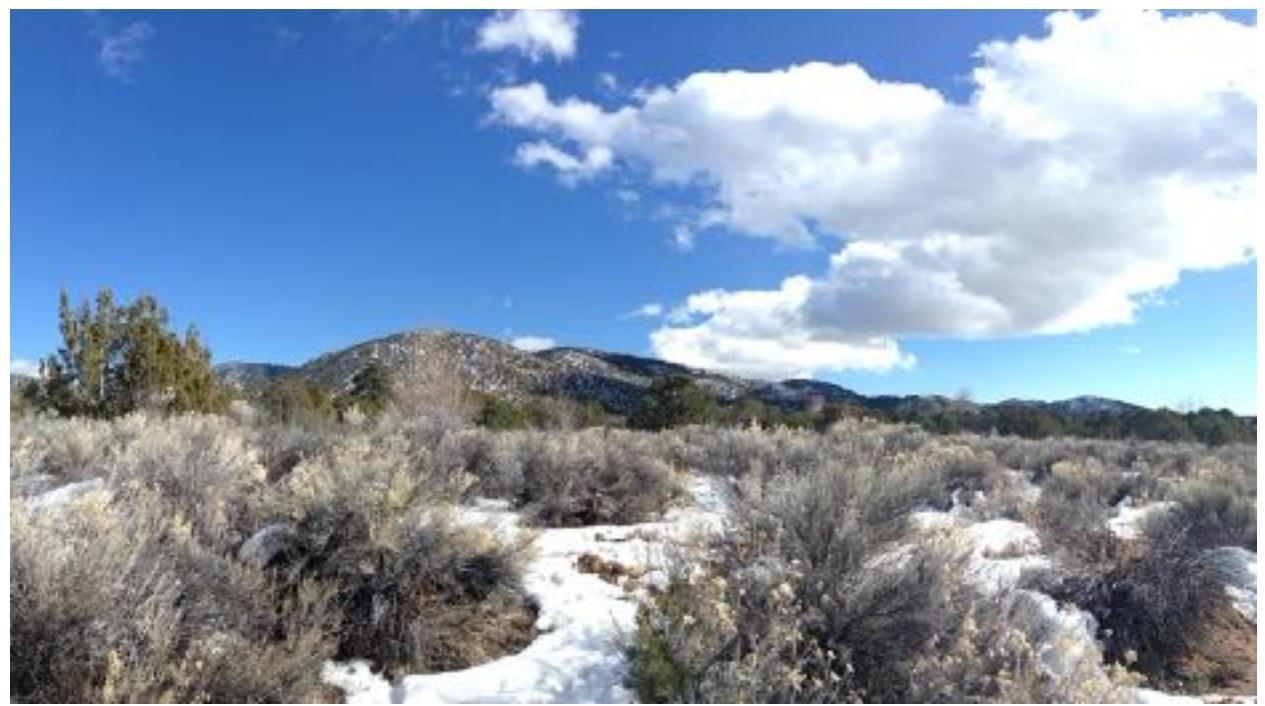
Notes: The channel of the Arroyo de los Chamisos broadens and becomes braided below Old Santa Fe Trail Bridge. The upper end of the arroyo is sparsely inhabited which provides wildlife a valuable corridor. Rabbits, lizards, and birds were sighted throughout the arroyo. The upper part of the arroyo is free of trail deterioration, exposed sewage lines, and deteriorating vehicle bridges. A stand of cottonwood trees continues to thrive in this section of the arroyo. Perhaps further restoration of this area and the addition of a water infiltration basin may enrich this part of the arroyo.

Segment B/ Broad open plain on the Arroyo de los Chamisos, 2016.

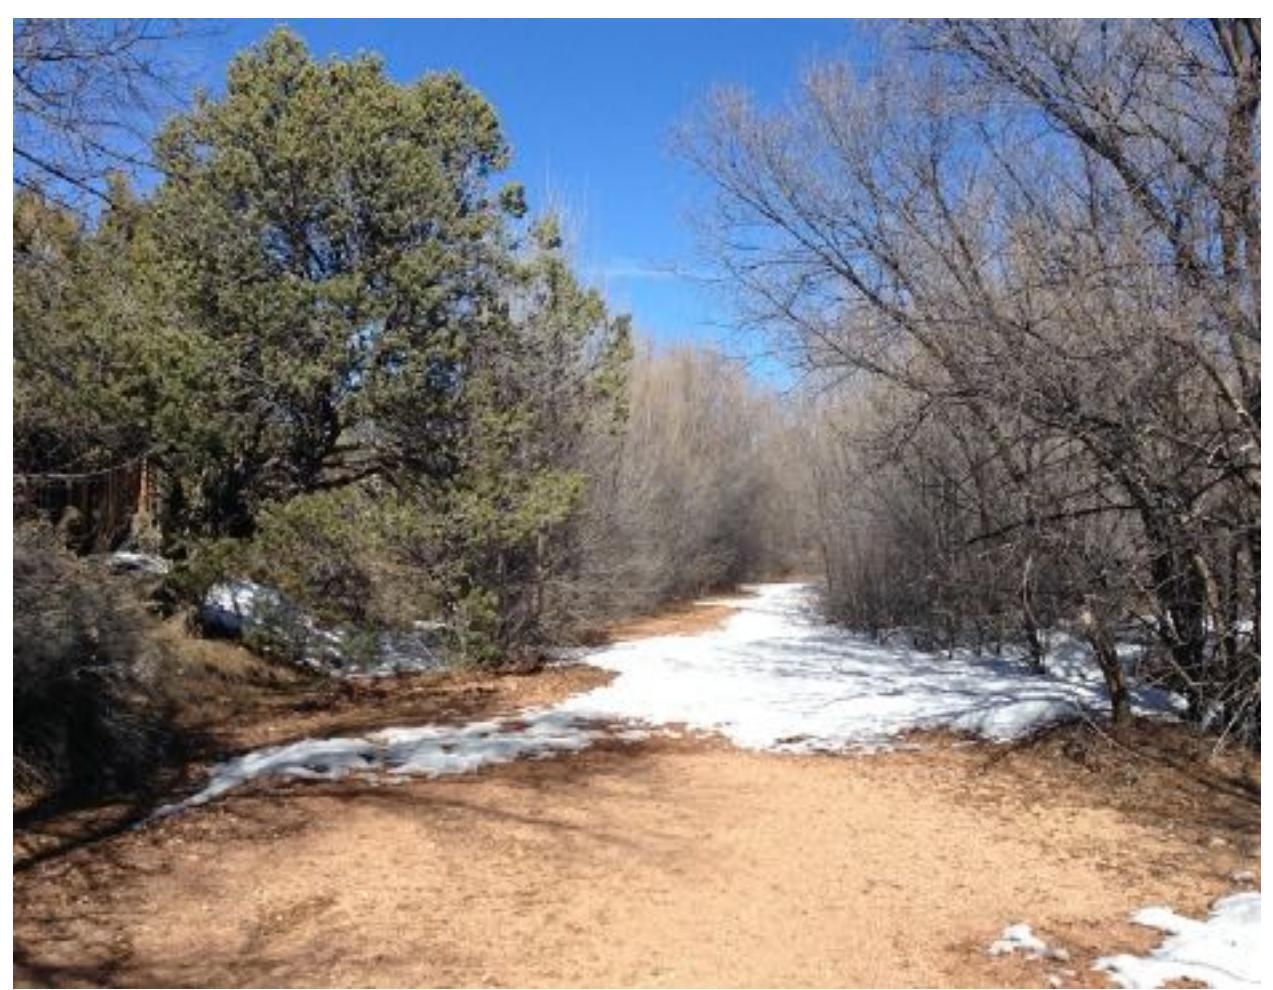
Notes: This segment of the arroyo continues to be used as a walking, jogging or biking path. Beyond the Conejo Road crossing, the arroyo widens then branches left and right to reconnect downstream. An exposed utility was found between Ft. Union Road and Calle Sebastian Bridge. The sandy, incised arroyo channel continues to narrow as it passes under the overgrown Calle Sebastion Bridge towards the Old Pecos Trail Bridge. Rip rap in varying states of disrepair along with submerged gabion baskets were observed in this section.

Segment C/ Illustration of the channel characteristic in Arroyo de los Chamisos, 2016.

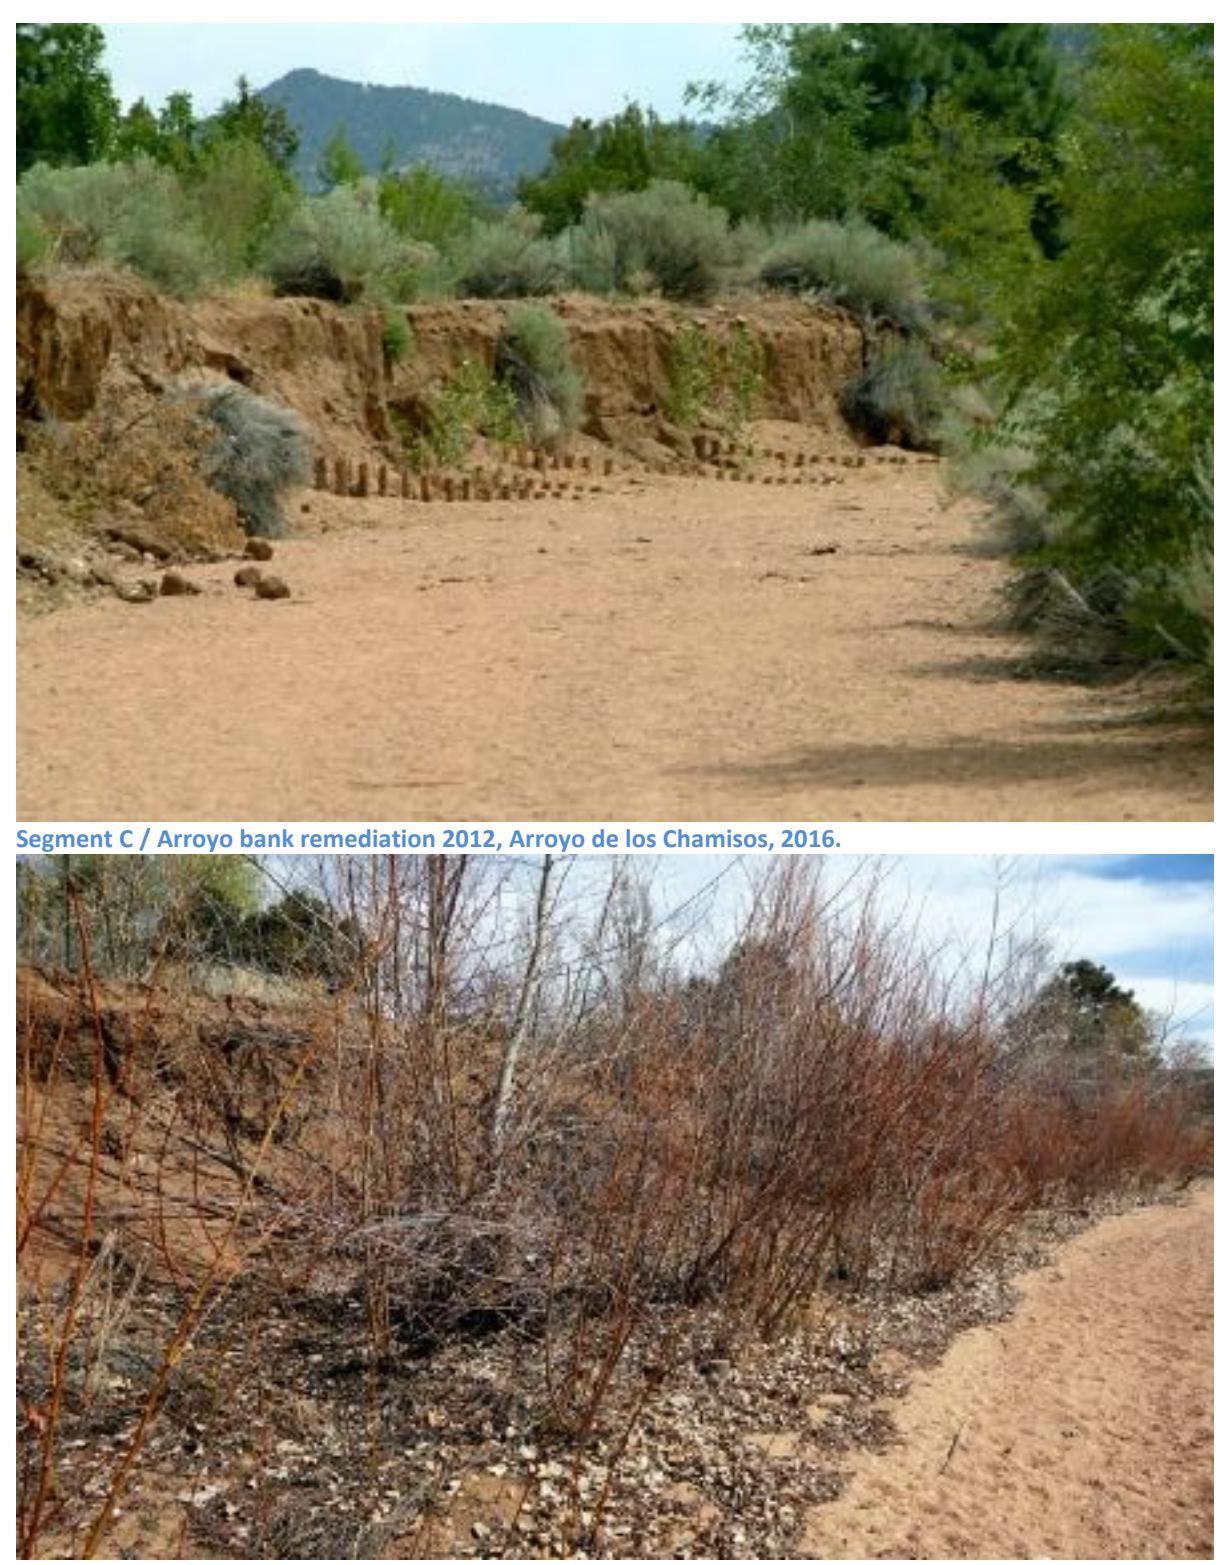
The arroyo continues beyond Old Arroyo Chamisos Road in the direction of Botulph Road. Between these two points, a bank restoration project begun in 2012 has matured and looks to be successfully retaining the banks of the arroyo.

Segment C / Mature cottonwoods and willows at arroyo bank remediation started in 2012, Arroyo Chamisos.

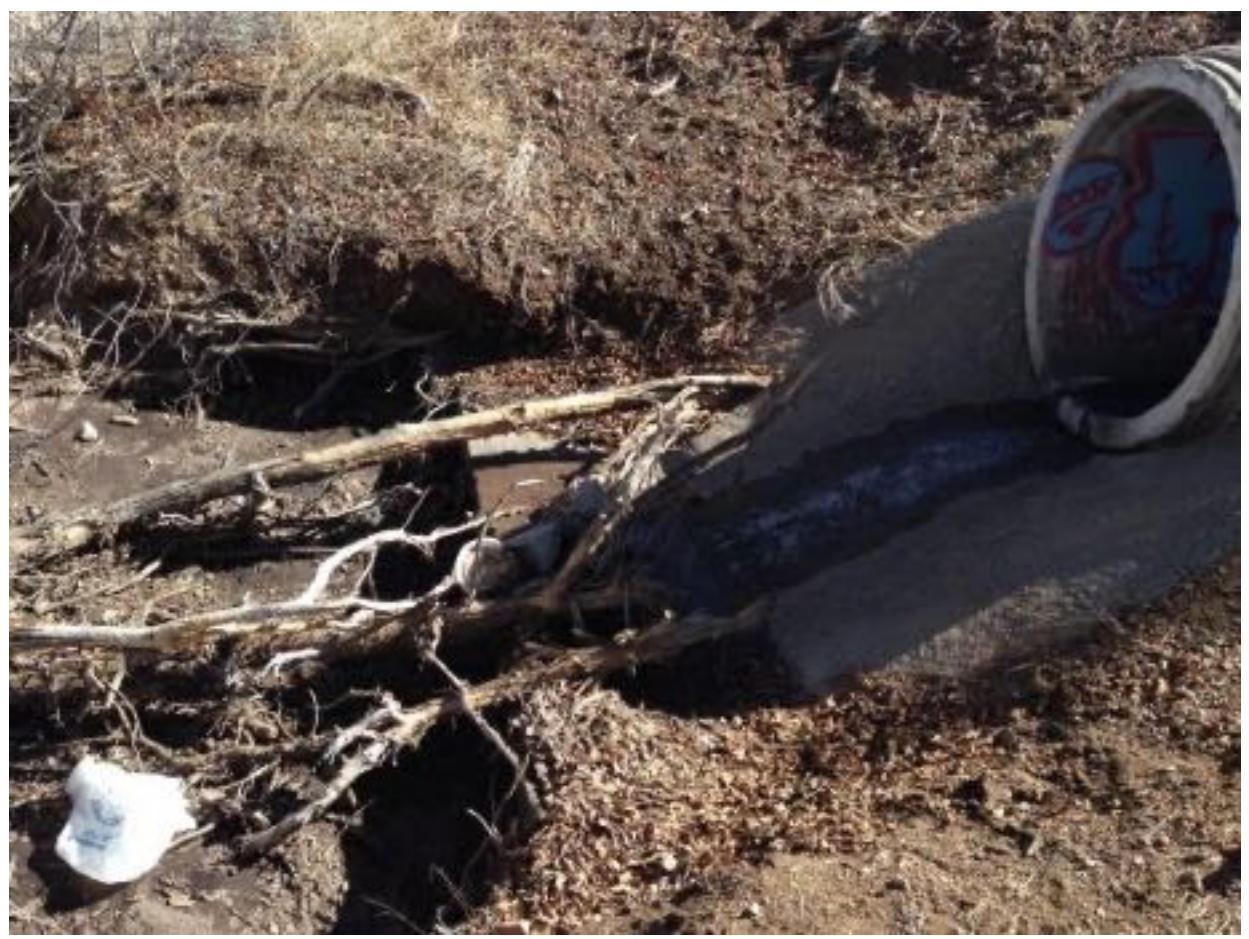
Segment F/Possible location for infiltration basin, Arroyo de los Chamisos, 2016.

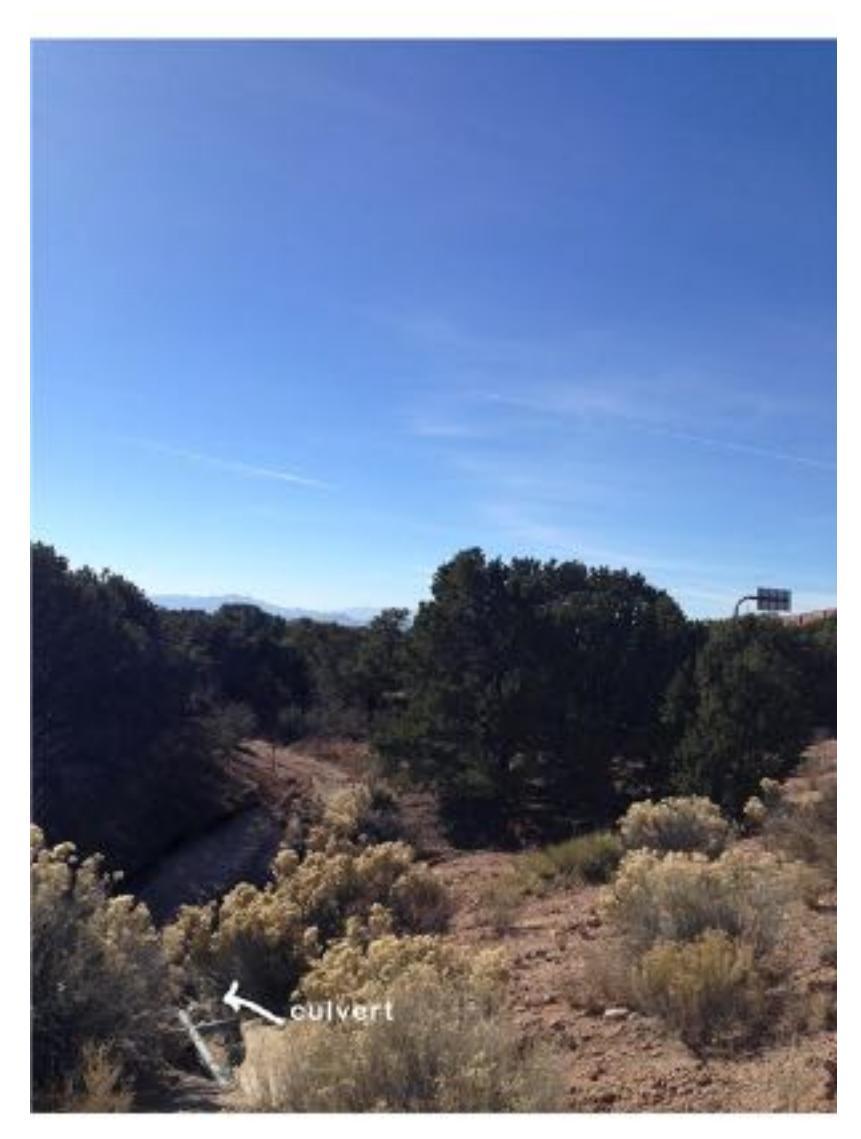
Segment A/View of Arroyo Rosario from culvert.2016

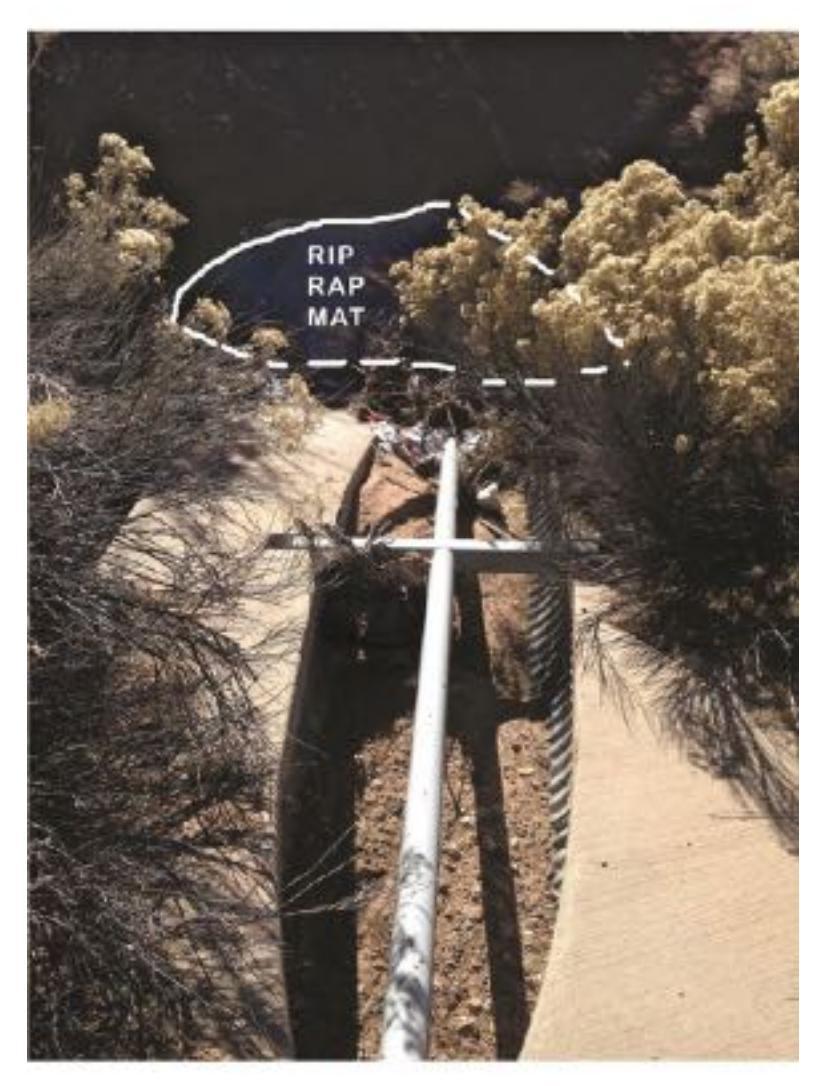
Segment A/ Outlet and rip rap map at head of Arroyo Rosario, 2016.

Notes: In general, the Arroyo Rosario is a city arroyo which begins at the base of a grade supporting the road bed for Hwy. 285 South, crossing Rio Grande Ave and flowing beneath the Paseo de Peralta Bridge box culvert. The main areas of concern are a culvert below 285 and the aforementioned bridge and surrounding area. Besides these concerns, the arroyo is a lively corridor for wildlife described by deer, coyote tracks, sighting of rabbits, in a juniper/piñon habitat. The arroyo is also home to recreational hiking, motorized vehicles, and Santa Fe's transient population. Evidence includes vehicle tracks, foot trails, campsites and encounters with hikers and homeless residents. Mature elm trees have successfully stabilized the banks of the arroyo's last segment.

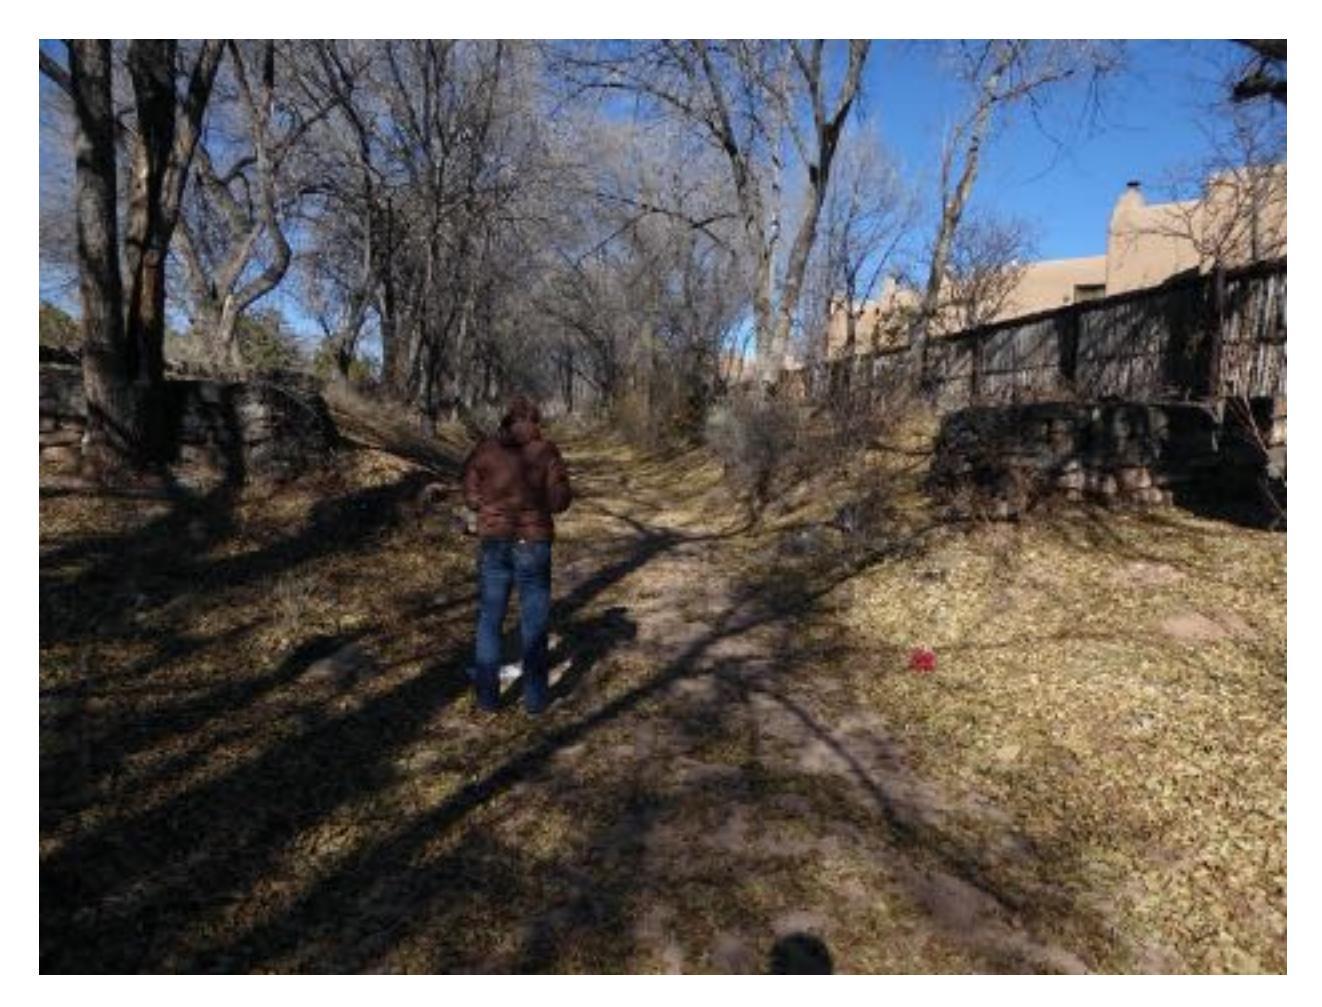
Segment E/ Mature elms hold banks in place, Arroyo Rosario, 2016.

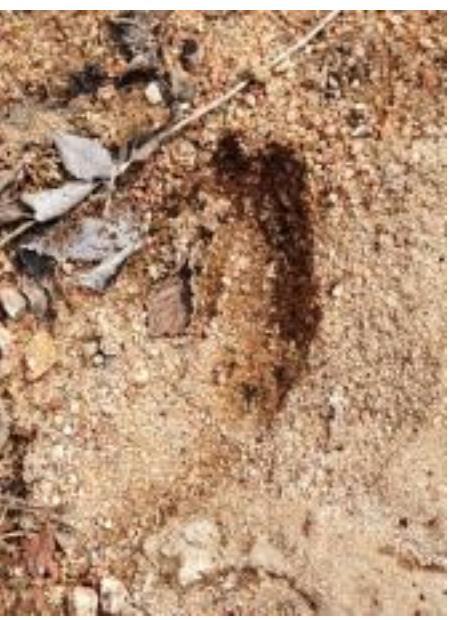
Deer track in arroyo bed, Arroyo Mora, 2016.
