Arroyo Threat Assessment Surveys of 15 Major Arroyos in the Santa Fe River Watershed

June 21, 2016

Santa Fe Watershed Association

Report to Melissa McDonald, River & Watershed Coordinator, Public Works Dept., City of Santa Fe 2016

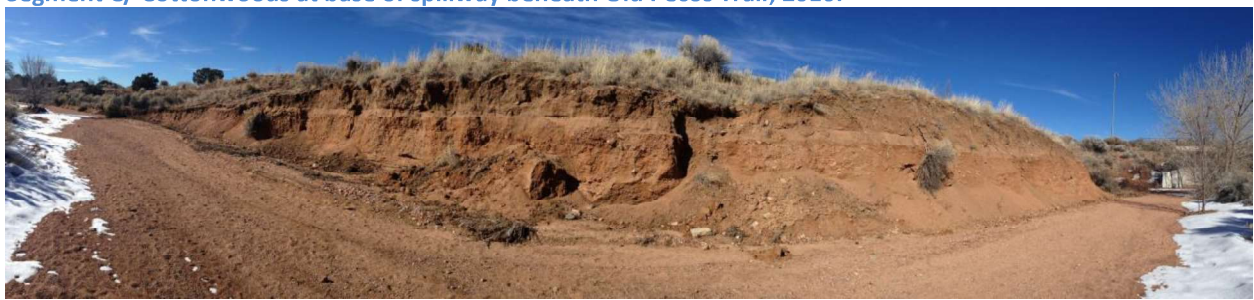
Segment C/ ~75 feet of eroded bank below spillway, Arroyo de los Chamisos, 2016.

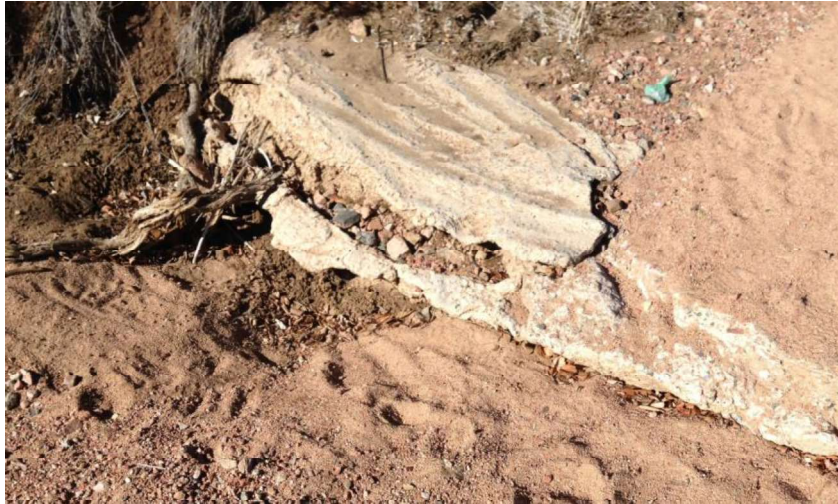
Approximately 1,000 feet downstream from the Old Pecos Trail Bridge, a concrete encased utility appears to be eroding from the bed of the arroyo.

Segment C/ Encased utility line, Arroyo de los Chamisos, 2016.

7) Cover Exposed Utility: If the utility component is sound and not leaking, the recommendation is to re-trench and re-cover the exposed line or pipe.

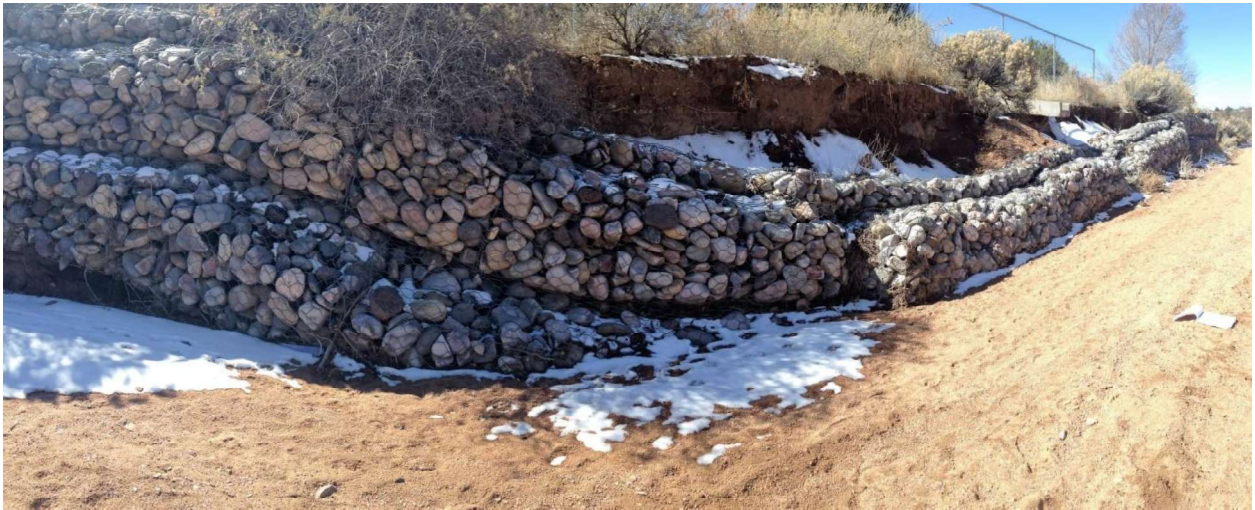
The arroyo passes beneath Botulph Road where the channel widens. Several bridges that serve the Gail Ryba trail system span the Arroyo de los Chamisos. Approximately 175 feet beyond the southern foot bridge, a protective gabion wall has separated from the arroyo bank to sag into the channel. Segment C ends beneath the S. St. Francis bridges. Sometime between 2012 and 2016 the concrete supporting the roadbed has become rotten enough below the guardrails to expose rebar.

Segment C/Gabion walls coming off arroyo bank, 2016.

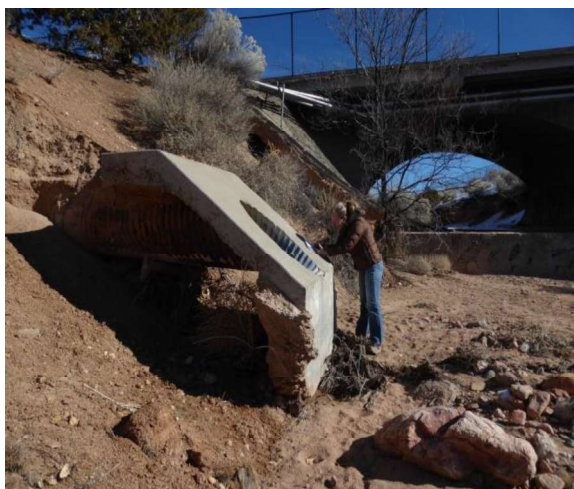
Segment D/ Bank erosion, Arroyo de los Chamisos, 2016.

Improvements since 2012 have helped protect sewage lines and minimized the impact of storm water in some areas. Segment D of Arroyo de los Chamisos is a high -risk area in much need of remediation. Immediate corrective action to the vertical banks along the Arroyo Chamisos trail between the Vo-Tech bridges is recommended.

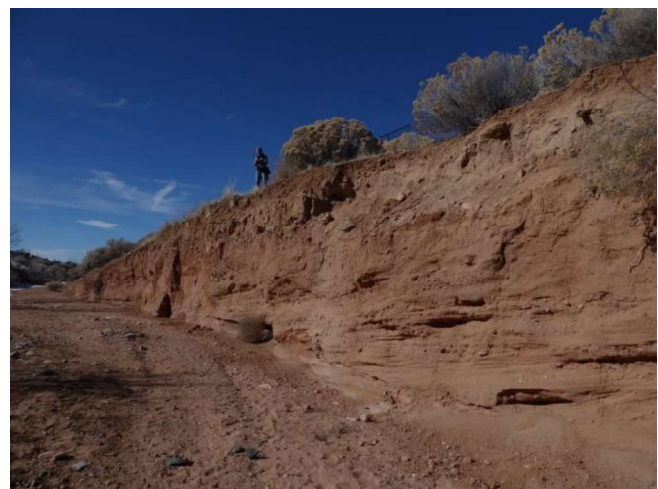
Notes: The arroyo segment has been severely incised due to poor drainage, soil type, natural and artificial constrictions. The height of an intermittent system of vertical walls increases as the arroyo channel drops in elevation. The corridor of these highly eroded vertical walls begins about 145 feet below the Santa Fe Rail Trail. The longest, continual, vertical wall system in the arroyo is approximately 1,300 feet in length. It is found in here. Although it is the longest corridor, the 1,150 foot section of vertical bank between the two Vo-Tech bridges is the most dangerous regarding trail safety and infrastructure stability.

Segment D/ Corridor of vertical banks, Arroyo Chamisos, 2016.

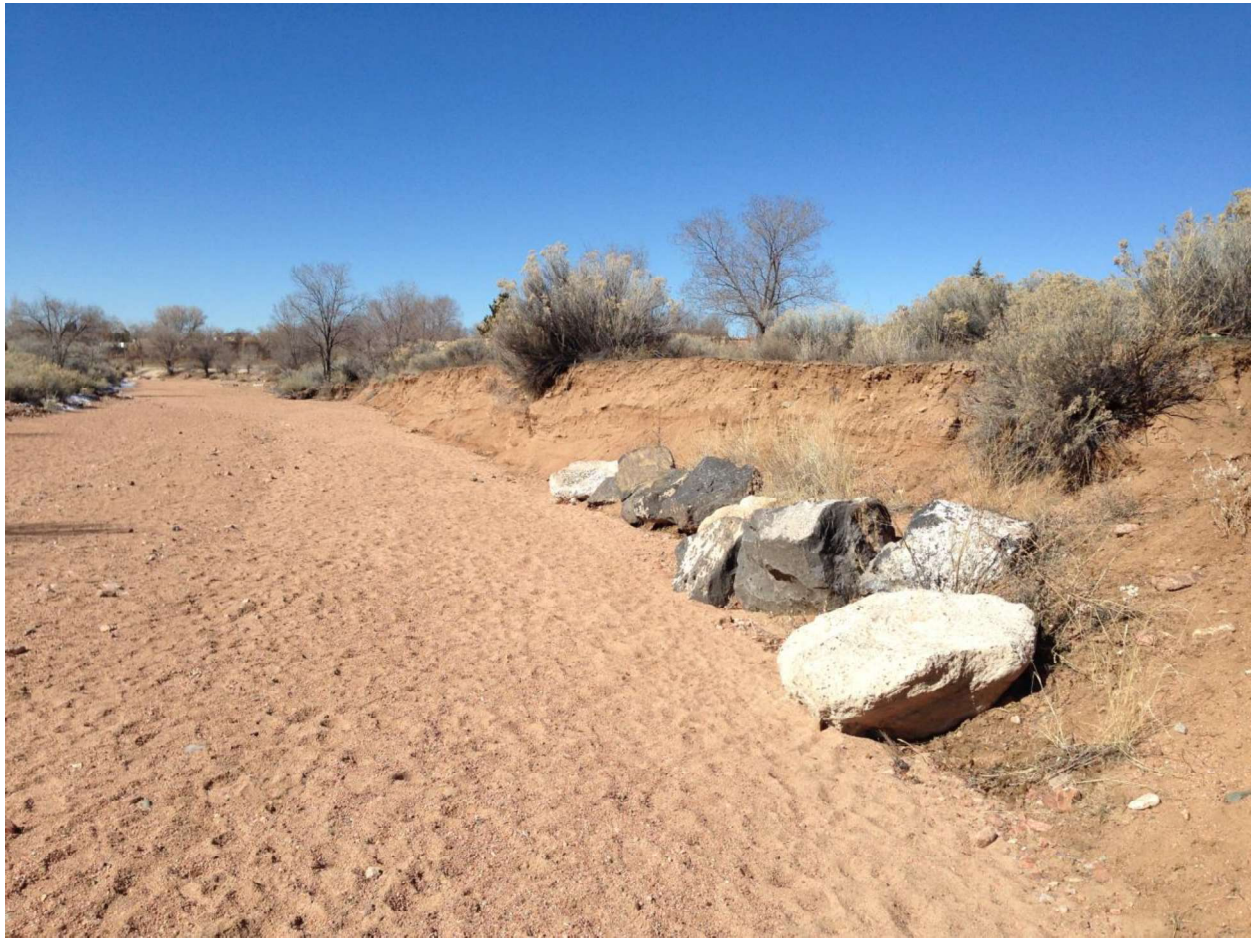
Notes: The arroyo in segment E is broader than Segments C and D. As expected, erosion continues throughout the entire length of the Arroyo de los Chamisos. Natural obstructions since 2012 have entered the arroyo bed and will affect the flow of storm water. The narrowest part of the entire Arroyo de los Chamisos is located in this segment. It measures roughly 20 feet across.

Segment E/ Erosion along arroyo bank, Arroyo de los Chamisos, 2016.

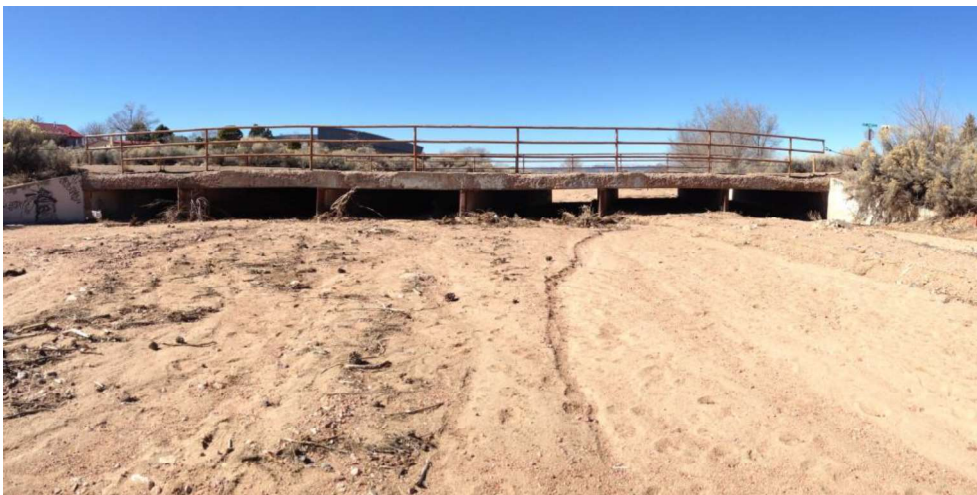
Notes: The arroyo continues to be broad in nature maintaining this characteristic through to Governor's Miles Road. Below the Camino Carlos Rey Bridge the damaged rip rap of 2012 is being replaced in 2016. Storm water has increased the number of vertical banks in this section. The Ave de Las Campanas Bridge suffers from deteriorating concrete sides.

Segment F/ Rotting concrete on Ave. de las Campanas Bridge, Arroyo de los Chamisos, 2016.

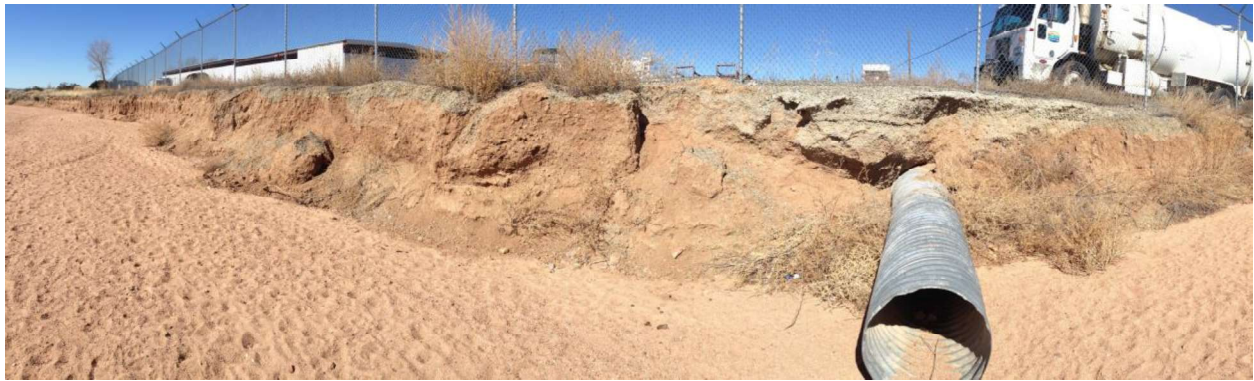
Segment G/Bank erosion at State facility, Arroyo de los Chamisos, 2016.

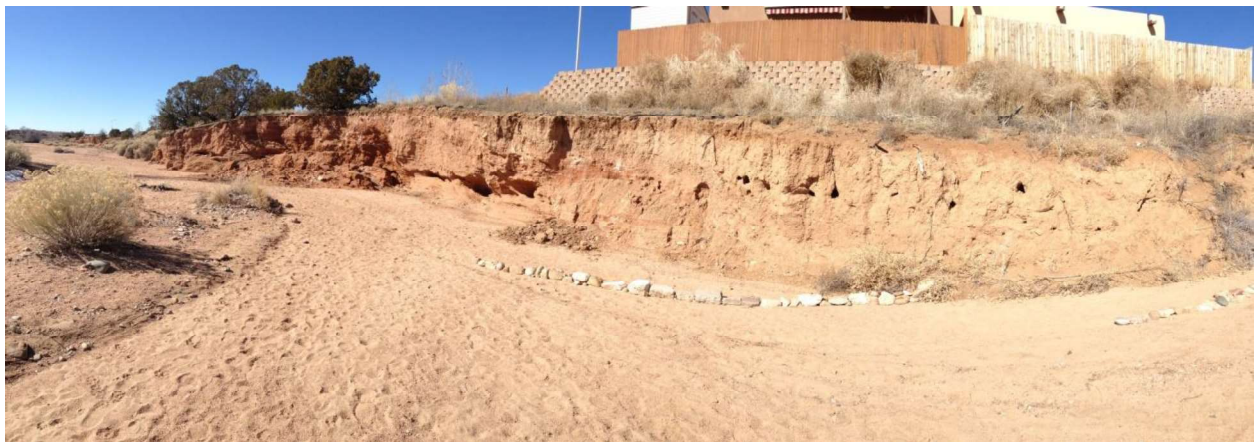
Notes: Between the Ave. de Las Campanas Bridge and the Rodeo Road Bridge several high cut banks exist that continue to threaten private property near the Kachina Heights subdivision. Rip rap used to stabilize the arroyo banks is undercut. Since 2012, a public utility, 300 feet upstream from a state maintenance yard has emerged from the arroyo bank. The chain link fence at this facility is flush with the arroyo bank. Also a steel culvert extends further into the arroyo than observed in 2012. It is in danger of being damaged by storm water.

Segment G/ Erosion below private property in Kachina Heights, Arroyo de los Chamisos, 2016.

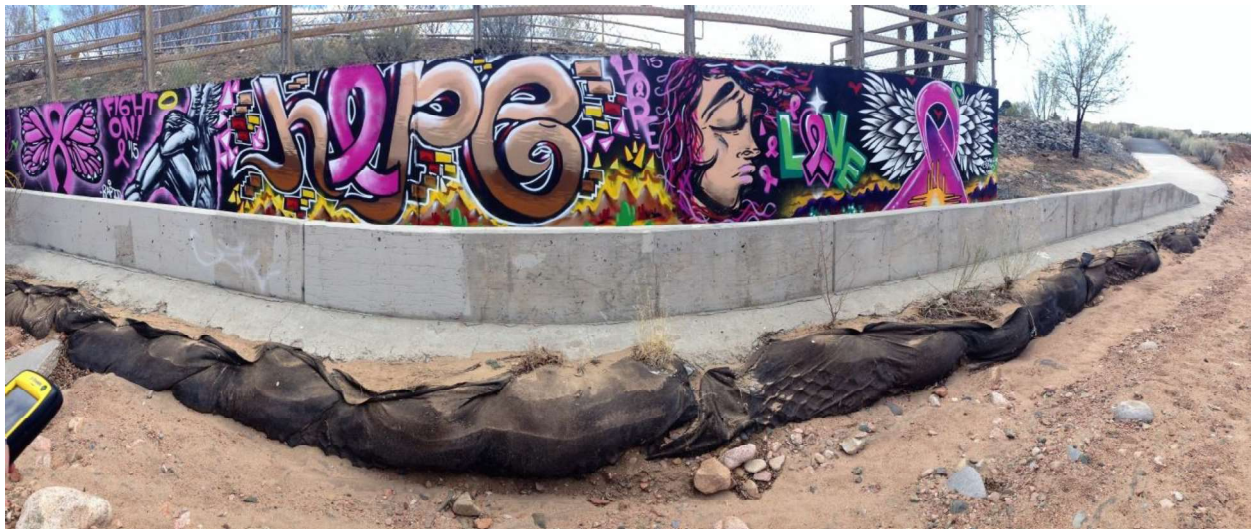
Segment H/Erosion threatens sidewalk, Arroyo de los Chamisos, 2016.

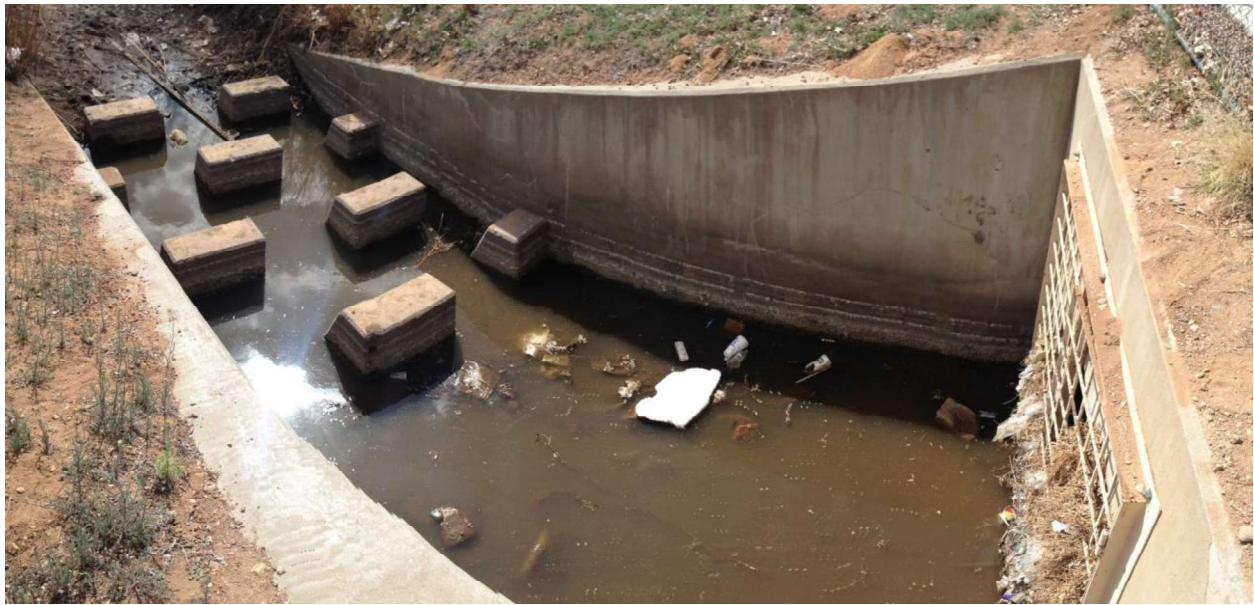
Notes: The Arroyo de los Chamisos bike trail below Rodeo Road Bridge has suffered from more erosion since 2012. Soil is eroding from the footing of the foot bridge closest to the Villa Linda Park. Also the grate of a large culvert located near the mall parking lot is restricted by a huge volume of trash. Another drainage ditch flowing from Santa Fe Place into the Arroyo de los Chamisos has bypassed a check dam control point to erode a large channel into this arroyo. Storm floods since 2012 have removed a considerable amount of sediment from the base of a gabion wall. The last point of erosion from a storm drainage pour off pad belonging to a tenant of the auto park has carved a deep channel into the arroyo bank. The arroyo continues to be a popular place for dumping trash. More transient camp sites were encountered throughout this arroyo segment. This arroyo segment is heavily used by off road vehicles. There are many places for vehicle access from the Governor Miles Road Bridge to the Villa Linda Park as noted in 2012.

Segment H/Culvert obstructed with trash, Arroyo de los Chamisos, 2016.

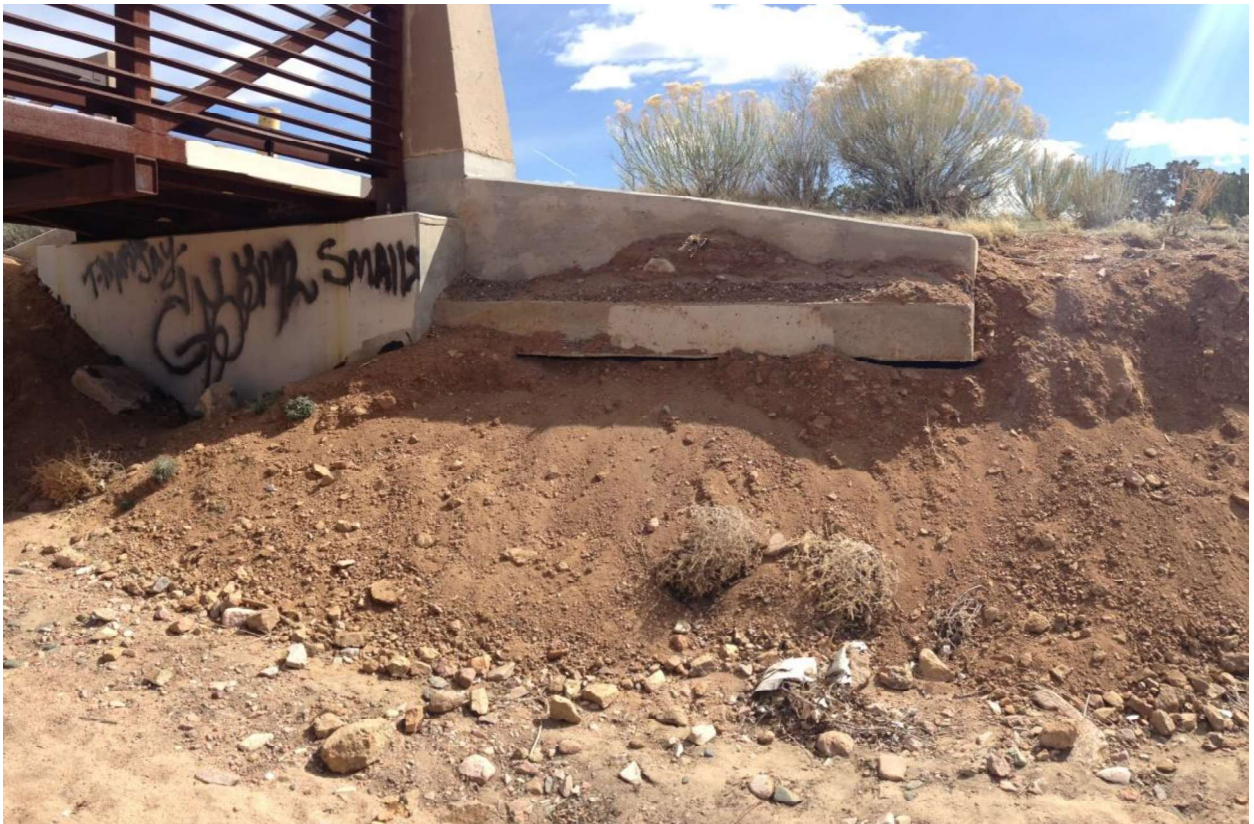
Segment H/Pedestrian bridge with exposed footing, Arroyo de los Chamisos, 2016.

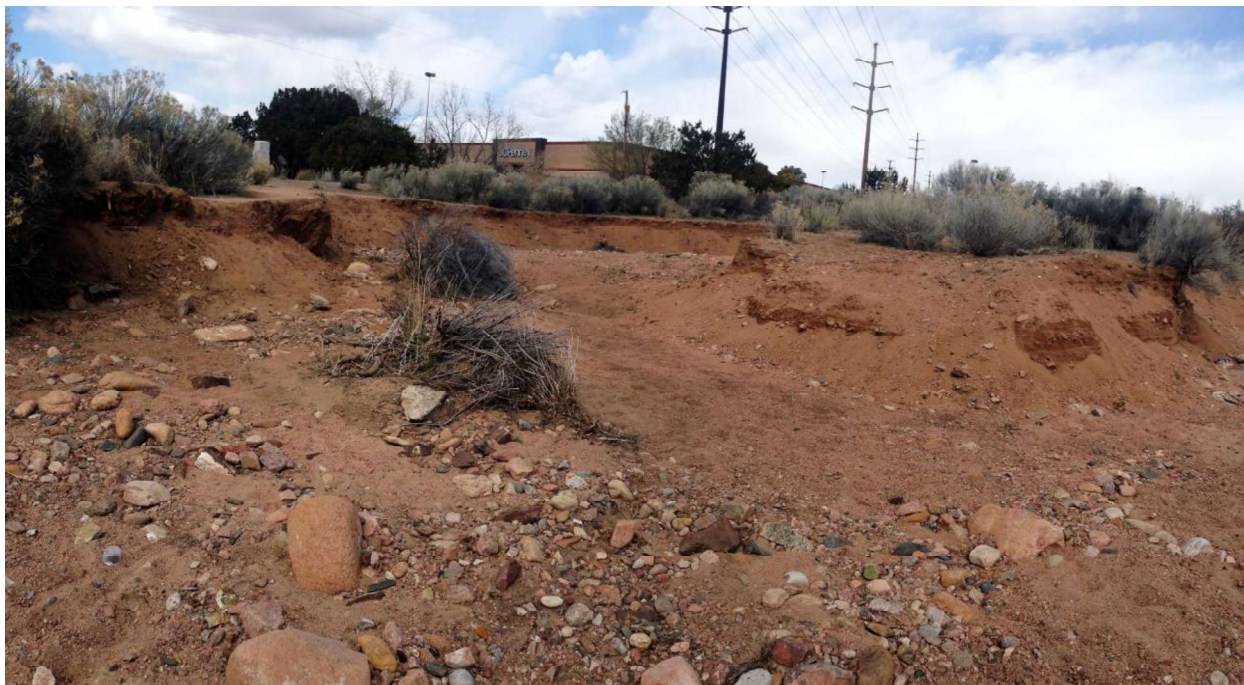
Segment H/Side channel bypasses gabion wall, Arroyo de los Chamisos, 2016.

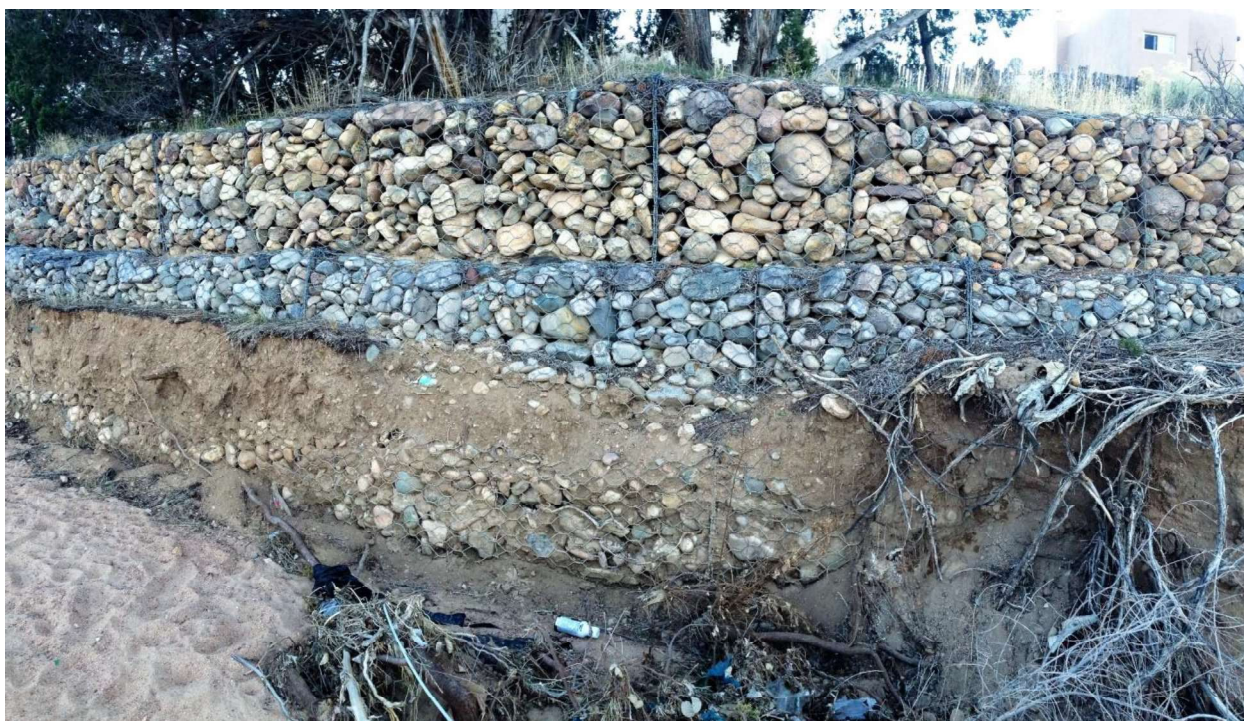
Segment H/ Illustration of sediment fluctuations. Sediment levels remain intact against gabion wall at far right of photo while left and center sediment no longer exists, Arroyo de los Chamisos, 2016.

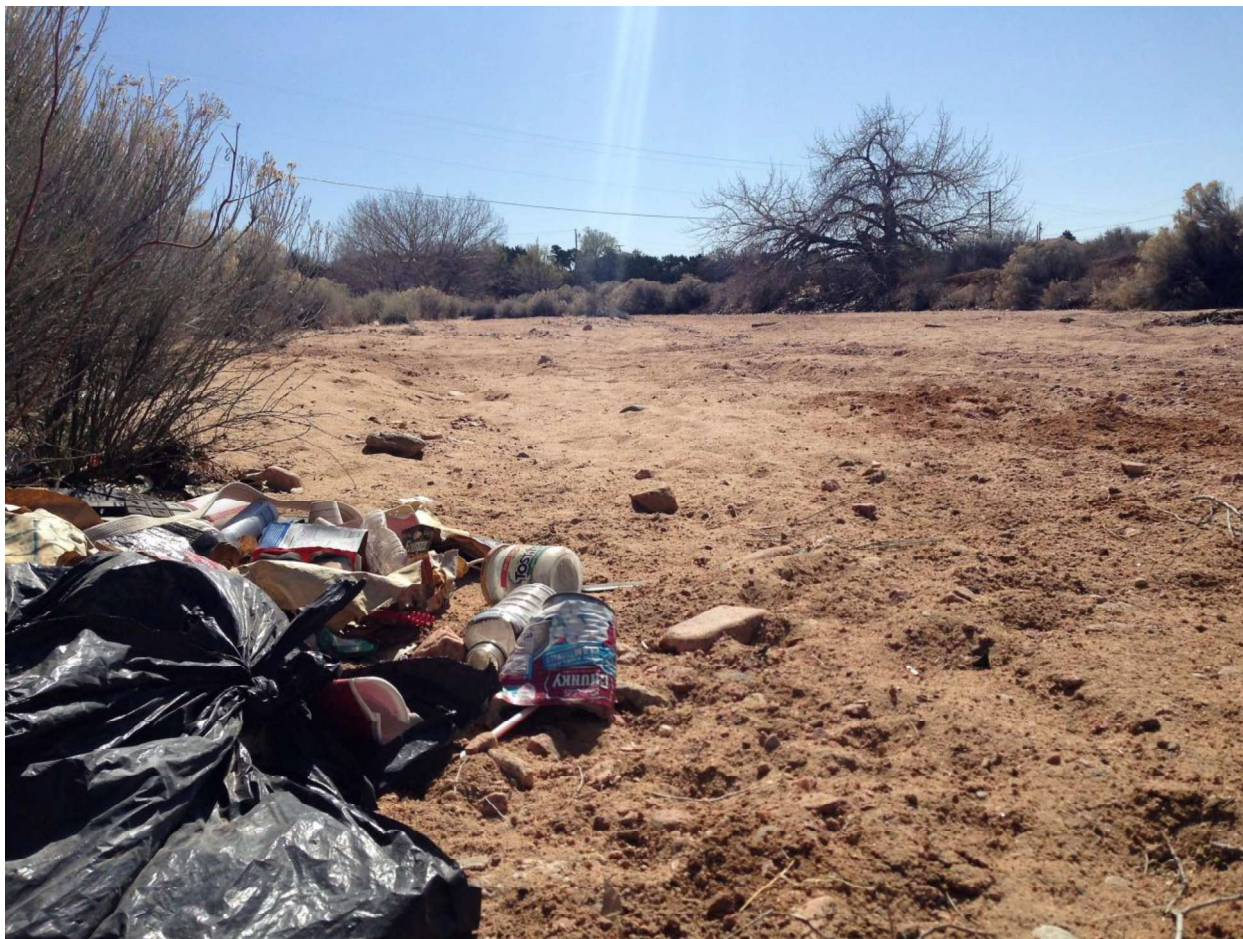
Segment H/ Trash a common presence from Segment G through Segment H, Arroyo de los Chamisos, 2016.

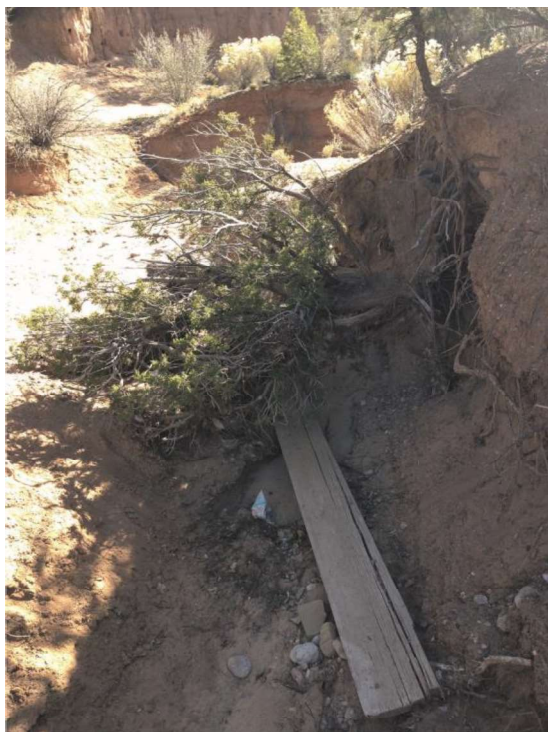
Segment A/ Tree blocking channel, Arroyo Rosario, 2016

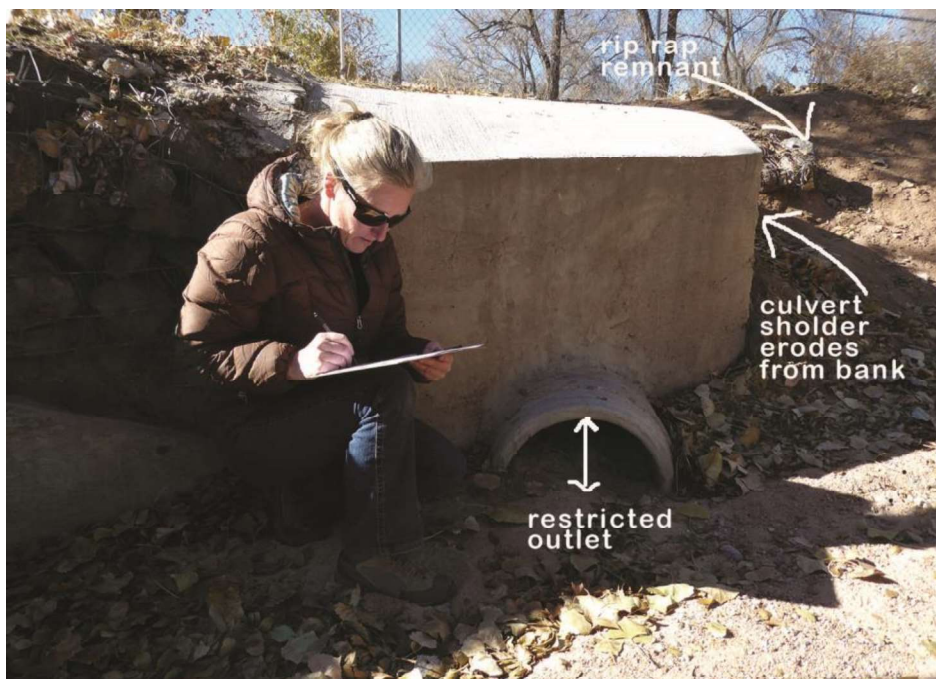
Notes: Notable areas of concern appear in close proximity of the Paseo de Peralta box culvert bridge. The box culvert itself continues to gain sediment from each storm event. Two feet of head room exist between the sandy bed of the arroyo and the top of the box culvert. Next to this structure is a concrete, 18", culvert extremely full of sand. There are approximately 7 "of head room left in this culvert. Another condition affecting this same culvert is erosion around its footings. Since the original rip rap barely remains, pedestrian traffic and water is wearing away the surrounding bank. Lastly, on the east bank of the arroyo above these places is a storm water outlet into the arroyo. Here, the culvert is recessed into the arroyo bank. The outlet is blocked by brush piled above and across it. This segment of the arroyo Rosario has been adopted by the Historic St. Catherine Neighborhood Association through the Santa Fe Watershed's Adopt and Arroyo program.

Figure 1 Segment E/ View of restricted outlet and eroded west bank,2016

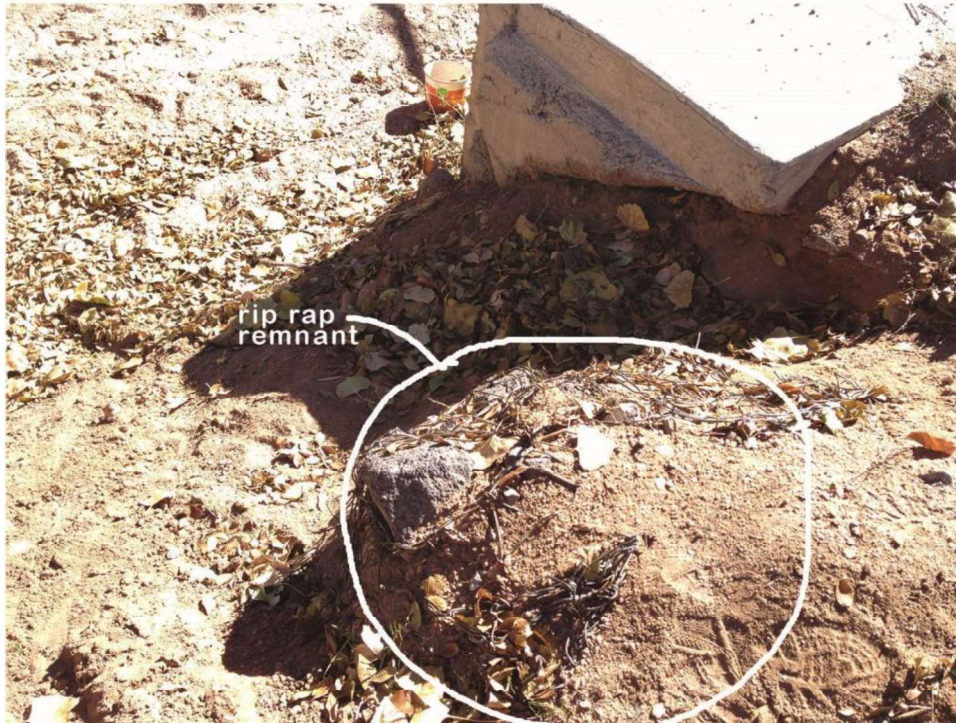
Figure 2 Segment E / Birds eye view of eroded west bank and culvert shoulder, 2016

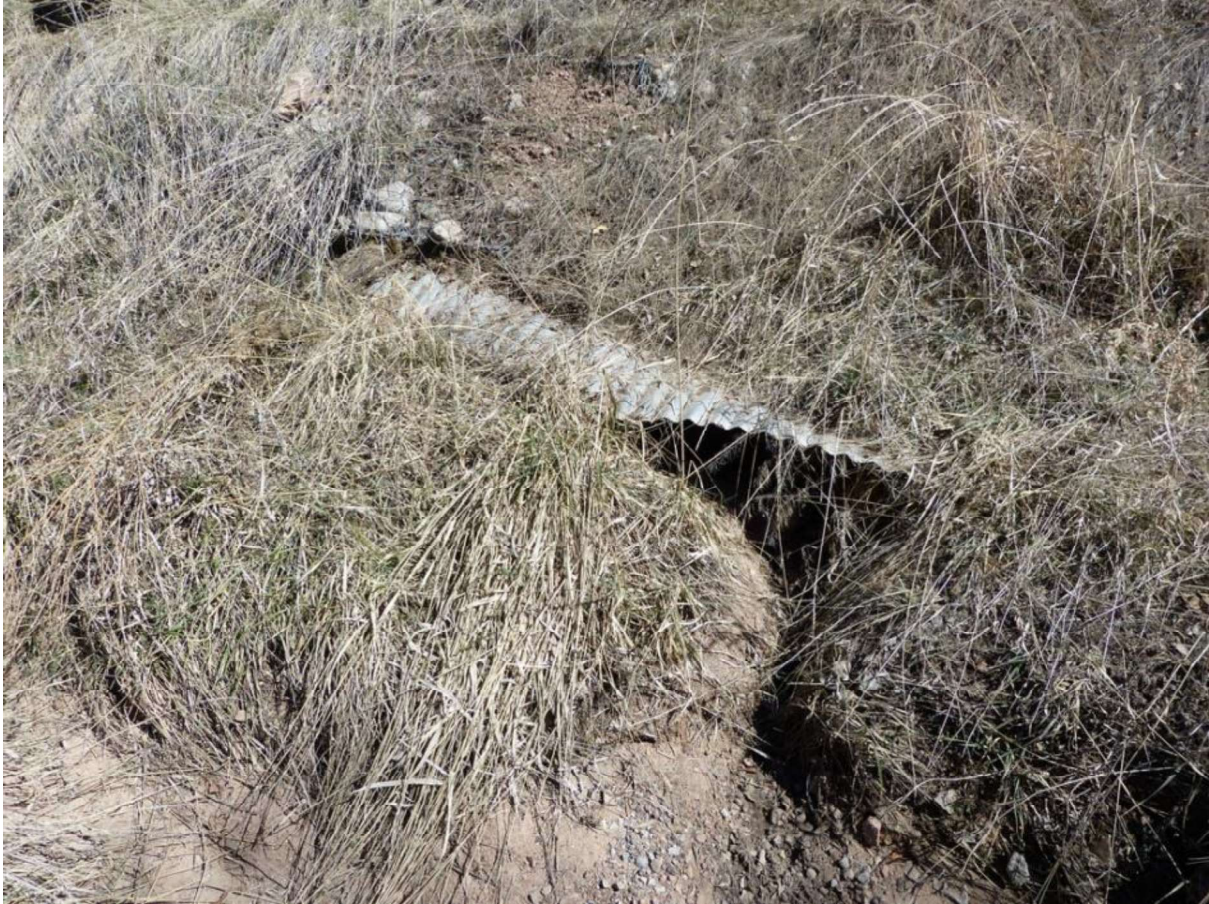
The arroyo then drops down into the Lorenzo Road area. The existing culverts and bridges are silted in. Again, the arroyo is constricted as it passes between homes. One culvert remains restricted however it may no longer be in service.

Silt clogged culvert in the Arroyo Saiz, 2016.

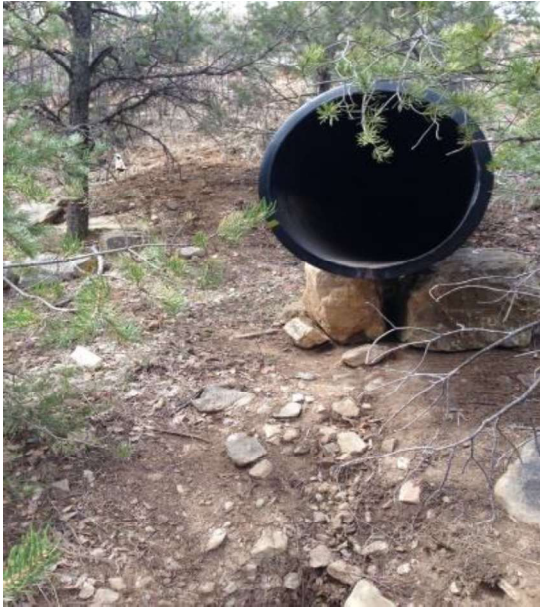
Notes: The narrow Arroyo Mora begins above Apodaca Hill where it flows closely between homes that have been built on either side of it. Many property owners have extended their borders into the arroyo with buildings, dumped earth, yard trash and trimmings, fences and drainage pipes.

Questionable drainage below residence in Arroyo Mora, 2016.

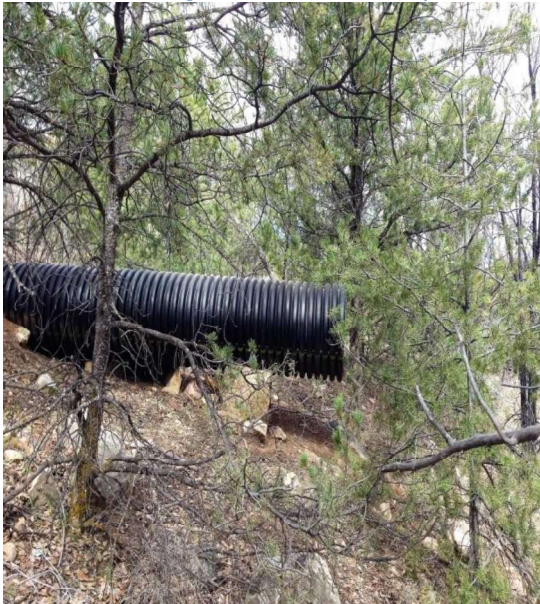
Questionable drainage below residence in Arroyo Mora, 2016.

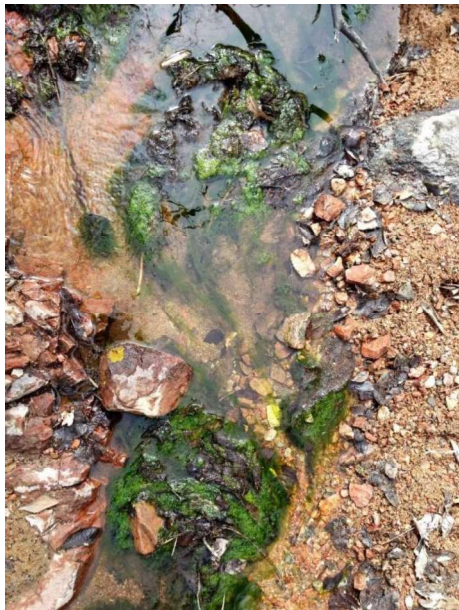
Running water with algae, Arroyo Mora, 2016.

The Mora quickly ends on the banks of the Santa Fe River. At the time of the field assessment in the early spring of 2016, running water with algal blooms was present at the time as were the presence of game trails. The arroyo Mora's channel can be characterized as a narrow, constricted, occasionally deeply incised arroyo with intermittent vertical walls. An iron pipe remains in the same condition that was noted in 2012. The dumps along the steep hillsides of the Arroyo Mora have remained the same and in some cases have been enlarged. The impacts of the arroyo used as a dumping ground of solid and liquid materials effects the quality of the water that enters the Santa Fe River.

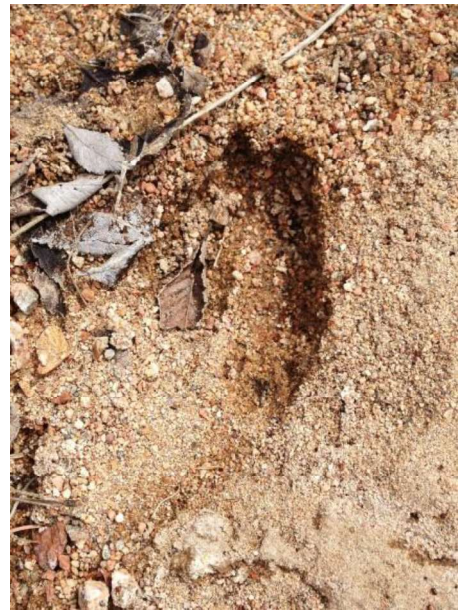
Deer track in arroyo bed, Arroyo Mora, 2016.

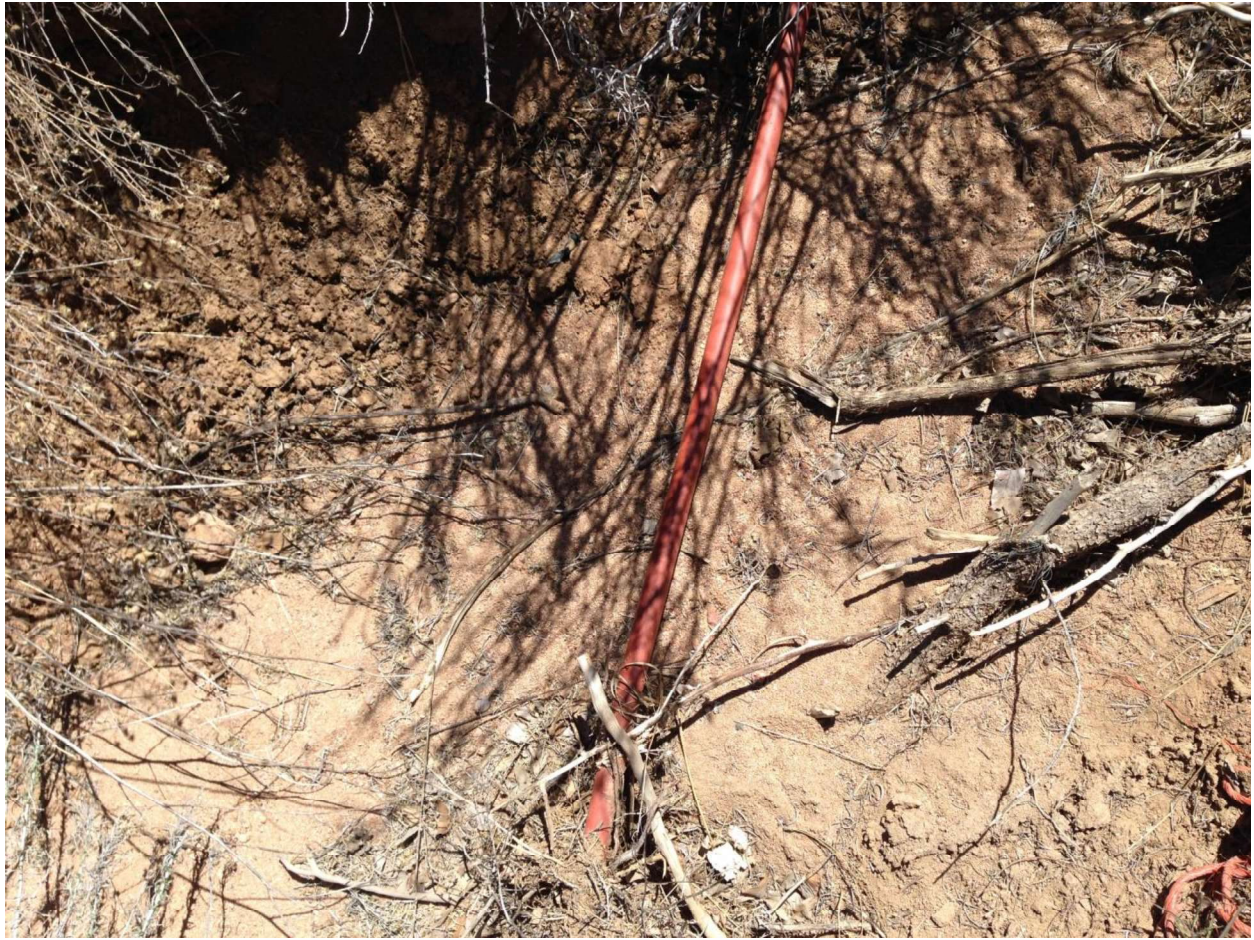
Notes: The Arroyo en Medio becomes the most constricted and incised between Rodeo Road and frontage road homes. Intermittent, vertical walls up to eight feet in height have developed in this segment. Erosion is affecting the condition of culverts, rip rap and out falls that were installed to allow residents to access their homes. These areas were marked with GPS coordinates for further examination. Also an exposed cable was located within this area.

Segment D/ Exposed cable in Arroyo en Medio,2016.

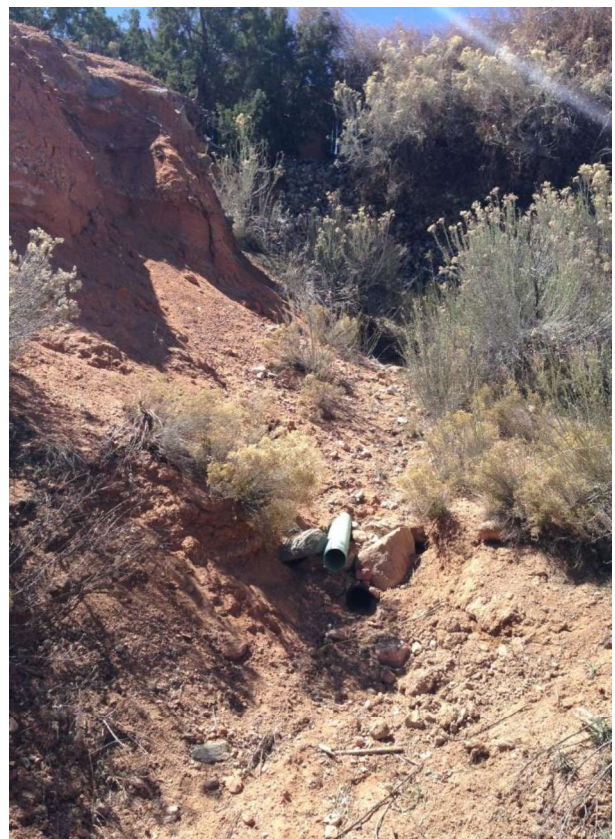
Notes: The sandy channel of the Arroyo en Medio broadens in this area. A variety of bank conditions appear in this area. Banks range from an average four feet to 20 feet in height. Along the highest banks, drainage pipes leading from residences have been installed to drain into the arroyo.

Segment F/Drain pipes in Arroyo en Medio, 2016.

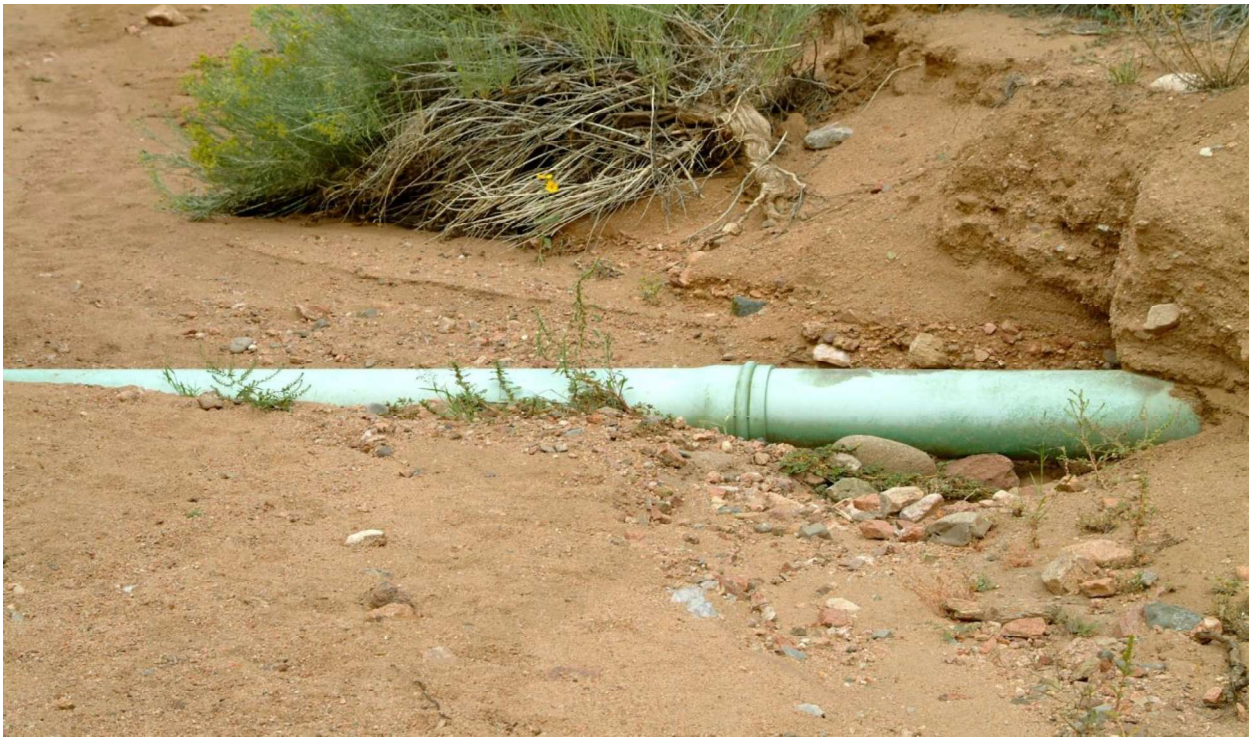
Notes: Infrastructure conditions in this segment are very poor in the Arroyo en Medio. Conditions noted in 2012 have since declined, further exposing a pipeline, exposing more cable, putting an important culvert out of service and dissolving a bank supporting a retaining wall and its system of rip rap and gabion walls. The breakdown of storm water infrastructure has caused major deterioration in this section of the arroyo. After passing S. St. Francis Drive the arroyo changes its name and becomes Arroyo Chaparral. Trash from the highway, surrounding properties (especially the shopping complex) and transient camps are common in this area.

Segment G/A partially exposed pipeline, Arroyo en Medio, 2012

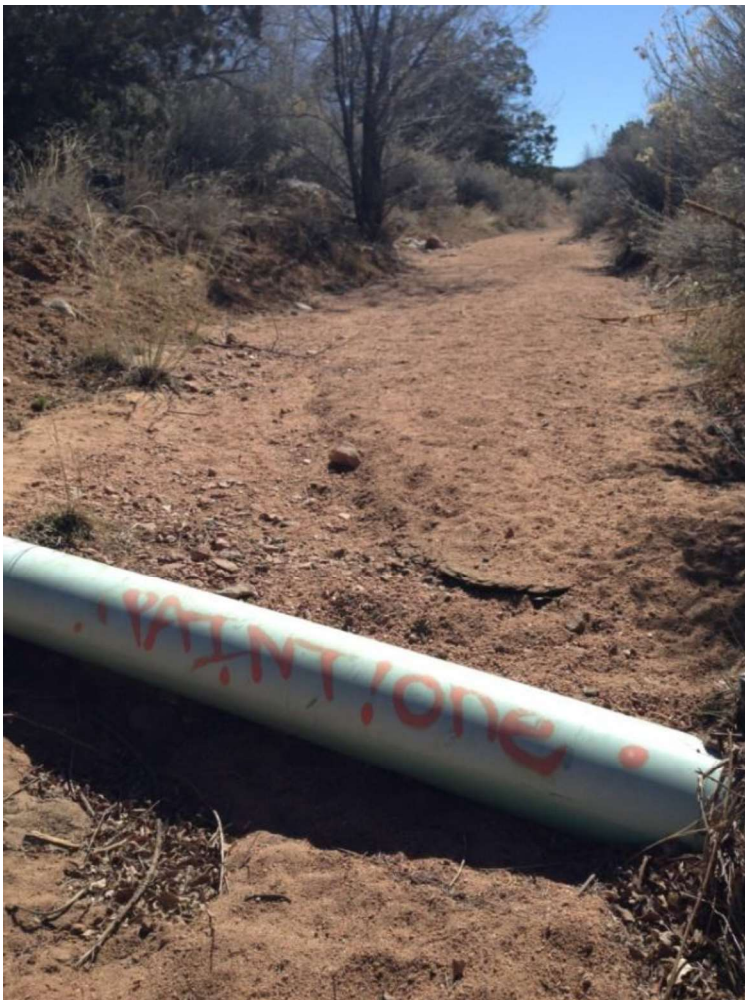
Segment G/Disconnected storm culvert in Arroyo en Medio ,2016.

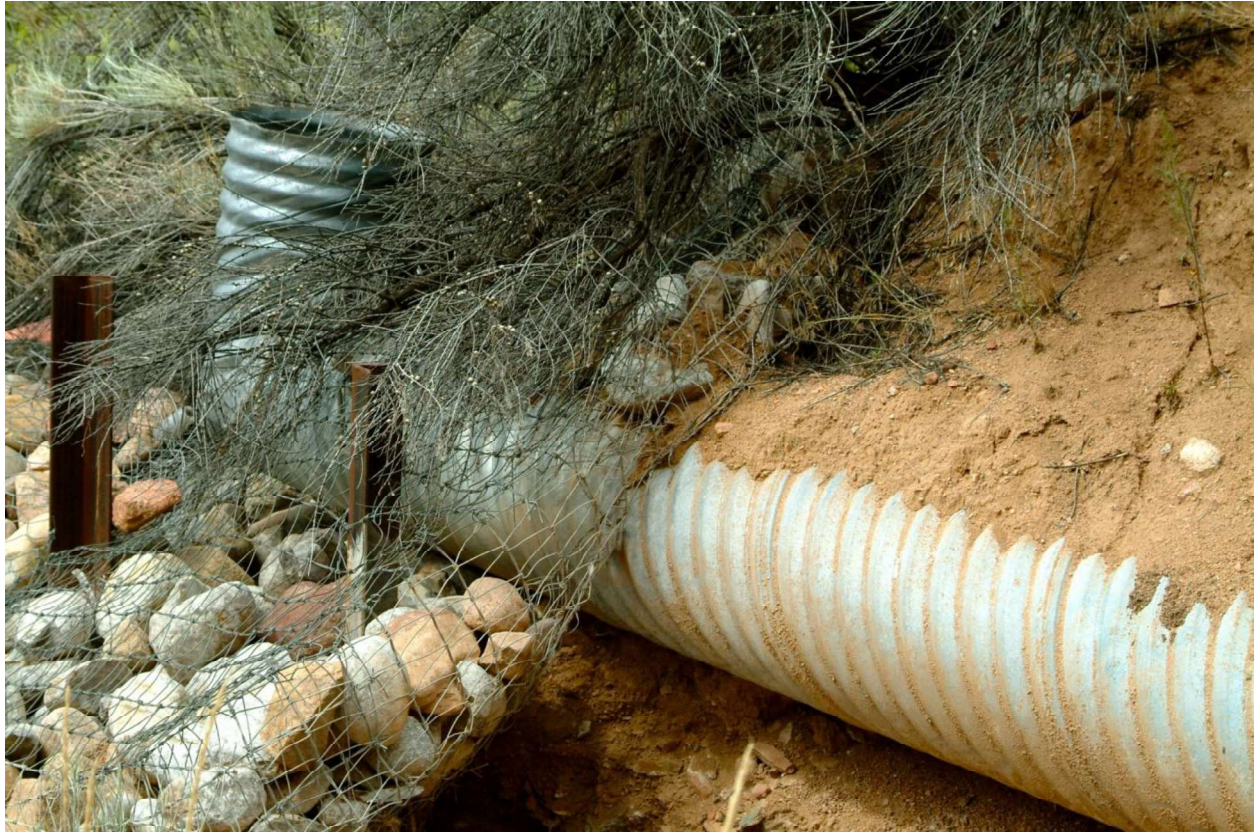
Segment G/Storm culvert in Arroyo en Medio 2012.

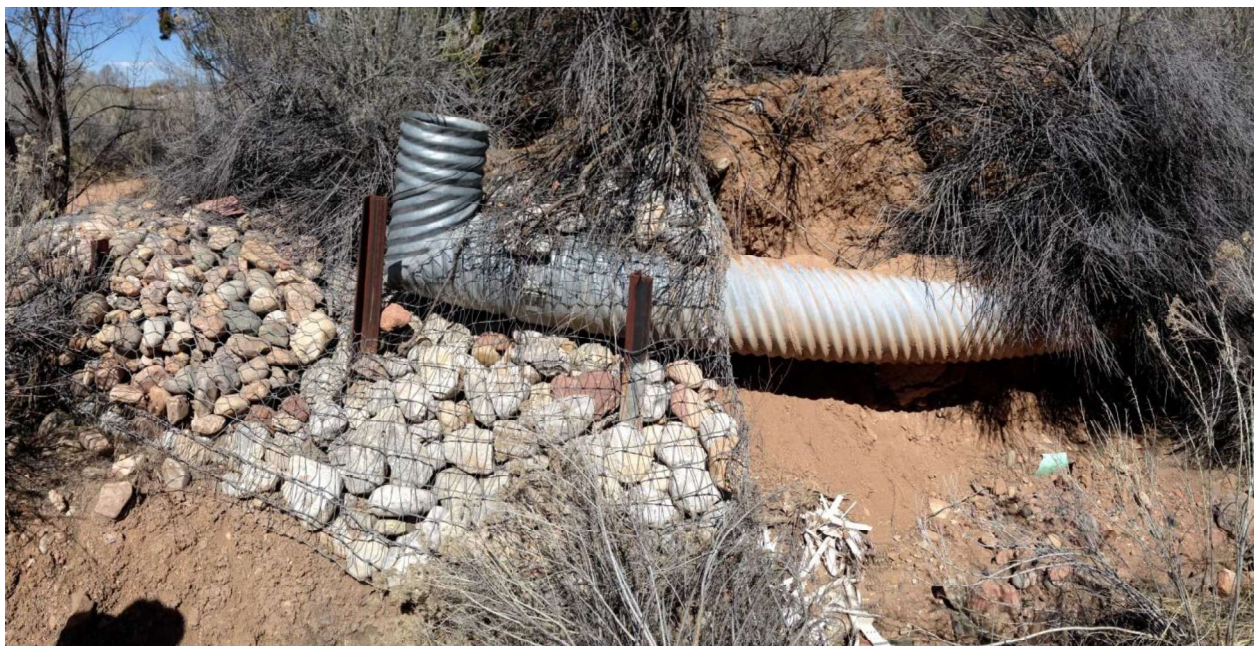
Segment G/Photo of the same storm culvert as pictured above in 2016, Arroyo en Medio.

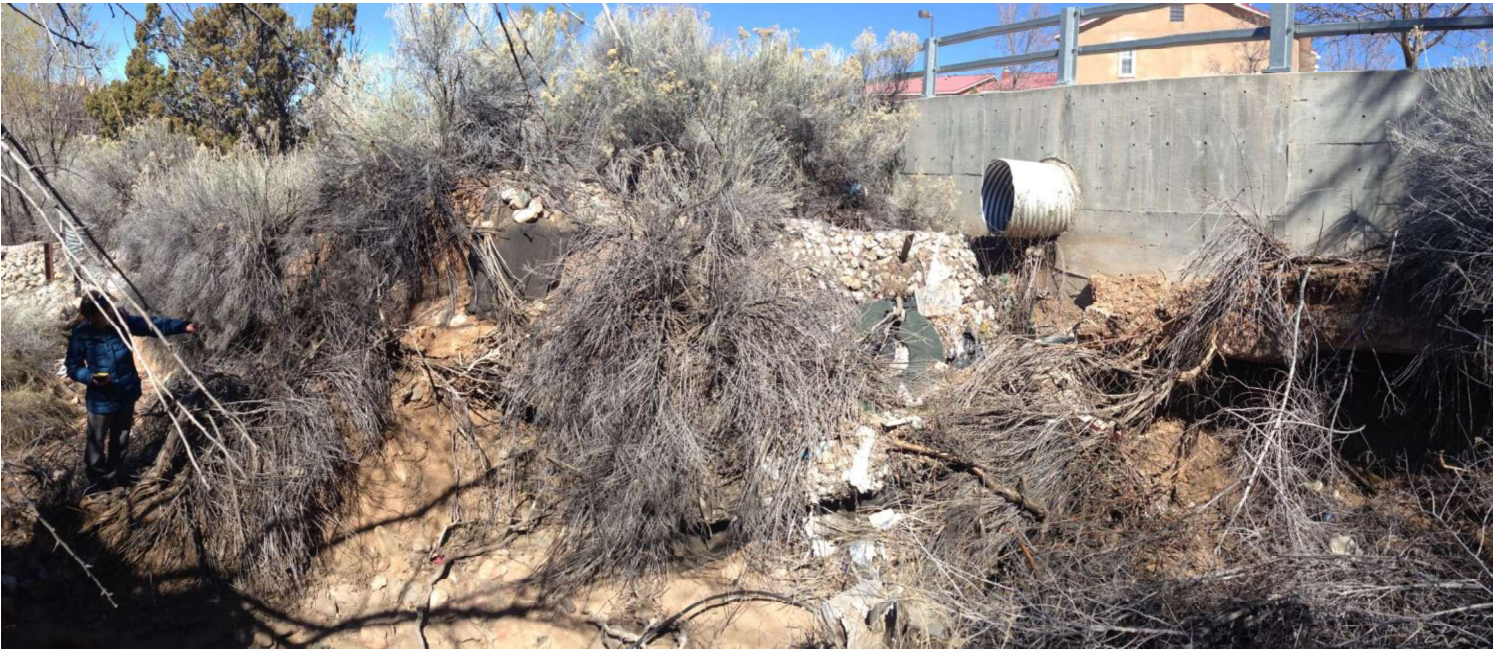
Segment G/Over view of multiple problems, Arroyo en Medio, 2016
