Arroyo Threat Assessment Surveys of 15 Major Arroyos in the Santa Fe River Watershed

June 21, 2016

Santa Fe Watershed Association

Report to Melissa McDonald, River & Watershed Coordinator, Public Works Dept., City of Santa Fe 2016

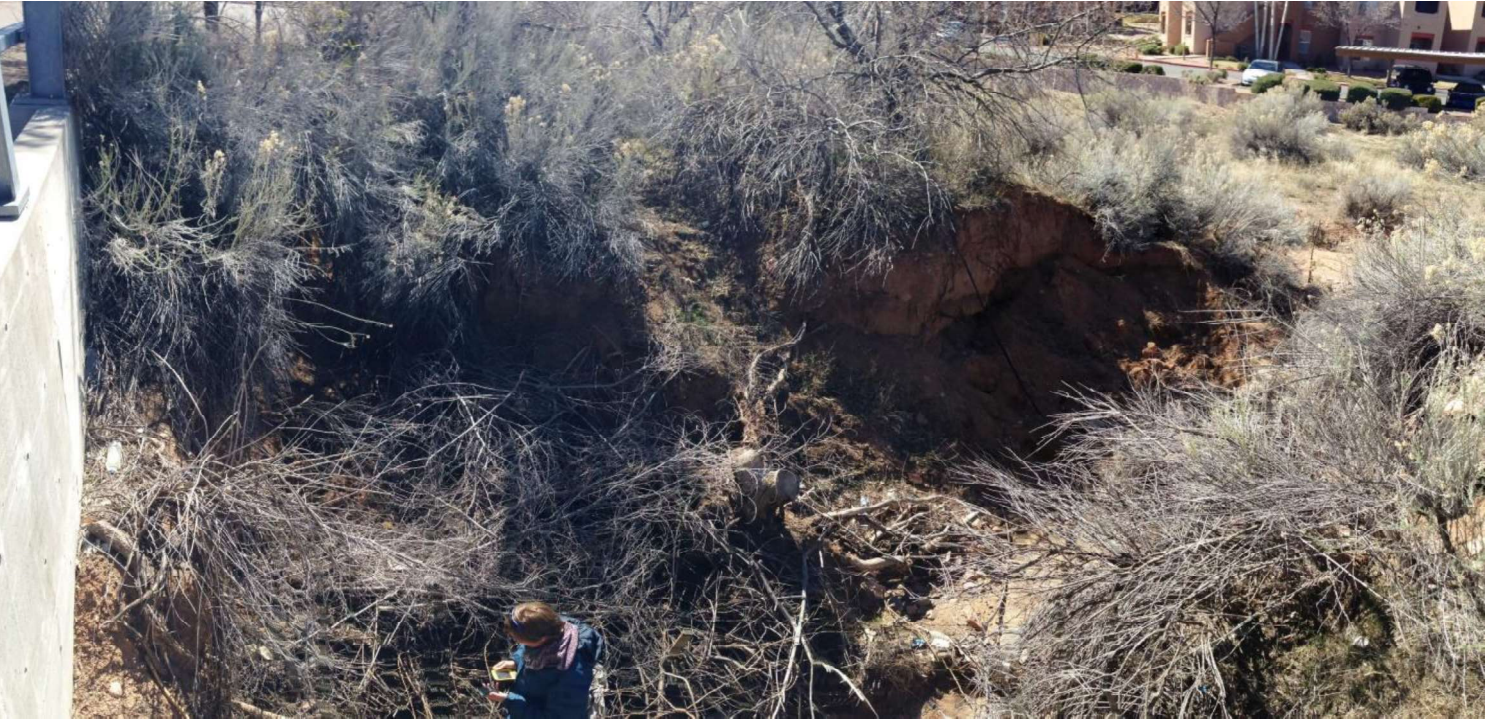
Segment G/Overview of multiple problems, Arroyo en Medio,2016

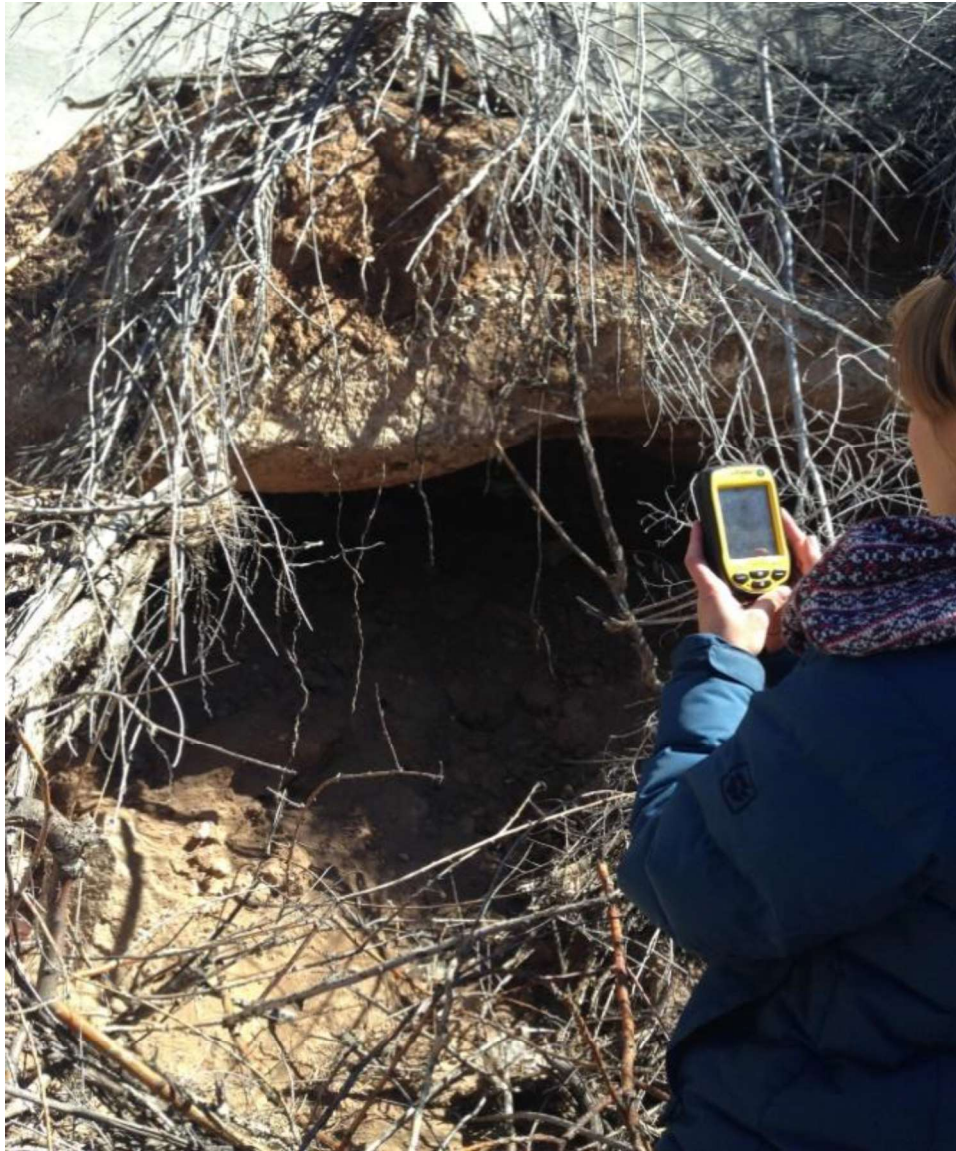
Segment G/ Undercut retaining wall, Arroyo en Medio, 2016, as pictured above.

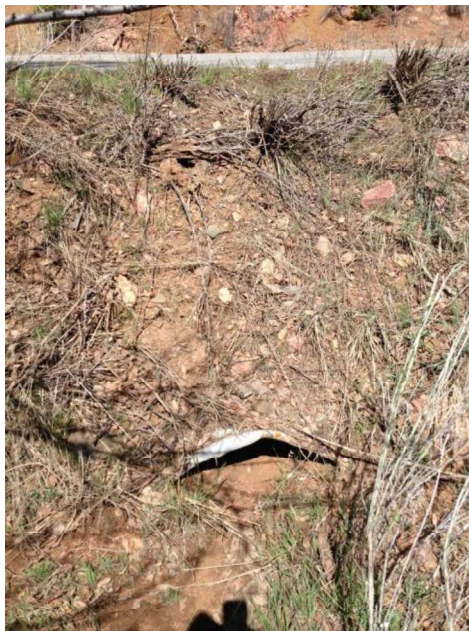
Notes: Hyde Park Road follows the Arroyo Ancha, a narrow, constricted, rocky waterway that passes beneath a canopy of ponderosa, piñon, and juniper. The passage attracts wildlife, hikers, and mountain bikers. When the arroyo enters the La Entrada area, it remains constricted and incised. Many culverts placed to drain storm water off of Hyde Park Road to then empty into the Arroyo Ancha are restricted by sediment.

Segment A/Obstructed culvert, Arroyo Ancha, 2016

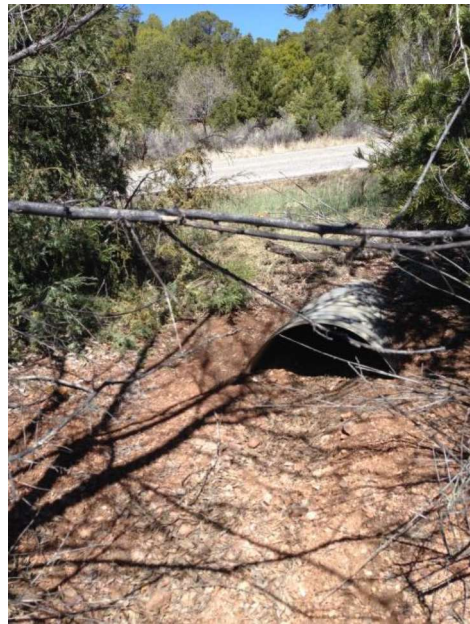
Segment A/Obstructed culvert, Arroyo Ancha, 2016

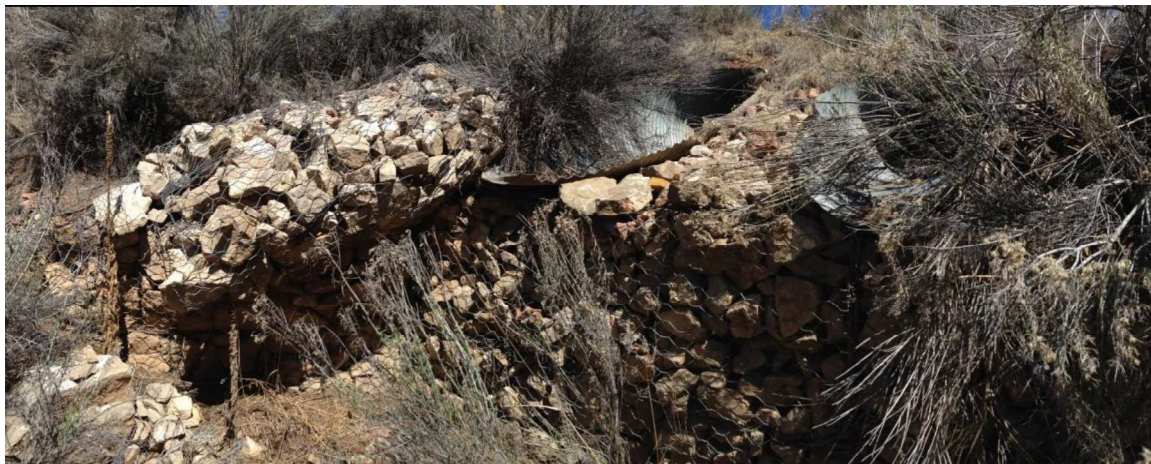
Segment A/Gabion askew, Arroyo Ancha, 2016.

Below Kachina Heights Drive, a gabion wall is hanging precariously off of the arroyo bank. Here water from the arroyo channel drops 10 feet below this culvert/gabion system expanding the arroyo bed in width and impacting infrastructure and channel characteristics.

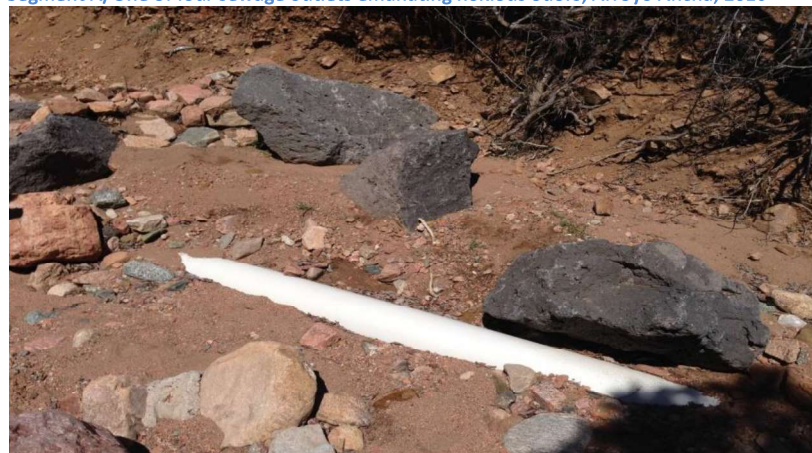
From this point, the condition of the arroyo is very poor due to extreme erosion. The sewage outlets found above ground were all emanating a noxious odor. Nearby, an above ground pipe labeled sewer was found. Corrective actions to protect infrastructure in this area are highly recommended and may be urgent. Foot and bike traffic is also frequent in this area.

Segment A/ Exposed sewer line in Arroyo Ancha, 2016

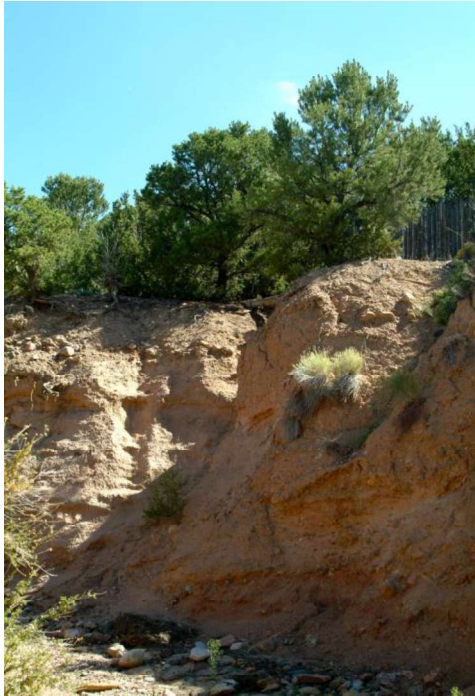
Segment B/ Example of bank erosion in Arroyo Ancha, 2016.

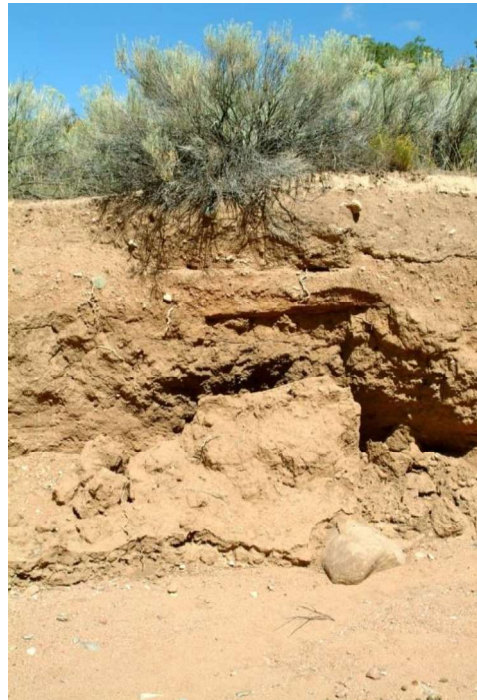
Segment B/ Example of bank calving in Arroyo Ancha, 2016.

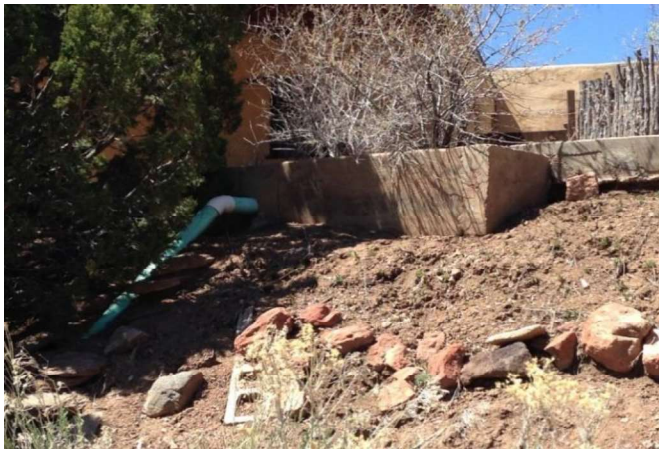
Segment B/Drain pipe with opening in the arroyo bed, Arroyo Ancha, 2016.

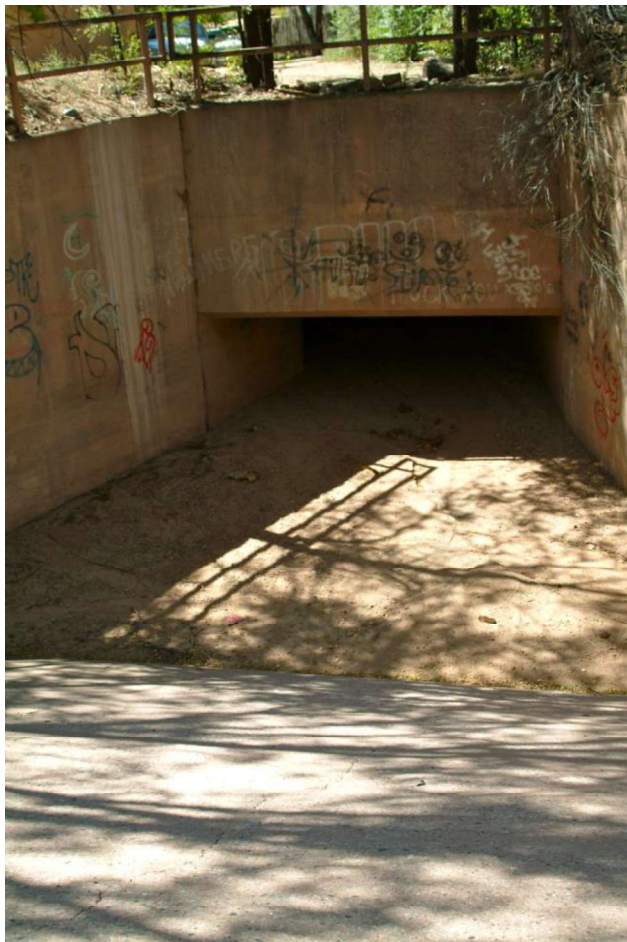
Drainage from this arroyo continues to wear on infrastructure such as rip rap mats, footings around concrete check dams and private property. The sediment in the box culvert at the junction of the arroyo and the Santa Fe River has increased.

Segment B/ Box culvert trapping sediment beneath E. Alameda St., Arroyo Ancha, 2012.

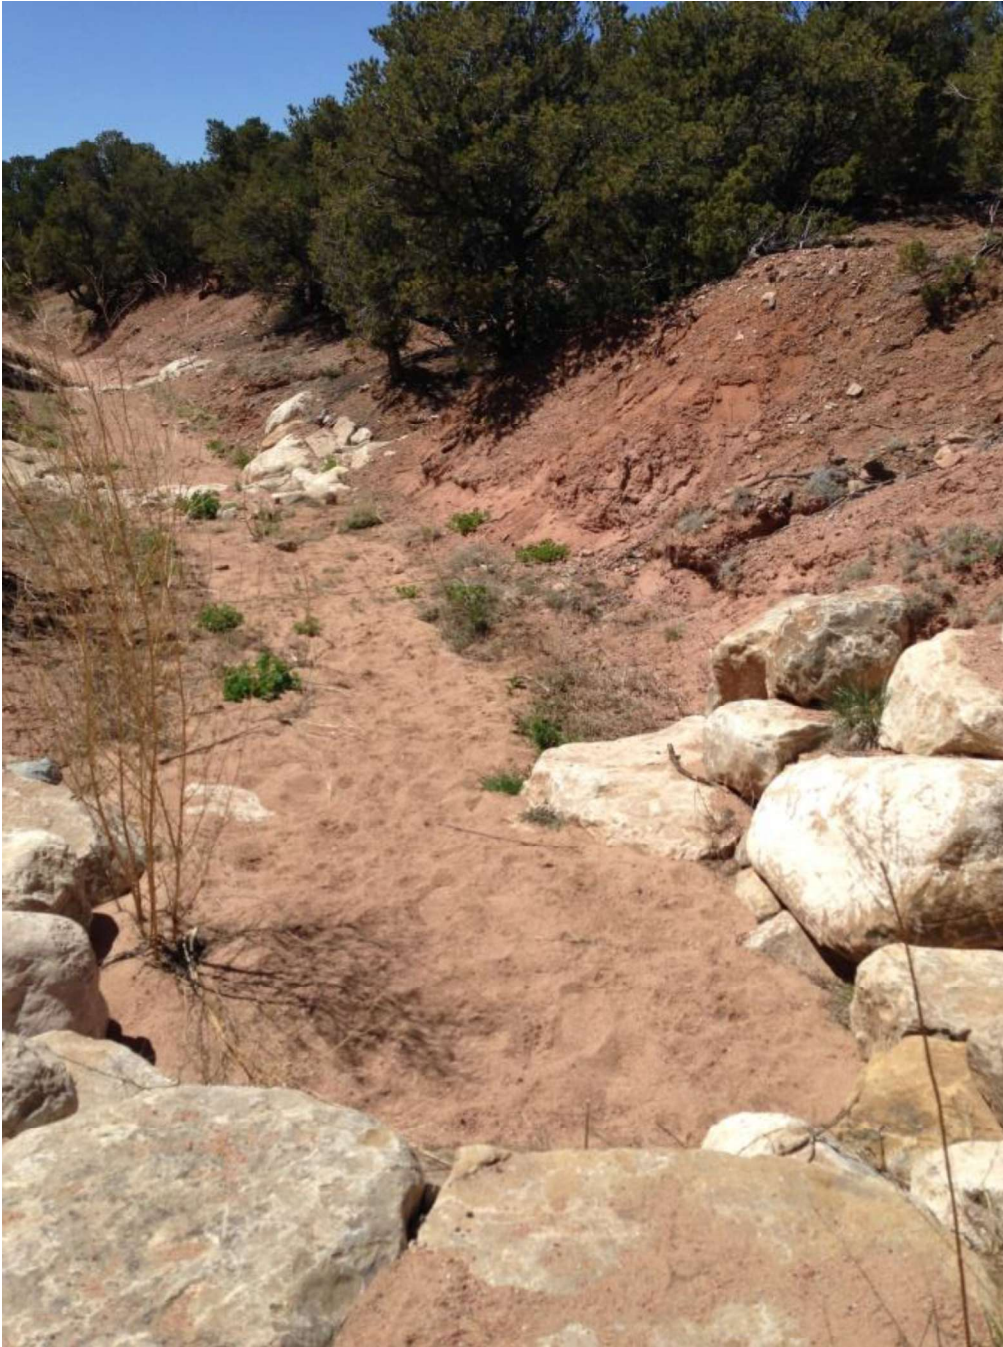
After 2012, structures like one rock dams and step downs have been placed in the arroyo and at intersections with smaller drainages in the arroyo between Galisteo and Old Pecos Road. At this time the condition of these additions appear to be functional.

Segment A. One rock check dams, Upper Arroyo Pinos North, 2016.

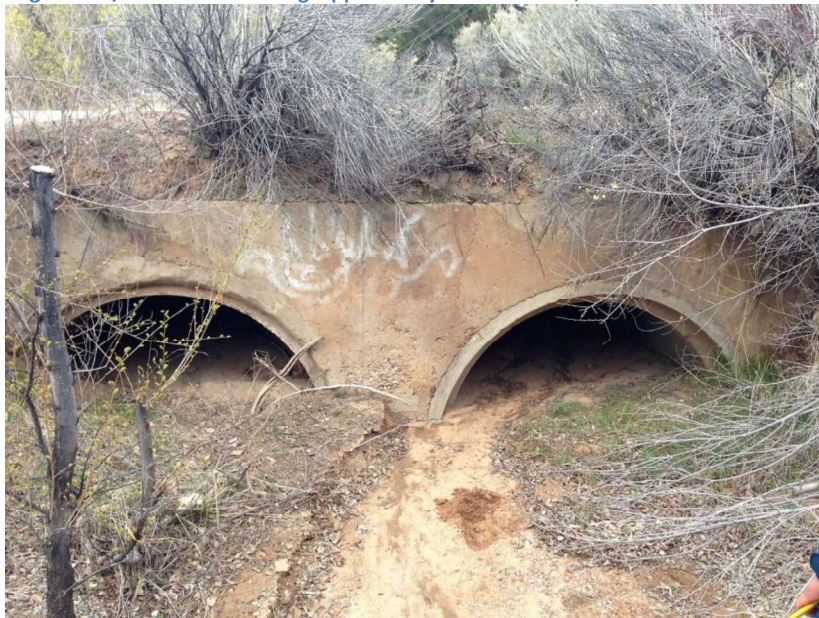
Notes: The two upper branches of Arroyo de los Pinos converge near Don Gaspar. As with Segment A, Upper Pinos South, the channel of the arroyo and vegetative zone are very similar. Obstructed culverts are the most common problem to be found within the infrastructure located in this arroyo. An unofficial walking trail along the banks and in the arroyo until can also be found here. Since 2012, a road has been made, leading from one property to another. Trash is present in this segment as well as the previous segment.

Segment B /Obstructed culvert Upper Arroyo Pinos South, 2016.

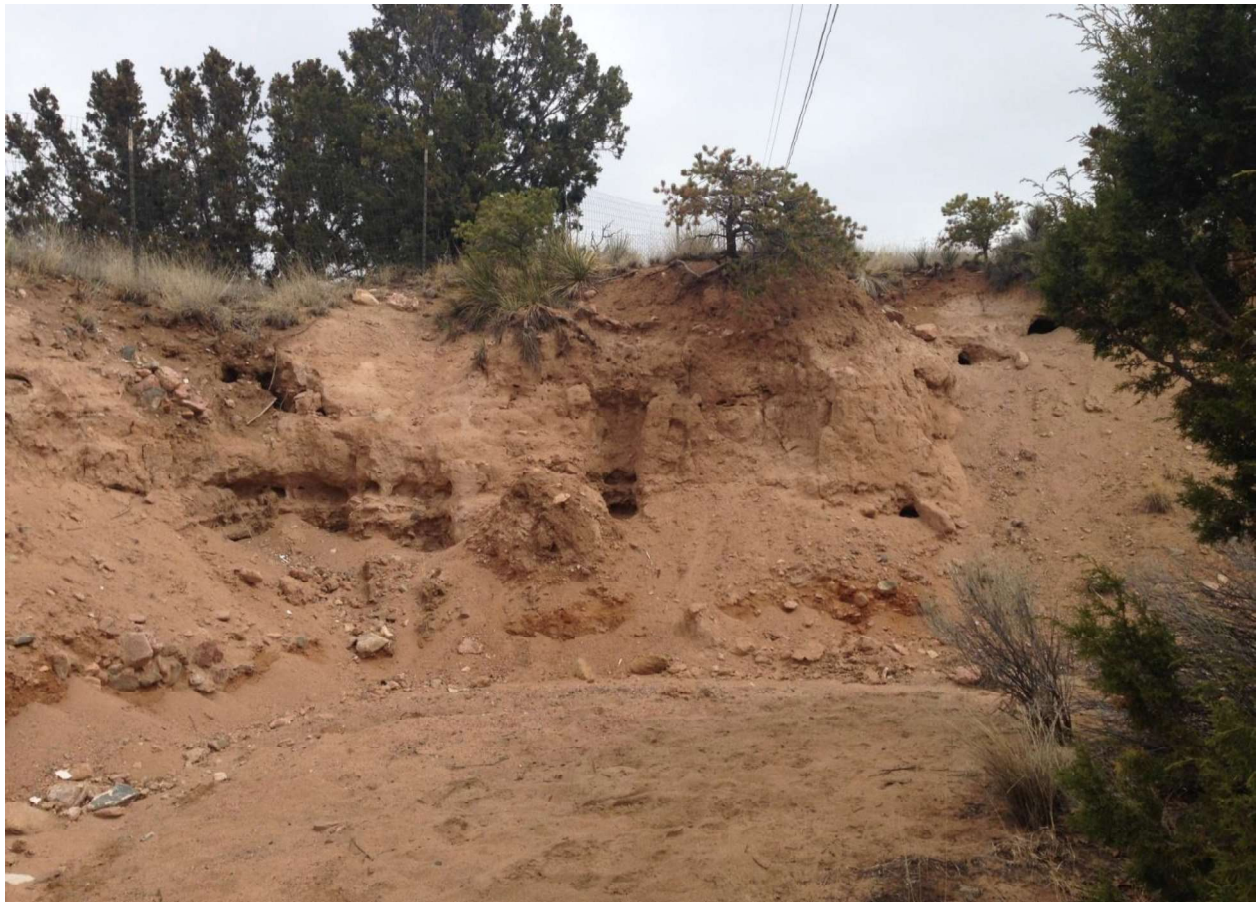
Segment B /Vertical banks Upper Arroyo Pinos South, 2016.

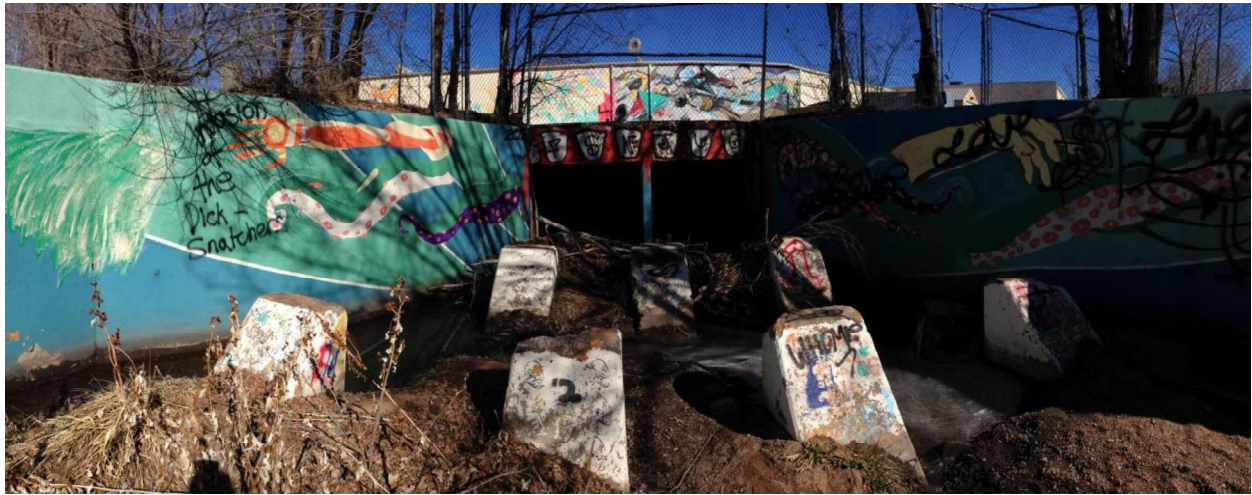
Segment X/ Storm outlet , Lower Arroyo Pinos, 2016.

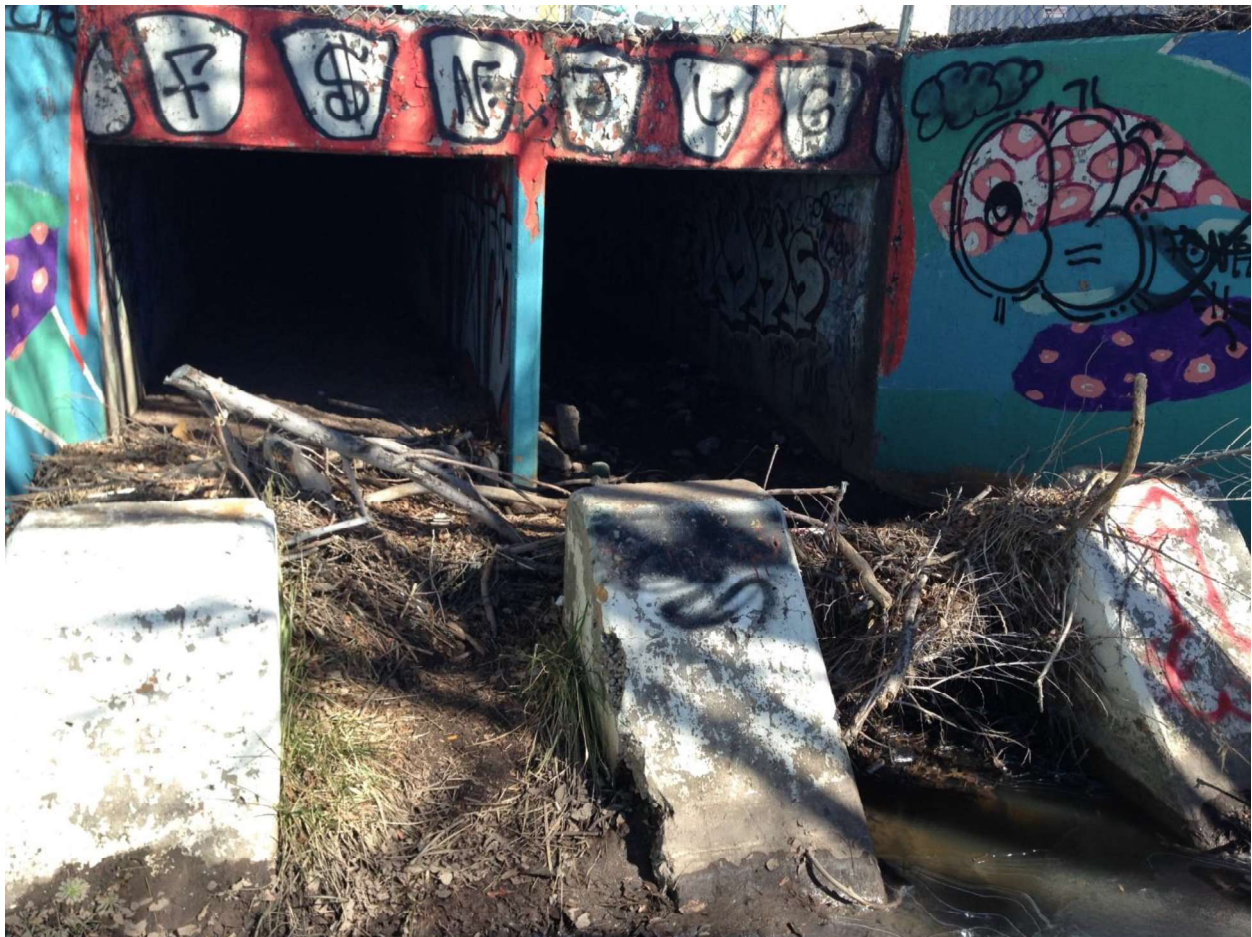
Segment X/ Debris caught in storm outlet , Lower Arroyo Pinos, 2016.

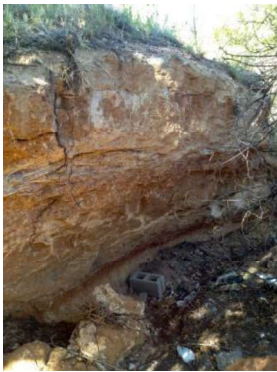
Segment A /Left photo 2012 bank erosion ; photo right 2016 bank erosion same location. Lower Arroyo de los Pinos,2016.

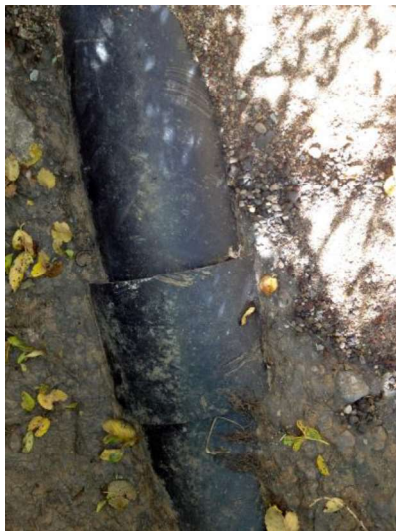
Segment B/Exposed pipe, Lower Arroyo Pinos, 2012.

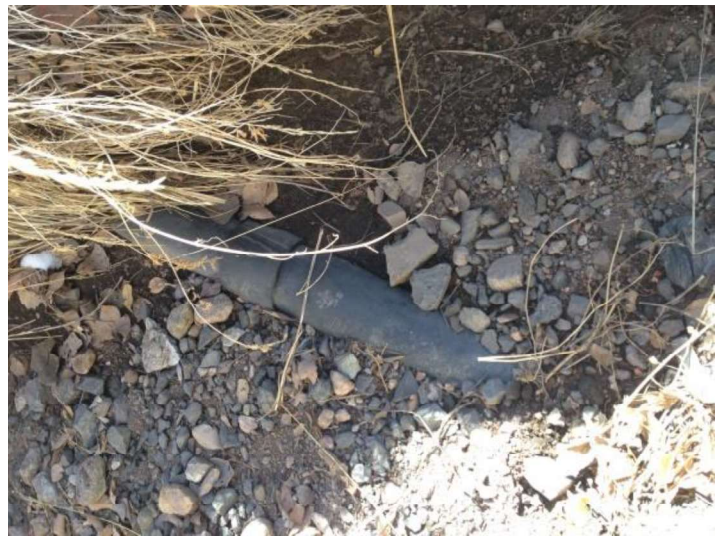
Segment B/ Exposed pipe same location, Lower Arroyo Pinos, 2016.

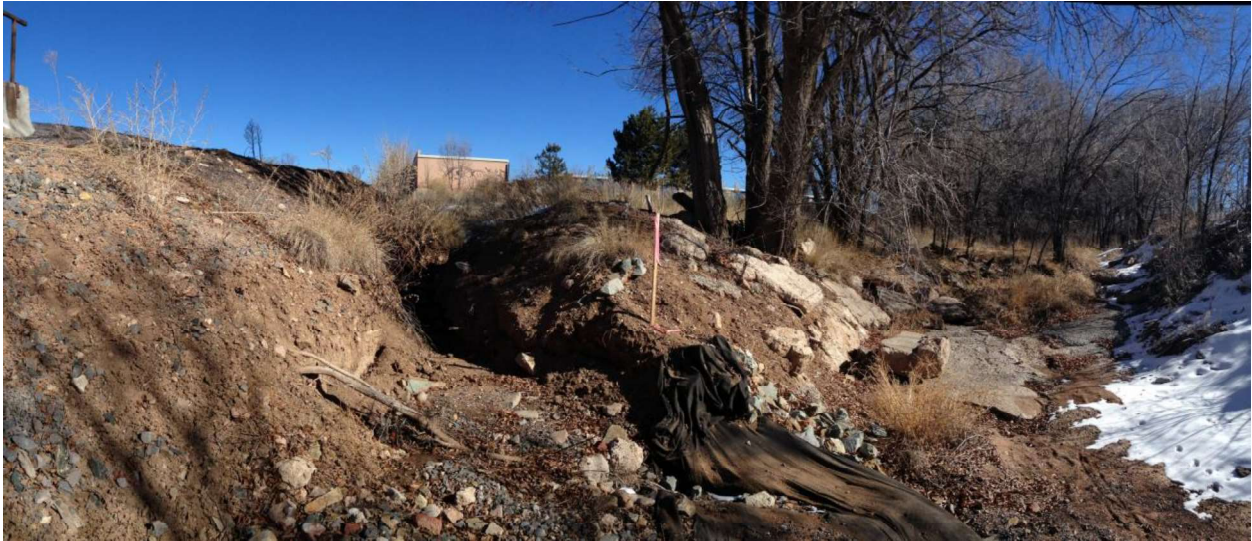
The stretch between St. Francis Drive and the Rail Runner crossing near Second Street is covered with dense ground vegetation and mature deciduous trees. In several areas beneath the trees, the arroyo is shallow and opens into a wide bed, later returning to an incised channel after passing under the Rail Runner tracks. The culverts beneath the tracks in 2012 were clear of sediment. These culverts are now no longer sediment free. A perpendicular ditch runs into the arroyo from the railroad property. Soils eroding from this ditch may be contributing to extra sedimentation in the culverts and has uncovered a conduit pipe that services rail infrastructure.

Segment B/ Heavy erosion on RR property into the Pinos, 2016.

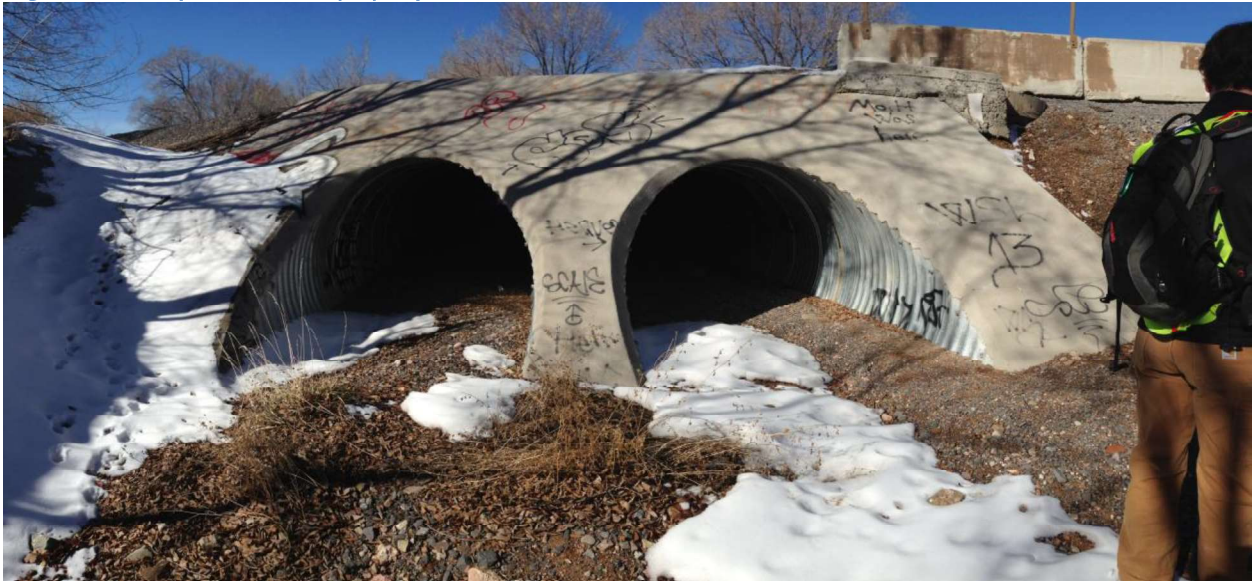
Segment B/ Culverts under Rail Runner tracks, Lower Arroyo Pinos, 2016.

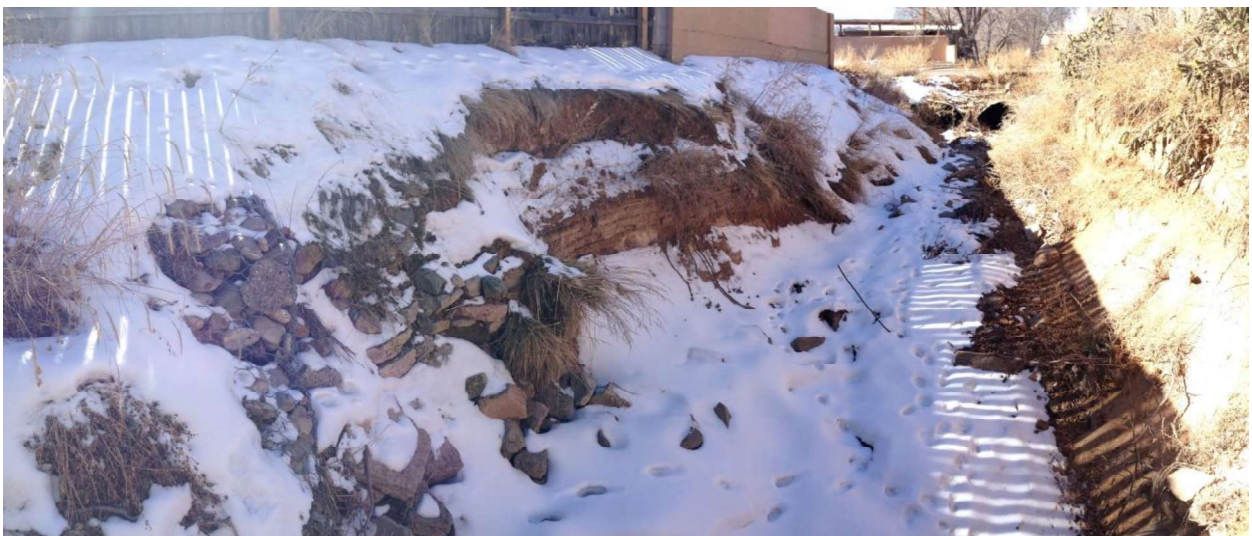
From Hopewell Street to 6th Street Arroyo de los Pinos transforms into a long, constricted ditch traveling through several neighborhoods. It is strewn with trash and concrete. Banks are undercut and are usually high in areas. The arroyo is encroaching on private property at the 5th street crossing.

Segment B /Bank erosion below private property, Lower Arroyo Pinos, 2016.

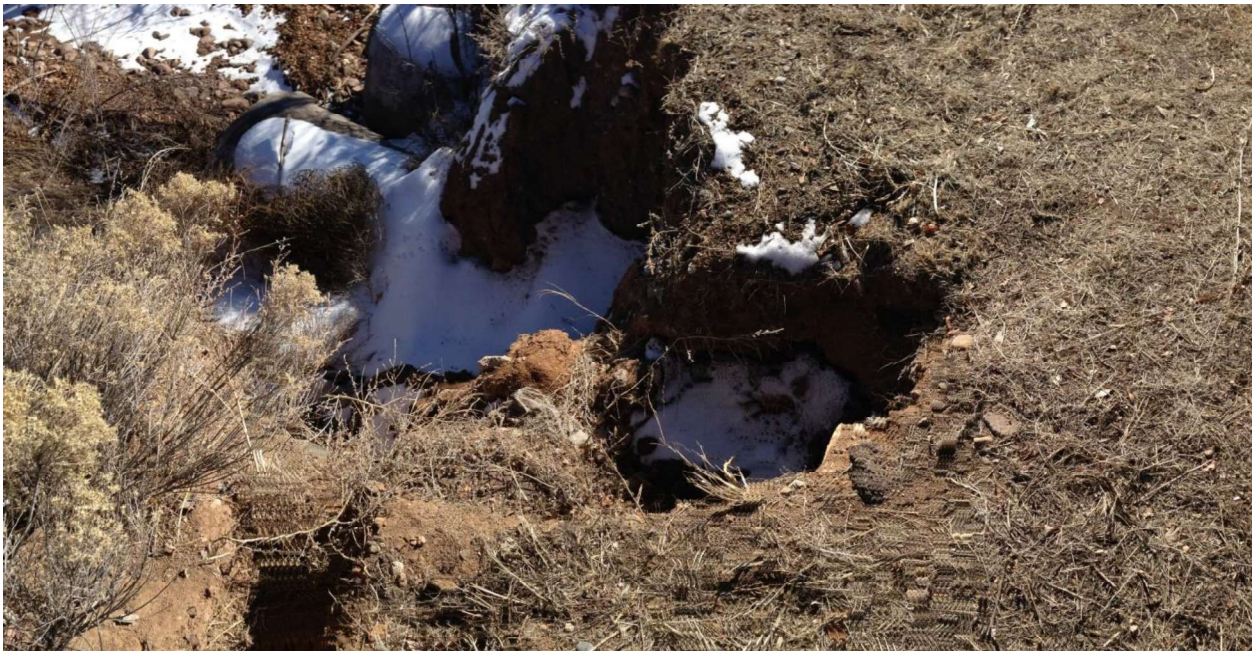
Segment C/ Bank erosion ~2 feet from manhole, Lower Arroyo Pinos, 2016.

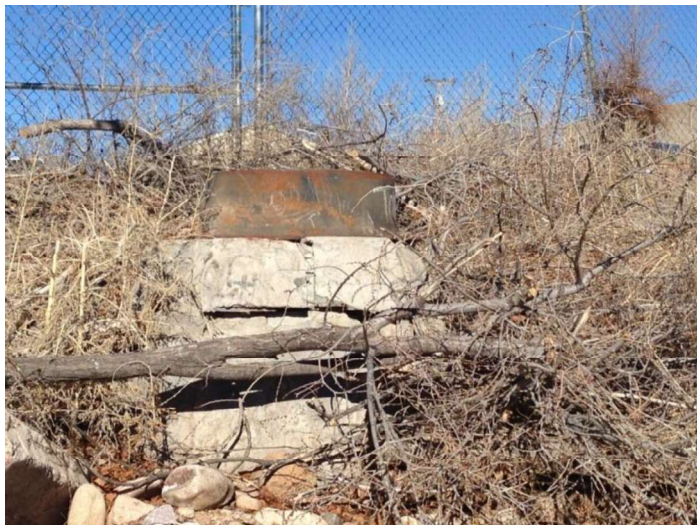
Same sewer outlet with protection, Lower Arroyo Pinos, 2016 .

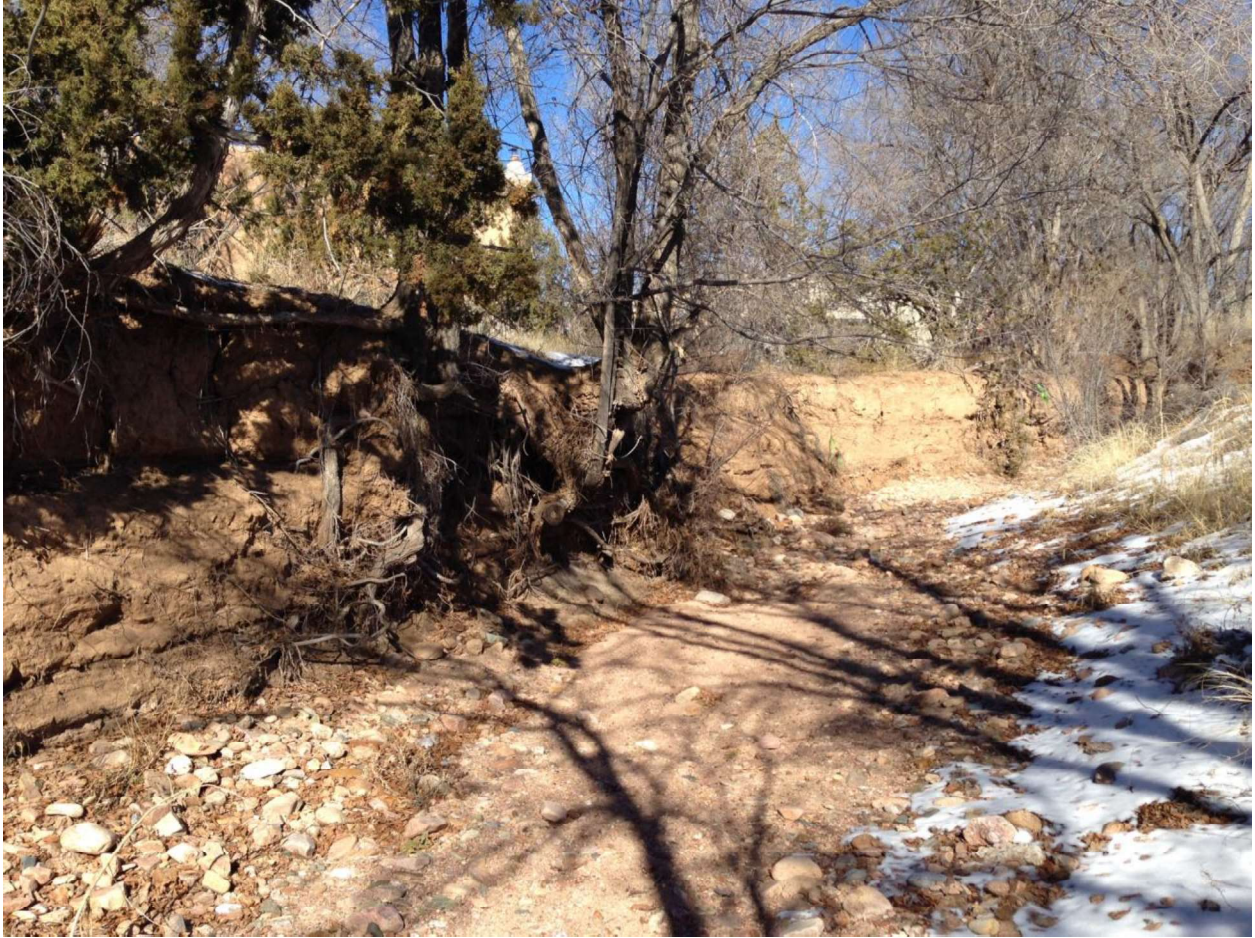
Segment E/ Bank erosion, Lower Arroyo Pinos, 2016 .

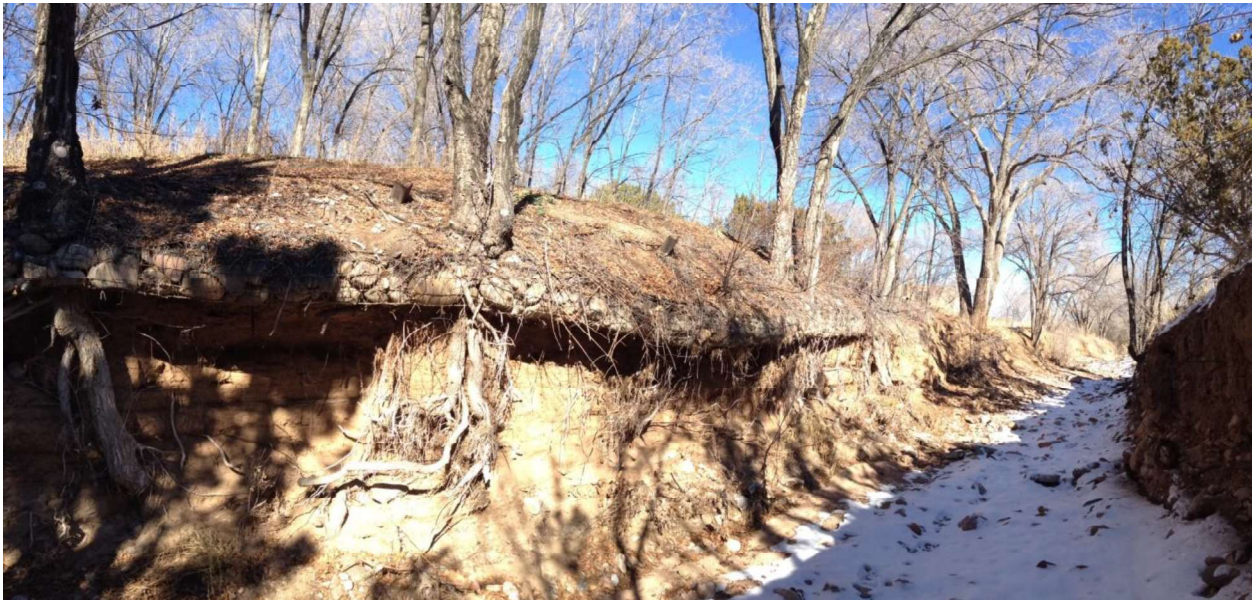
Segment E/ Bank erosion, Lower Arroyo Pinos, 2016 .

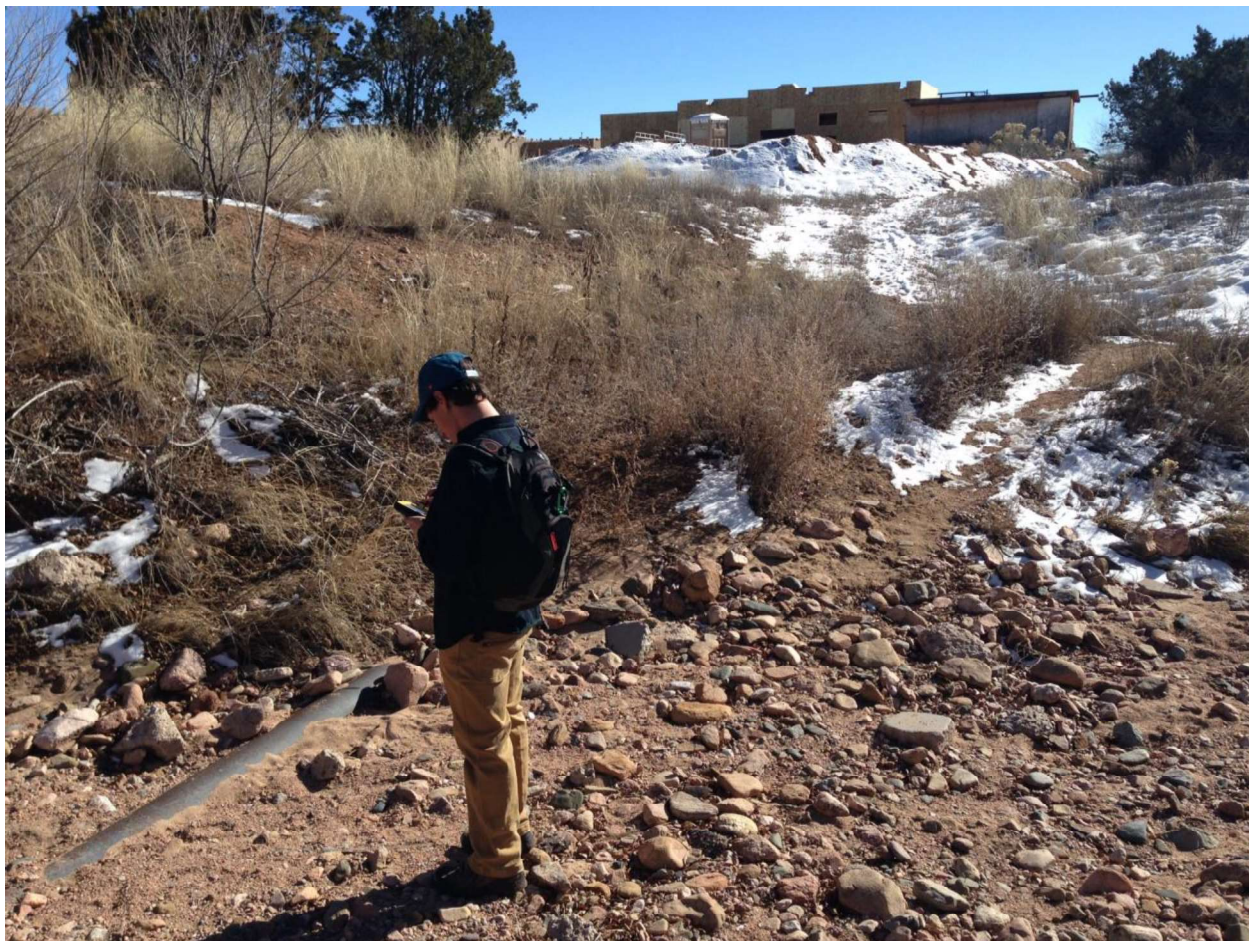
Segment E/ Exposed utility, Lower Arroyo Pinos, 2016.

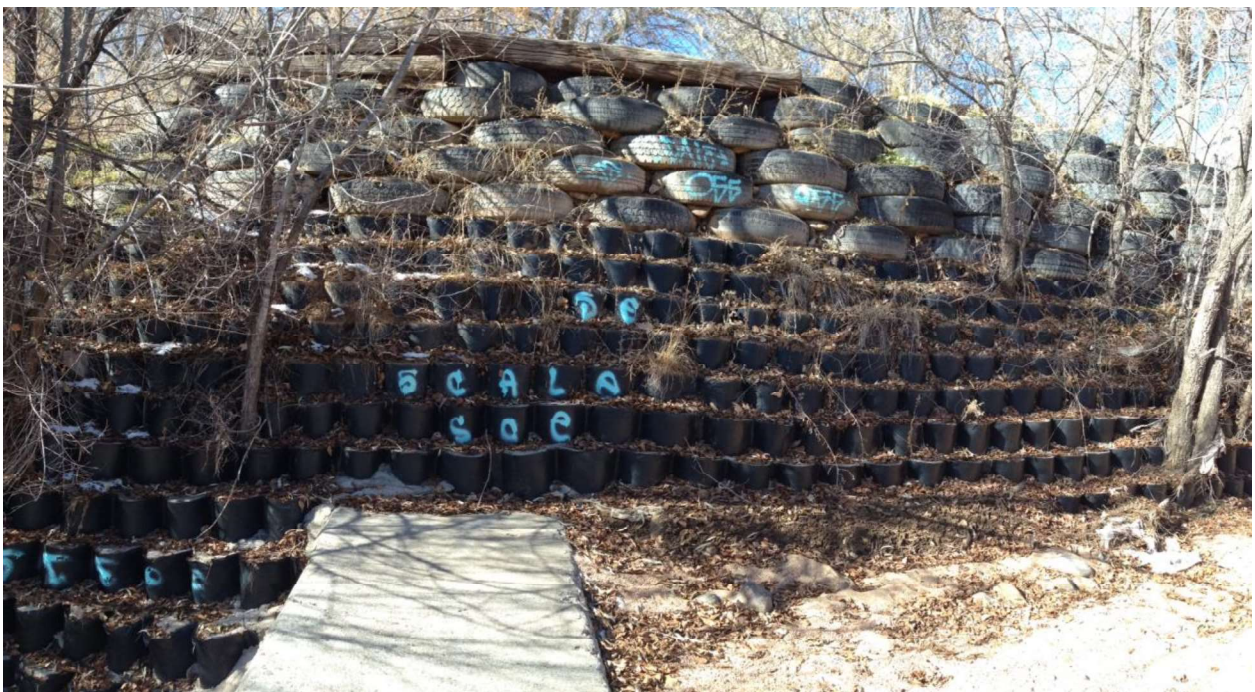
Segment E/ Young trees anchor bank stabilization materials, Lower Arroyo Pinos, 2016.

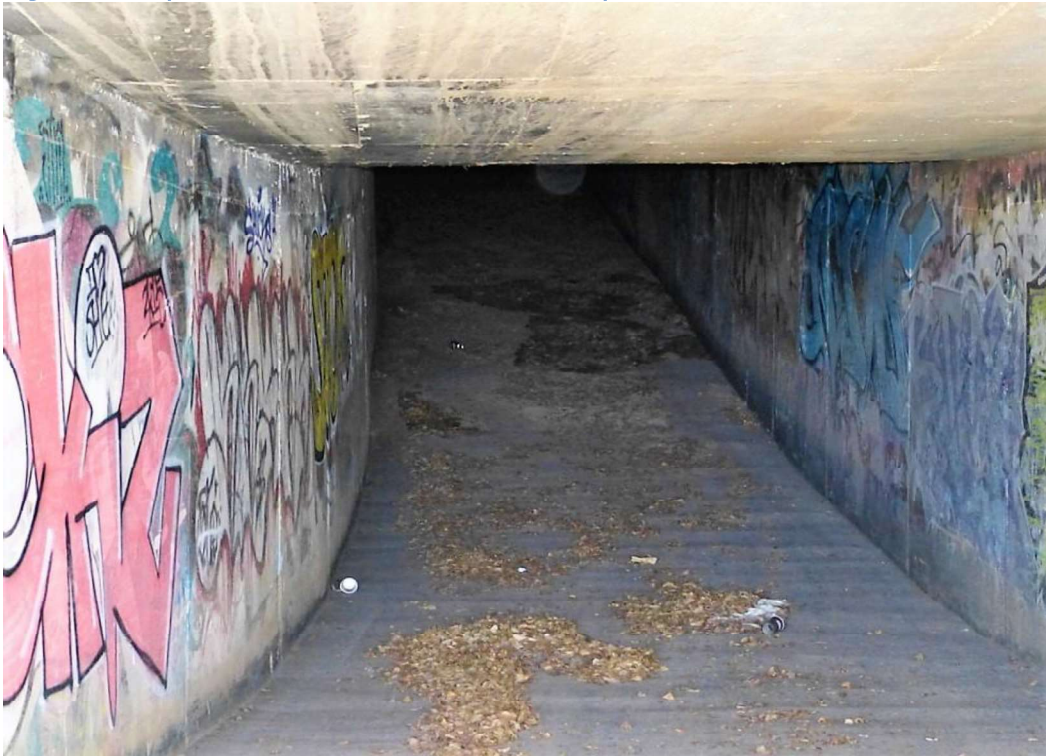
Segment C/ Paseo de Peralta culvert, Arroyo Mascaras, 2016.

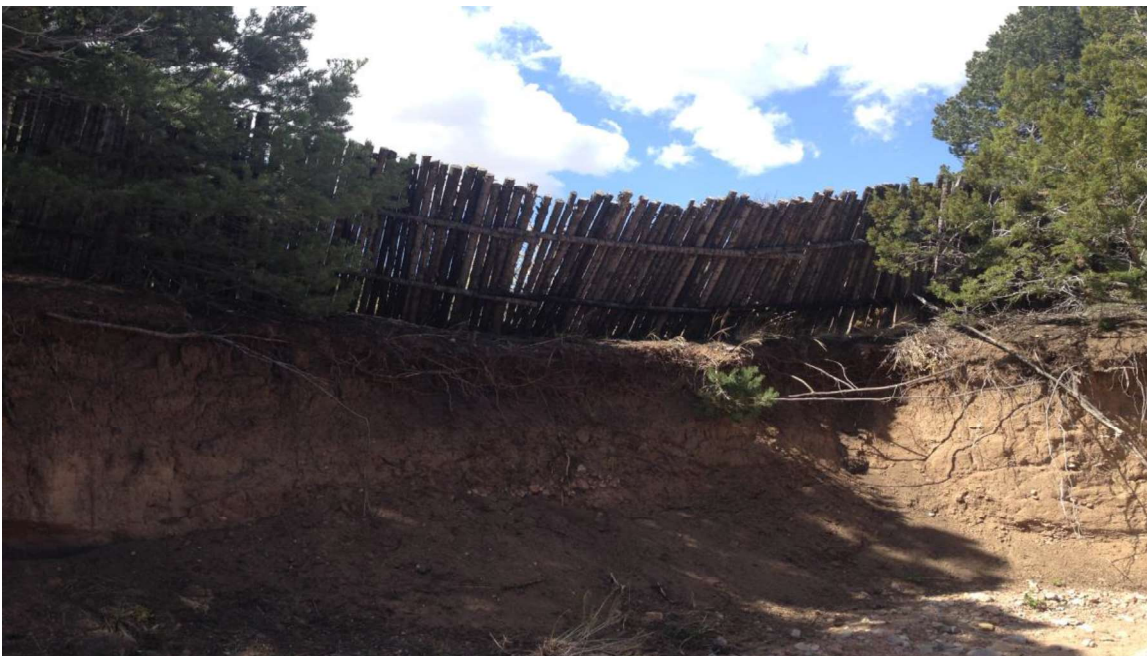
Segment A/ Bank erosion, Arroyo Piedra, 2016.

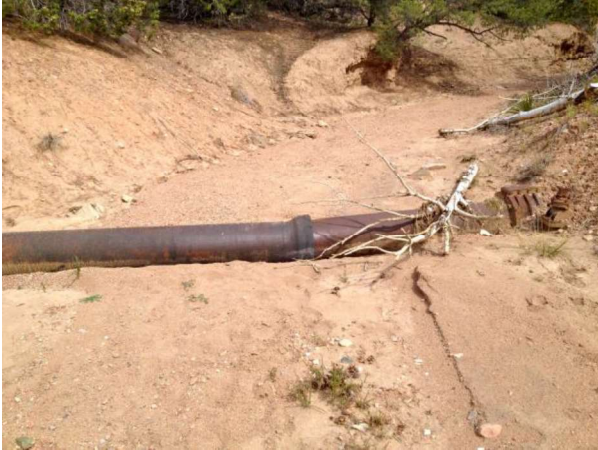
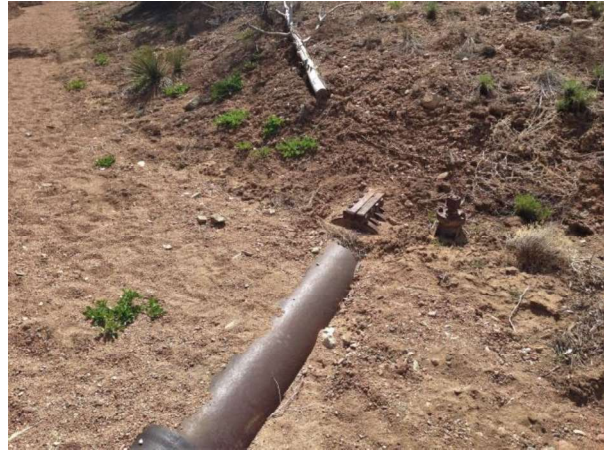
Segment A/ Comparison of exposed iron pipe. Left 2016 condition/ Right 2012 condition, Arroyo Piedra, 2016.

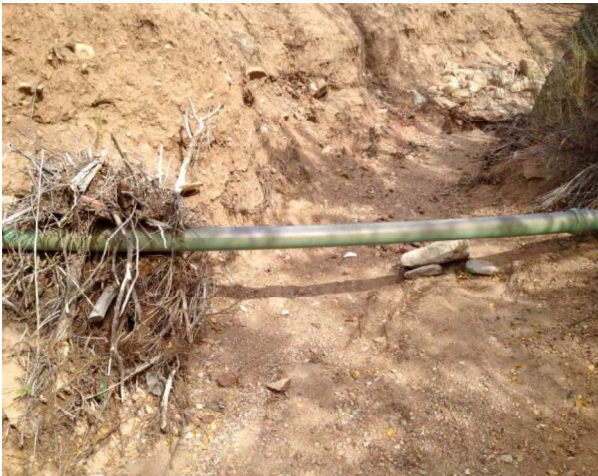
Segment A/ Comparison of exposed green pipe. Photo left 2012 condition and photo right 2016 condition, Arroyo Piedra, 2016.

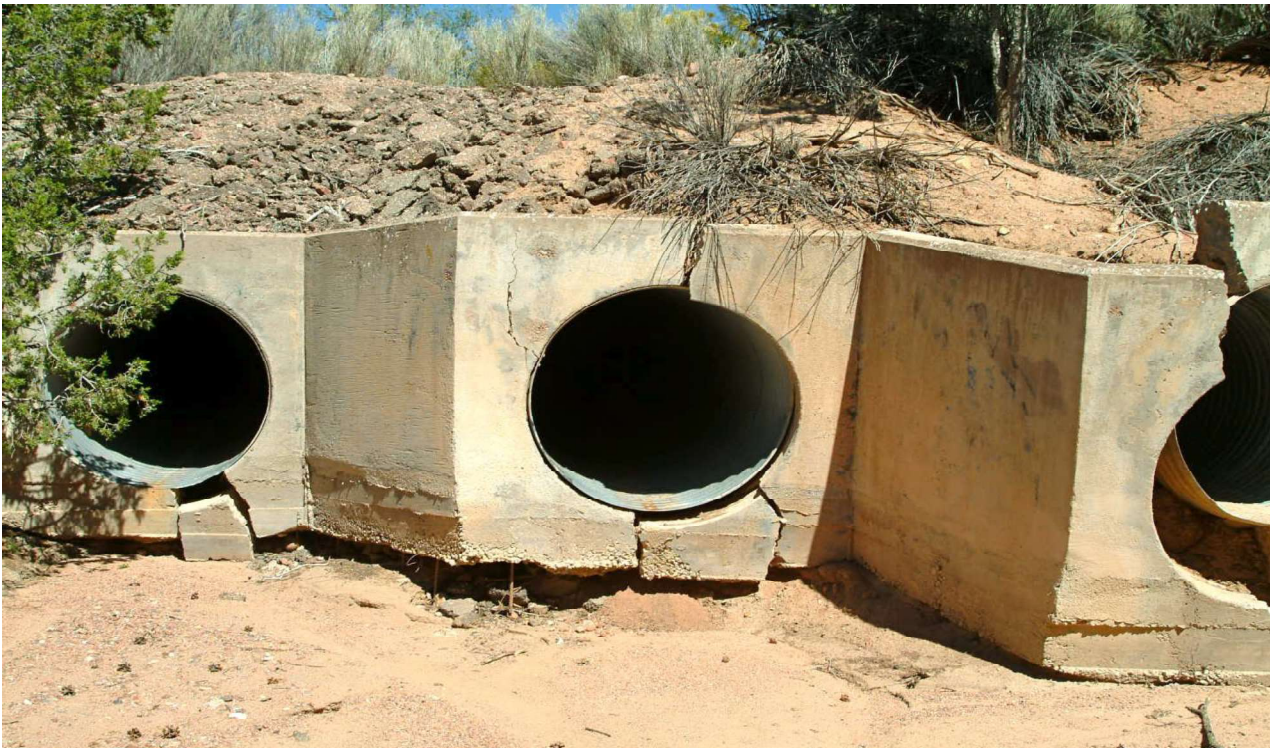
Segment B/ Comparison of culverts photo from 2012, Arroyo Piedra.
