Arroyo Threat Assessment Surveys of 15 Major Arroyos in the Santa Fe River Watershed

June 21, 2016

Santa Fe Watershed Association

Report to Melissa McDonald, River & Watershed Coordinator, Public Works Dept., City of Santa Fe 2016

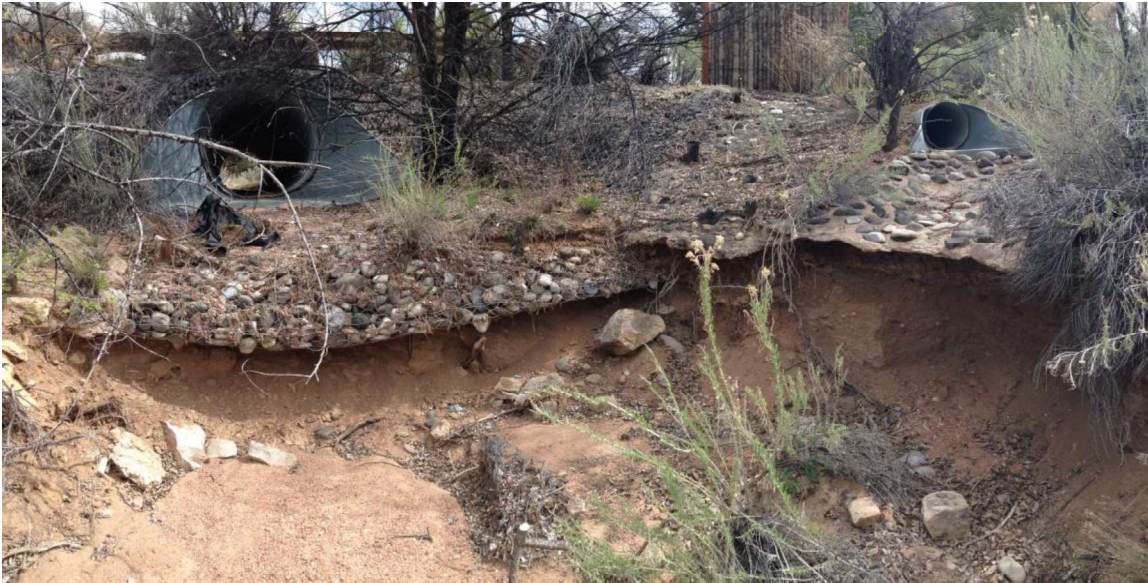
Segment B/ Rip rap mats undermined , Arroyo Piedra, 2016.

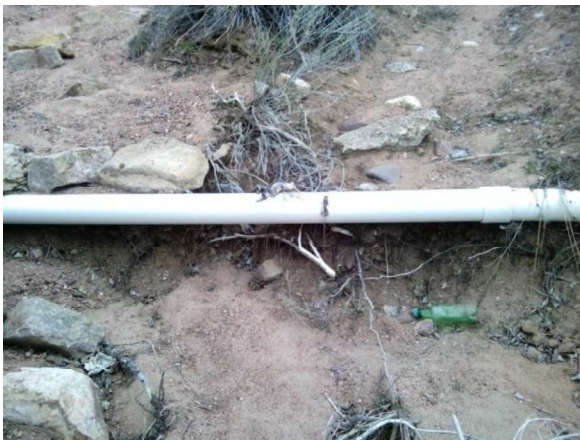
Segment B/ Exposed utility 2016 , Arroyo Piedra.

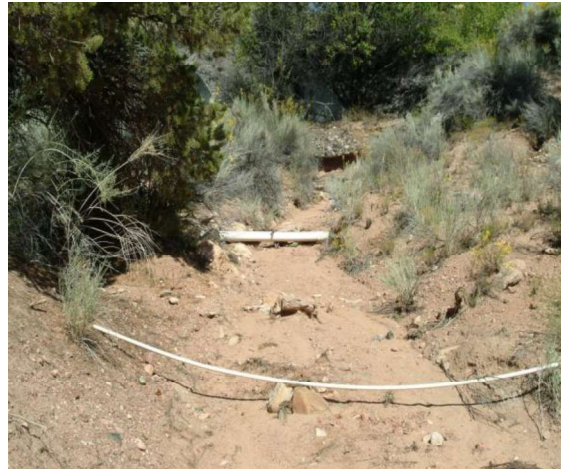
Segment B/ Exposed utility 2012 , Arroyo Piedra.

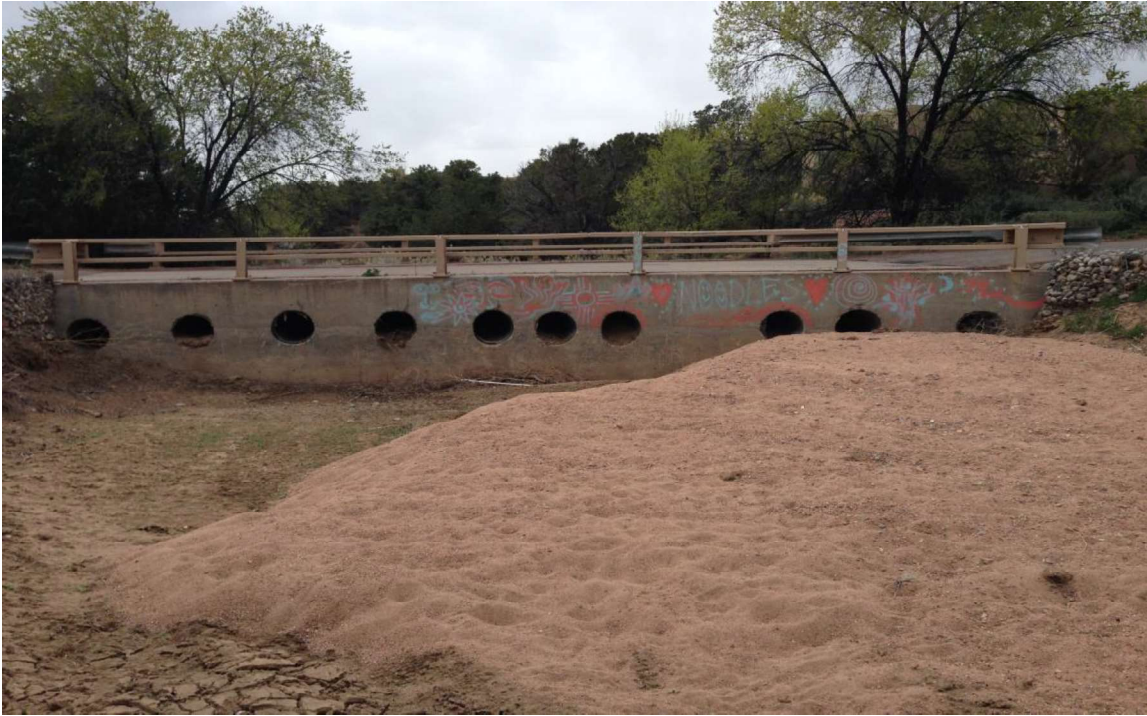
Segment B/ Upstream side of restricted culverts with sediment displacement , Arroyo Piedra, 2016.

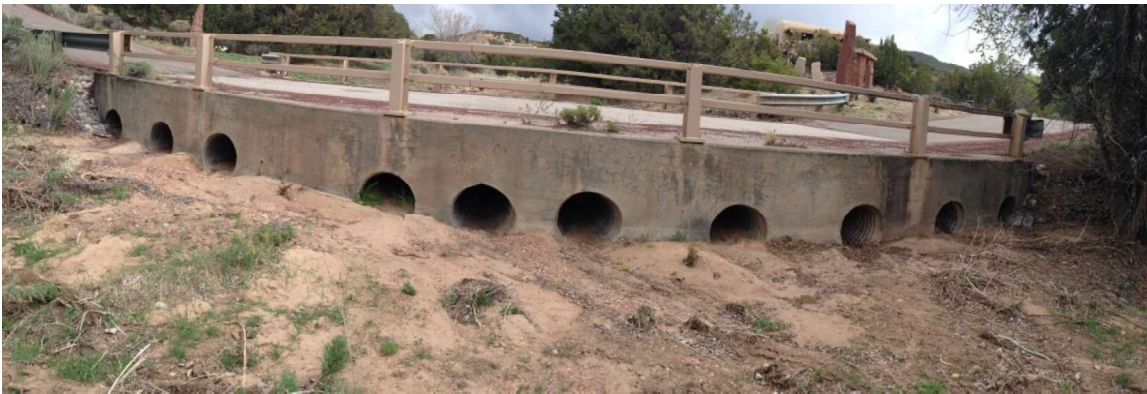
Segment B/ Downstream side of restricted culverts , Arroyo Piedra, 2016.

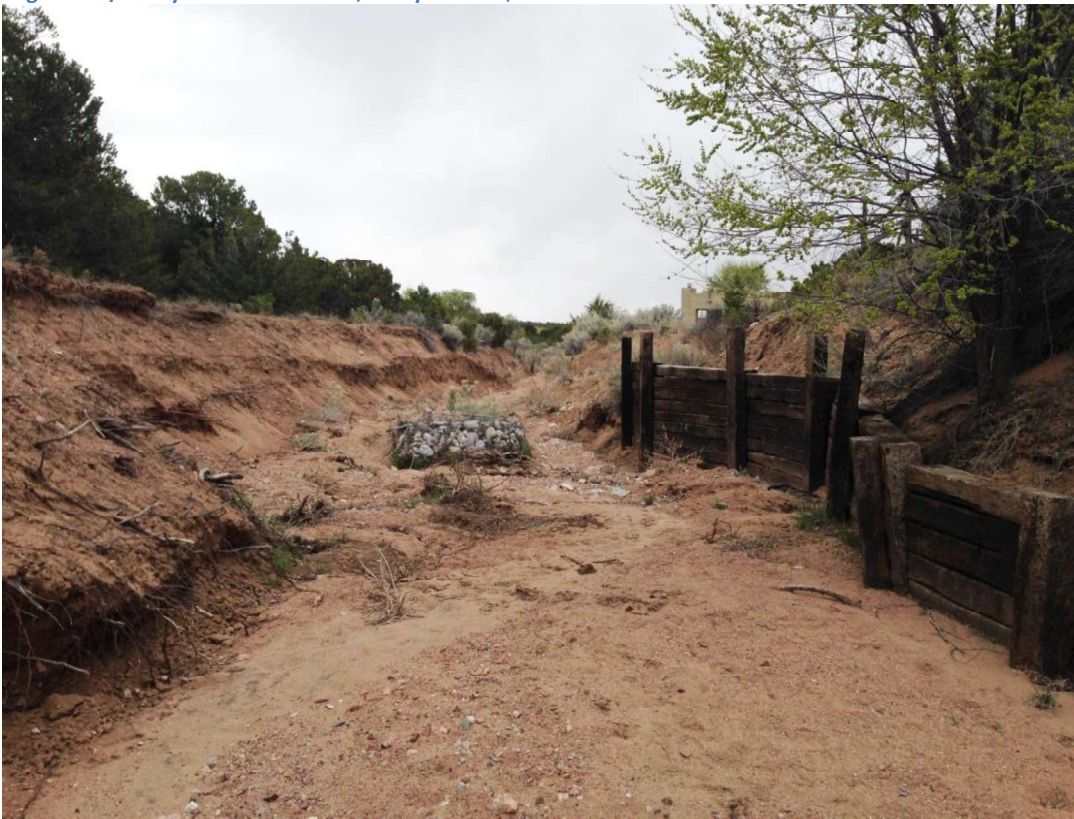
Segment B/ Retaining wall and gabion basket added to arroyo channel, Arroyo Piedra, 2016

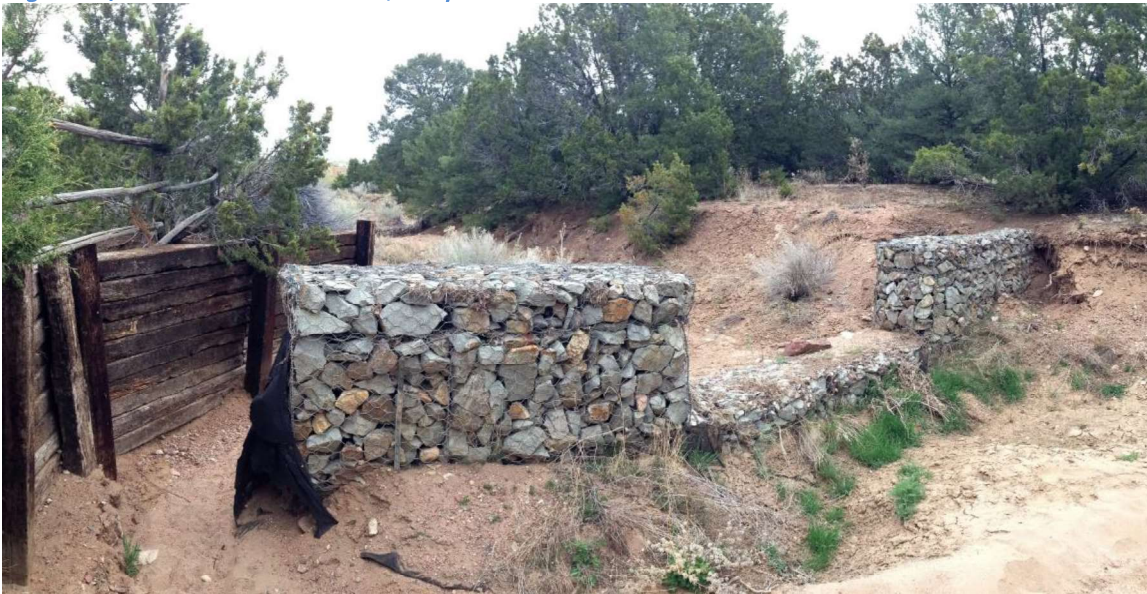
Segment B/ Same gabion check dam with added retaining wall, Arroyo Piedra, 2016

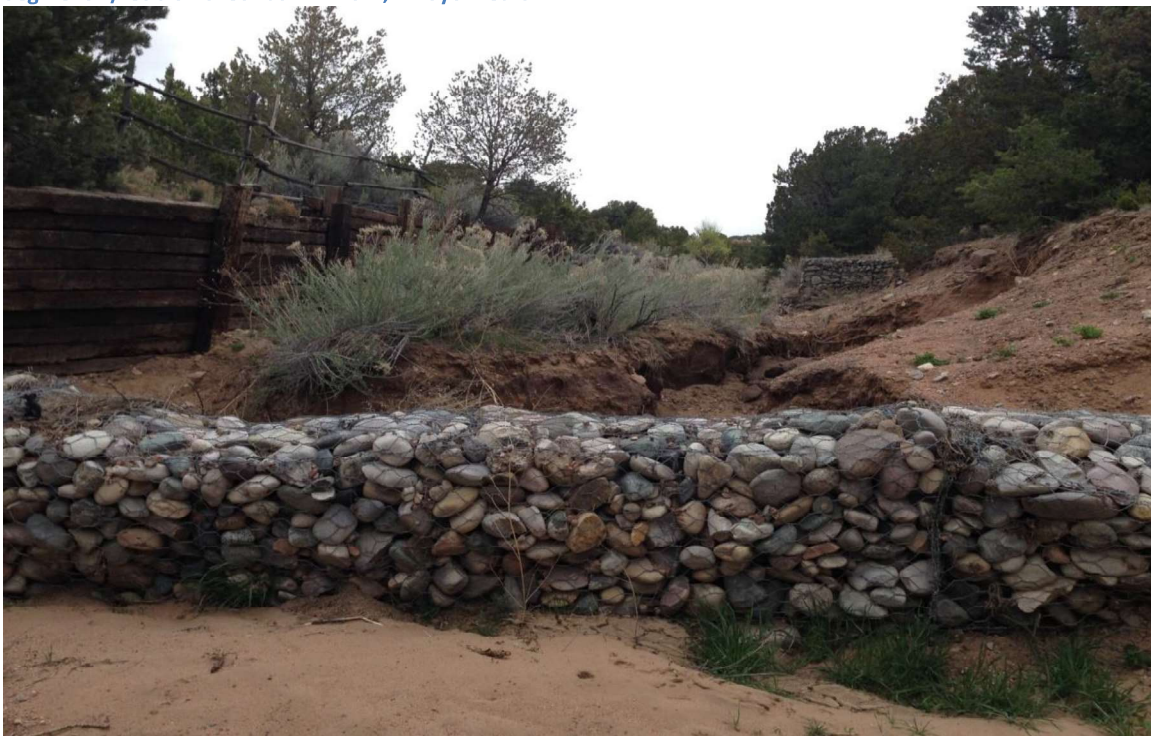
Segment B/ Same gabion check dam with added retaining wall, Arroyo Piedra, 2016

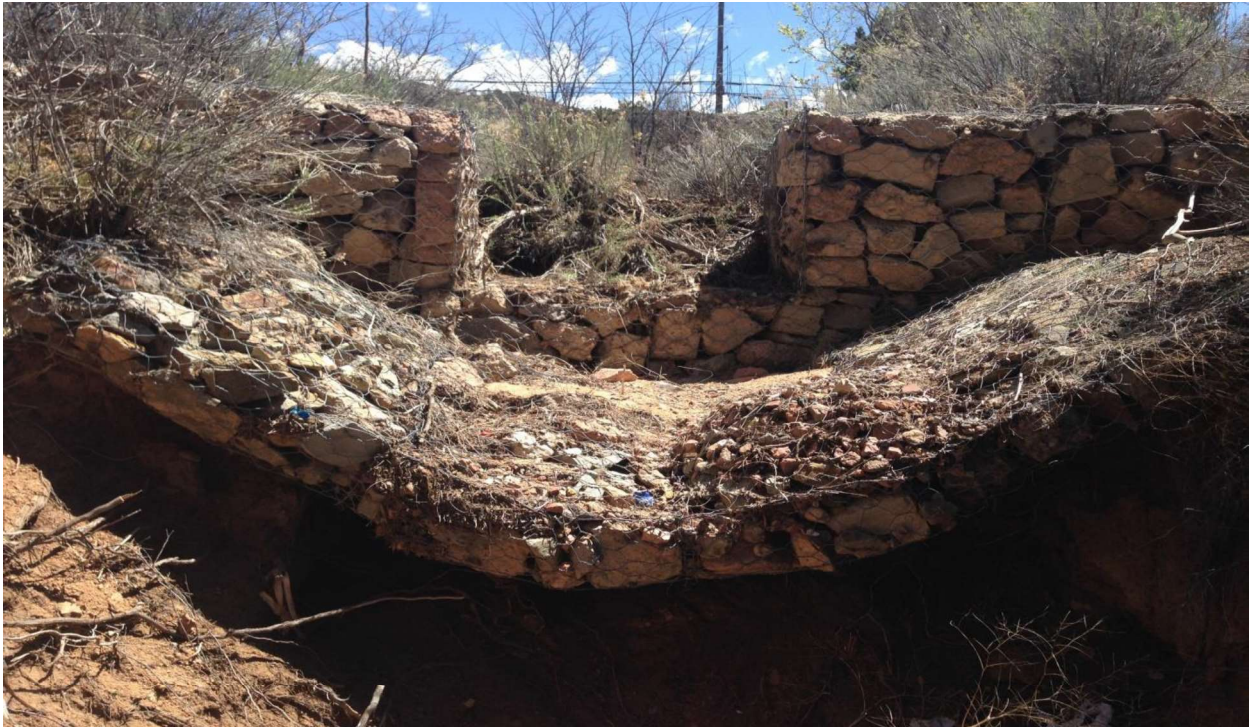
Segment A/ Rip rap mat undermined, Foothills Arroyo, 2016.

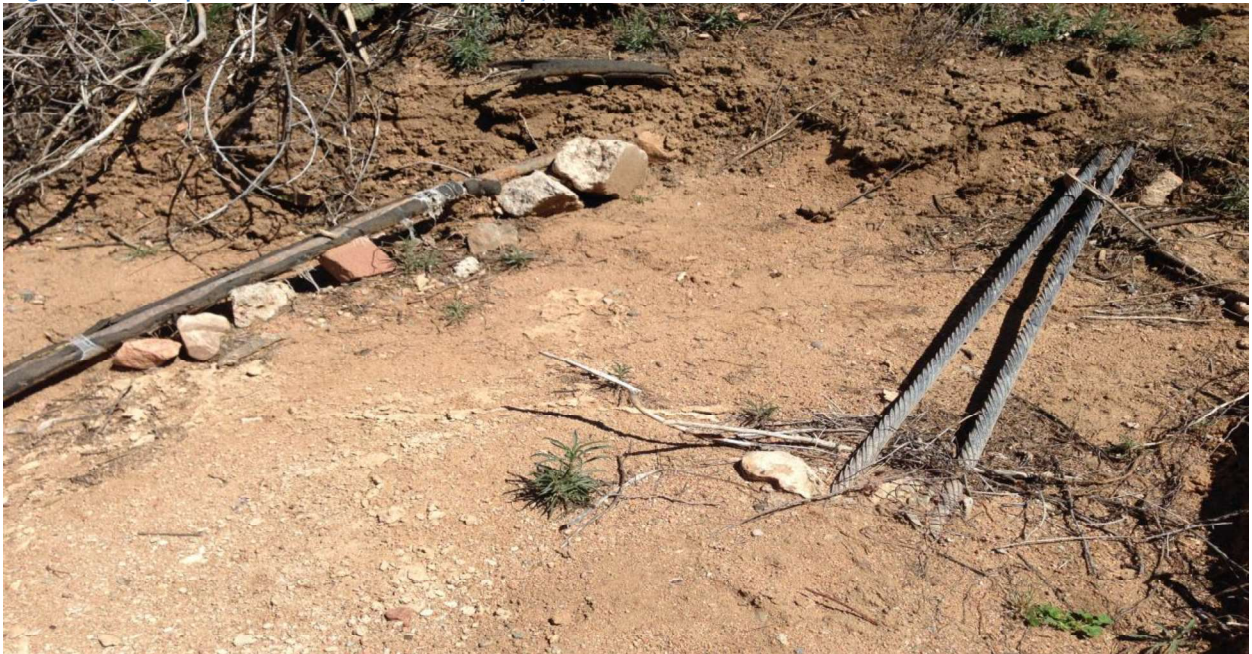
Segment A/ Exposed cables, Foothills Arroyo, 2016.

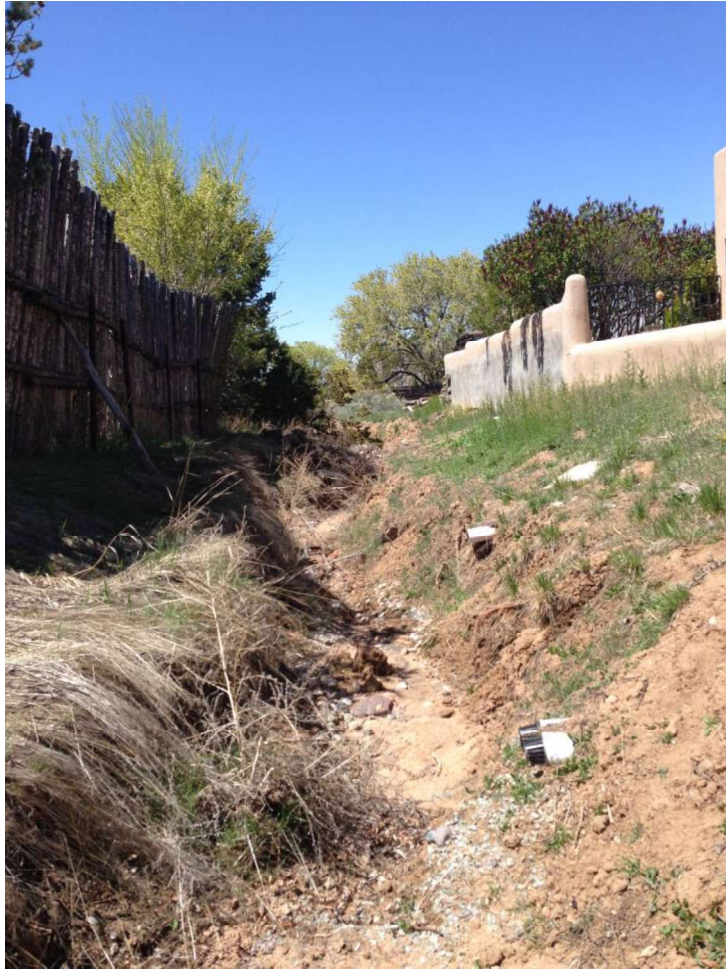
Segment A/ Drain pipes protrude into arroyo from private property, Foothills Arroyo, 2016.

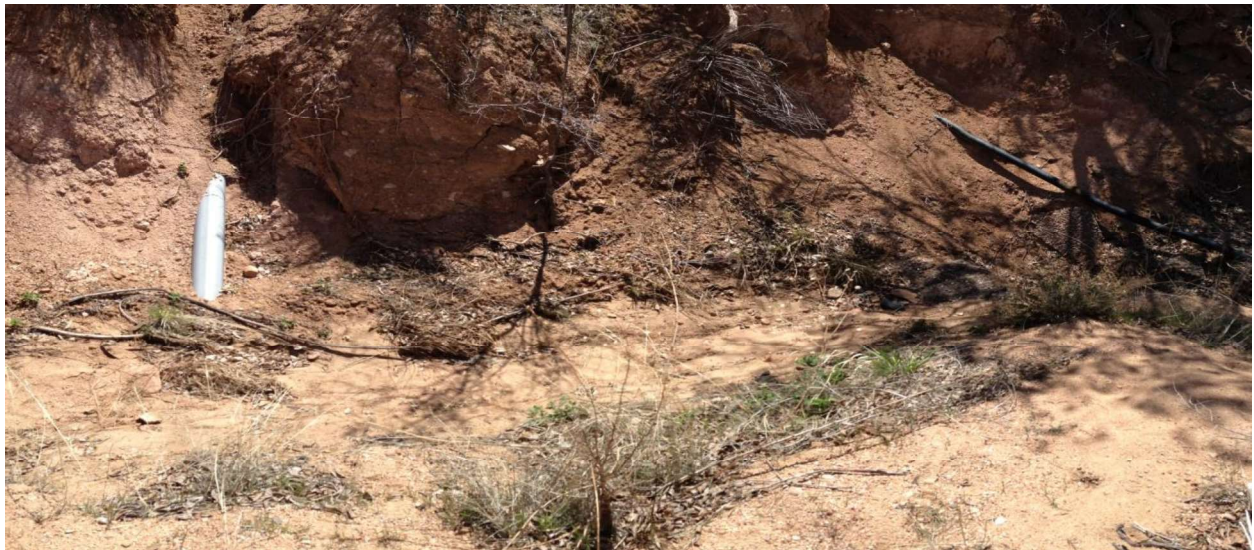
Segment A/ Two exposed utilities, Foothills Arroyo, 2016.

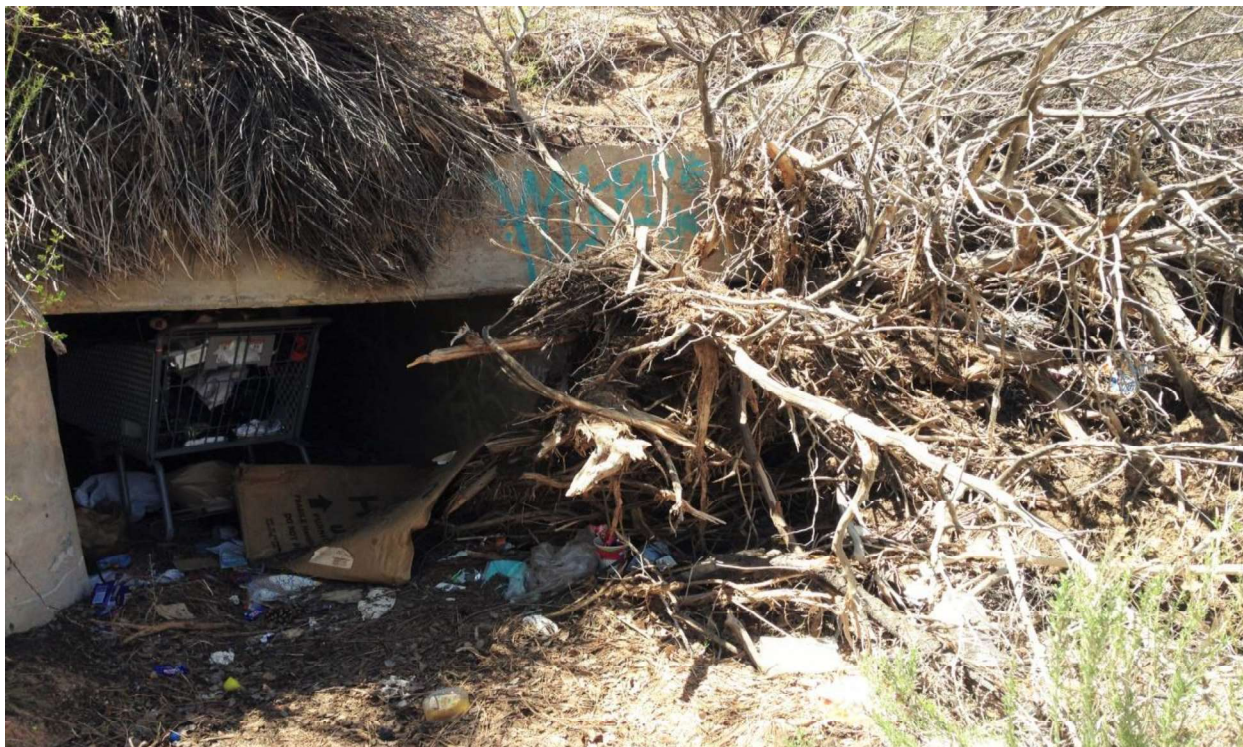
Segment A/ Obstructed box culvert with transient camp, Foothills Arroyo, 2016.

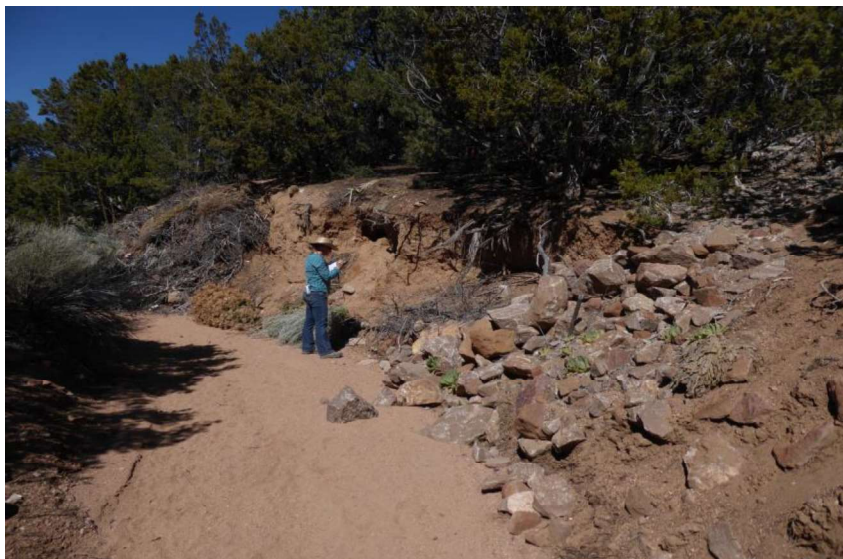
Segment A/Erosion of bank, Arroyo Cloudstone,2016.

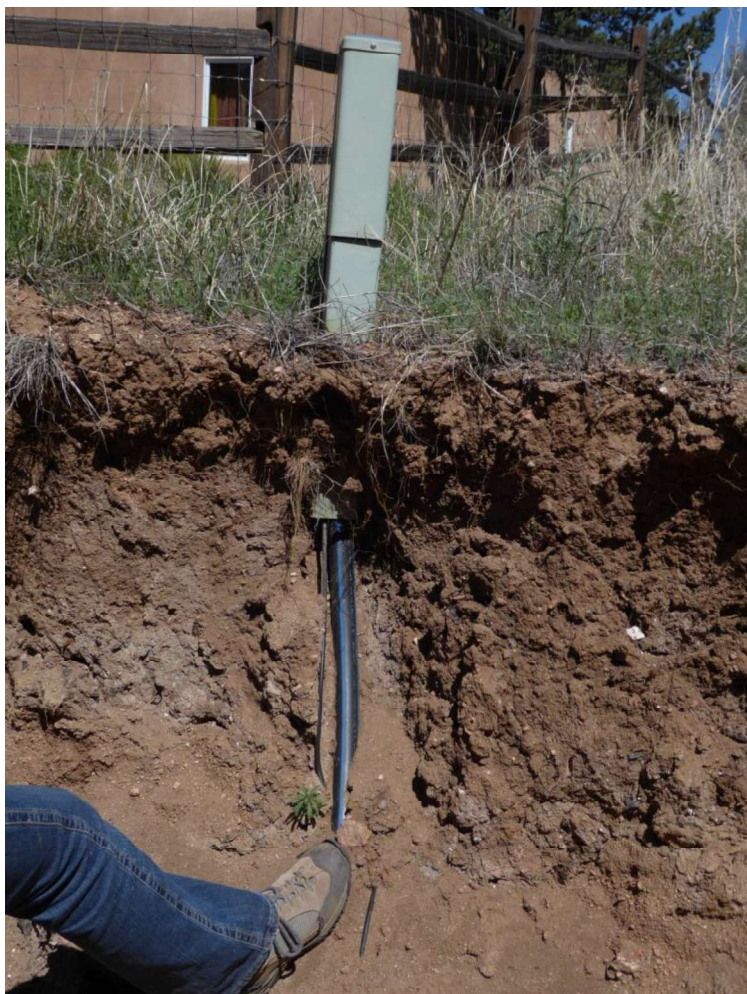
Segment A/Exposed cable, Arroyo Cloudstone, 2016.

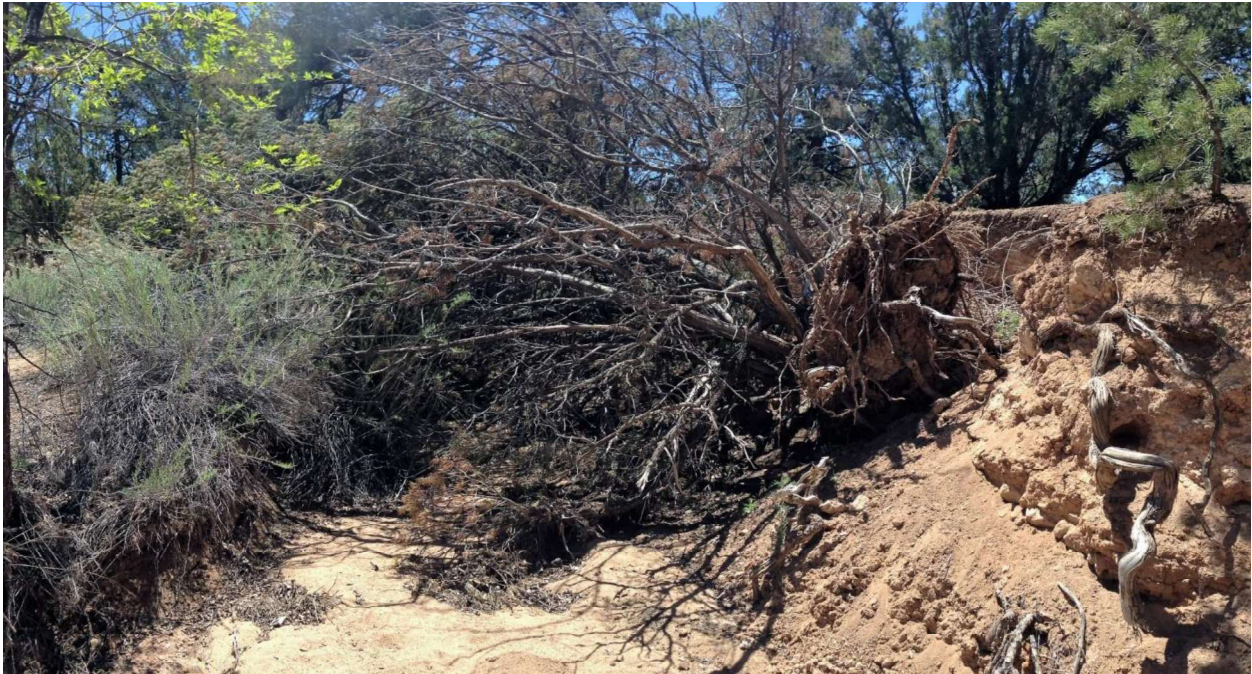
Segment B/One of several tree obstructions in the narrow constricted section of Arroyo Cloudstone, 2016.

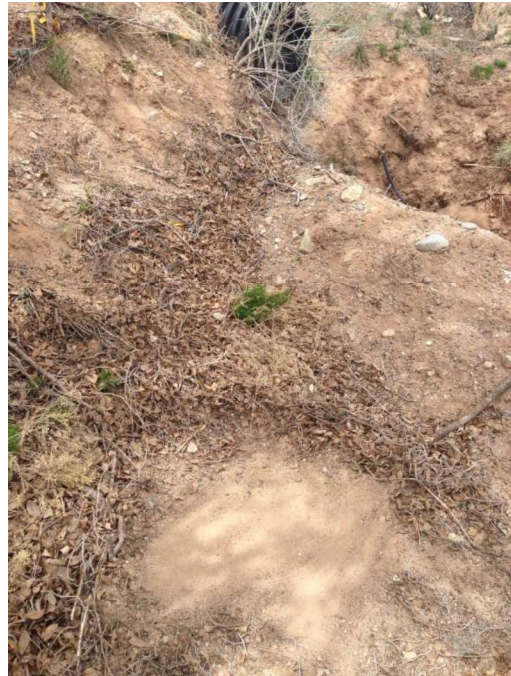
Detail of sewage outlet next to incised bank, Arroyo Nopal, 2016

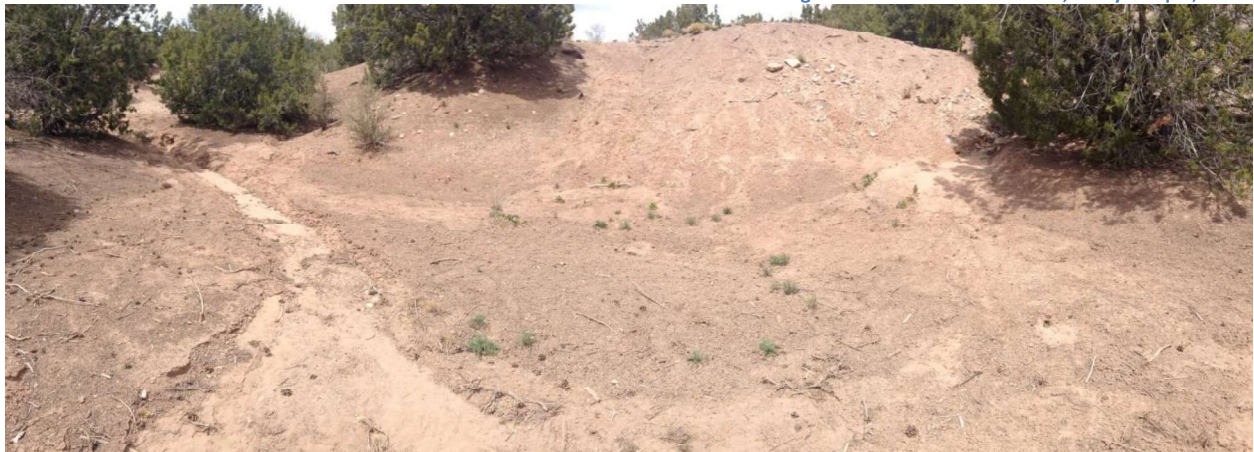
An upper and lower system of check dams and basins over filled with sediment, are unable to accommodate large volumes of water. Rather than slowing the water, these check dams are often by passed. As a result, damage to the arroyo channel and property has increased. Beyond the catch basins the arroyo becomes extremely incised as it flows toward W. Alameda.

Example of storm water bypassing upper catchment basin as it enters the lower basin, Arroyo Nopal, 2016.

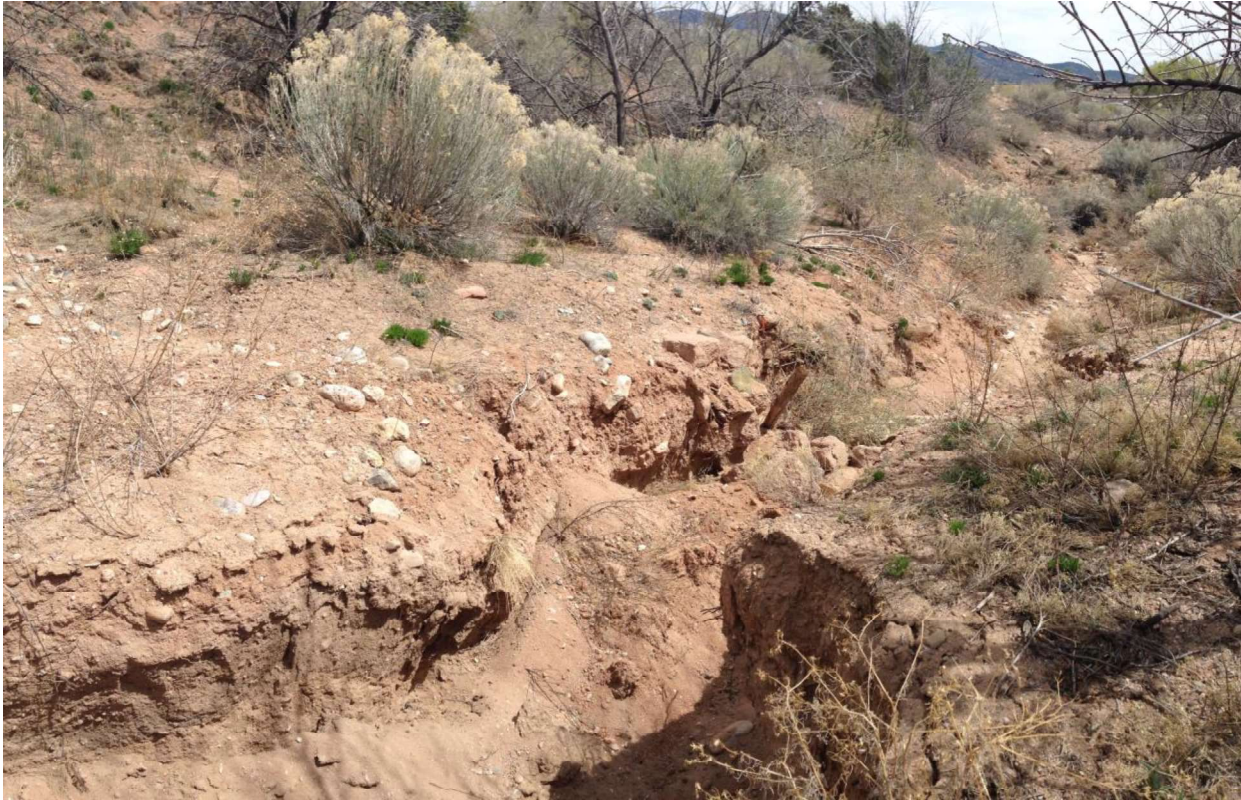
Example of incision created by run off, Arroyo Nopal, 2016.

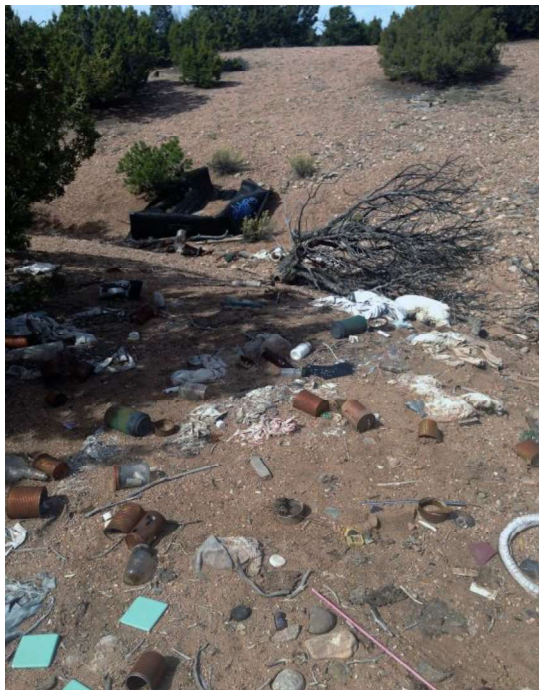
Segment A/Example of one of many trash sites in Arroyo Torreon, 2016.

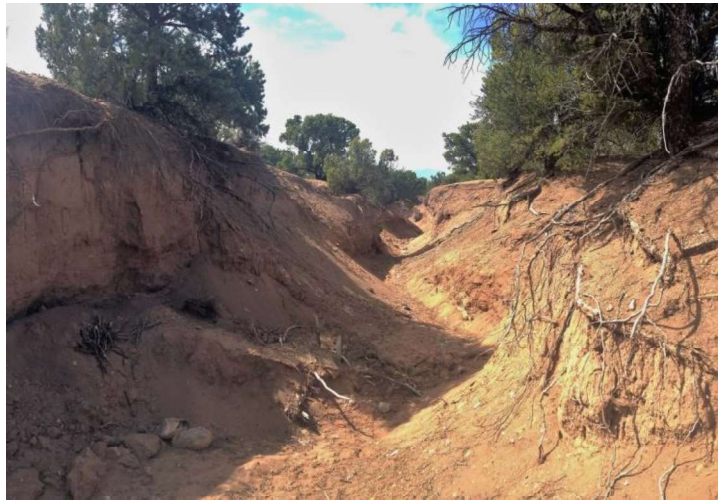
Segment A/ Upper Arroyo Torreon, 2016.

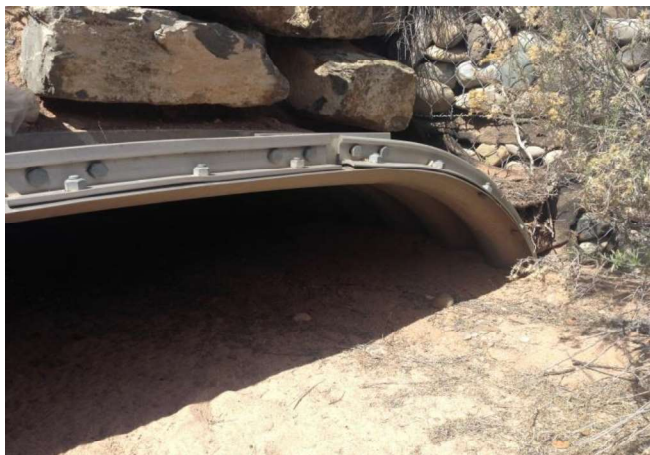
Segment A/Silt trapped in culvert, Arroyo Torreon, 2016.

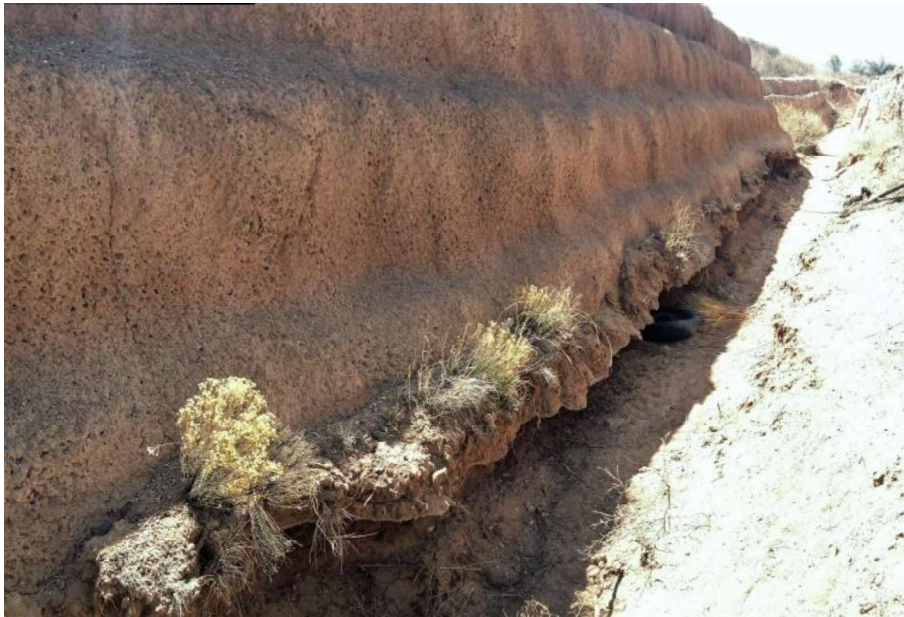
Segment B/Two views of engineered walls made of tire and adobe with undercutting, Arroyo Torreon, 2016.

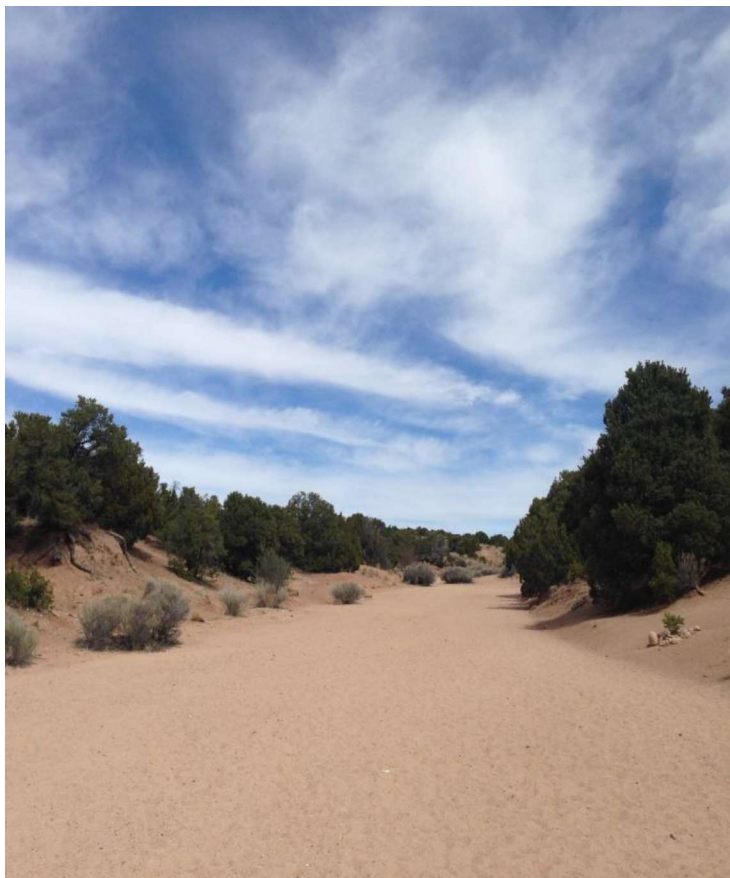
Segment B/Arroyo character below engineered channel, Arroyo Torreon, 2016.

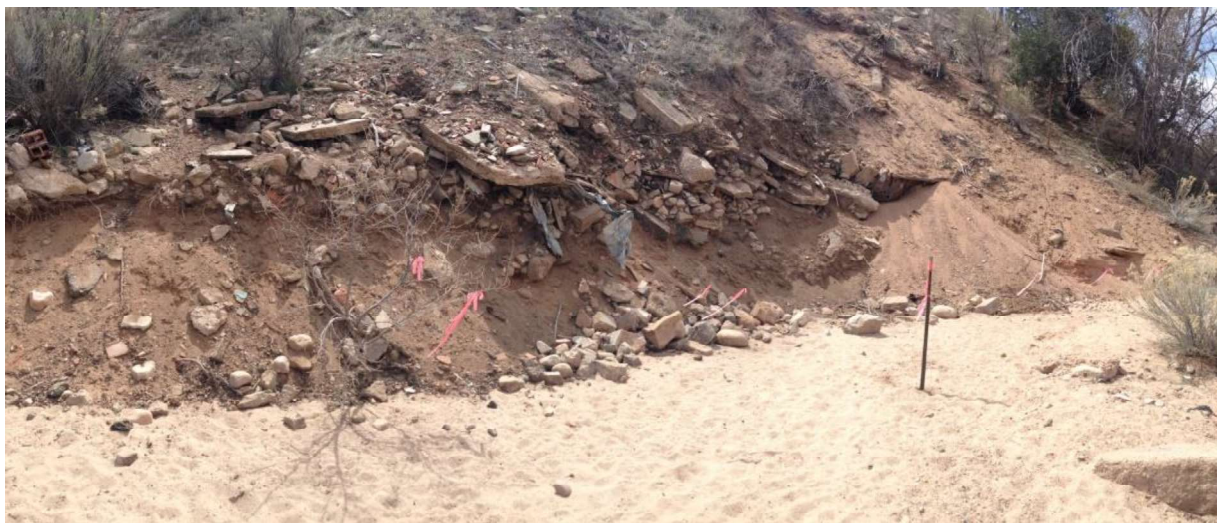
Segment B/Collapsing debris from steep bank, Arroyo Torreon, 2016.

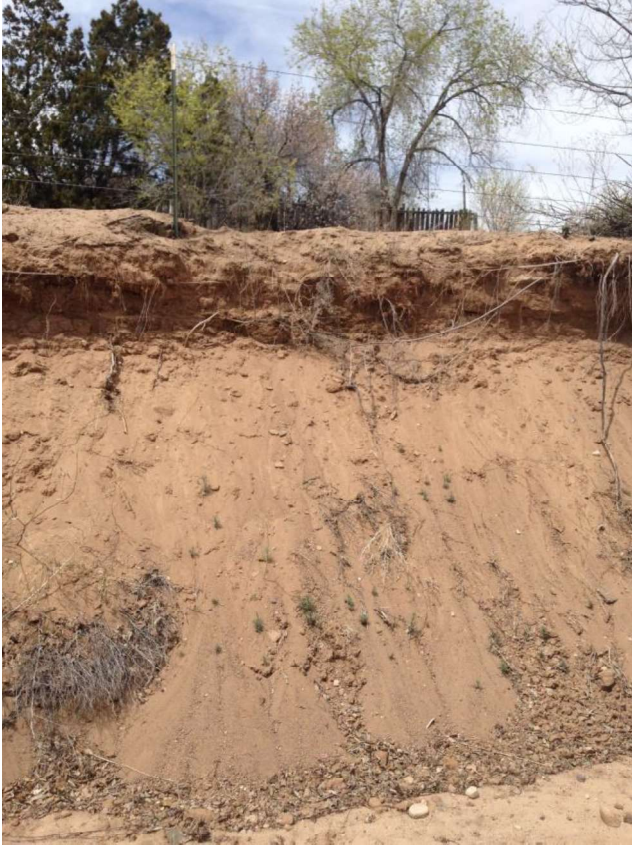
Segment B/Collapsing bank against Rincon de Torreon, Arroyo Torreon, 2016.

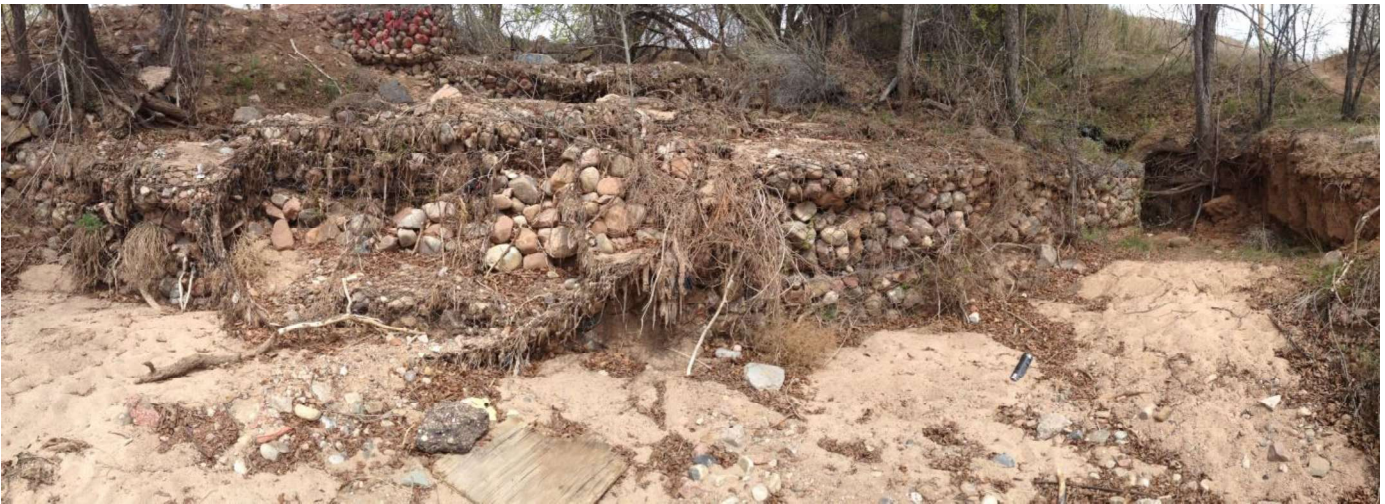
Segment B/Collapsing gabion and bank collapse (far right), Arroyo Torreon, 2016.
