# **ARROYO ASSESSMENT SURVEYS OF 10 MAJOR ARROYOS IN THE SANTA FE WATERSHED**

November 16<sup>th</sup>, 2012

## **Santa Fe Watershed Association**

**Report to the Public Works Department, City of Santa Fe 2012**

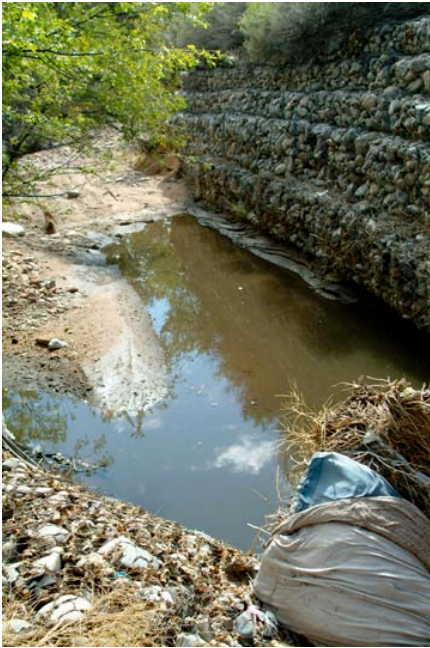
Standing water, Lower Arroyo Pinos, Segment D.

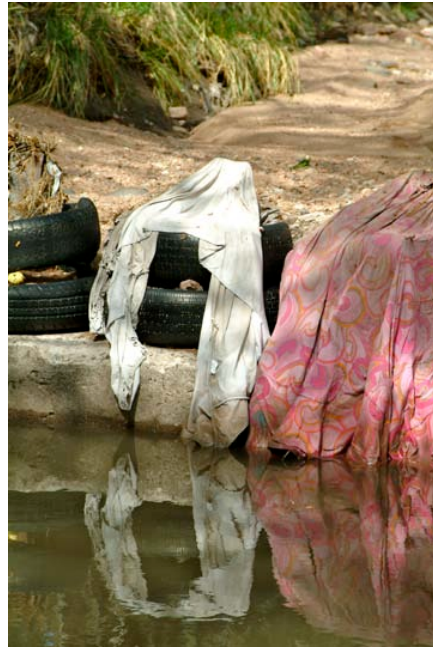
Tires, trash, water, Lower Arroyo Pinos, Segment D.

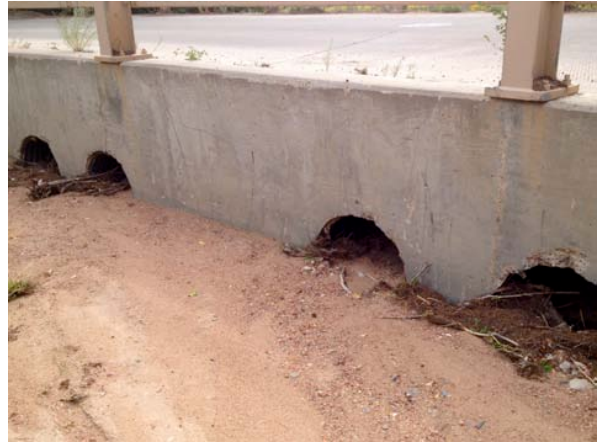
Obstructed culverts crossing Arroyo Piedra East, Segment A.
