VI. Arroyo en Medio – Old Santa Fe Trail to Arroyo Chamisos

VII. Arroyo Ancha Headwaters to Cañada Sur

VIII. Arroyo de los Pinos North

VIII. Lower Arroyo de los Pinos

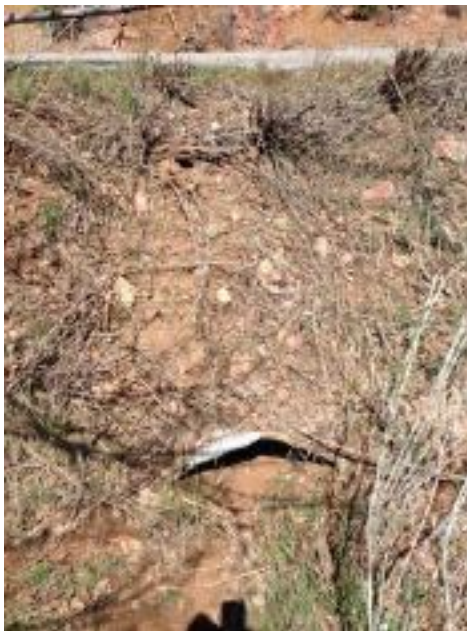
Notes: Hyde Park Road follows the Arroyo Ancha, a narrow, constricted, rocky waterway that passes beneath a canopy of ponderosa, piñon, and juniper. The passage attracts wildlife, hikers, and mountain bikers. When the arroyo enters the La Entrada area, it remains constricted and incised. Many culverts placed to drain storm water off of Hyde Park Road to then empty into the Arroyo Ancha are restricted by sediment.

Segment A/Obstructed culvert, Arroyo Ancha, 2016

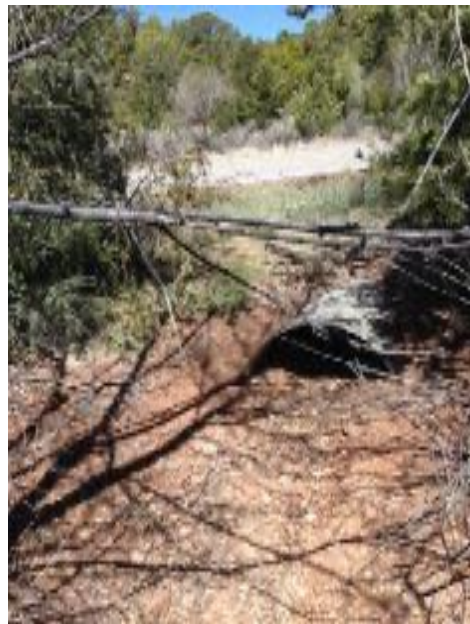
Segment A/Obstructed culvert, Arroyo Ancha, 2016

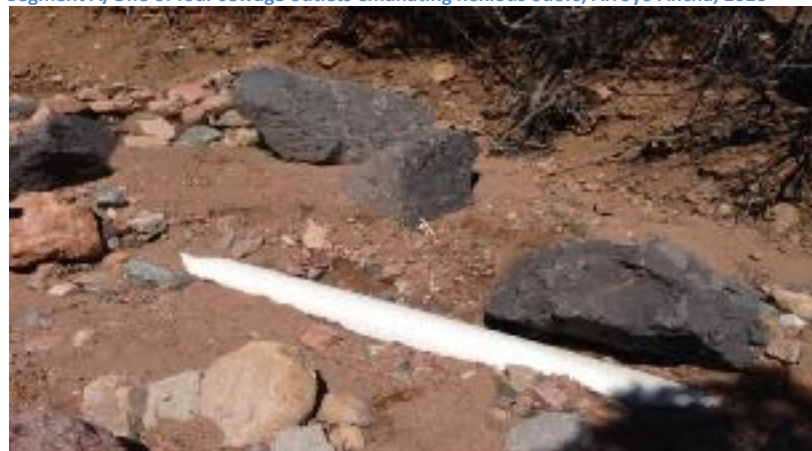
From this point, the condition of the arroyo is very poor due to extreme erosion. The sewage outlets found above ground were all emanating a noxious odor. Nearby, an above ground pipe labeled sewer was found. Corrective actions to protect infrastructure in this area are highly recommended and may be urgent. Foot and bike traffic is also frequent in this area.

Segment A/ Exposed sewer line in Arroyo Ancha, 2016

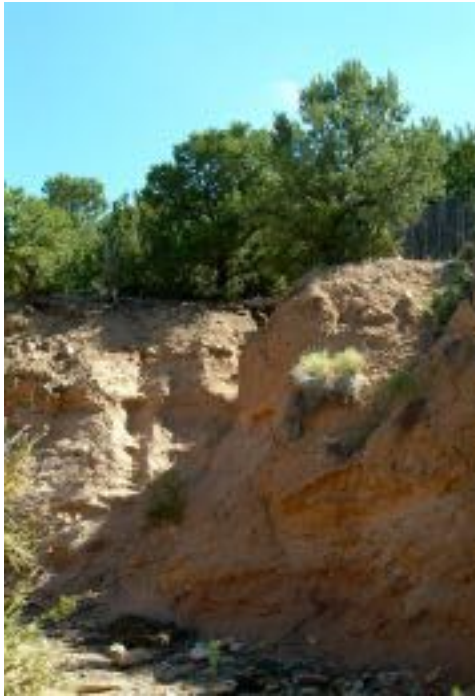
Segment B/ Example of bank erosion in Arroyo Ancha, 2016.

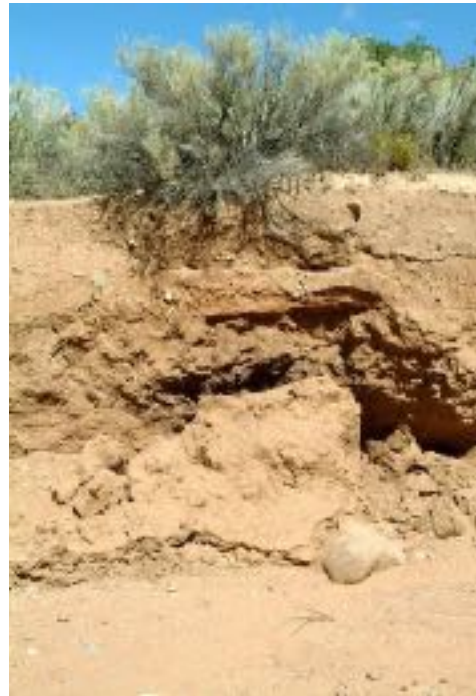
Segment B/ Example of bank calving in Arroyo Ancha, 2016.

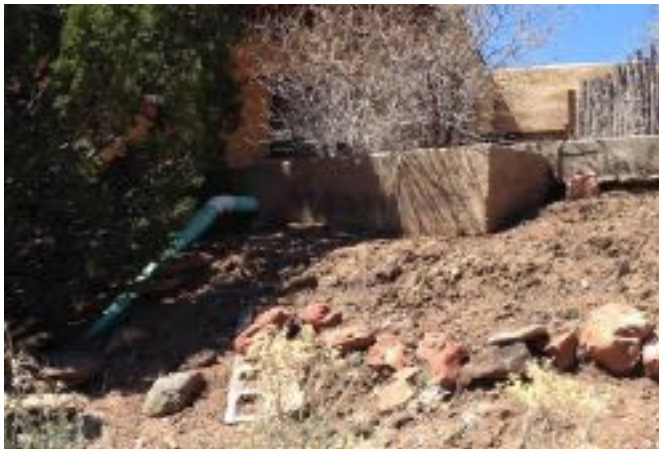
Segment B/Drain pipe with opening in the arroyo bed, Arroyo Ancha, 2016.

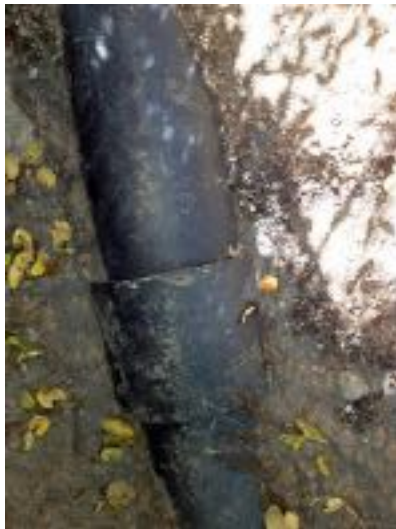
Segment B/Exposed pipe, Lower Arroyo Pinos, 2012.

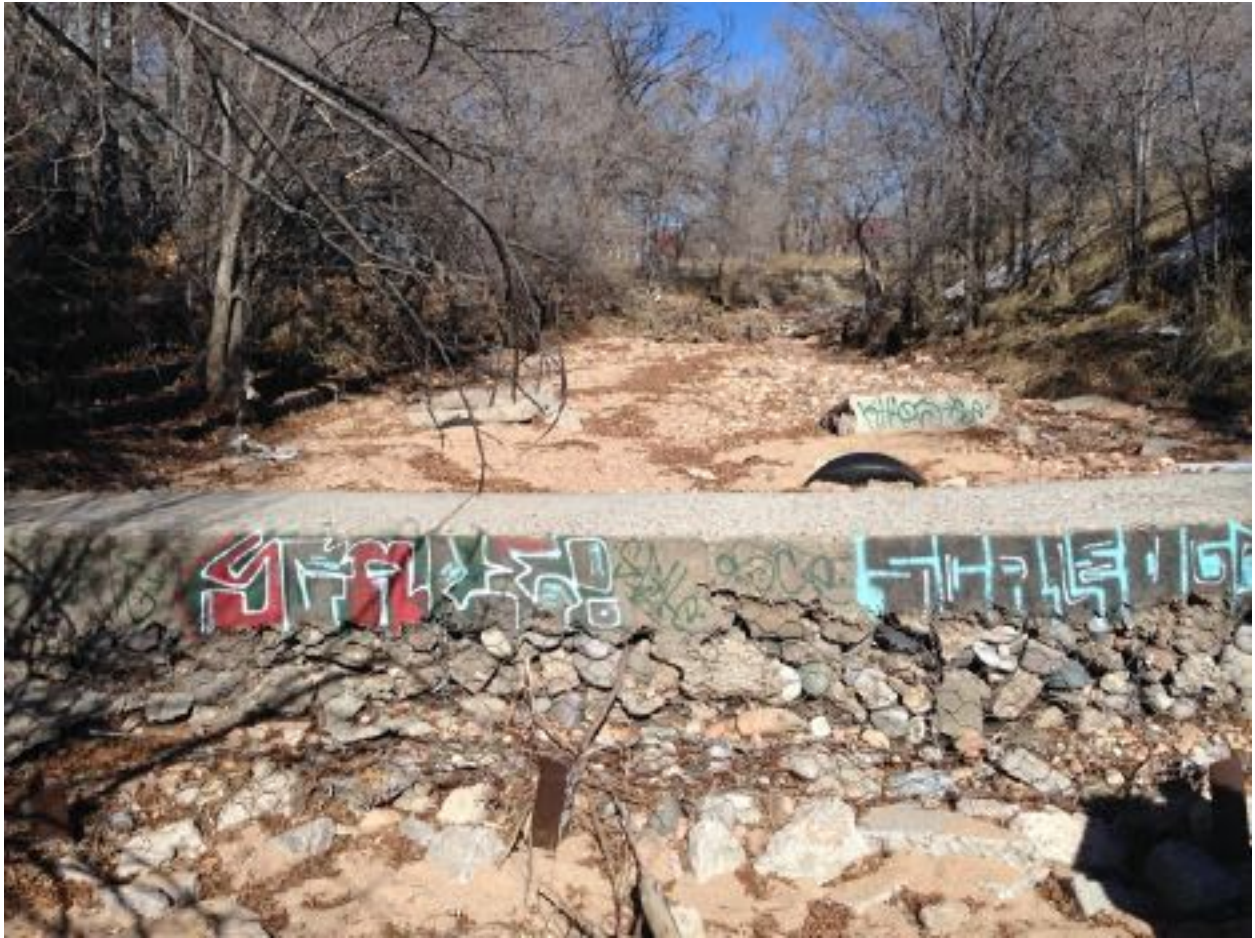
Segment E/ View of Lower Arroyo Pinos, 2016.
