IX. Arroyo Mascaras

X. Arroyo de la Piedra

XI. Foothills Arroyo

XII. Arroyo Cloudstone

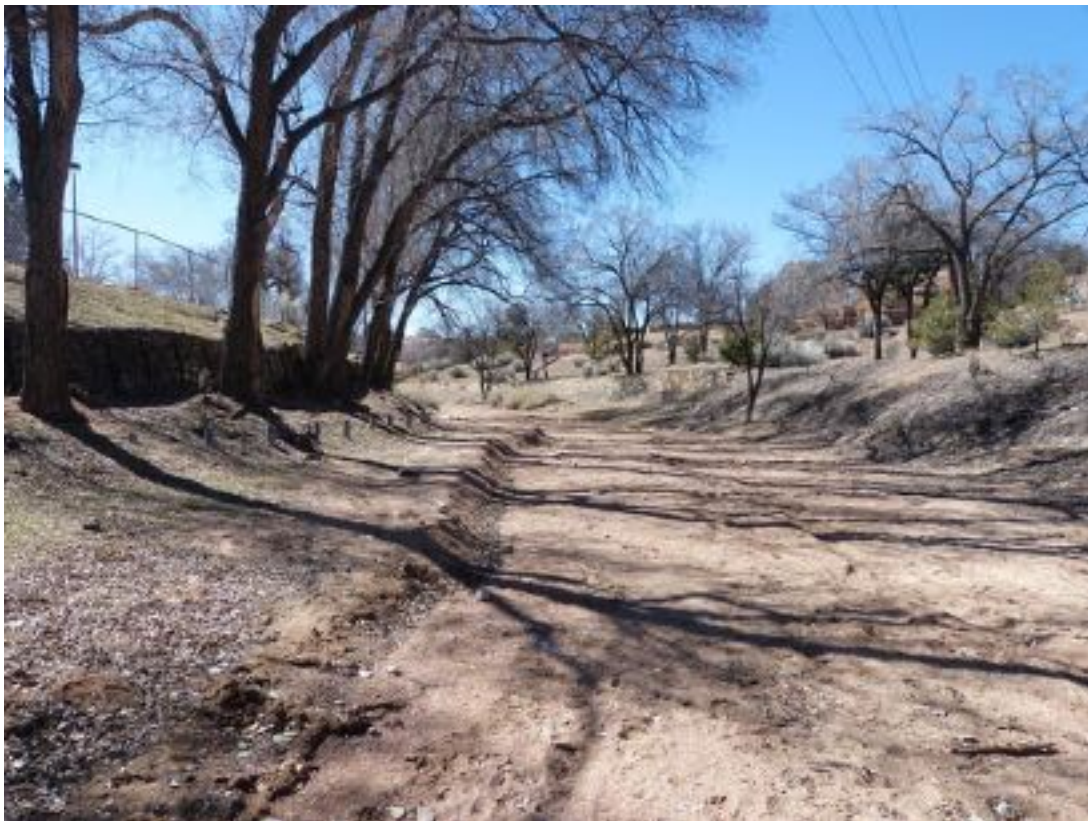
Segment B/Example of Upper Mascaras ,2016.

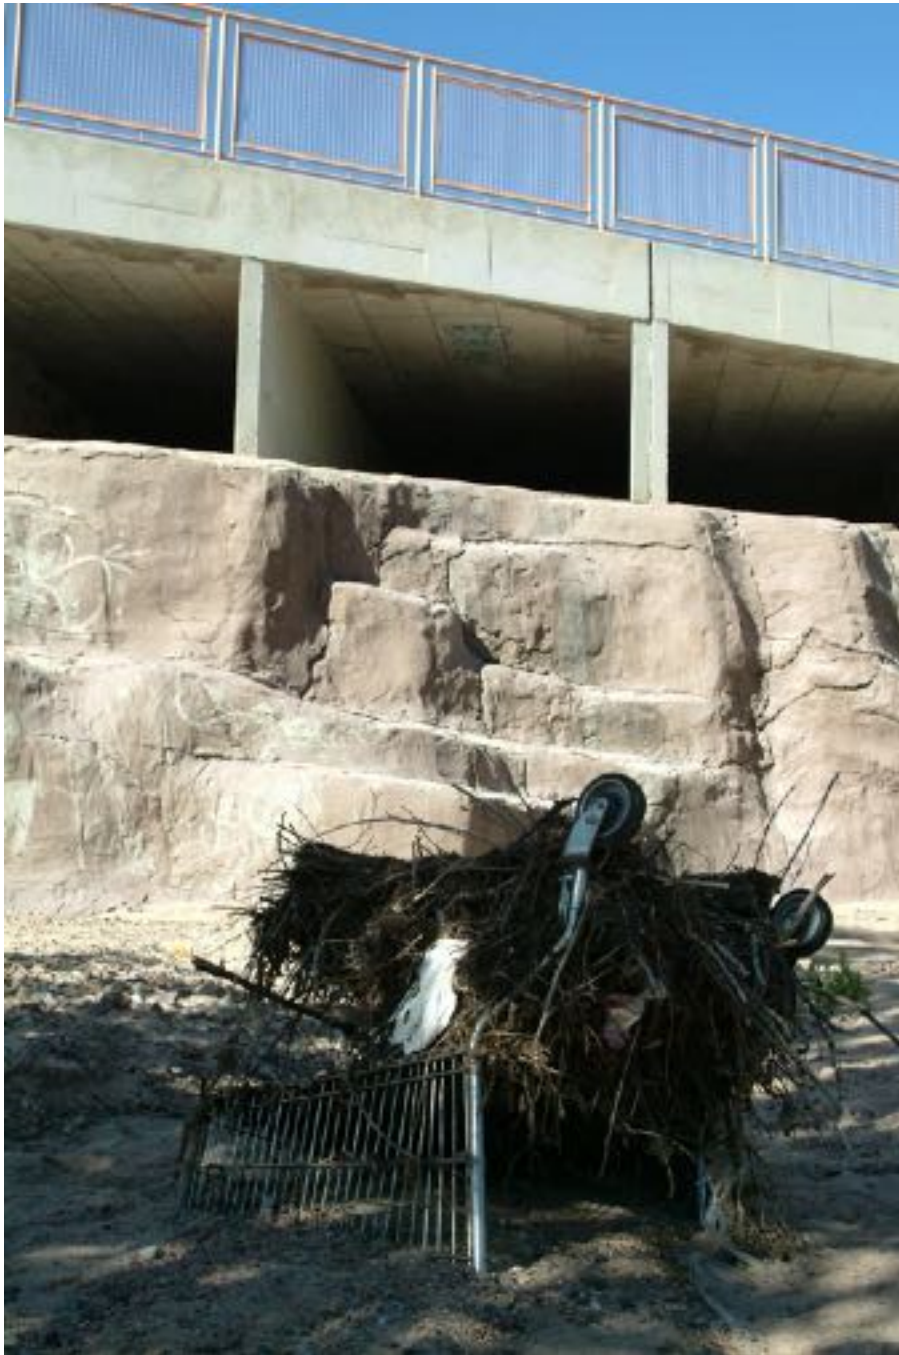
Segment D/ Entry way into the Santa Fe River for the Arroyo Mascaras , 2016.

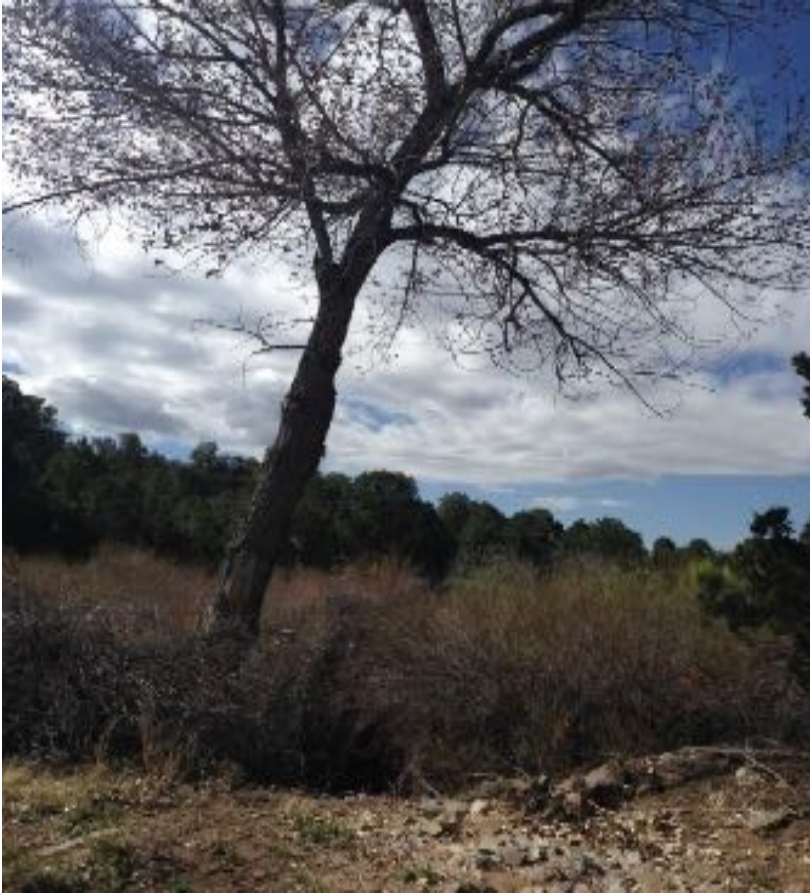
Segment A/ Wetland located in Arroyo Piedra, 2016.

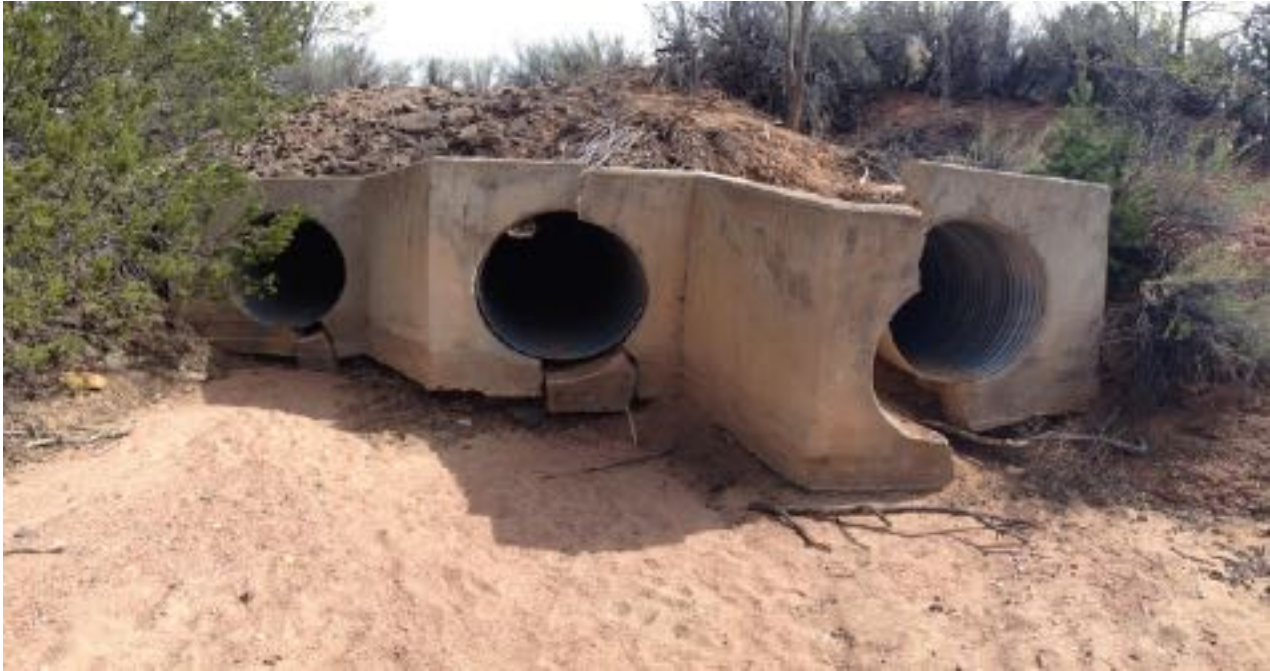
Segment B/ Comparison of culverts, Arroyo Piedra, 2016.

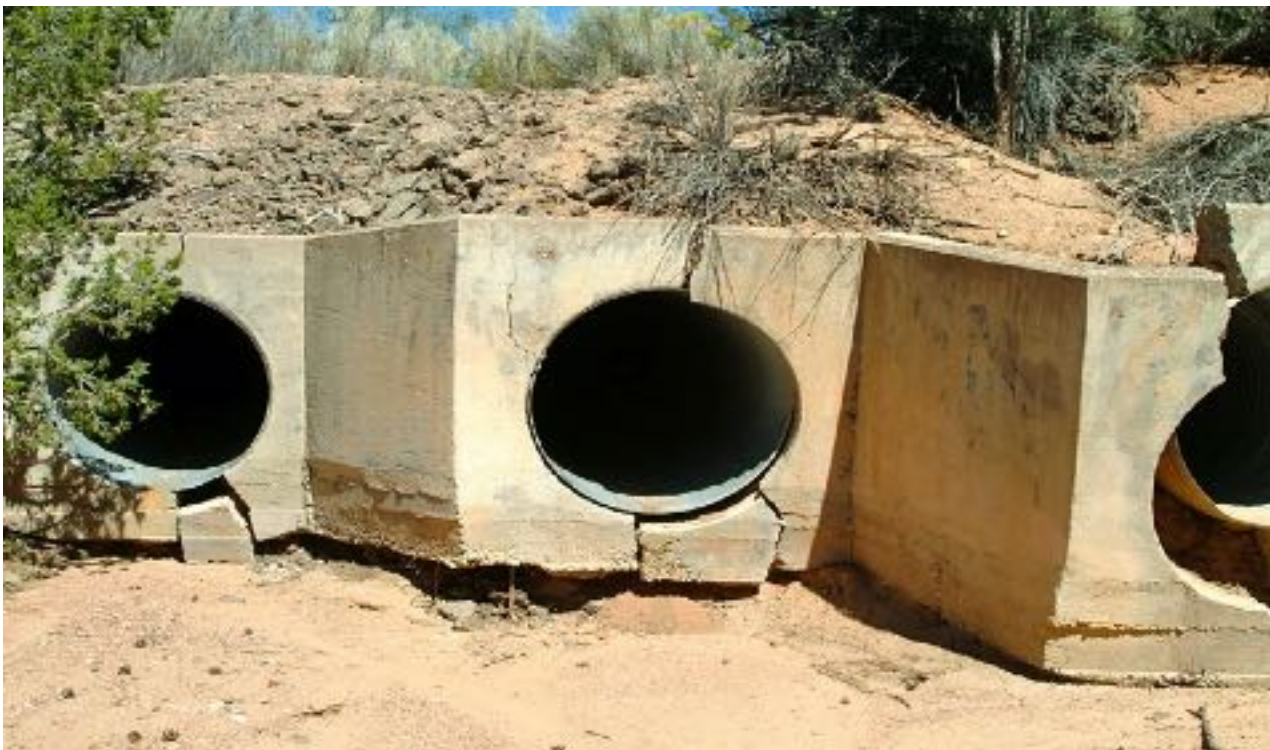
Segment B/ Comparison of culverts photo from 2012, Arroyo Piedra.

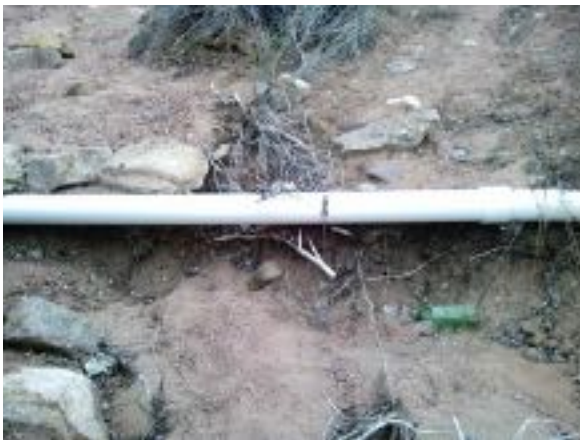
Segment B/ Exposed utility 2016 , Arroyo Piedra.

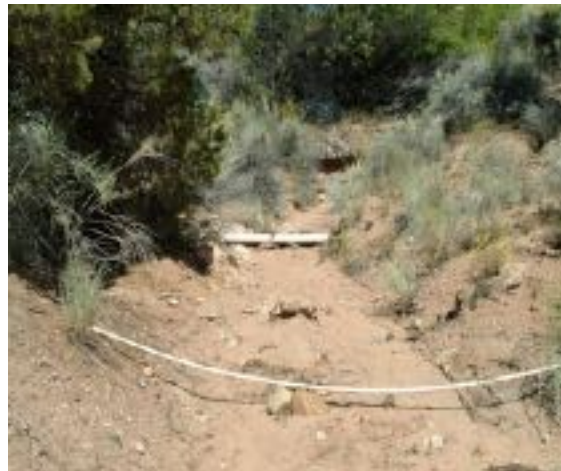
Segment B/ Exposed utility 2012 , Arroyo Piedra.

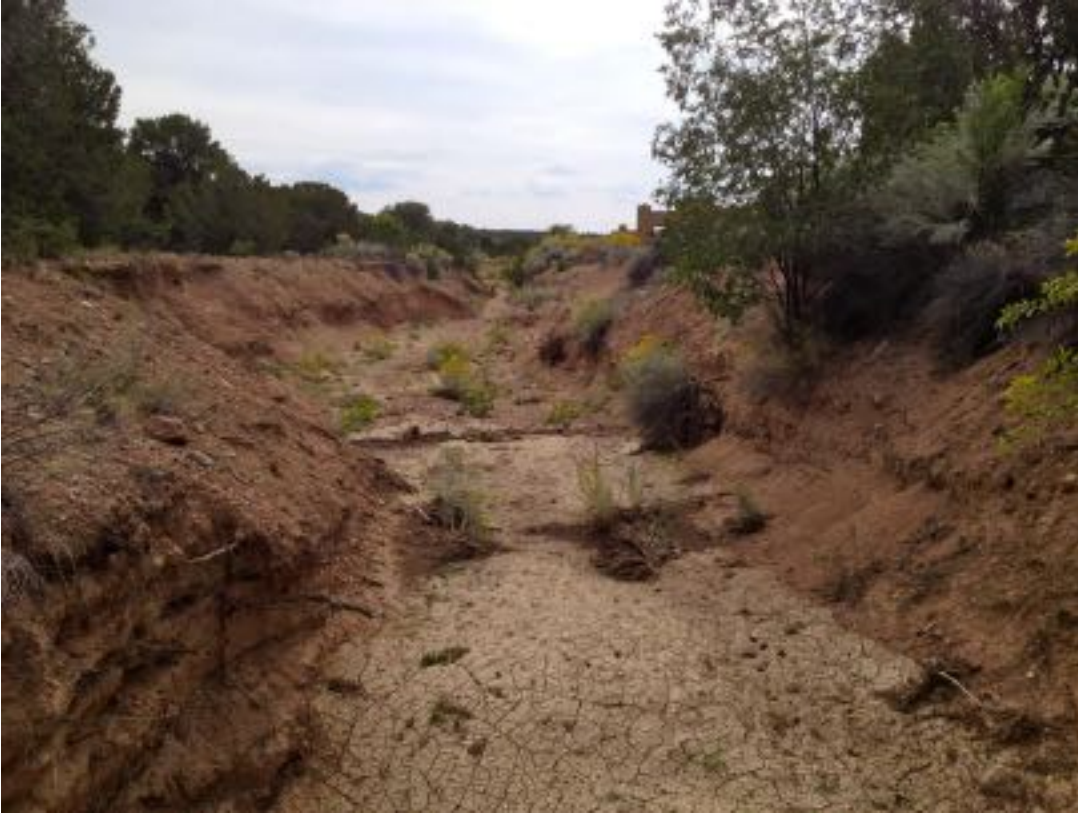
Segment B/ Arroyo channel in 2012, Arroyo Piedra, 2016.

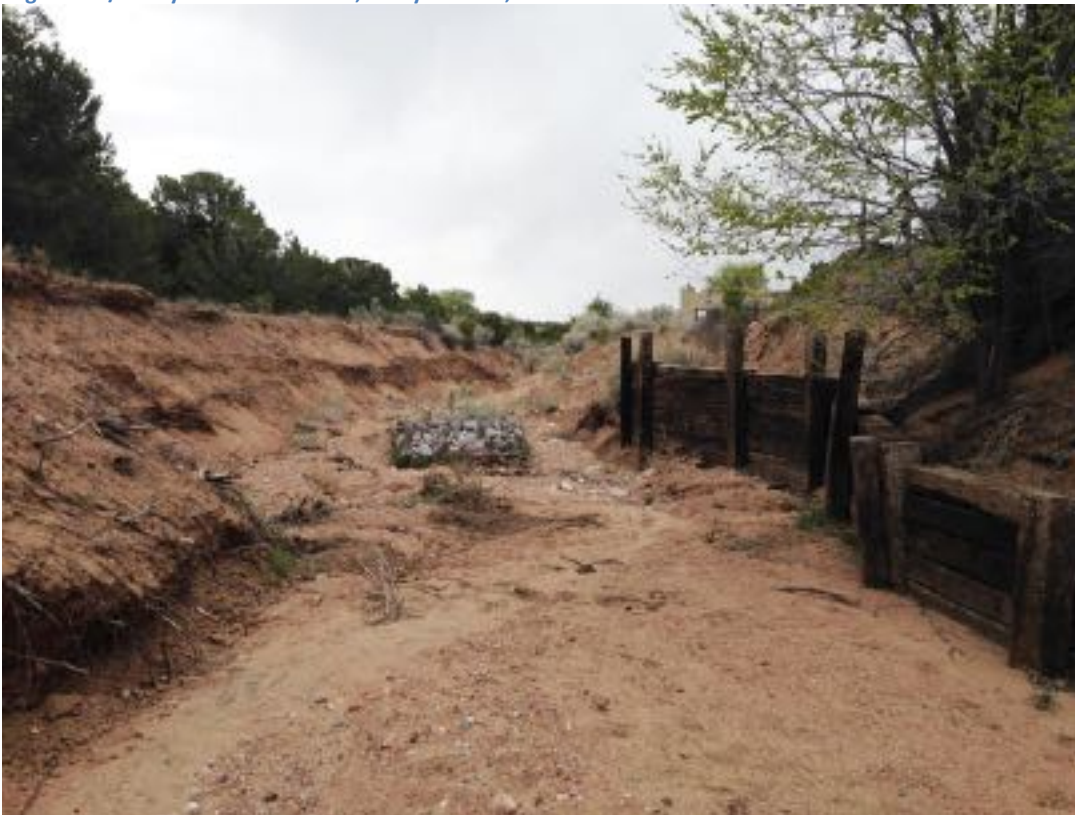
Segment B/ Retaining wall and gabion basket added to arroyo channel, Arroyo Piedra, 2016

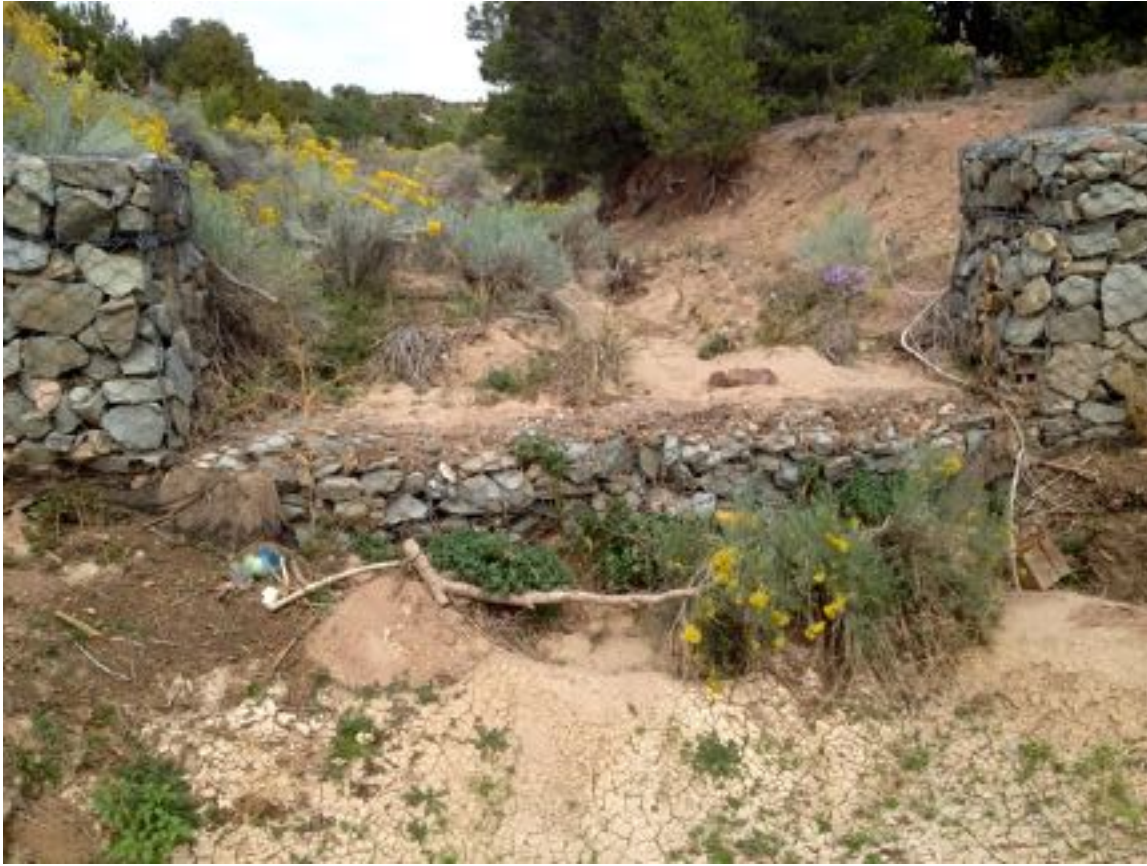
Segment B/ Gabion check dam in 2012, Arroyo Piedra.

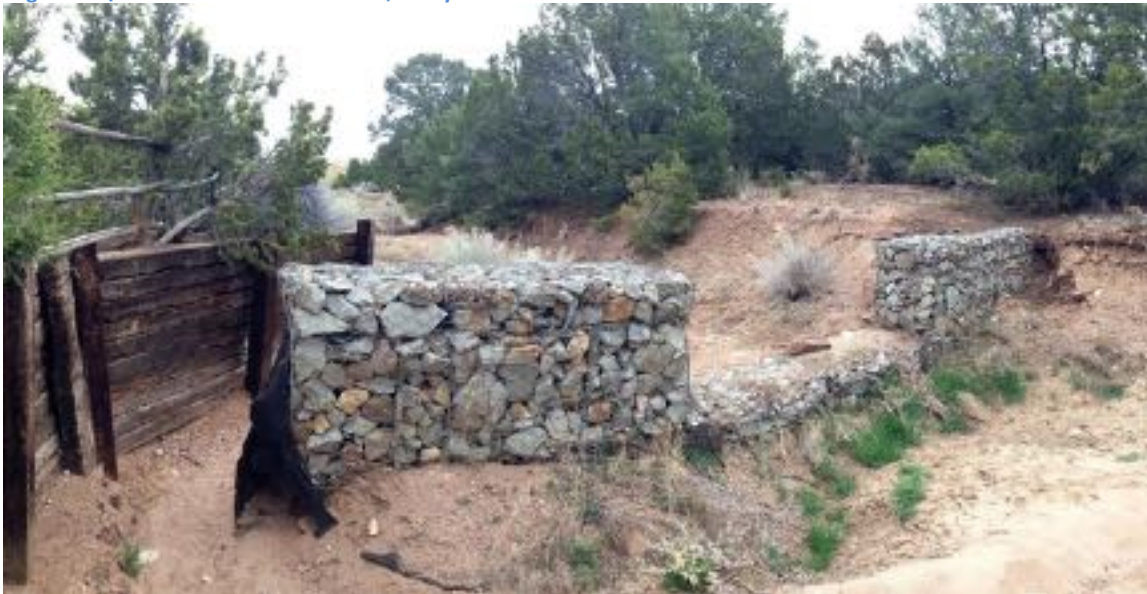
Segment B/ Same gabion check dam with added retaining wall, Arroyo Piedra, 2016

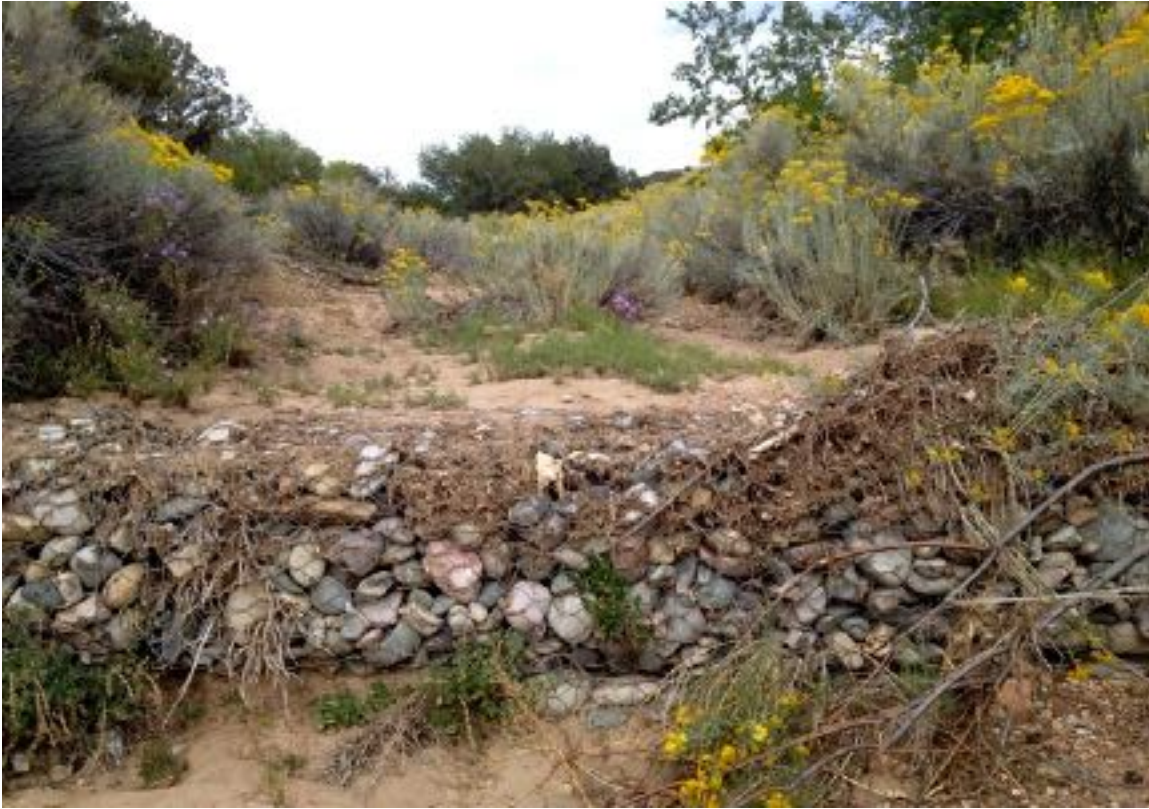
Segment B/ Gabion check dam in 2012, Arroyo Piedra.

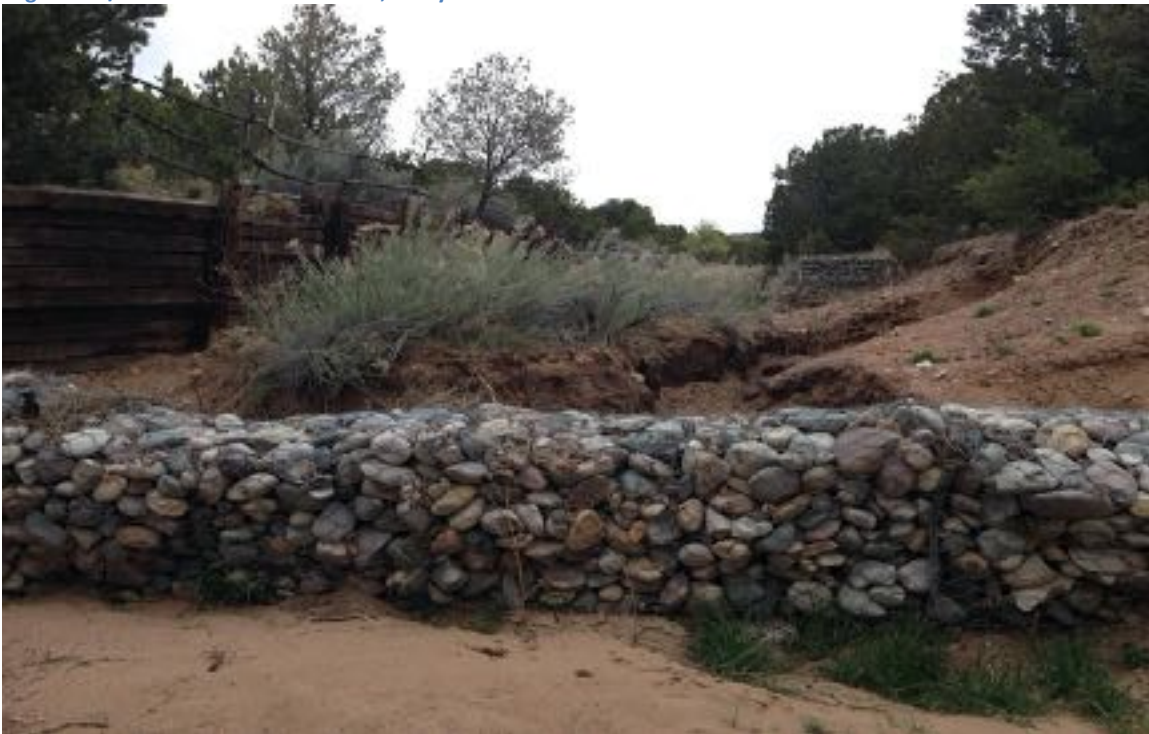
Segment B/ Same gabion check dam with added retaining wall, Arroyo Piedra, 2016

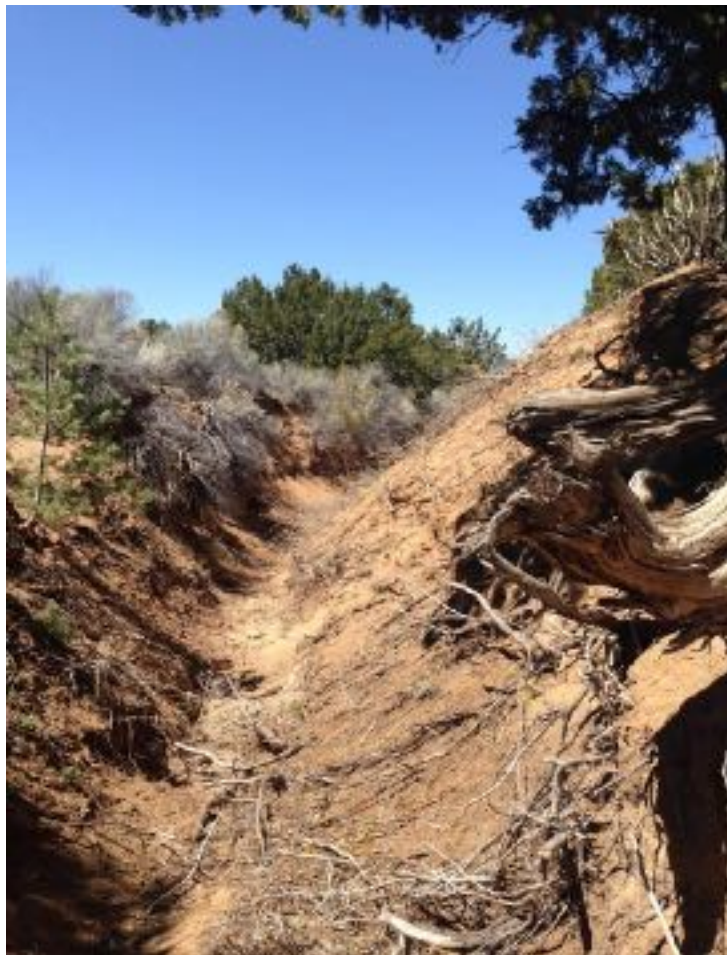
Segment A/ Upper Foothills Arroyo, 2016.

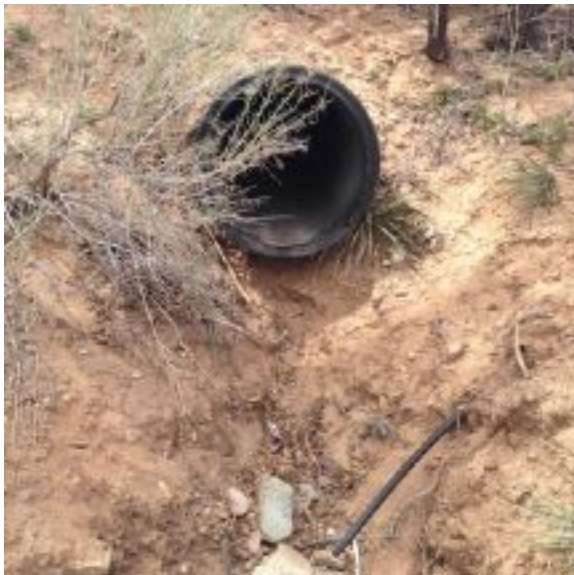
Several culverts drain the west side of Calle Nopal, Arroyo Nopal, 2016.

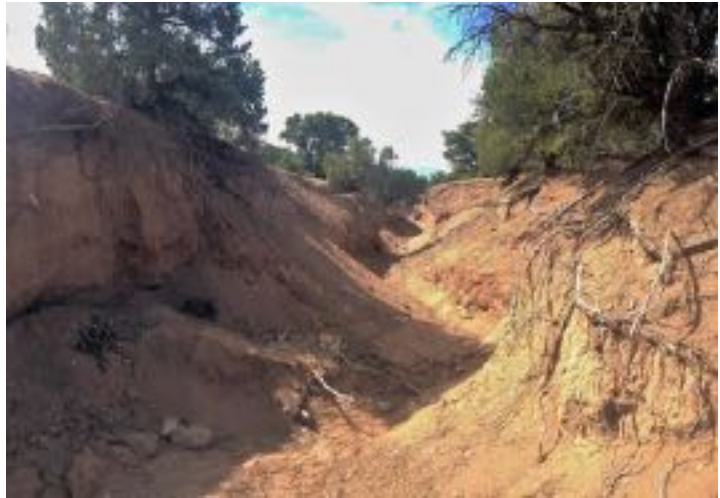
Segment A/ Upper Arroyo Torreon, 2016.

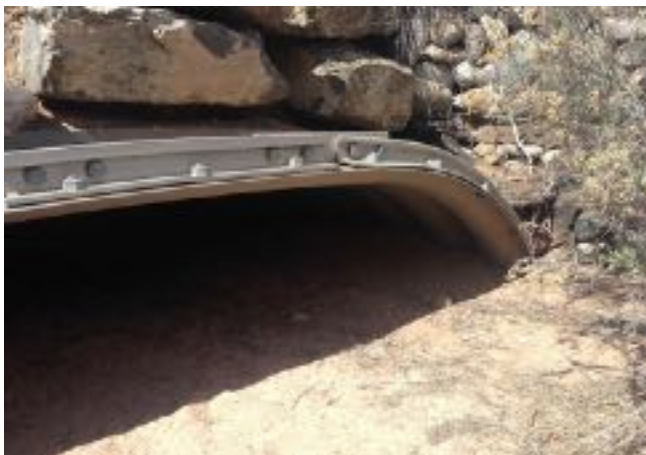
Segment A/Silt trapped in culvert, Arroyo Torreon, 2016.

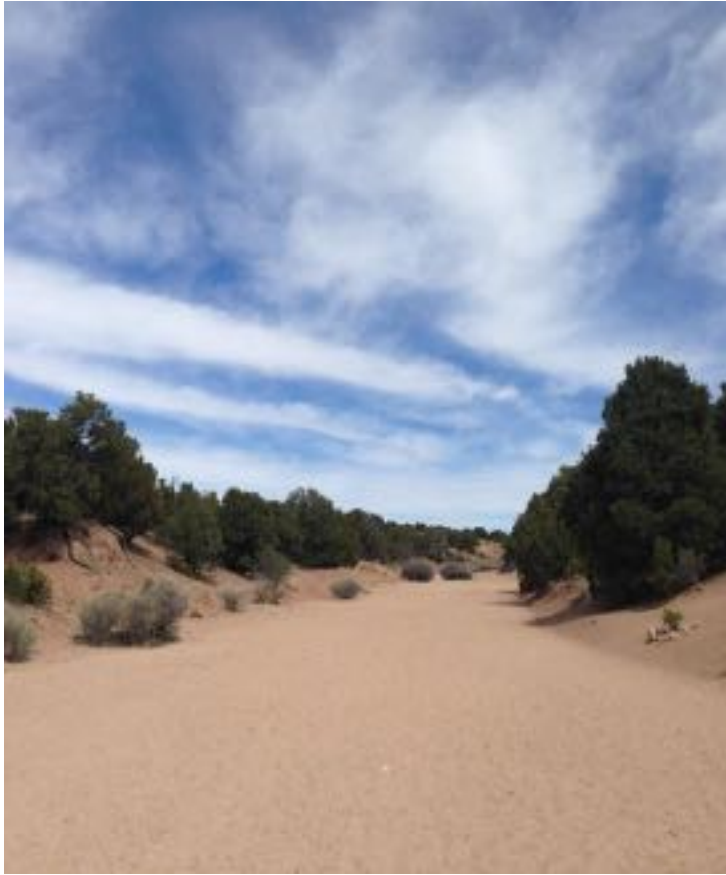
Segment B/Arroyo character below engineered channel, Arroyo Torreon, 2016.

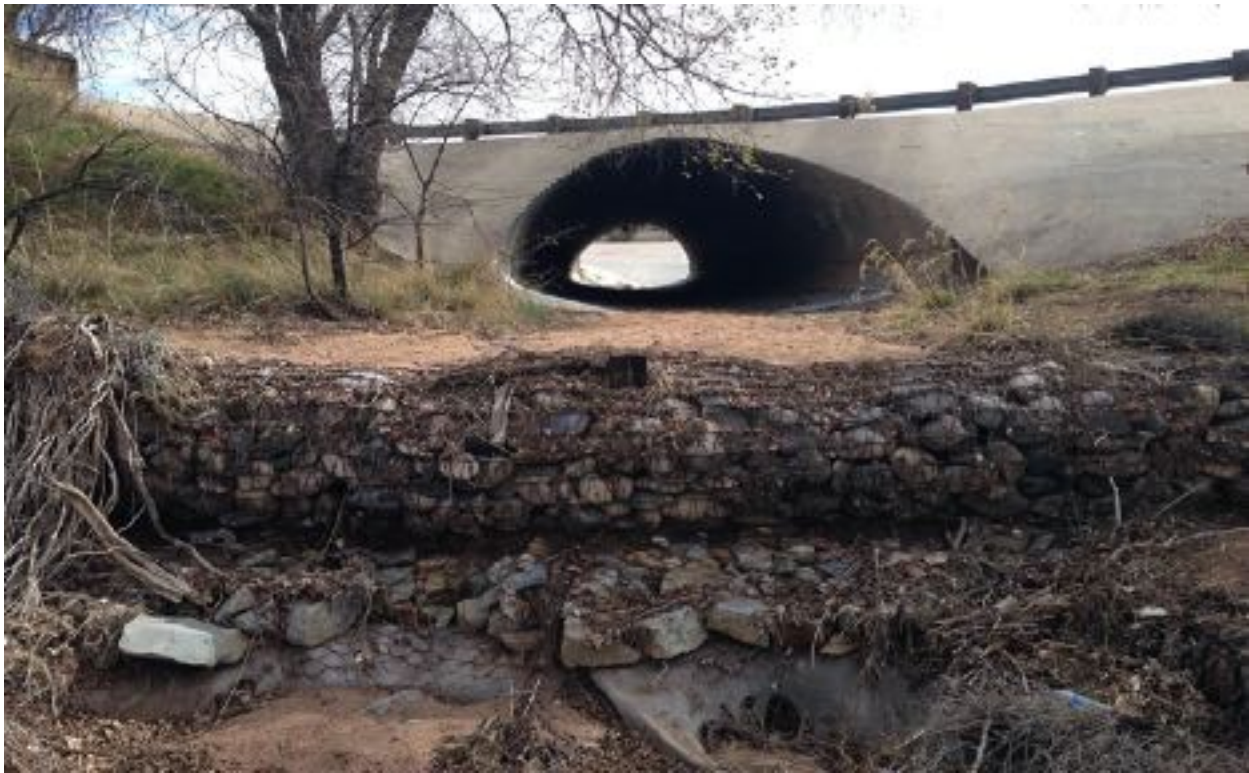
Segment A/Rip rap below culvert, Arroyo Chaparral, 2016.
